**BLACKWOOD DISTRICT FIRE 18
BRIDGETOWN
27 DECEMBER 2003**

FIRE NARRATIVE

**Compiled by
Lachlan McCaw¹ and Rob Round-Turner²**

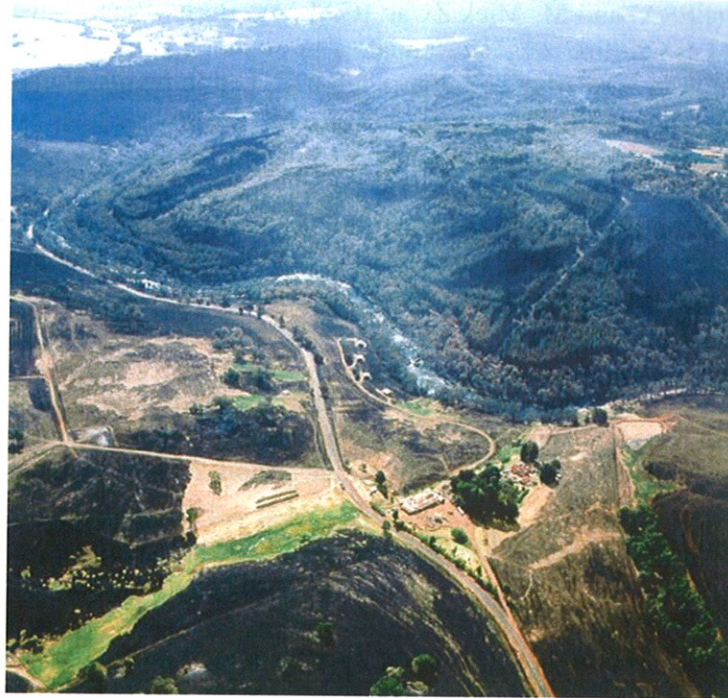
Rainfall at Bridgetown was 826 mm during the 12 month period to December 2003, closely matching the average of 823 mm. However the period from October to December was slightly drier than average (Anon. 2003). The month of December was dry with only 4 mm of rain recorded over four days from 18 to 21 December. At the time of the fire most dams retained good water levels, including some smaller dams that would normally dry out completely by the end of summer. Good seasonal conditions resulted in heavier than average growth of annual grasses. Dense swards of Wild Oats more than 1m tall were common in un-grazed areas. By the end of December, grasses in upland pastures and pine plantations were fully cured. Grass curing was incomplete in moist sites along the valley of the Blackwood River, including within and around the Bridgetown townsite. Swards of Kikuyu grass along drainage lines remained green and lush (Fig. 1).

Figure 1. View NW from the Brockman Highway across the Blackwood River in early January 2004. Low lying areas still carried green grass at the time of the fire, while upland pastures were fully cured. The extent of crown damage in pine plantation north of the river varies from minor crown scorch through to complete defoliation. Buildings are on Loc. 6361.

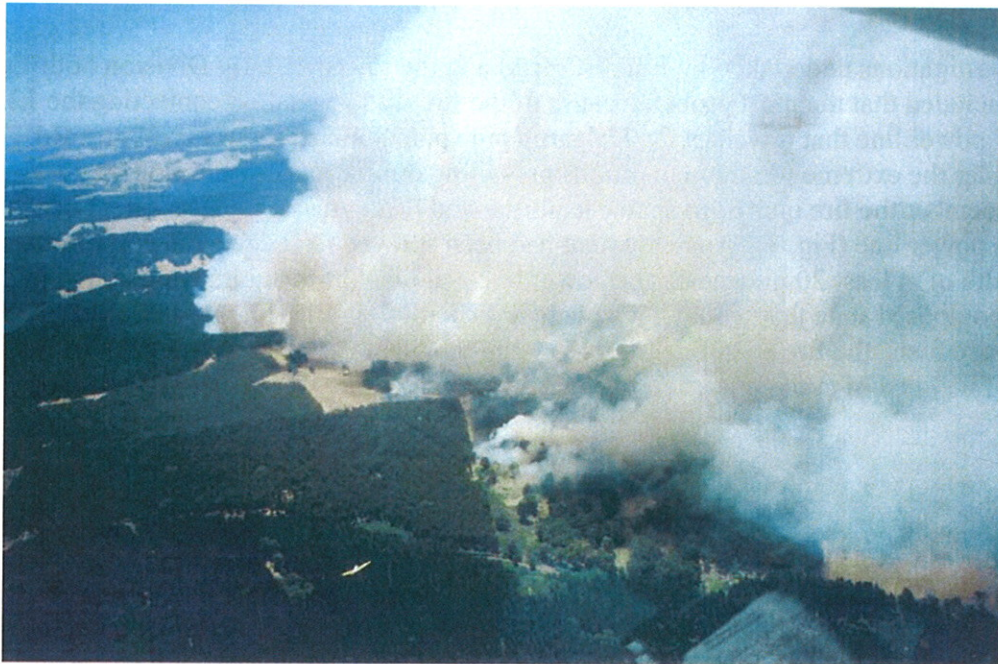
Figure 2. Photograph taken by the pilot of the CALM spotter aircraft looking north towards the origin of the fire at around 1200 hrs on 27 December. The large smoke plume appears to originate from fire in the Dalgarpur pine plantation. In the foreground a number of spot fires are visible in private property (Locs. 20 and 886) adjoining Davies Rd.

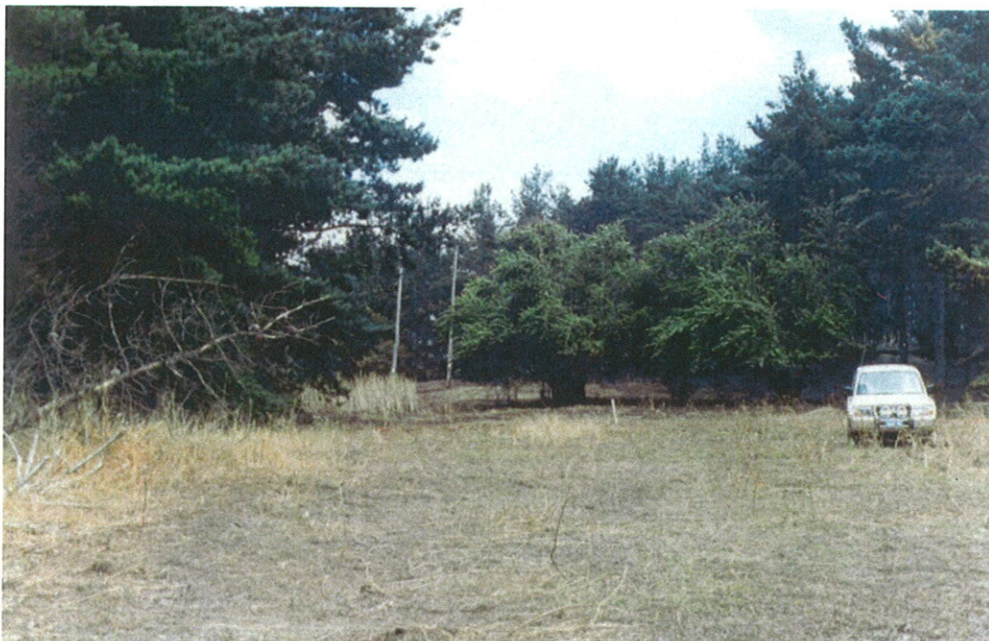
Figure 3. View southwards along the easement beneath the power line. The vehicle is parked immediately adjacent to Five Gates Rd. Two large Manchurian Pear trees can be seen growing on the easement directly beneath the power line. Spraying has restricted the growth of grass and weeds on the easement.

Investigations undertaken by FESA/CALM and the Energy Safety Division both concluded that the most probable cause of the fire was vegetation contacting the 12.7 kV power line that traverses the Dalgarpine plantation south of Five Gates Rd. Under the extreme weather conditions prevailing during the late morning on 27 December the fire ignited in sparse leaf litter and dead grass on the easement beneath the power line (Fig. 3). The easement had been sprayed to remove the grass for a width of at least 20 m beneath the power line and most of the grass residue was in a decomposed state that would have made it difficult to ignite (Fig 4). Despite the sparse fuels, the fire continued to spread into the plantation where it developed rapidly in a fuel bed of cured grass and pine needles (Fig. 5)

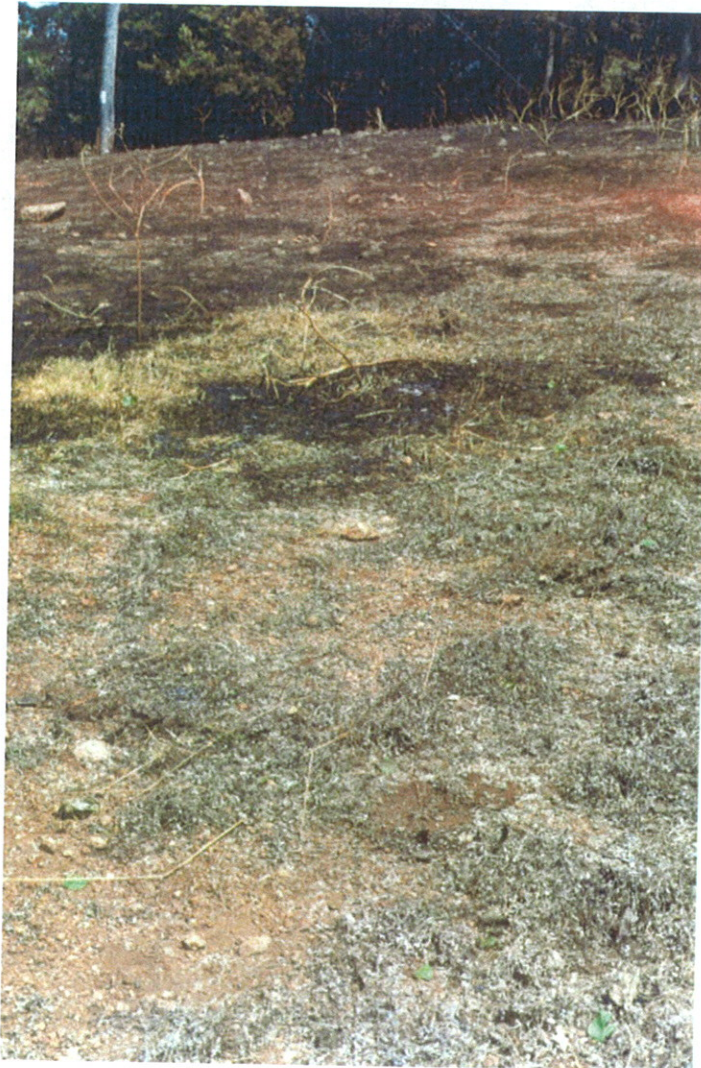
Figure 4. Section of easement south of the two pear trees showing the sparse condition of the ground fuels and patches of bare ground and unburnt grass residue.

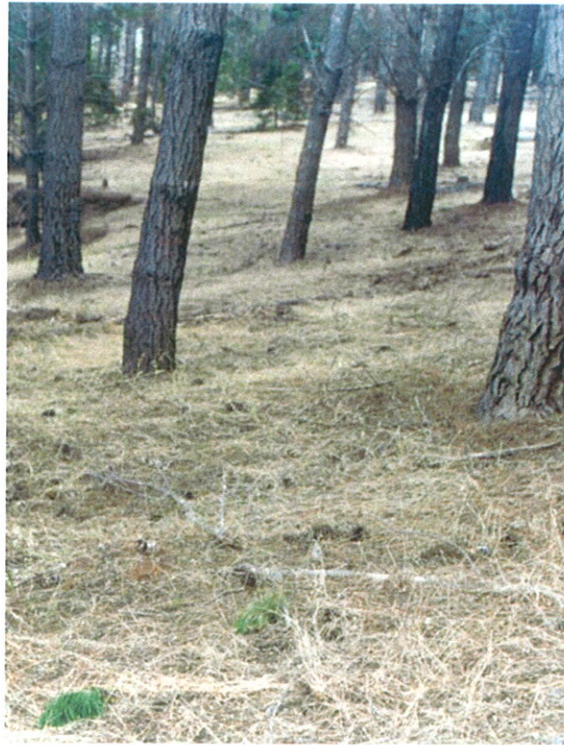
Figure 5. Fuel bed of pine needles and cured grass fuel in Dalgarup pine plantation about 500 m east of the fire origin.

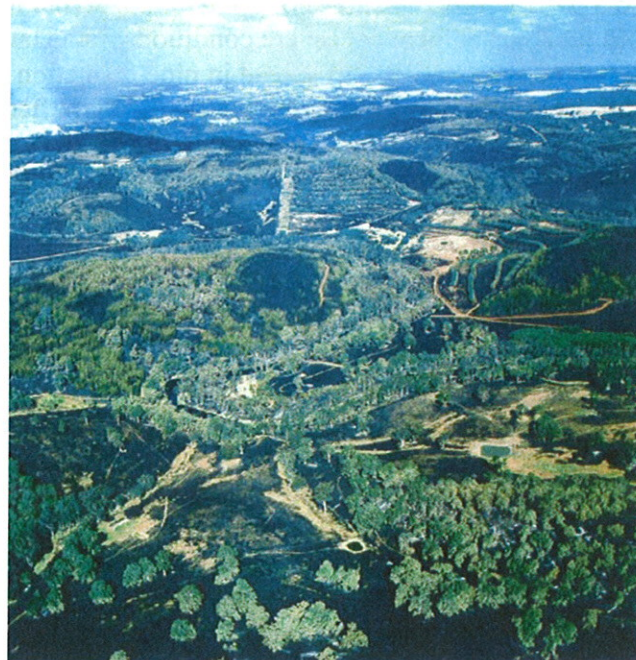
Figure 6. Looking ESE along the direction travelled by the head-fire. Longs Plantation and the Blackwood River are visible in the foreground. Much of the remnant native forest in paddocks and along the river has not been fully scorched by the fire, and there are unburnt patches where the pasture has not fully cured.

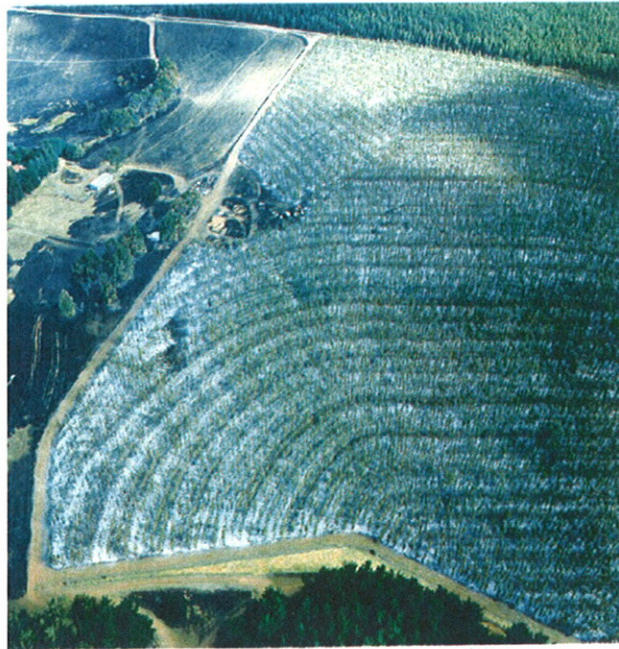
Figure 7. View to the south-east across Loc. 2 showing burnt second rotation Bluegum plantation in the foreground, and unburnt Bluegum plantation behind.

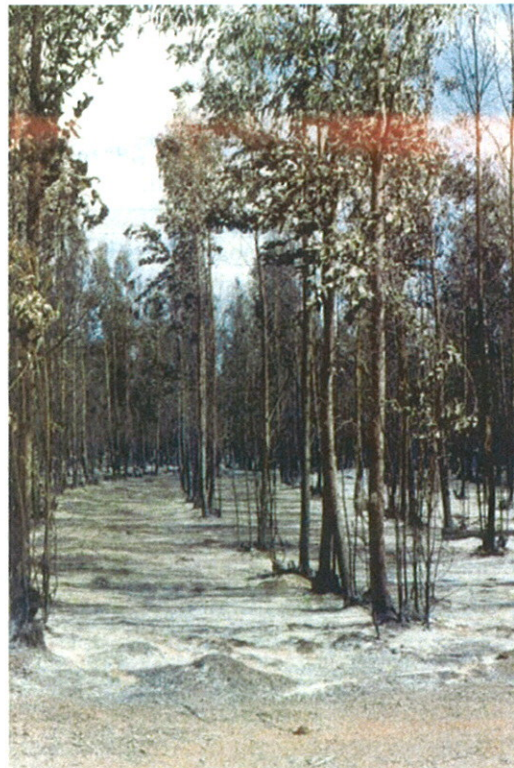
Figure 8. Looking into burnt second rotation Bluegum plantation on Loc. 2 showing coppice stems re-grown from harvested stumps, and white ash resulting from consumption of thinning slash on the ground.
