**REPORT OF AN INVESTIGATION INTO THE  
ORIGIN OF BUSHFIRES  
ON 15 NOVEMBER 2002  
IN THE SHEEPWASH AND REDMOND AREAS  
ADJOINING THE HAY RIVER,  
SOUTH-WESTERN AUSTRALIA**

Prepared by Lachlan McCaw  
Department of Conservation and Land Management  
Science Division  
Manjimup, 6258, Western Australia  
14 March 2003

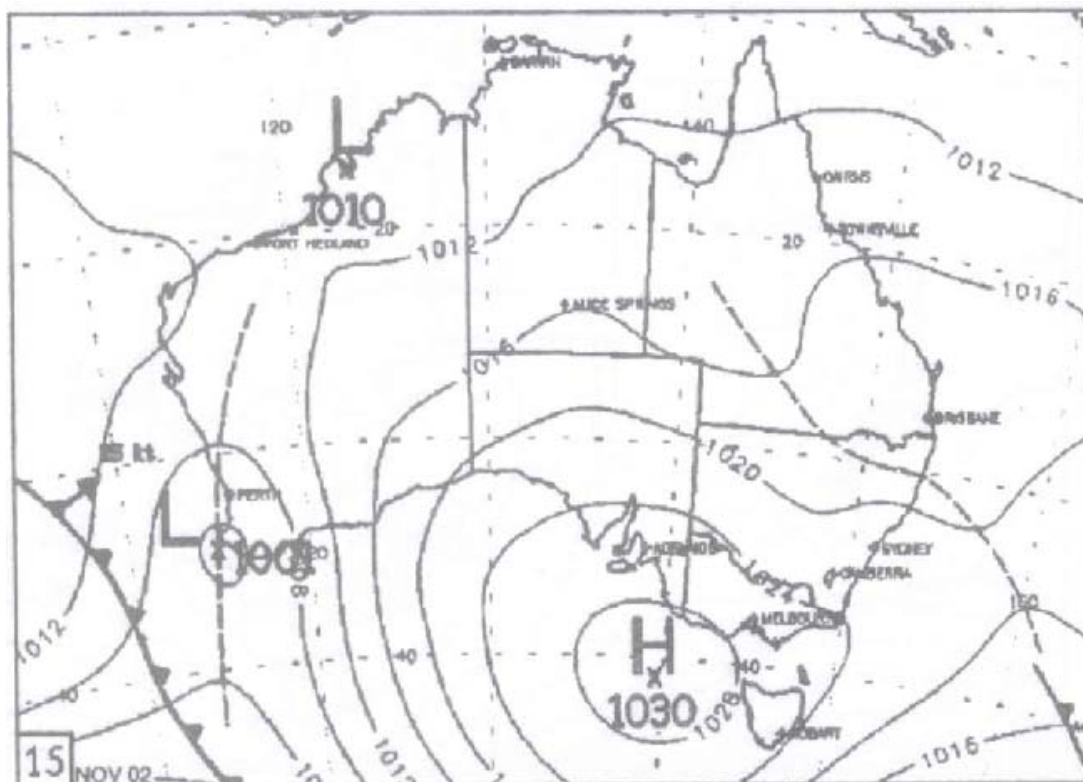
Figure 2. Synoptic chart for 15 November 2002 (Source: Bureau of Meteorology)

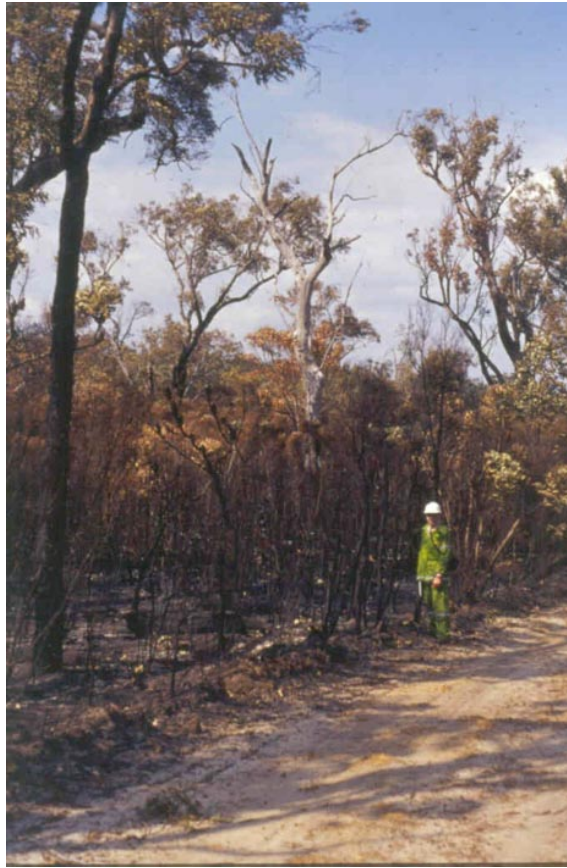
It is possible that, under the extreme fire danger conditions during the morning of 15 November, smouldering logs or stumps re-ignited unburnt areas of fuel within the burn boundary. The first-arriving personnel at the fire observed active fire behaviour both north and south of the road and reported that pockets were continuing to burn actively north of the road until after 1100 hrs. During a field inspection on 16 November fire investigators were able to find a number of locations where fire had re-burnt through the previously edge-burnt vegetation on the northern side of the road, particularly where there was a dense layer of understorey shrubs that had been scorched but not fully consumed during the edge-burning operations earlier in the spring (Figures 3-6).

**Figure 3.** Centre Break Rd, showing an area on the north side of the road where the fire had re-burnt through previously edging and spread to the south side of the road.

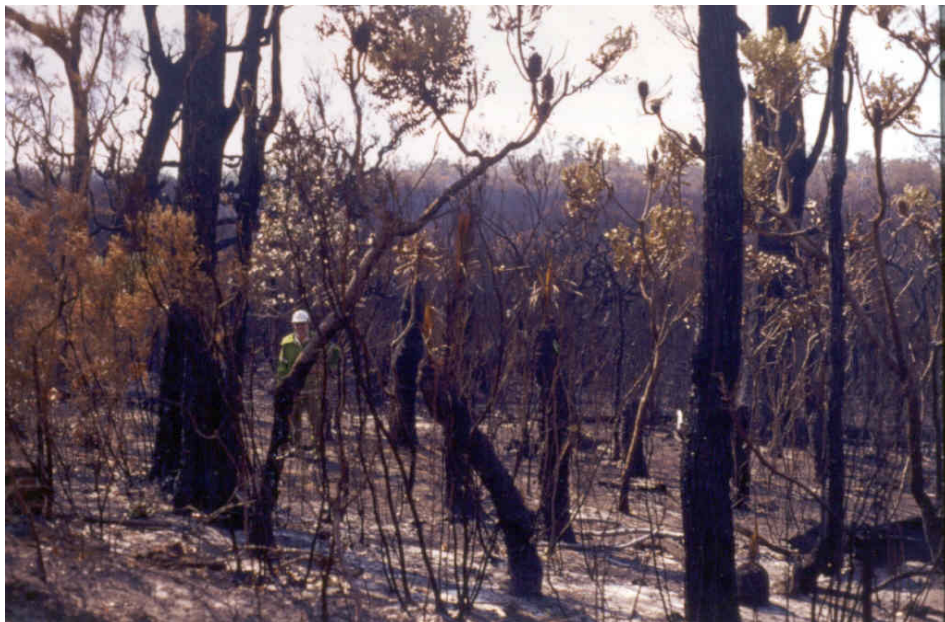
**Figure 4.** Centre Break Rd, showing an area directly north from the location of Figure 3 where fire had been active during the morning of 15 November. Note the evidence of high intensity fire behaviour in shrubby fuels at the rear of the photograph.

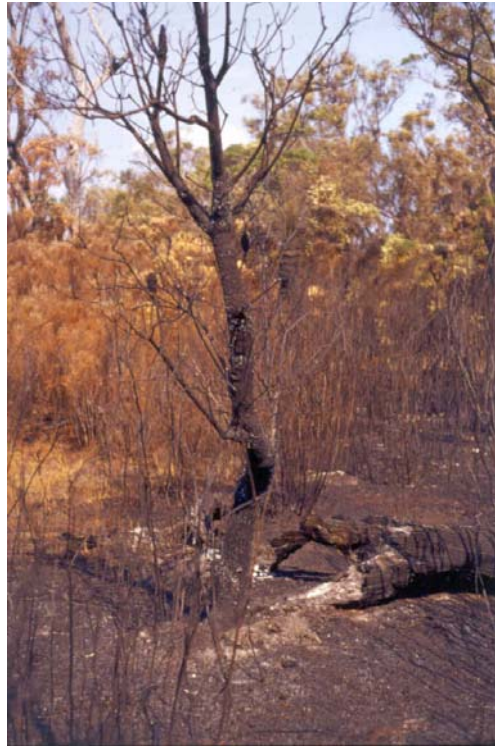
**Figure 5.** Centre Break Rd, showing an area north of the location of Figure 3. Blackened areas on the right of the photo indicate where fire has re-burnt through shrub fuels previously burnt at low intensity during edge burning operations. The left side of the photo shows browned shrub foliage remaining from the edge burning.

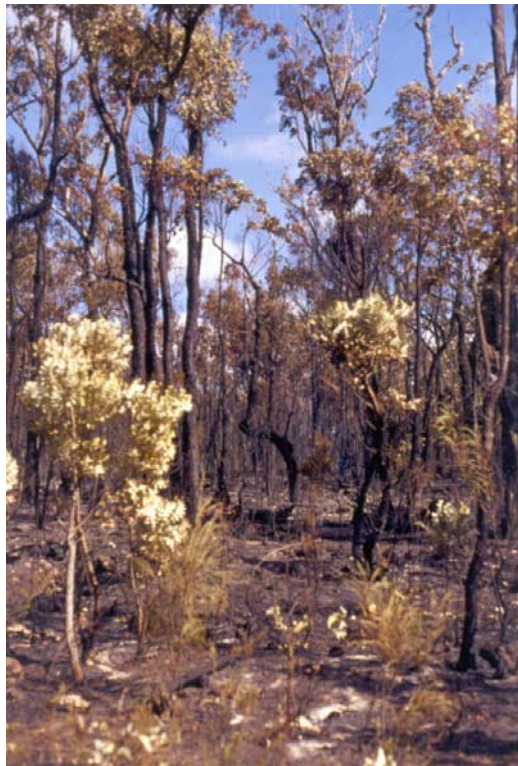
**Figure 6.** Centre Break Rd, showing the path of fire spread south of the road from the same location as Figure 3.

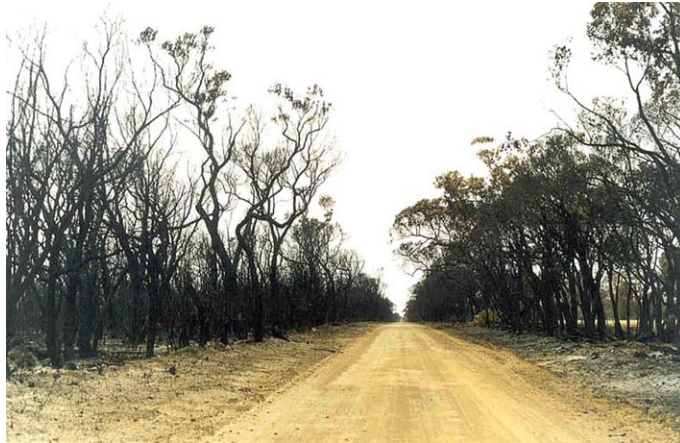
**Figure 7.** West Redmond Rd, looking east across the path of the head-fire. Cleared paddocks on Loc.6636 are visible on the right hand side of the photo behind the road reserve vegetation.

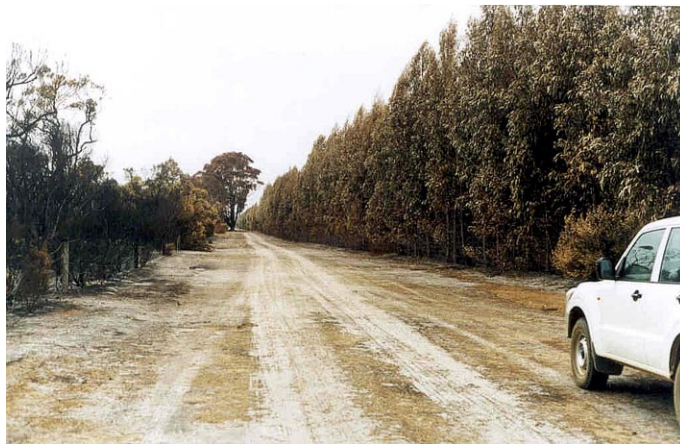
along the road (Figure 8). Large numbers of firebrands were also deposited within the plantation and associated patches of remnant native forest. Within the plantation, fires resulting from spotting activity generally burnt with low intensity in sparse surface fuels that consisted mostly of clover and scattered eucalypt leaves. In contrast, patches of remnant native forest burnt at high intensity with trees up to 20 m tall defoliated by crown fire. Firebrands also ignited a number of log heaps in paddocks containing green pasture (Figure 9), and an area of swampy vegetation on the boundary between eastern side of the Reed plantation and Loc. 6638 about 1 km south of the West Redmond Rd.

**Figure 8.** West Redmond Rd, looking east along the northern boundary of the Reed bluegum plantation. Photographed from the north-east corner of Loc 6636. Note defoliated native vegetation in the road verge on the left of the photograph.

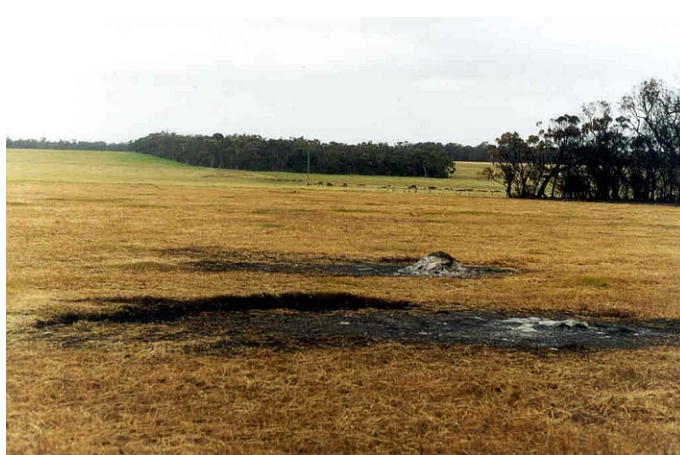
**Figure 9.** West Redmond Rd, view south into Loc.6636 with burnt log piles in the foreground. Brown appearance of pasture is due to heat scorch from the fire.

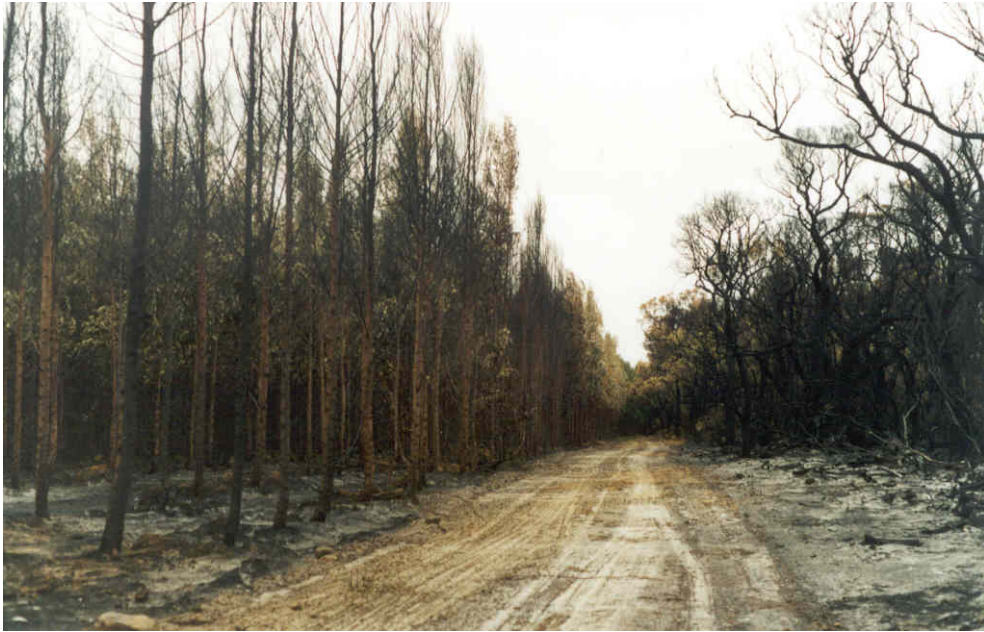
**Figure 10.** Reed bluegum plantation, looking south. The patch of remnant native vegetation on the right of the photograph has been ignited by spotfires, and following the west-south-west wind change has spread across the track into the 3-year-old bluegum plantation resulting in defoliation of the first 5 rows of trees. Fire subsequently reverted back to a surface fire burning in sparse litter beneath the plantation, and spread a total distance of about 70 m into the plantation.

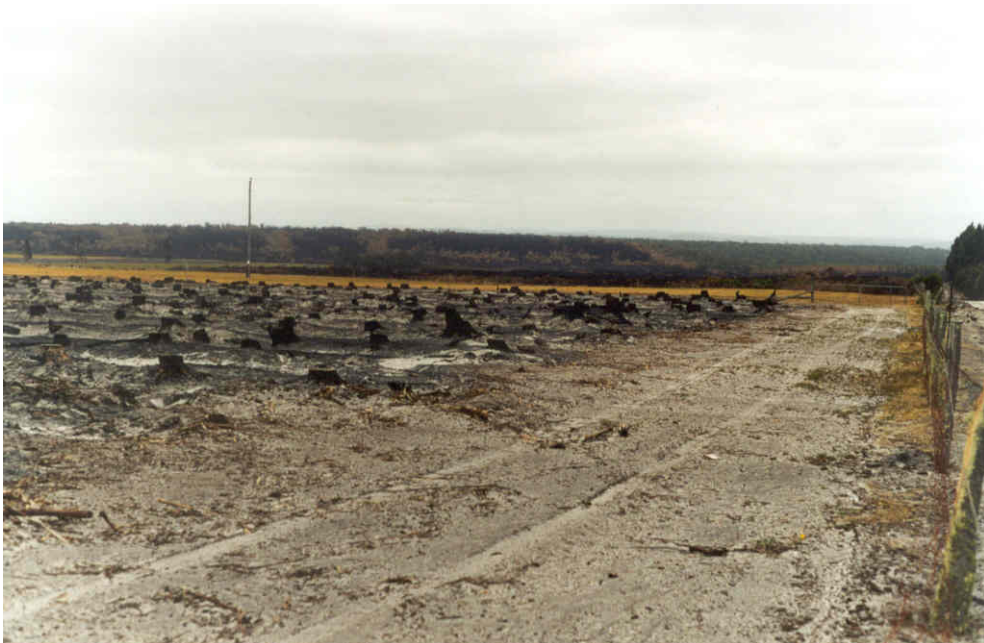
**Figure 11.** West Redmond Rd, looking south into Loc. 6638 across burnt bluegum slash fuel.

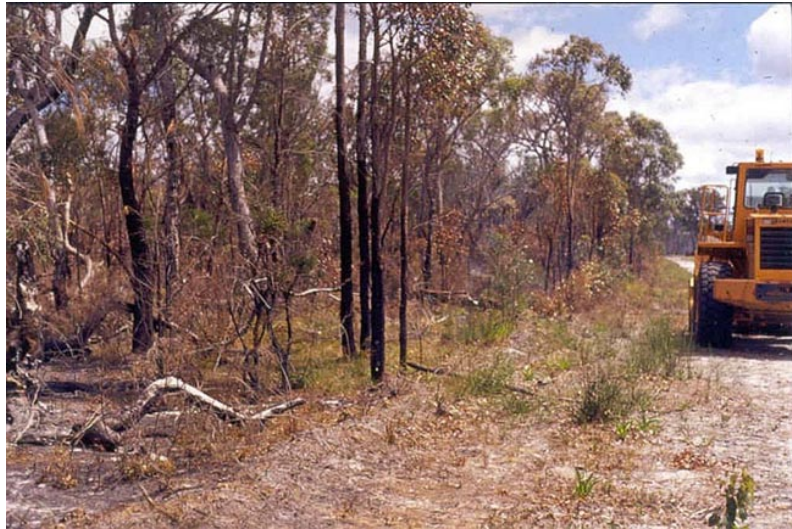
The Investigation Team undertook a detailed field inspection of the area within WLP\_110 south of Spencer Rd. and west of Loc. 85 where fire activity had been initially reported by the spotter aircraft (Figure 12). We identified a distinct path where a head-fire had run with a north-west wind from within the prescribed burn out towards the boundary. In places this run re-burnt through the sparse litter layer that had accumulated since the edging was done in late autumn 2002 (Figure 13). The Investigation Team followed the head-fire path back to the north-west limit to the point where young fuel resulting from the autumn 2002 edging were encountered. Investigators did not find any burning trees or fallen logs that had obviously acted as a source of ignition for the fire run, although this could be difficult to locate in such a large burnt area.

**Figure 12.** Spencer Rd, looking north along the edge of Sheepwash block where it adjoins Loc. 85.

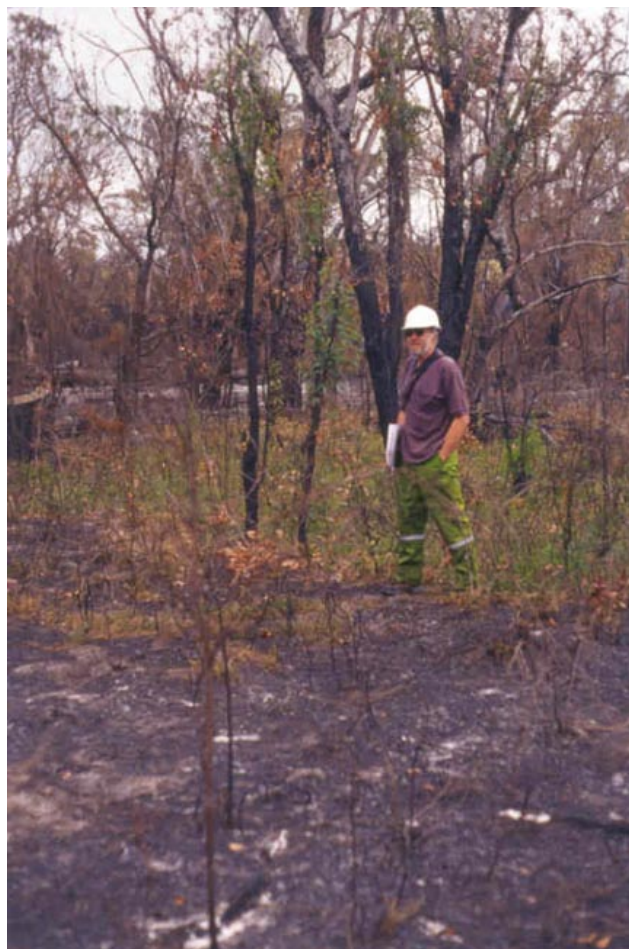
**Figure 13.** Area of Sheepwash block adjacent to Loc.85 showing blackened ground where the fire of 15 November had re-burnt through the edging done in late autumn 2002. The patch of green shrubs behind Jim Gould (CSIRO) is a section of the autumn-burnt edge that did not re-burn.

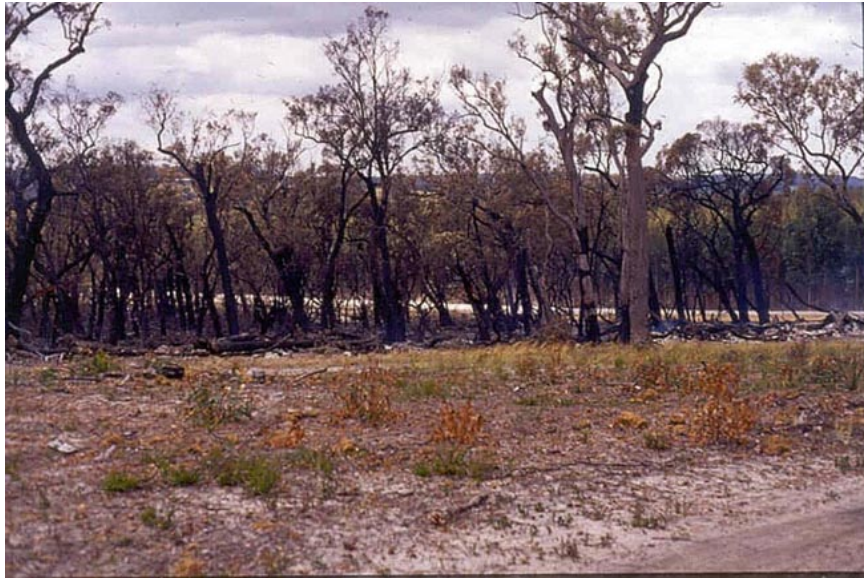
**Figure 14.** View to the south-east from the boundary of Sheepwash block across Loc.85 showing the 35 m wide cleared break in the foreground and the remnant native forest beyond. The Crystal Brook bluegum plantation is beyond the firebreak that is visible in the middle of the photograph, and is about 170 m from the point where the photograph was taken.

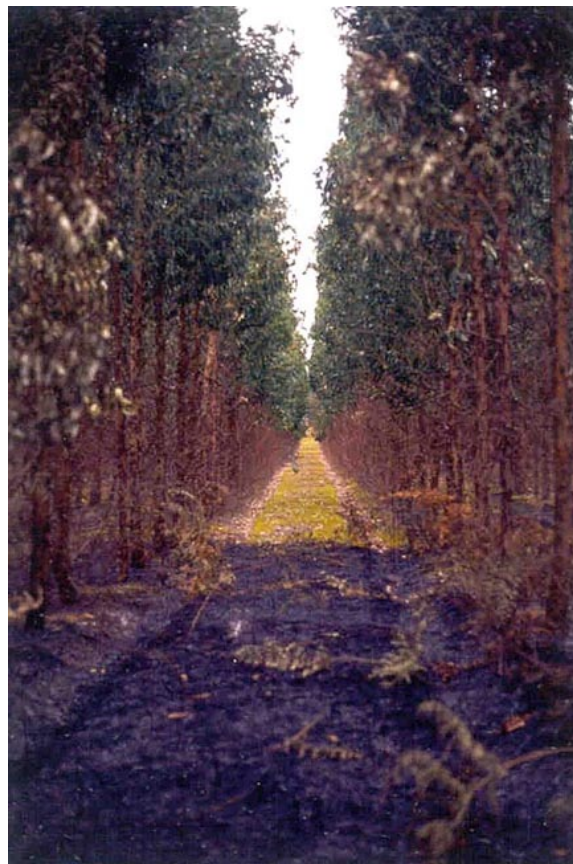
Spot-fires that developed within the plantation generally burnt at low intensity because of light ground fuels (Figure 15). A small area of second rotation plantation on the east side of the Hay River that had coppice shoots several metres tall was burnt, with the fire spreading predominantly in slash fuels remaining after the harvesting operation. There were several places where edge trees in bluegum plantation were severely scorched by radiant heat from fires in adjacent remnant forest.

**Figure 15.** Light surface fuel of litter, bracken and clover ignited by a spot-fire that landed in the Crystal Brook bluegum plantation.

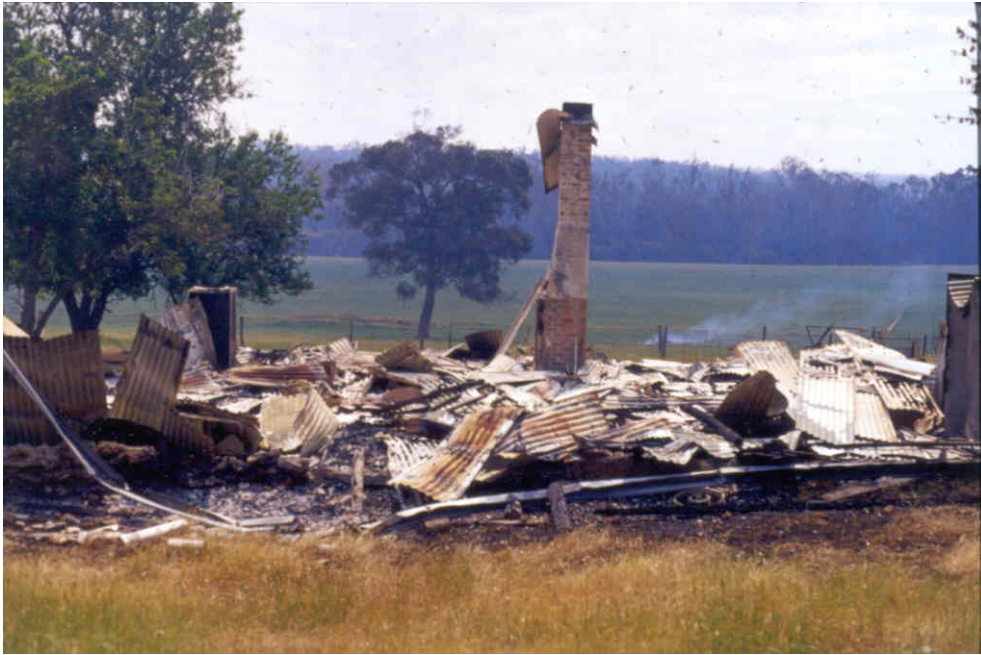
The most likely cause of ignition of a building on Loc. 1899 was from firebrands of bark and eucalypt leaves originating from the fire west of the Hay River. This would have required burning material to be transported a distance of at least 800 m across green paddocks. The considerable age of the house, the style of construction, and the fact that it was unoccupied at the time would have contributed to its vulnerability to attack by burning fragments of bark and leaves.

**Figure 16.** East side of the Hay River on Loc. 1899, showing the remains of the wood and iron house burnt on 15 November 2002. The photograph is looking west back towards the river. The grass surrounding the house was uncured at the time of the fire.

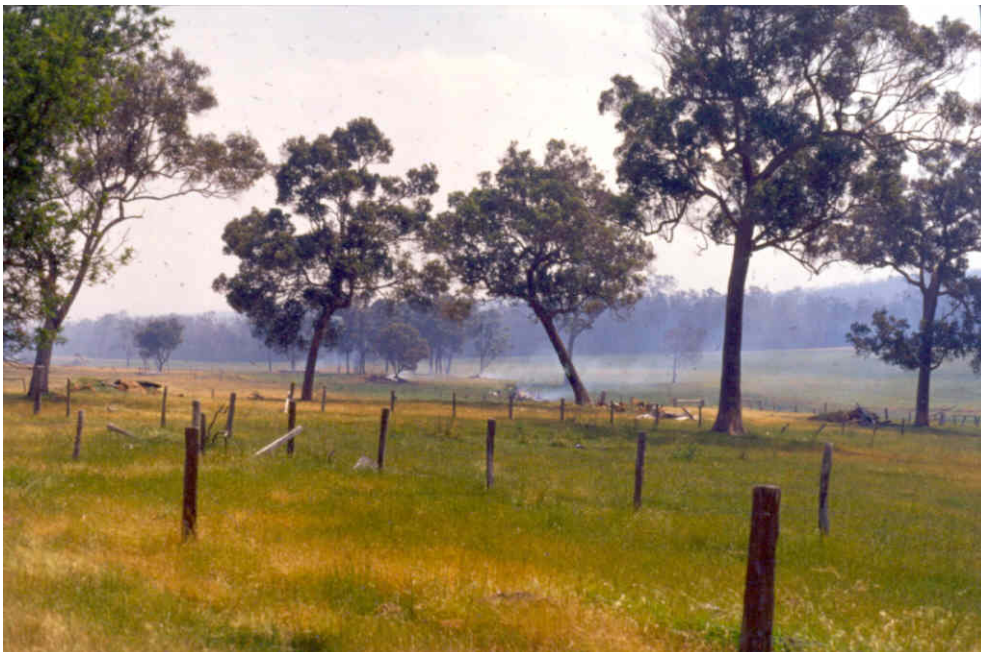
**Figure 17.** East side of the Hay River on Loc. 1899, looking south-west back towards the river. Note the green grass in the paddocks and the numerous piles of smouldering logs that appear to have been ignited by firebrands.

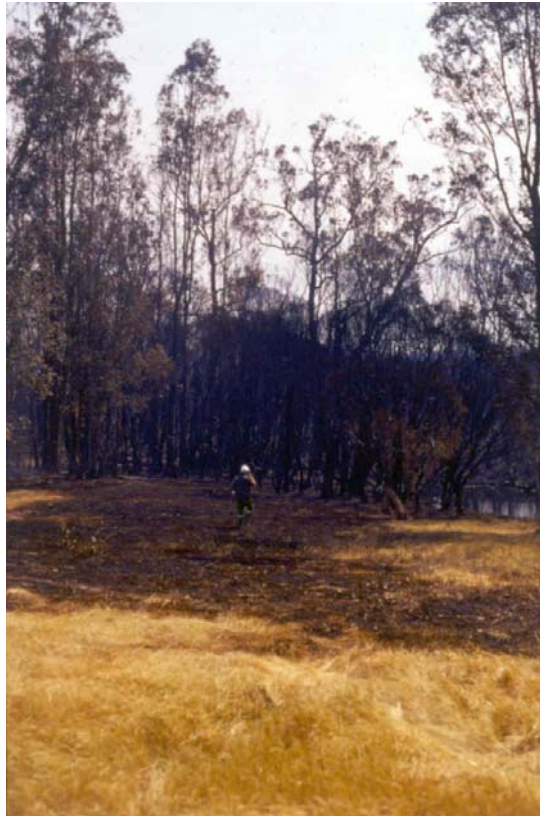
**Figure 18.** Loc. 1899, looking south-west back into the channel of the Hay River. The blackened grass in the foreground has been dried out by the heat from the fire and then burnt.

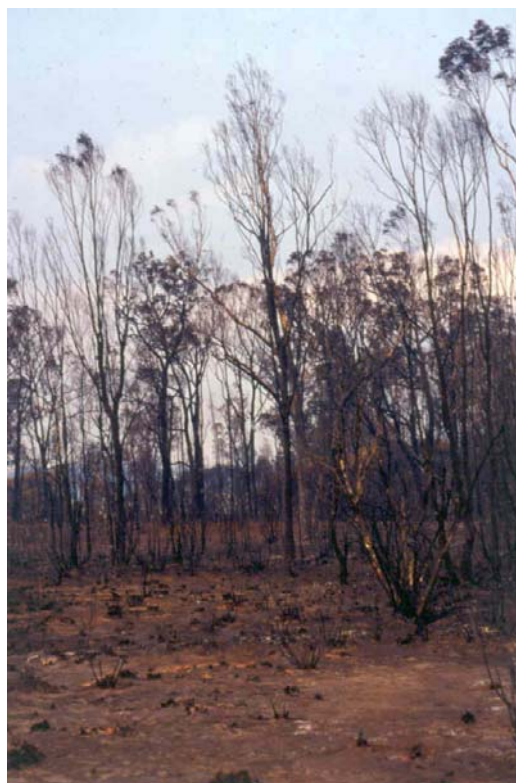
**Figure 19.** Forest along the Hay River defoliated by high intensity fire.
