CONSERVATION MANAGEMENT STRATEGY

GOLDEN VALLEY TREE PARK HOMESTEAD

PREPARED FOR: DEPARTMENT OF
BIODIVERSITY, CONSERVATION AND
ATTRACTIONS

DATE: FEBRUARY 2023

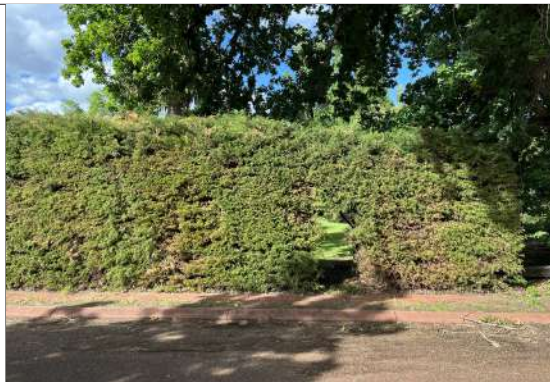
ITEM/ LOCATION	DESCRIPTION & DEFECTS	CONDITION	PROPOSED WORKS	PRIORITY	PHOTOGRAPH
EXTERNALS					
LANDSCAPING					
HEDGE (Cupressus macrocarpa or Monterey Cypress)	<ul style="list-style-type: none"> Large hedge to front perimeter approximately 4m high. Areas of overgrowth, potential disease damage and foliage loss. DBCA has advised that maintenance of the hedge is an issue and is seeking replacement options. 	C	<ul style="list-style-type: none"> Removal of the current hedge and planting of a low-maintenance hedge. Low-maintenance hedge species to be recommended by the DBCA. 	3

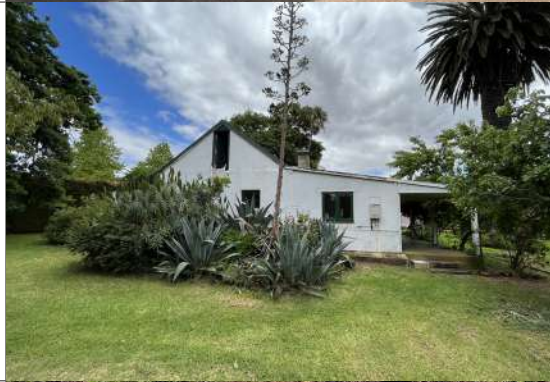
GENERAL PLANTING	<ul style="list-style-type: none"> Garden beds positioned directly against Homestead exterior walls, causing moist environment and lack of drainage to base of exterior walls. Undertake archaeological landscape work to gain understanding on locations of former paths and garden beds. 	C	<ul style="list-style-type: none"> Remove selected areas of gardens. Install perimeter break around exterior walls which could include blue metal or permeable paving to limit weeds. 	2-3

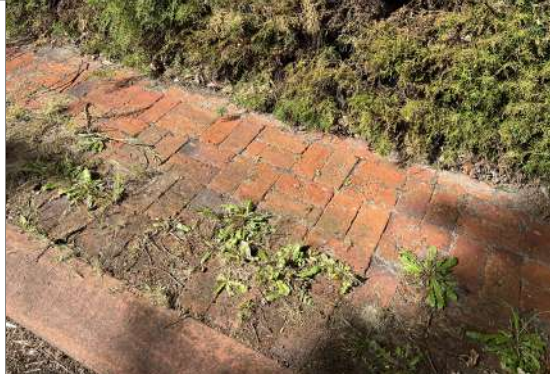
PATHWAYS	<ul style="list-style-type: none"> Convict bricks from Old Bridgetown Gaol installed c2010. 	B	<ul style="list-style-type: none"> Remove weeds and overgrowth between pavers. Paver history is considered disconnected from the significance of the Homestead, however, a record of these pavers ought to be maintained. 	4

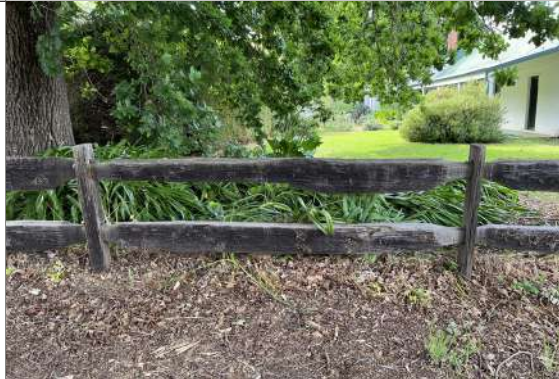
ITEM/ LOCATION	DESCRIPTION & DEFECTS	CONDITION	PROPOSED WORKS	PRIORITY	PHOTOGRAPH
FENCING	<ul style="list-style-type: none"> • Timber slab and post fence that encloses the rear of the Homestead property. • Some deterioration to timber slabs. 	B	<ul style="list-style-type: none"> • Repair damaged timber elements where necessary. • Apply oil mix to conserve timber fencing. 	4

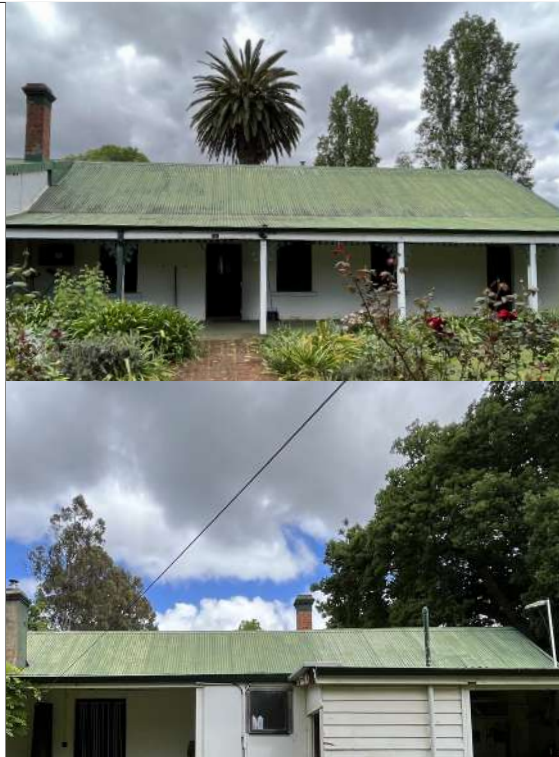
ROOF					
ROOF SHEETING	<ul style="list-style-type: none"> • Existing corrugated steel long roof sheets painted green. • Roof sheets appear generally in fair condition with some deterioration of paint. • Verbal information suggests some areas of internal water ingress. 	C	<ul style="list-style-type: none"> • The existing roof sheets should be replaced with galvanised corrugated steel roof suffi sheets. Current green finish is considered at odds with best practice. Current roof sheeting is deteriorated with evidence of damp. 	1-2

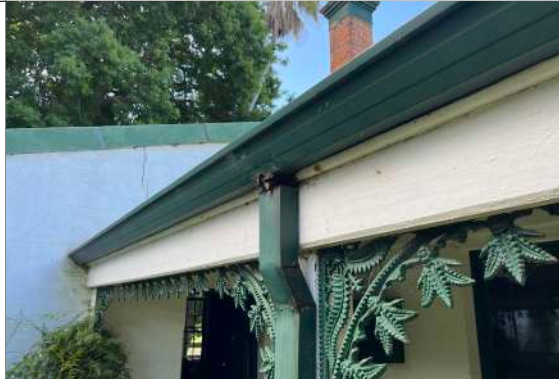
ITEM/ LOCATION	DESCRIPTION & DEFECTS	CONDITION	PROPOSED WORKS	PRIORITY	PHOTOGRAPH
GUTTERS AND DOWNPIPES	<ul style="list-style-type: none"> Green colorbond gutters. Rectangular profile downpipes painted green. Downpipes in poor condition. 	D	<ul style="list-style-type: none"> New round profile galvanised downpipes to be installed. New galvanised gutters in ogee profile. Storm water on all sides of building to be reviewed and relocated away from walls. Regular cleaning and maintenance schedule to be implemented. 	1

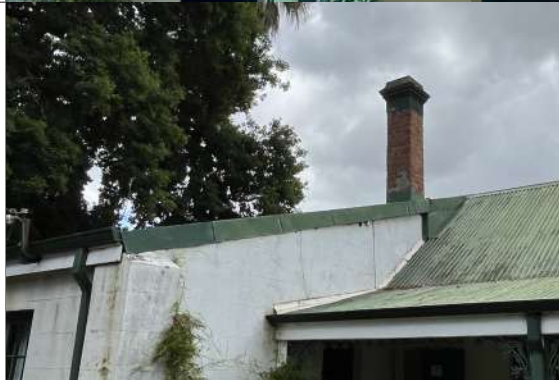
FLASHINGS AND CAPPINGS	<ul style="list-style-type: none"> Cappings and flashings painted green. Flashings to dining room chimney in poor condition. 	C	<ul style="list-style-type: none"> Replace all roof cappings, apron flashing and over flashings at same time as roof sheet replacement. New products to be galvanised. 	2

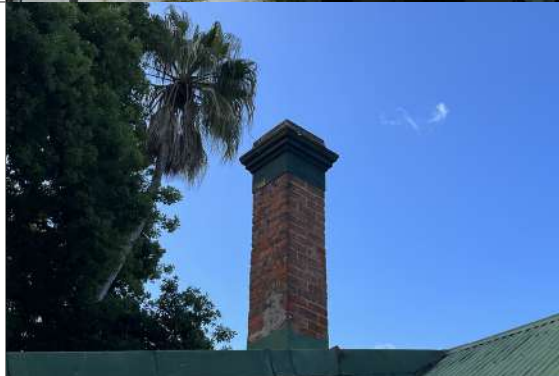
CHIMNEY (1)	<ul style="list-style-type: none"> Face brick chimney with rendered moulding. Some repair work to base of chimney. 	B	<ul style="list-style-type: none"> Remove deteriorated pointing and repoint chimney brickwork. Clean and repaint rendered moulding. Works to be completed in accordance with structural assessment. 	3

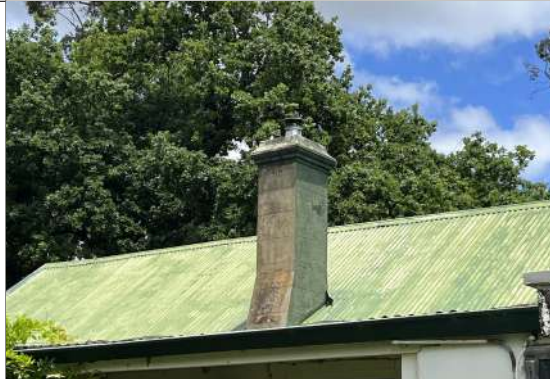
ITEM/ LOCATION	DESCRIPTION & DEFECTS	CONDITION	PROPOSED WORKS	PRIORITY	PHOTOGRAPH
CHIMNEY (2)	<ul style="list-style-type: none"> Rendered chimney with scored ashlar pattern and rendered moulding. The render appears to be peeling with a build up of organic matter. 	B	<ul style="list-style-type: none"> New flashings to be installed around base. Inspect render material. Clean and repair render. Works to be completed in accordance with structural assessment. 	3

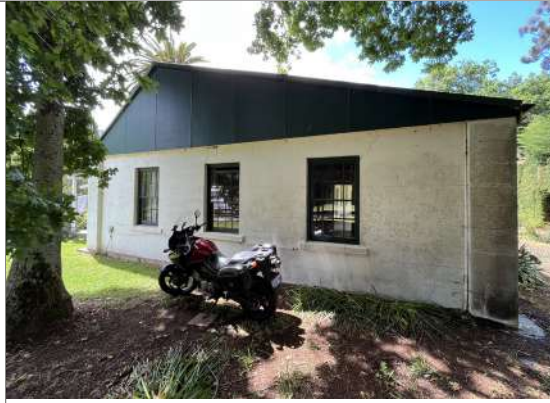
EXTERNAL WALLS					
NORTH ELEVATION (Organ Room)	<ul style="list-style-type: none"> Rendered masonry walls with scored ashlar pattern. Projecting pillars to each corner. Fibre cement sheeting to gable end. Organic matter build up to external render. Cracks to walls above windows. 	C-D	<ul style="list-style-type: none"> Material assessment to be undertaken to determine render composition. Investigate removal of external render. Works to be completed in accordance with structural assessment. Removal of fibre cement and returning gable to organ room roof considered long term priority. 	1

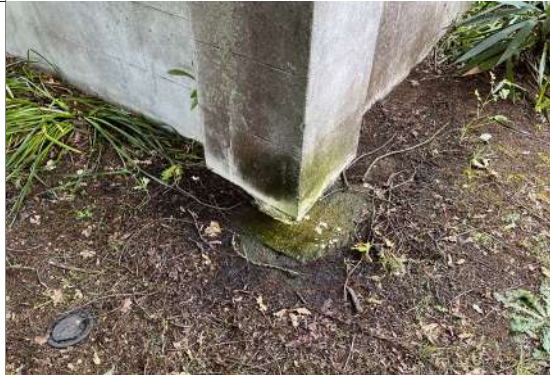
NORTHERN FOUNDATION	<ul style="list-style-type: none"> Concrete strip foundation visible above ground. Evidence of wall subsidence. 	D	<ul style="list-style-type: none"> Clean organic matter, moss and moisture build up. Remove planting from against perimeter. Works to be completed in association with external walls. Works to be completed in accordance with structural assessment. 	1

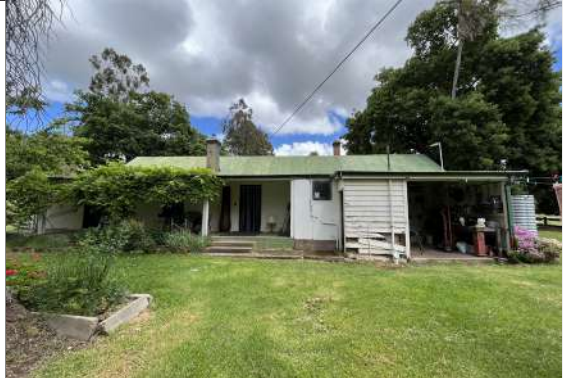
ITEM/ LOCATION	DESCRIPTION & DEFECTS	CONDITION	PROPOSED WORKS	PRIORITY	PHOTOGRAPH
EAST ELEVATION (Verandah)	<ul style="list-style-type: none"> Rendered masonry walls with scored ashlar pattern. Cracks to walls above windows and doors. 	C	<ul style="list-style-type: none"> Material assessment to be undertaken to determine render composition. Investigate removal of external render. Works to be completed in accordance with structural assessment. 	2

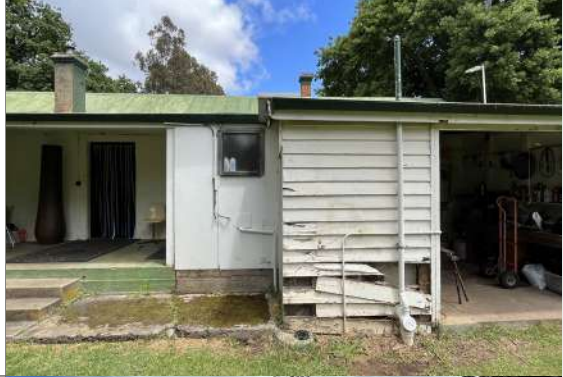
EAST ELEVATION (Bathroom and WC)	<ul style="list-style-type: none"> Bathroom walls are compressed fibre cement sheets painted white. Some damage and deterioration to exposed sheets. 	D	<ul style="list-style-type: none"> Deteriorated weatherboards to WC to be removed and replaced. Investigate material composition of CFC sheets (remove and replace if asbestos). Repair and repaint fibre cement sheeting to Bathroom. 	2

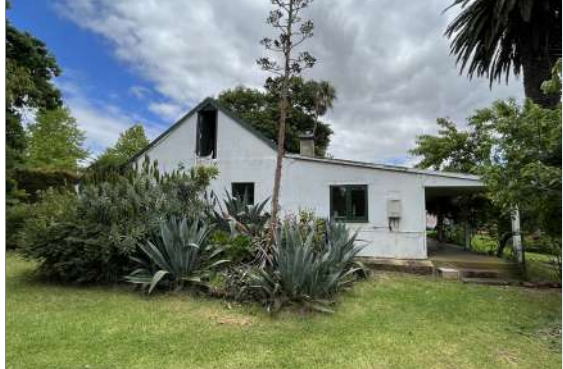
SOUTH ELEVATION	<ul style="list-style-type: none"> Rendered masonry walls with scored ashlar pattern. Wall exposed to weathering. Large areas of render are coming away from wall with large cracks. Evidence of previous repairs. 	D	<ul style="list-style-type: none"> Material assessment to be undertaken to determine render composition. Investigate removal of external render. Works to be completed in accordance with structural assessment. 	1

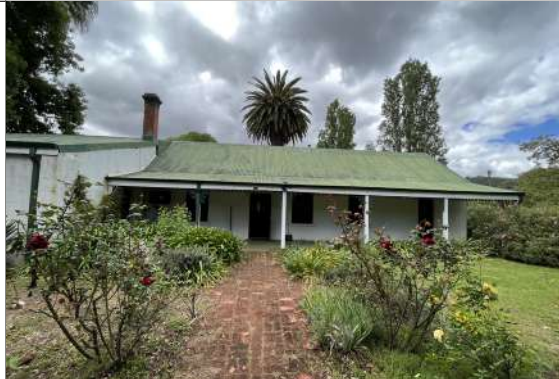
ITEM/ LOCATION	DESCRIPTION & DEFECTS	CONDITION	PROPOSED WORKS	PRIORITY	PHOTOGRAPH
WEST ELEVATION	<ul style="list-style-type: none"> Rendered masonry walls with scored ashlar pattern. Cracks to walls above windows and doors. Damage to rendered masonry window sills. 	C-D	<ul style="list-style-type: none"> Material assessment to be undertaken to determine render composition. Investigate removal of external render. Works to be completed in accordance with structural assessment. 	1

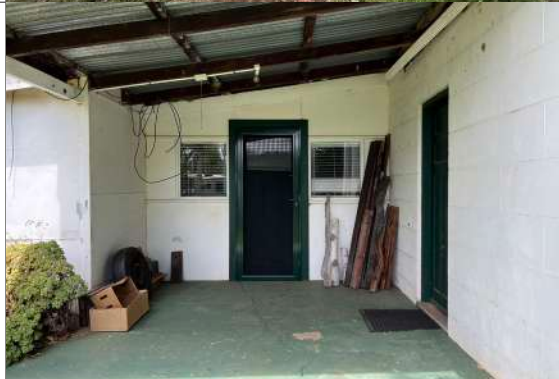
NORTH VERANDAH (COLUMNS,SLAB, CEILING)	<ul style="list-style-type: none"> 120 x 120mm square timber supporting posts. Cracking evident to concrete verandah with some peeling of paint. Roof sheeting exposed underside verandah. Electrical wiring exposed and unresolved. 	C	<ul style="list-style-type: none"> Qualified Electrician to be engaged to resolve wiring issues. Concrete verandah considered intrusive and is recommended for replacement in the long term with a timber verandah. 	1

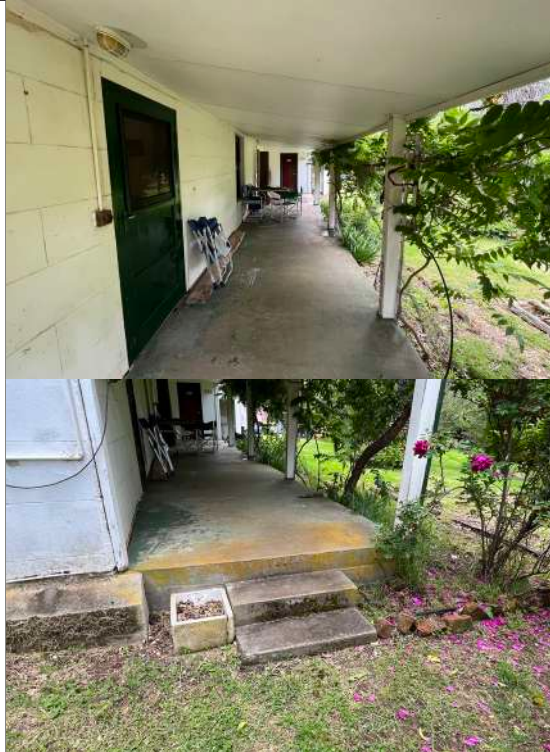
ITEM/ LOCATION	DESCRIPTION & DEFECTS	CONDITION	PROPOSED WORKS	PRIORITY	PHOTOGRAPH
EAST VERANDAH (COLUMNS, SLAB CEILING)	<ul style="list-style-type: none"> • 120x120mm square timber posts supporting verandah. • Evidence of cracking and peeling paint to the concrete verandah. • Verandah lined with compressed fibre cement boards. • Concrete steps south of the verandah. • Stairs in fair condition, some organic matter evident. 	B-C	<ul style="list-style-type: none"> • Concrete verandah considered intrusive and is recommended for replacement in the long term with a timber verandah. • Investigate material composition of CFC sheets (remove and replace if asbestos). • Follow any recommendations made by the structural engineer regarding the verandah. 	4

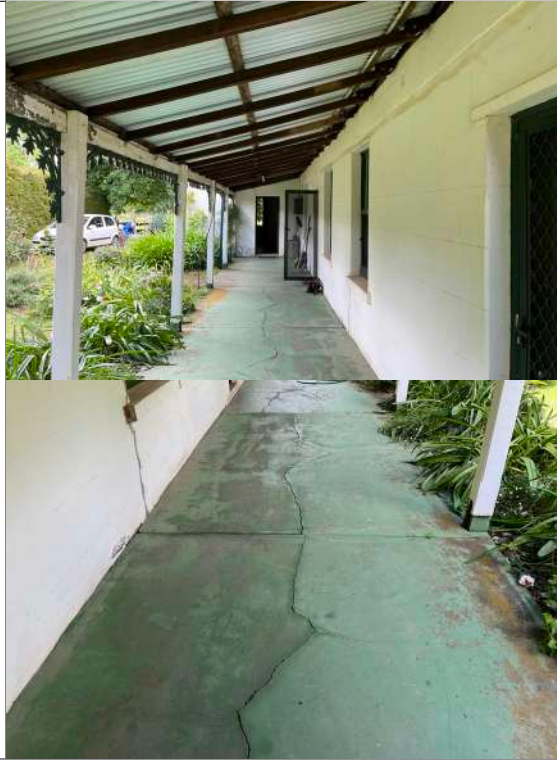
ITEM/ LOCATION	DESCRIPTION & DEFECTS	CONDITION	PROPOSED WORKS	PRIORITY	PHOTOGRAPH
WEST VERANDAH (COLUMNS,SLAB, CEILING)	<ul style="list-style-type: none"> • 120 x 120mm timber columns on concrete plinths. • Plinths potentially previous repair to address damp to base of columns. • Evidence of previous line and height of verandah against the exterior wall. • Underside of the roof sheeting exposed at verandah. • Verandah purlins and rafters unpainted. • Cast iron bracket detailing with large screw fixings to either side of columns. • Paint to columns and verandah edge beam weathered. • Concrete to verandah cracking and paint deteriorated. 	C	<ul style="list-style-type: none"> • Concrete verandah considered intrusive and is recommended for replacement in the long term with a timber verandah. • Painting of the columns and verandah beam. • Refer to structural engineer's recommendation for any column repairs. 	3

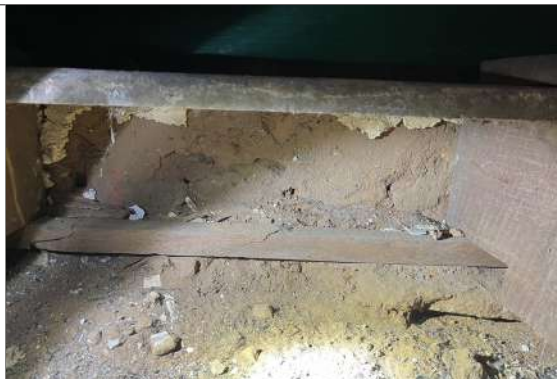
BUILDING STRUCTURE & INTERIOR					
GENERAL INTERIOR					
SUB-FLOOR	<ul style="list-style-type: none"> • 200mm deep joists on 200 x 200m plank ends bedded in the ground. • Brick piers with mud render. • Some deterioration evident with bouncing floorboards. 	B	<ul style="list-style-type: none"> • Minor repairs required where there is variation in the floor levels. • Local repair and restumping may be required. 	3

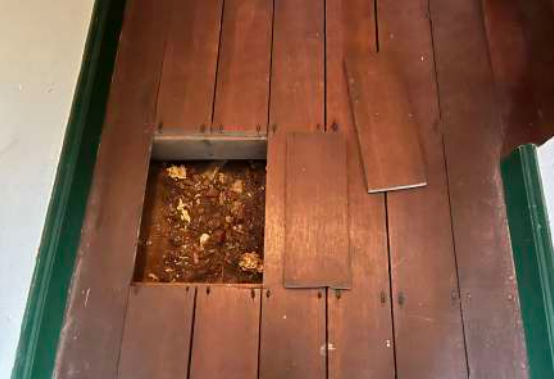
ITEM/ LOCATION	DESCRIPTION & DEFECTS	CONDITION	PROPOSED WORKS	PRIORITY	PHOTOGRAPH
FLOOR HALL, LIVING AND KITCHEN	<ul style="list-style-type: none"> 160 x 25mm jarrah boards, pit sawn and butt joined. 	B	<ul style="list-style-type: none"> Minor repairs required where there is variation in the floor levels. Local restumping required. 	3

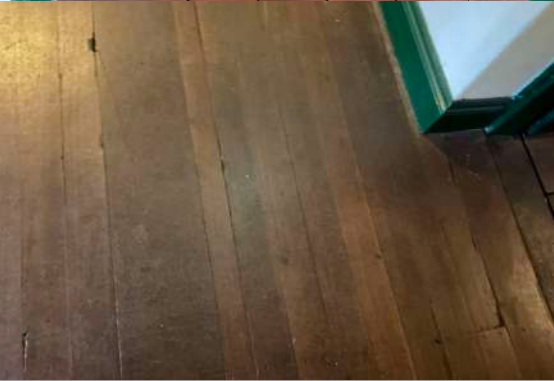
FLOOR DINING	<ul style="list-style-type: none"> 85 x 25mm tongue and groove floor boards to dining. Floor replaced in 1990s. 	B	<ul style="list-style-type: none"> Minor repairs required where there is variation in the floor. Local restumping required. 	3

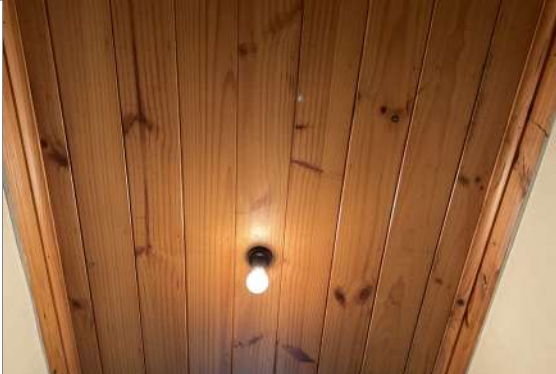
CEILINGS	<ul style="list-style-type: none"> 1990s - Pine tongue and groove with moulding at edge. 	B	<ul style="list-style-type: none"> If further information is uncovered on the original detail of the ceilings then this detailing should be reinstated. This is considered a long term conservation aim. 	4

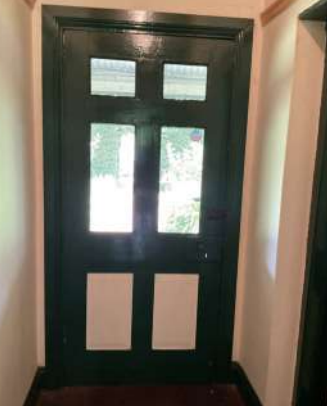
ITEM/ LOCATION	DEFECT DESCRIPTION	CONDITION	PROPOSED WORKS	PRIORITY	PHOTOGRAPH
D1 Front Entry	<ul style="list-style-type: none"> 6 panel timber door with top four panels glazed. New screen to door (Suntec). New lock/ hardware introduced. Messy paintwork. Dropped door. 	B	<ul style="list-style-type: none"> Dropped door to be further investigated. Potentially adjustment of hinges required. Poorly finished paintwork to be rectified. 	2

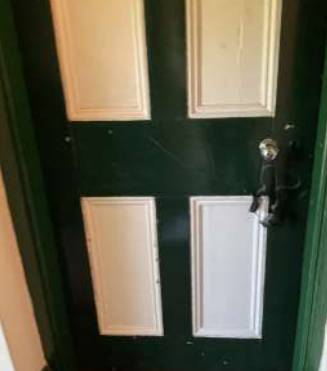
D2 Bed 2	<ul style="list-style-type: none"> 4 panel timber door. New hardware introduced. Stray paintwork. Prior repairs evident. Cracking above doorway. Door doesn't shut properly. 	B	<ul style="list-style-type: none"> Cracking above doorway to be rectified. Door frame to be checked to ensure the door is able to close. 	2

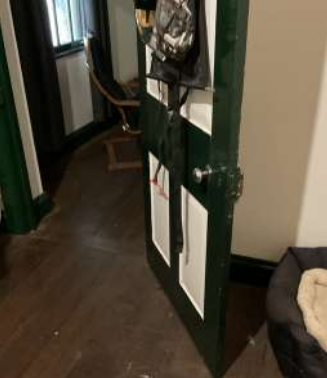
D5 Study	<ul style="list-style-type: none"> 4 panel timber door. New hardware introduced. Height of door with panes appears reduced. Door not fitting frame with some movement to frame evident. 	B	<ul style="list-style-type: none"> Door panel and frame to be adjusted to allow door to close. 	2

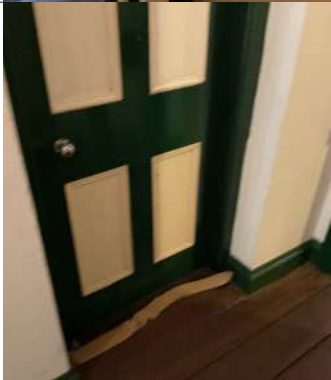
D8 Store/ Hall	<ul style="list-style-type: none"> 4 panel timber door. Termite damage to frame. Door leaf appears to be in good condition. Locked shut. 	B	<ul style="list-style-type: none"> Repair termite damage to timber frame. 	4

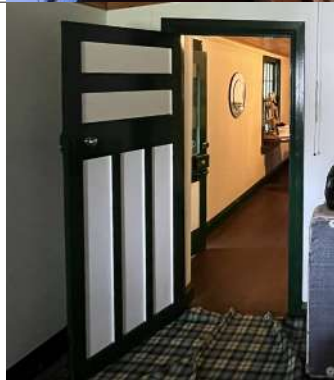
D11 Bed 3	<ul style="list-style-type: none"> Timber panel door with 2 horizontal and 3 vertical panels. Crack above door. New hardware. 	B	<ul style="list-style-type: none"> Cracking above doorway to be rectified. 	2

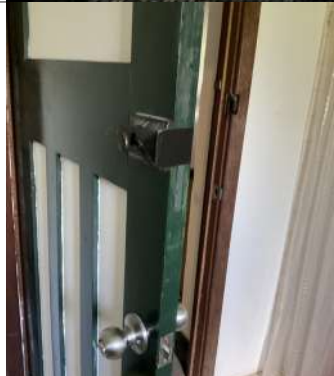
D12 Bathroom/ Bed 3	<ul style="list-style-type: none"> Timber panel door with 2 horizontal and 3 vertical panels. Lock rendered shut with tape (lock not needed). New hardware. 	B	<ul style="list-style-type: none"> Adjust hardware to meet tenant's needs. 	2

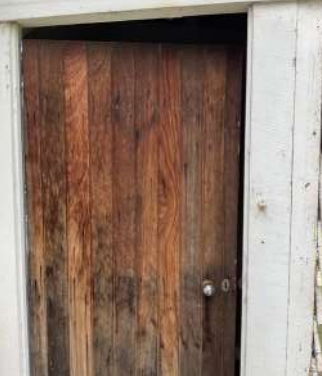
ITEM/ LOCATION	DEFECT DESCRIPTION	CONDITION	PROPOSED WORKS	PRIORITY	PHOTOGRAPH
D16 WC	<ul style="list-style-type: none"> Ledged and braced timber door. Requires new hardware. Timber panelling is weathered. 	C	<ul style="list-style-type: none"> Replace hardware. Repair and oil timber door. 	1

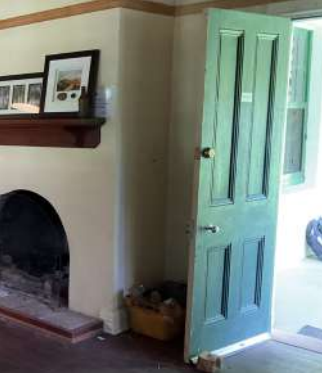
D18 Organ Room Front	<ul style="list-style-type: none"> 4 panel timber door. New threshold seal. New hardware. Crack above door. 	B	<ul style="list-style-type: none"> Cracking above doorway to be rectified. 	2

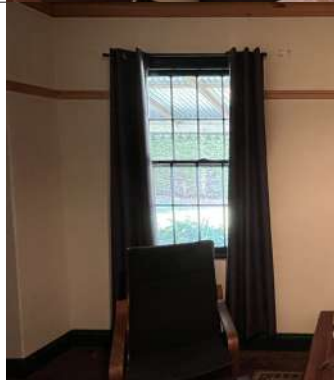
W3 Living	<ul style="list-style-type: none"> • Double-hung with 8 pane sashes. • Minor crack above window • Previous curtain fixing 	B	<ul style="list-style-type: none"> • Rectify cracking above window 	2

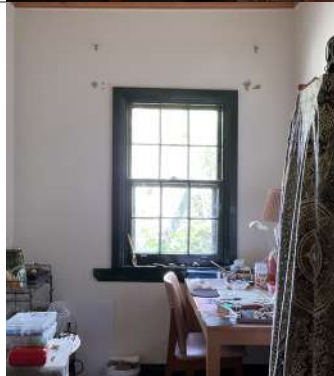
W4 Study	<ul style="list-style-type: none"> • Double-hung with 6 pane sashes. • Screen to outside. • Window goes up but nothing to prop open 	B	<ul style="list-style-type: none"> • Double hug window needs to have weights and ropes replaced to allow safe opening 	2

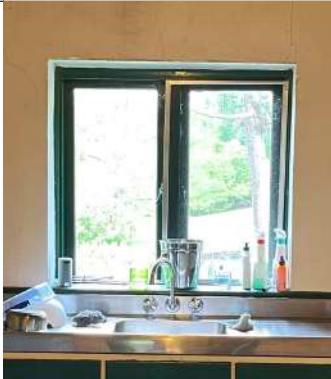
ITEM/ LOCATION	DEFECT DESCRIPTION	CONDITION	PROPOSED WORKS	PRIORITY	PHOTOGRAPH
W5 Kitchen	<ul style="list-style-type: none"> Glazed double casement window. Hardware faulty and screen screws loose and broken. Crack above window. Timber lintel to the exterior. 	B	<ul style="list-style-type: none"> Rectify cracking above window. Rectify screen and hardware so window is operable. 	2

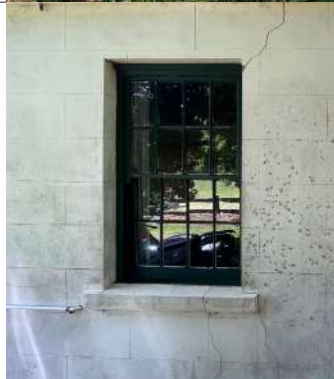
W10/W11/W12	<ul style="list-style-type: none"> • Double-hung with 8 pane sashes. • W12 isn't able to be closed. • Cracking above windows. 	C	<ul style="list-style-type: none"> • Rectify so all windows are functional. • Rectify cracking above windows. 	2

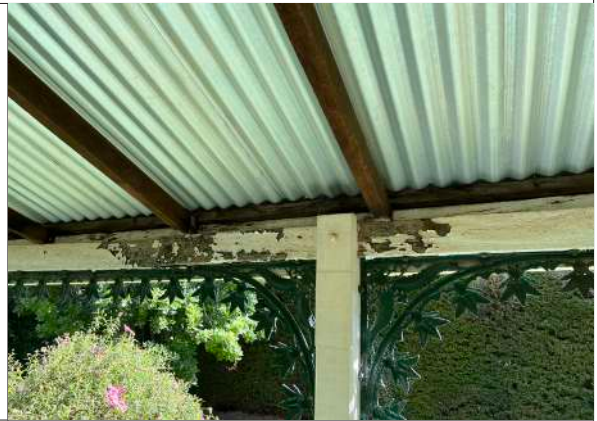
Damage and weathering to verandah beams

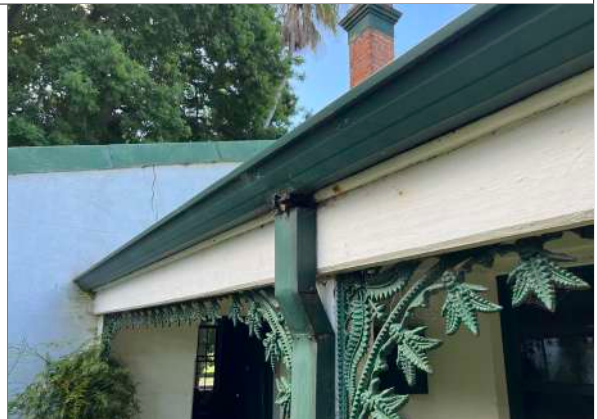
Damaged down pipes to verandah

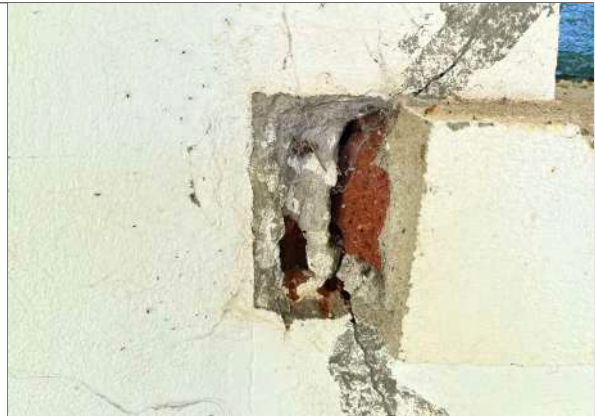
The elevation features two doors and three double hung windows. The doors and windows have cracking to the sills and window heads. Window (W3) has a large crack below the sill causing damage to the sill.

Damage to window sill (W3)

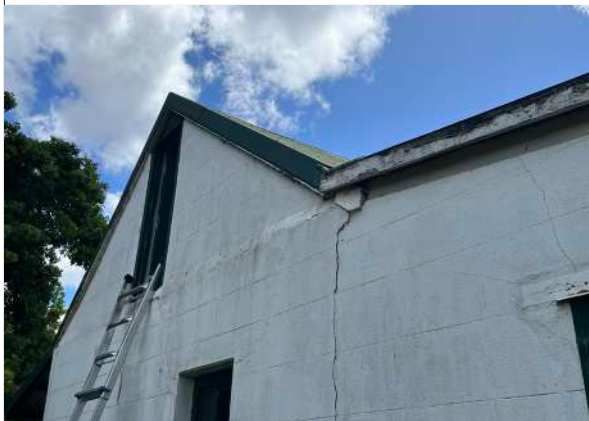
Cracking to south facade

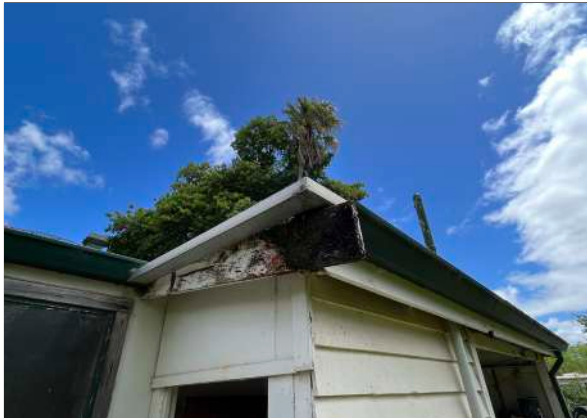
Damage to fascia above toilet

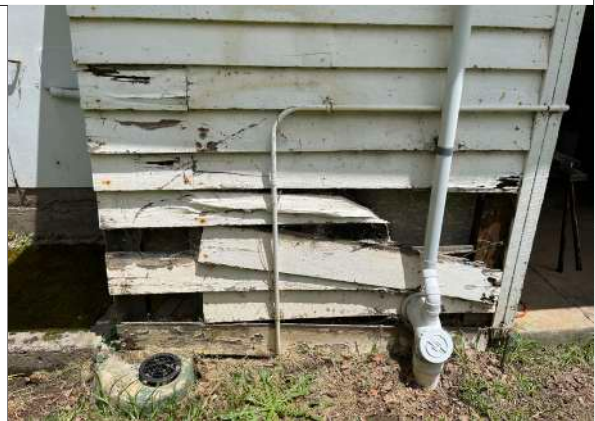
Toilet wall damage

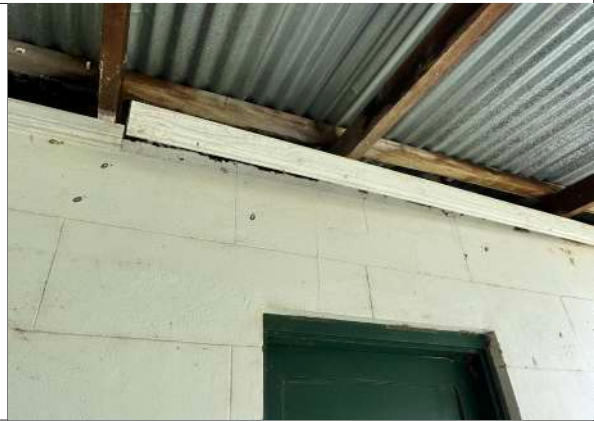
Damaged external cornice to side verandah

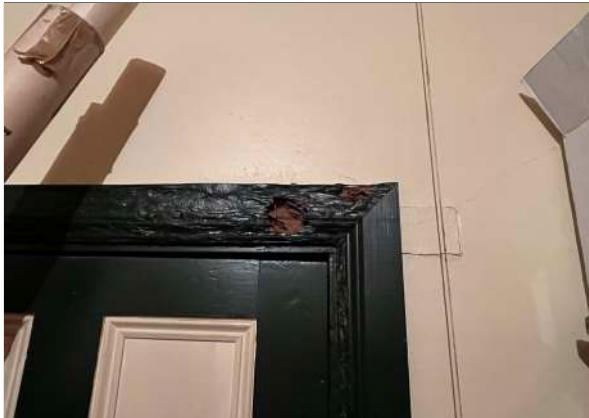
Termite damage to D8

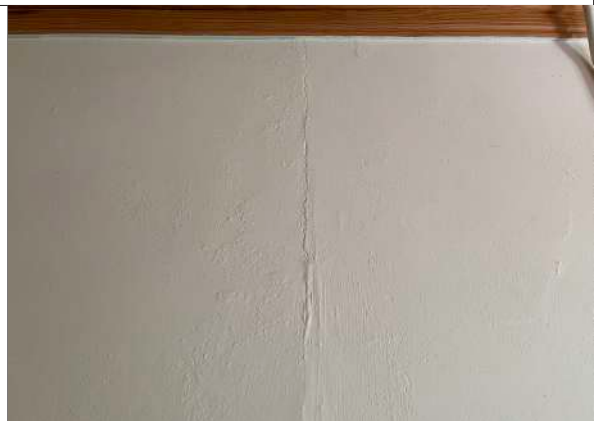
Large filled crack to Study
