Golden Valley Homestead, Golden Valley Tree Park,
164 Old Padbury Road, Balingup WA
Structural Engineering Services Assessment

Department of Biodiversity, Conservation and Attractions

Date: March 2023

Our Ref: 2234B

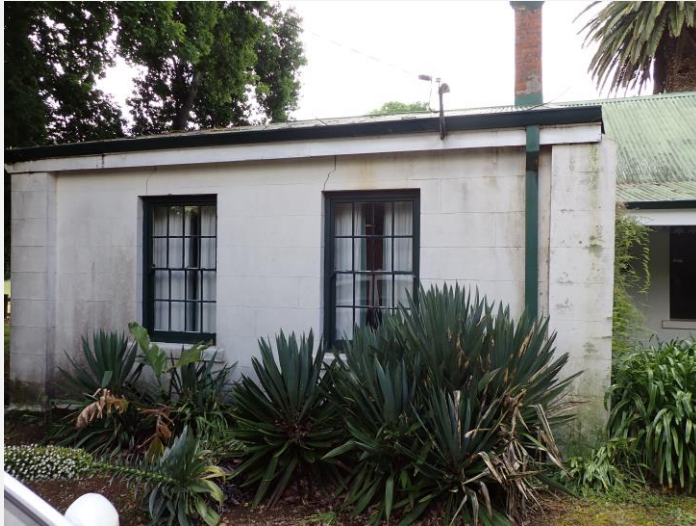
Room/Area Reference	Condition Rating	Defect Location and Description	Work to Rectify Defect	Priority Ranking
Organ Room wall	D	<ul style="list-style-type: none"> This wall, despite reconstruction and remodelling works in 1991, has shown new movement. The wall has adopted a lean to the west and wall piers at each end have also rotations outwards to the north and south respectively. Associated vertical cracking up to 8mm in width occurs externally and internally. 	<ul style="list-style-type: none"> The movement is associated with the reactive behaviour of the supporting clay soil. Some of the movement may be historic depending on the extent of 1991 reconstruction work, the panel is nevertheless still active. The appropriate action is to implement the actions on drainage and vegetation, recommended in 3.3 and 3.4 to aid soil stabilisation. No redecoration work is worthwhile until walls can be suitably stabilised. 	2

<ul style="list-style-type: none"> Monitor crack for 12 months thereafter to gain confidence of wall stability. There no danger to building users through this time. There may already be serviceability problems with windows and doors however which may continue. Engage heritage engineer to set up monitor regime. 	3
			<ul style="list-style-type: none"> Repair wall damage using standard crack stitching methods such as those by Helifix Pty Ltd prior to redecoration work. Stitching work may expand in scale for wider tying action depending on monitoring results. Works best undertaken ahead of re-decoration works. 	4
Front Verandah	C	<ul style="list-style-type: none"> Continuous crack centrally in granolithic floor slab. Historic settlement of the western side rotation has occurred here due to shrinkage effects in the supporting ground. 	<ul style="list-style-type: none"> It is important to first implement the actions on drainage and vegetation recommended in 3.3 and 3.4 to aid soil stabilisation. Removal of the garden bed in front of the slab included. 	2

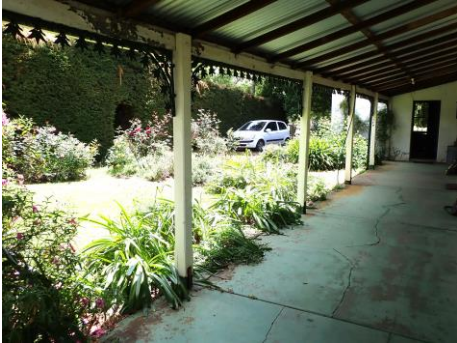
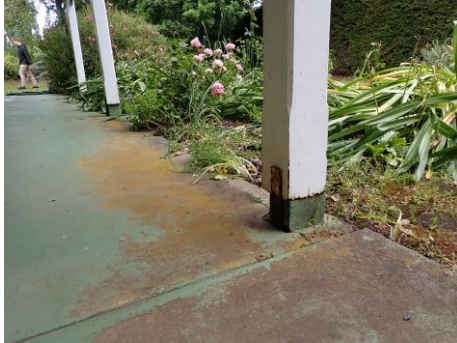
<ul style="list-style-type: none"> The steel stirrups with concrete pedestals to verandah posts have served reasonable well to date. The stirrups now have corrosion issues however to varying levels.

<ul style="list-style-type: none"> Undertake re-protection work to stirrup steel and replace bolts to prolong life of post bases. Replace stirrups where corrosion is advanced. 	M
Bedroom 2, Hall, Living and Bedroom 1 external wall	C	<ul style="list-style-type: none"> Render cracking over all openings to varying degrees, most strongly over the Hall door (4mm wide). Lighter cracks occur below Bedroom 1 window (hairline) and the southern window of the Living room. Many areas have seen previous patching and re-opening. Damage is symptomatic of behaviour on reactive soil. The render is hard compared to the mid brick substrate but is not delaminating in any quantity. The presentation of wall movement in such render may be heightened. The balance in materials is uneasy but render is allowing some breathability to the substrate. 	<ul style="list-style-type: none"> Implementing the actions on drainage and vegetation, included removal of the garden bed on this side of the house, recommended in 3.3 and 3.4 will aid these movements. It is advisable to provide some mechanical stitching across these cracks at the time of next decoration to resist re-opening and safeguard the new finishes being applied.

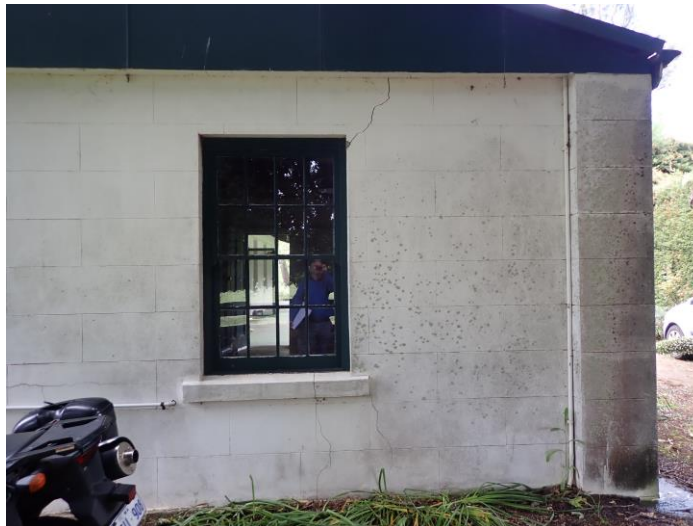
Room/Area Reference	Condition Rating	Defect Location and Description	Work to Rectify Defect	Priority Ranking
Organ Room wall	C	<ul style="list-style-type: none"> This wall was partially reconstruction and remodelled in 1991. It has also seen some shallow concrete apron/underpinning work in the past. The west end has shown new movement associated with movement in the room's west wall but also has horizontal cracking which reflects the probable interfaces of old and reconstructed brickwork. Higher level diagonal cracking above windows is likely to reflect reactive soil conditions but early corrosion in steel angle lintels (expected 1991 fabric) has begun to impact. 	<ul style="list-style-type: none"> As for the west wall, the appropriate action is to implement the actions on drainage and vegetation, recommended in 3.3 and 3.4 to aid soil stabilisation. No redecoration work is worthwhile until walls can be suitably stabilised. 	2

<ul style="list-style-type: none"> Monitor crack for 12 months thereafter to gain confidence of wall stability. There no danger to building users through this time. There may already be serviceability problems with windows and doors however which may continue. Engage heritage engineer to set up monitor regime. 	3
			<ul style="list-style-type: none"> Repair wall damage using standard crack stitching methods such as those by Helifix Pty Ltd prior to redecoration work. Stitching work may expand in scale for wider tying action depending on monitoring results. 	4
			<ul style="list-style-type: none"> Re-protect steel angle lintel experiencing corrosion. 	M

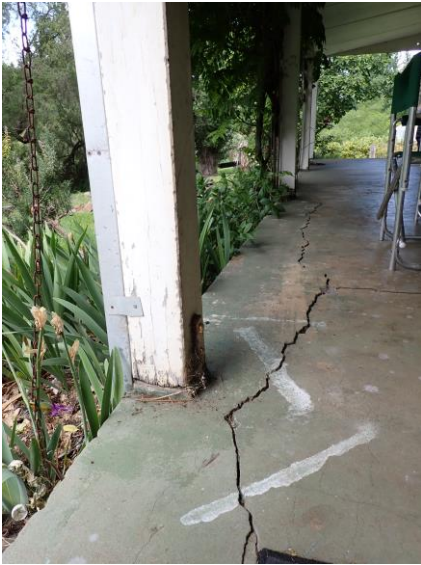
WC	C	<ul style="list-style-type: none"> Weatherboard cladding at base of eastern wall deteriorated due to falling damp from roof and subsequent termite attack. Supporting timber wall frame sound however. 	<ul style="list-style-type: none"> Replace weatherboards where required. 	M
Back Verandah	C	<ul style="list-style-type: none"> Continuous wide crack in granolithic floor slab, 300-400mm back from eastern edge. Historic eastward rotation of the shallow retaining edge has occurred here due to shrinkage effects in the supporting ground. The tear in the slab back from the edge has resulted. The steel stirrups and shallow concrete pedestals to verandah posts have served reasonable well to date. The stirrups now have corrosion issues however to varying levels.

<ul style="list-style-type: none"> It is important to first implement the actions on drainage and vegetation recommended in 3.3 and 3.4 to aid soil stabilisation. Removal of the garden bed included. Undertake re-protection work to stirrup steel and replace bolts to prolong life of post bases. Replace south corner post stirrup where corrosion is advance due to falling damp from down pipe. 	<p>2</p> <p>M</p> <p>M</p>

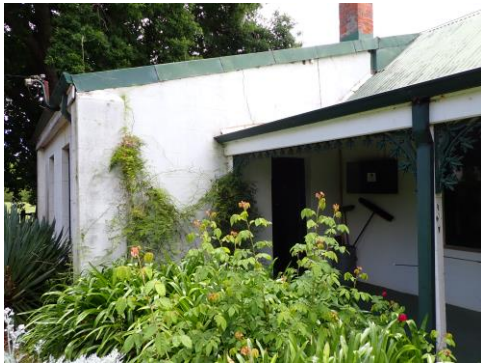
Room/Area Reference	Condition Rating	Defect Location and Description	Work to Rectify Defect	Priority Ranking
Organ Room wall	C	<ul style="list-style-type: none"> The west end has shown movement associated with movement in the room's west wall. The panel between corner pier and door opening has rotated in plane producing two tears in the brickworks above the door. The panel also has developed a lean to the south, most progressed at the corner pier.

<ul style="list-style-type: none"> As for the west wall, the appropriate action is to implement the actions on drainage and vegetation, recommended in 3.3 and 3.4 to aid soil stabilisation. No redecoration work is worthwhile until walls can be suitably stabilised. Monitor crack for 12 months thereafter to gain confidence of wall stability. There no danger to building users through this time. There may already be serviceability problems with the door however which may continue. Engage heritage engineer to set up monitor regime. Repair wall damage using standard crack stitching methods such as those by Helifix Pty Ltd prior to redecoration work. Stitching work here to be applied internally above picture rail and extended to corner of room from side of chimney breast. 	2 3 4

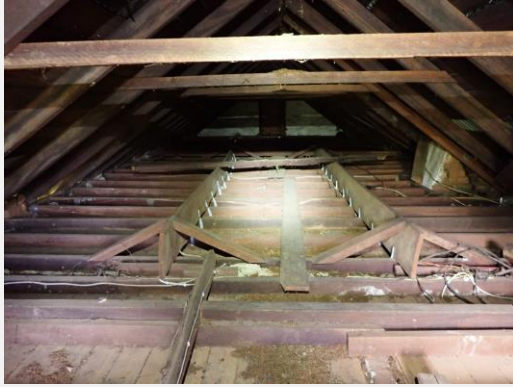
Room/Area Reference	Condition Rating	Defect Location and Description	Work to Rectify Defect	Priority Ranking
Over Store, Bedroom 2, Hall, Living, Study and Bedroom 1	C	<ul style="list-style-type: none"> All roof framing generally in good condition.

<ul style="list-style-type: none"> Old termite damage to wall plate over western wall of Bedroom 2. 1895 gable northern gable wall (with window) still extant, 1900 Organ Room wall standing behind. Mud render noted on inside faces of north and south gable walls probably last areas of original plaster/render. Condition of brickwork to Living/Dining chimney stack good. 	<ul style="list-style-type: none"> N/A

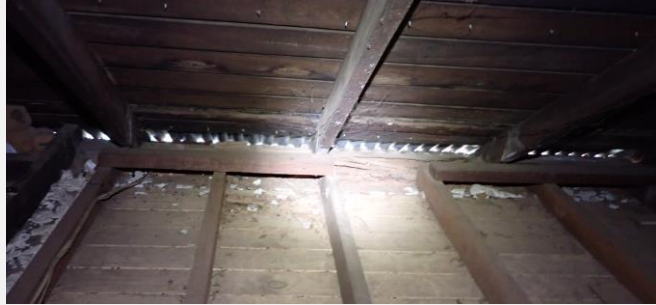
<ul style="list-style-type: none"> Whilst damage is not insignificant, close inspection and any action can be delay until time of re-roofing works.
