**Biodiversity and
Conservation Science**

Preliminary assessment of plastic infrastructure in the Swan Canning Riverpark

Katrina Bornt, Joshua Rule and Peter Novak

June 2024

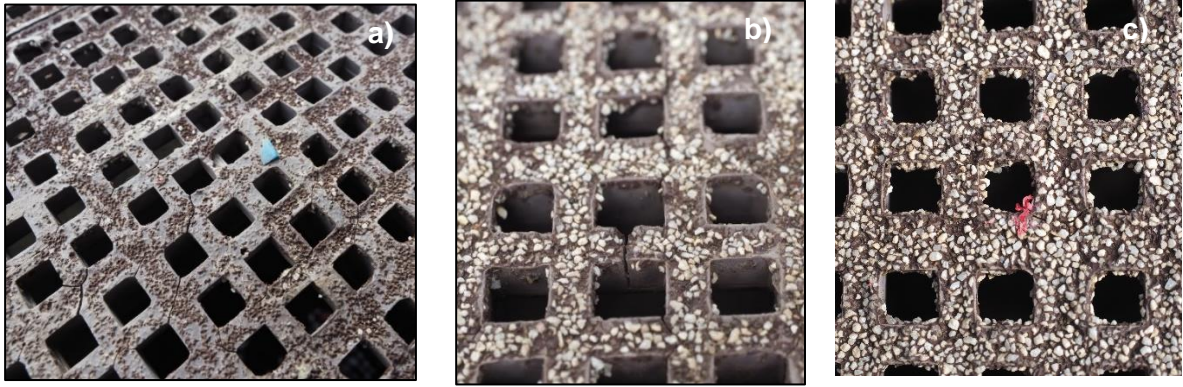
Figure 11. Moderate to severe cracking (a & b) and captured microplastics (c) on the fibre reinforced plastic grating used for the canoe launch at the Middle Swan Reserve.

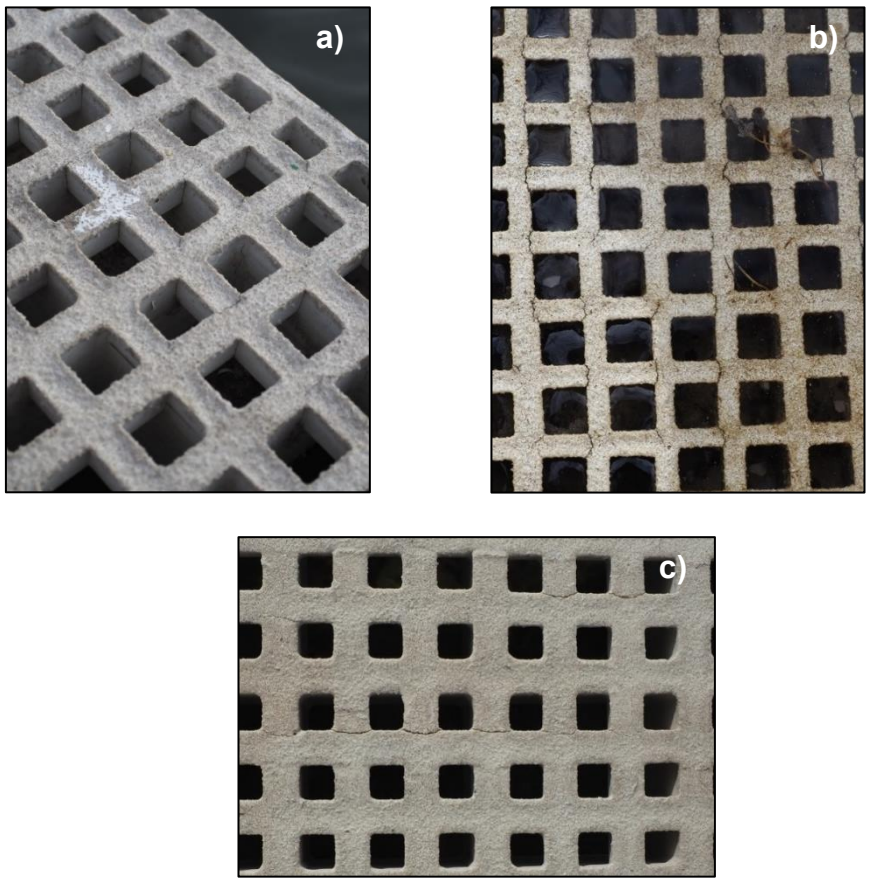
Figure 12. Fibre reinforced plastic (FRP) standard mesh with grit at Deep water Point finger jetty (a) and boat ramp (b) showing where cracking often occurs in grating decking; (c) cracking on FRP decking from quadrat 1 on the pontoon at South of Perth Yacht Club.

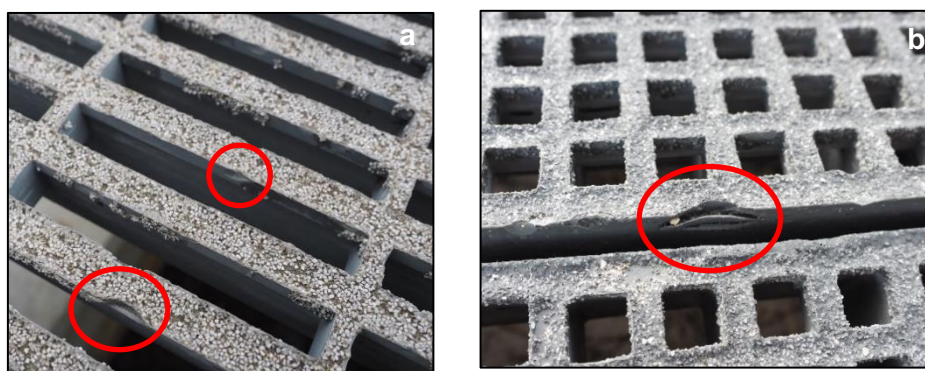
The mean score for chips in FRP decking was 0.81 (SE \pm 0.33) (Figure 10b & Figure 13). Chips were evident in almost all FRP grated decking at all sites, except the jetty at the Swan Yacht Club (Figure 10b). Cracks often led to chipping on the edges of structures such as along the grating at the Kent Street Weir Bridge (Figure 13a) and the beach access ramp at John Tonkin Reserve where FRP panels were joined at different angles (Figure 13b).

Figure 13. Chipping on grating at Kent Street Weir Bridge (a) and on edging of the beach access ramp at John Tonkin Reserve (b).

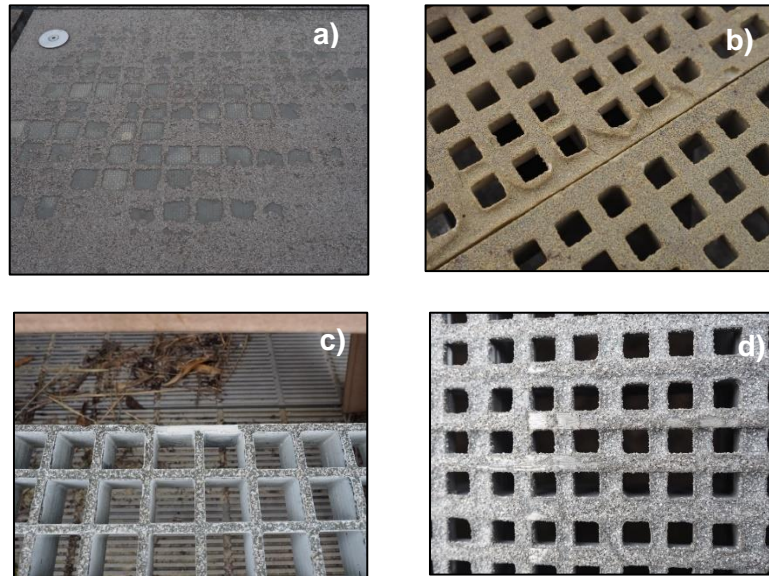
The surface of the solid top decking installed at Kent Street Weir showed material loss in about a third of the panels (10 / 33 panels) (Figure 13a & Figure 14a).

Figure 14. Material loss on the solid top section of the raised walkway at Kent Street Weir (a), the loading jetty at Aquarama Marina (b), an access staircase at Applecross boardwalk (c) and exposed fibres at Miller's Pool boardwalk (d).

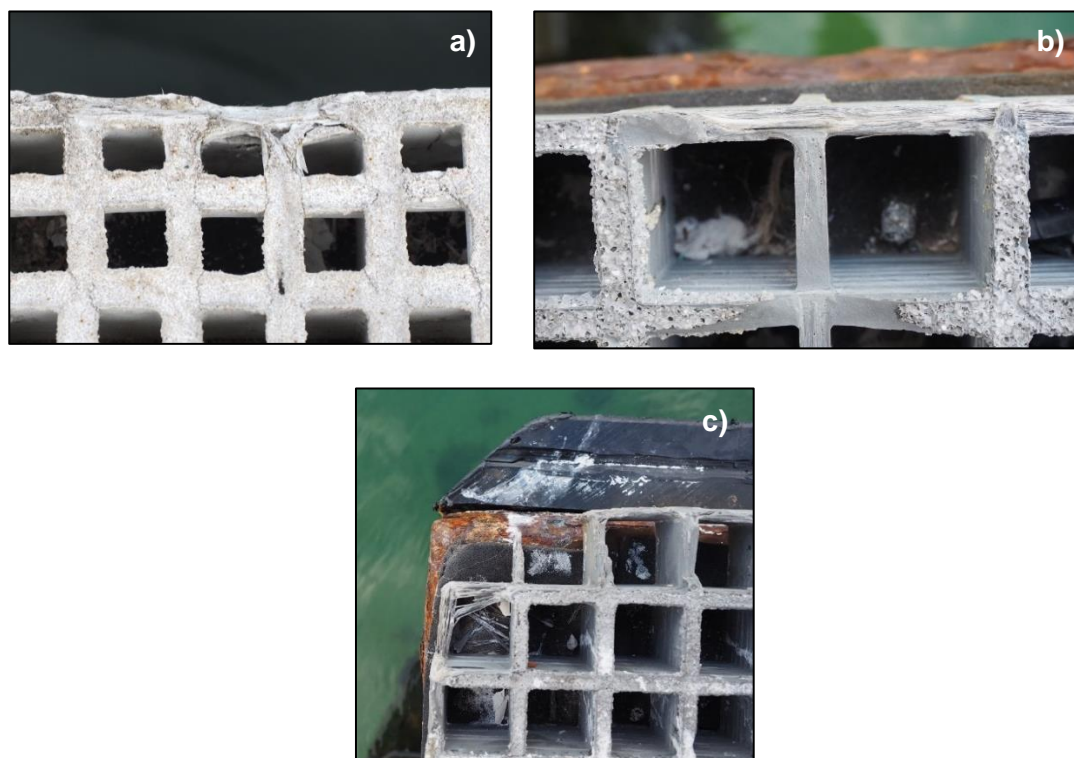
Boat strike: FRP decking on the water-facing sides of jetties were particularly susceptible to boat strikes (Figure 17). The centre of the decking on these structures was much less damaged and often showed less exposed fibres than the outside margins of the FRP panels (Figure 17).

Structure type and finish: More wear was evident on the edges of grated FRP decking with a larger grid size (e.g. standard grid versus micro-grid) (Figure 17). More wear was also

Figure 17. Examples of degradation from boat strikes on edges of grated fibre reinforced plastic decking at Deep Water Point finger jetty (a) and Leeuwin boat ramp finger jetty (b) and (c) end of Leeuwin boat ramp.

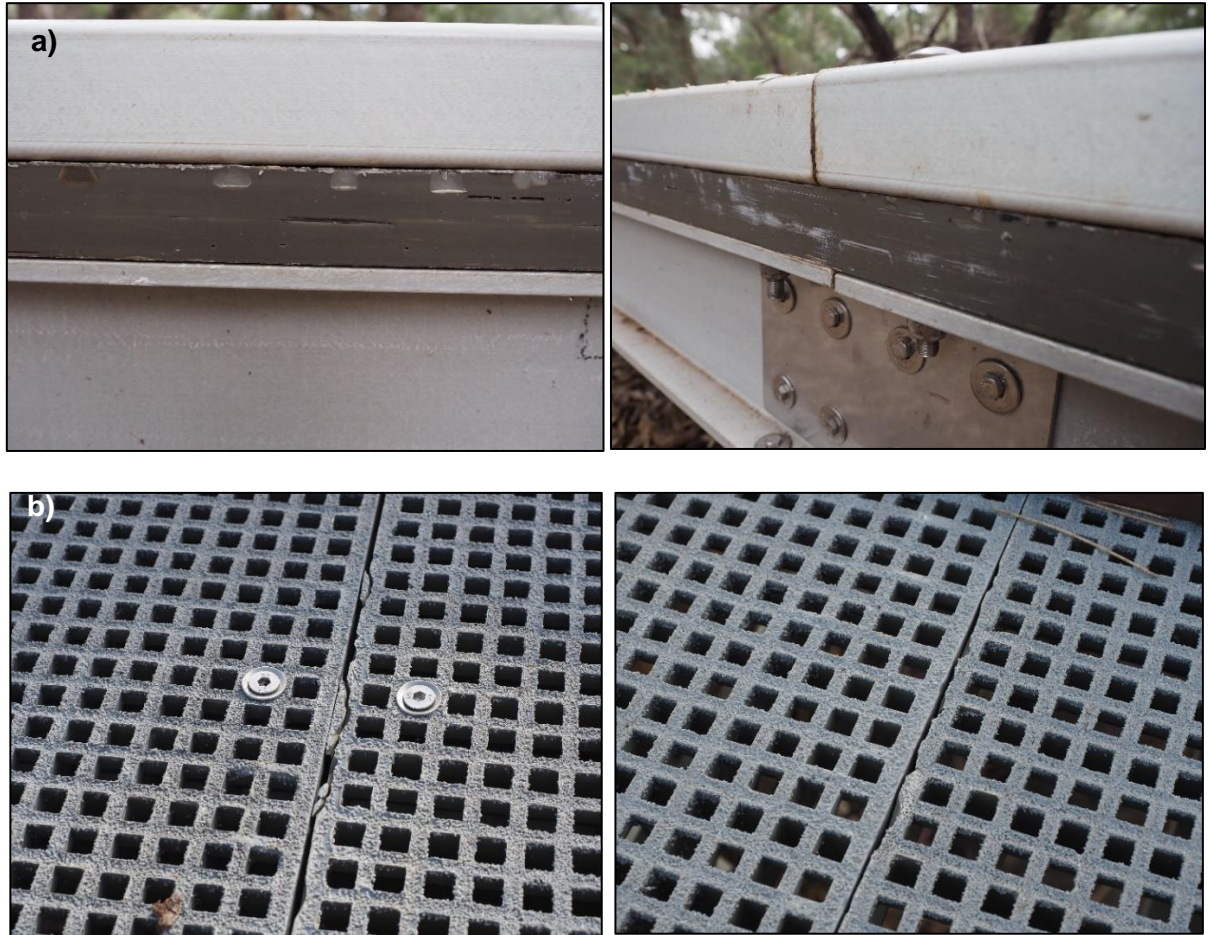
Installation: Scuffing on the edges of newer structures may have been caused from installation and transport of materials to site (Figure 18a).

Figure 18. (a) Fibre reinforced plastic (FRP) kick rail (top), FRP mini mesh edging (middle dark grey layer) and FRP substructure (bottom layer) along board walk at Thornlie nature reserve; (b) FRP decking joints at Melville bird view platform.

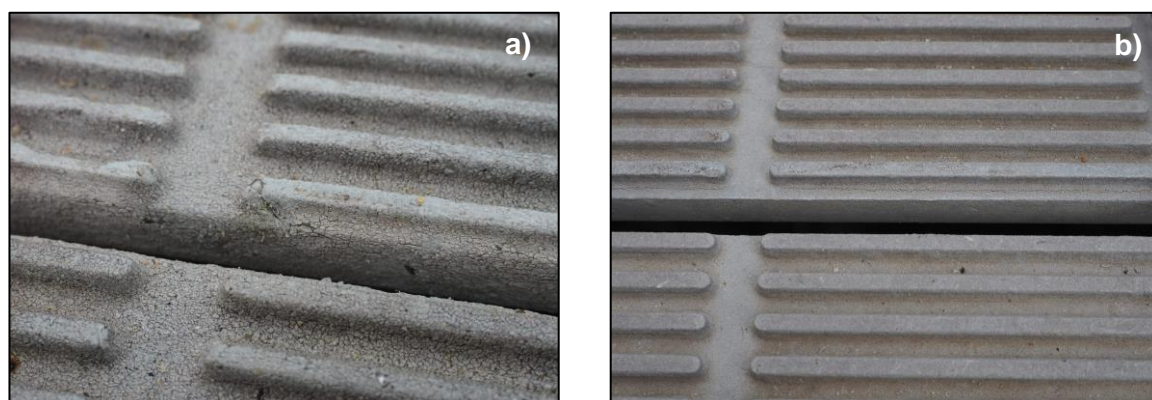
Figure 19. Cracking of recycled plastic decking observed at the Mount Henry jetty (a) and the Applecross boardwalk (b).

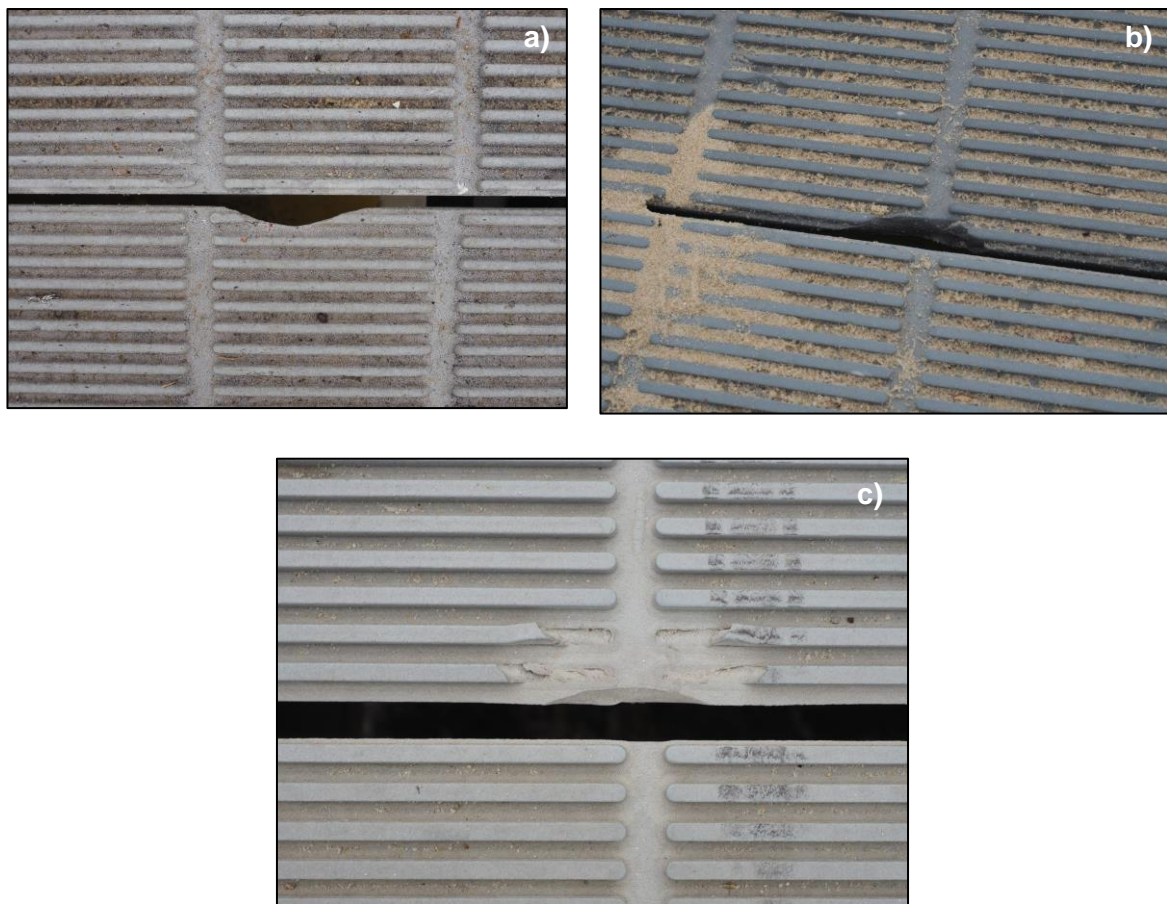
Figure 20. Chipping present on recycled plastic decking at the Mount Henry jetty (a), Pollard Park jetty (b) and the Applecross Boardwalk (c).

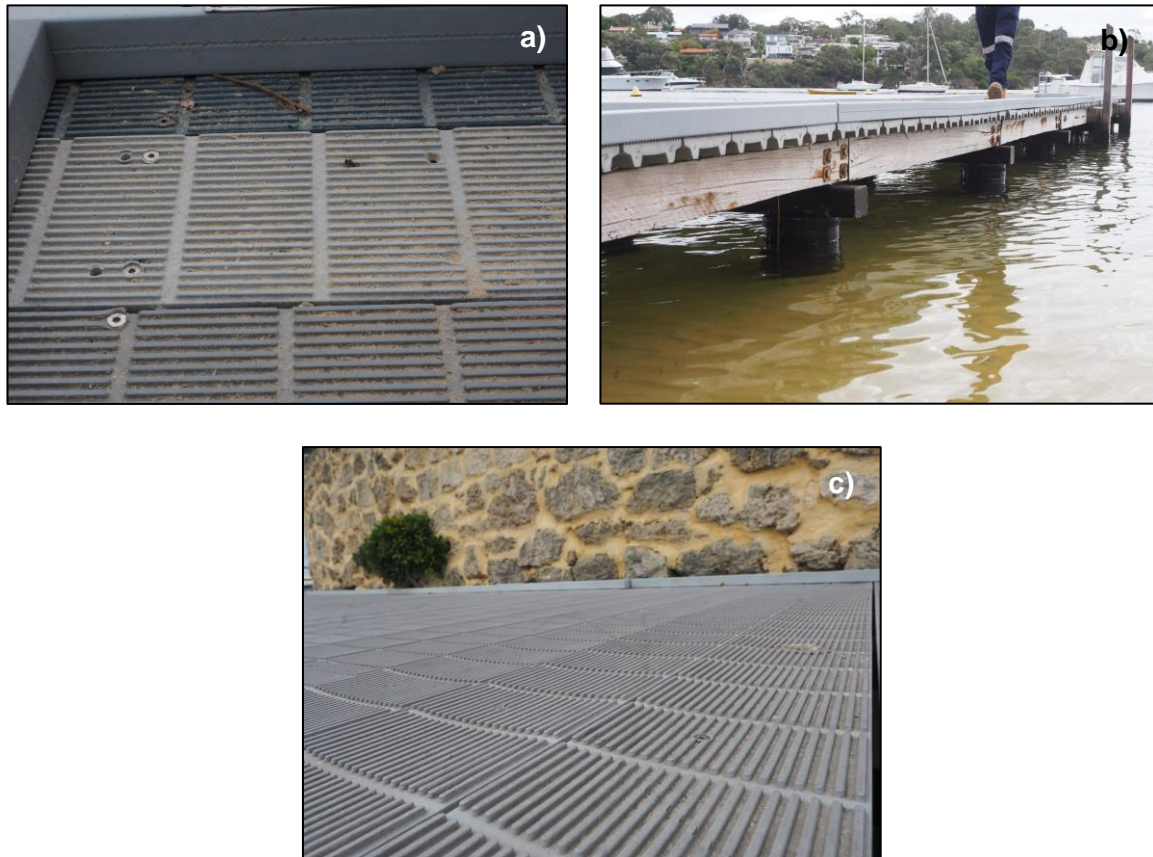
Figure 21. Deformation of recycled plastic decking observed at Pollard Park jetty (a, b) and Applecross boardwalk (c).

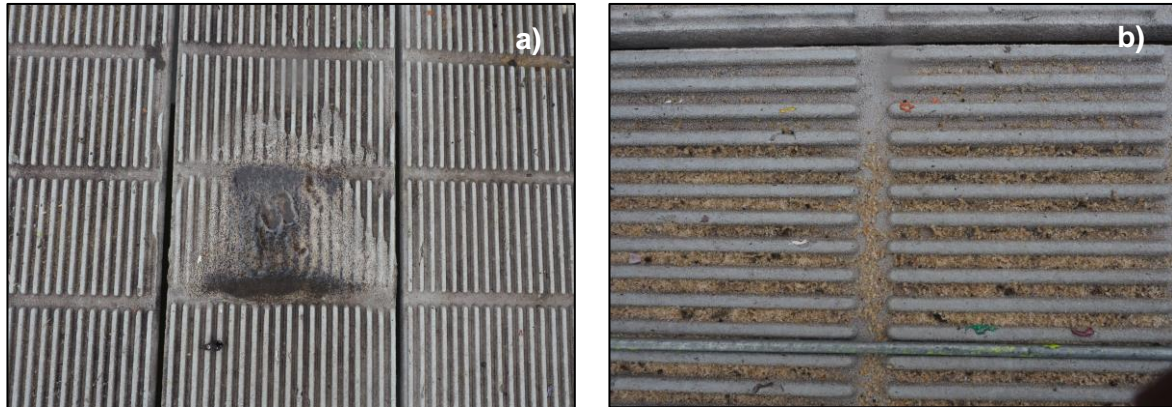
Figure 22. Material loss observed on recycled plastic decking at the Mount Henry jetty (a – chemical or fire damage, b – exposed plastics of different colours).

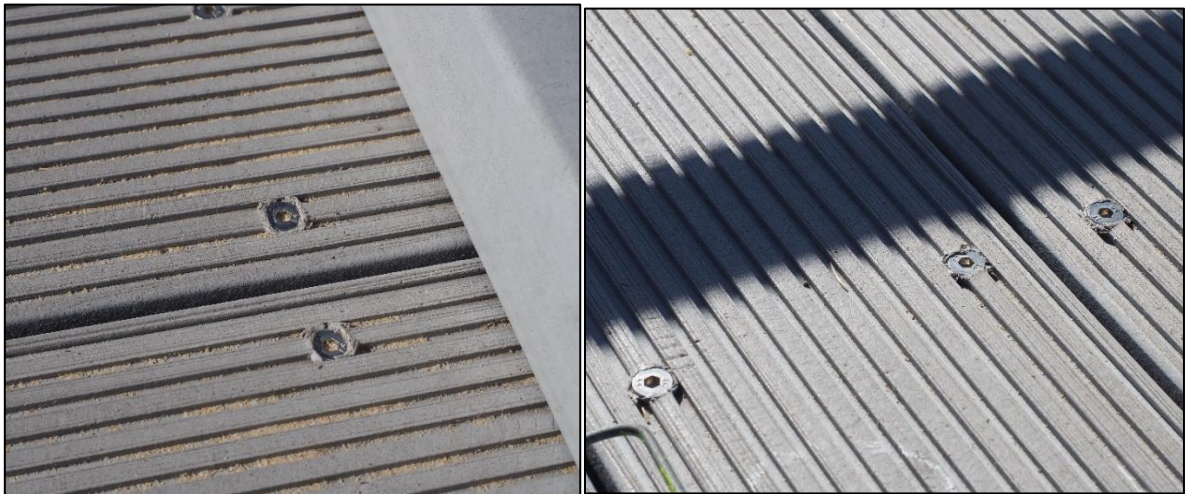
Figure 24. Poor installation of screws to install recycled plastic decking at Rockwood Street (Esplanade) jetty.

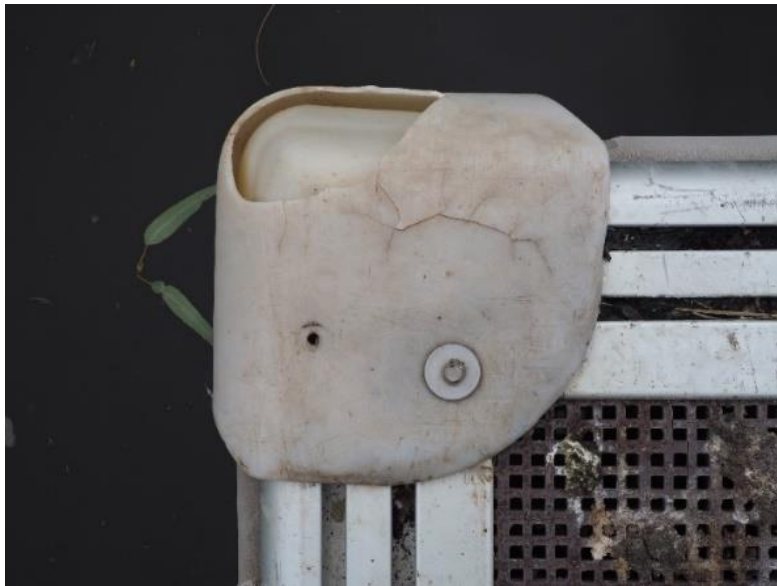
Figure 31. Damaged rigid capping used on corners of the pontoon at Middle Swan Reserve.

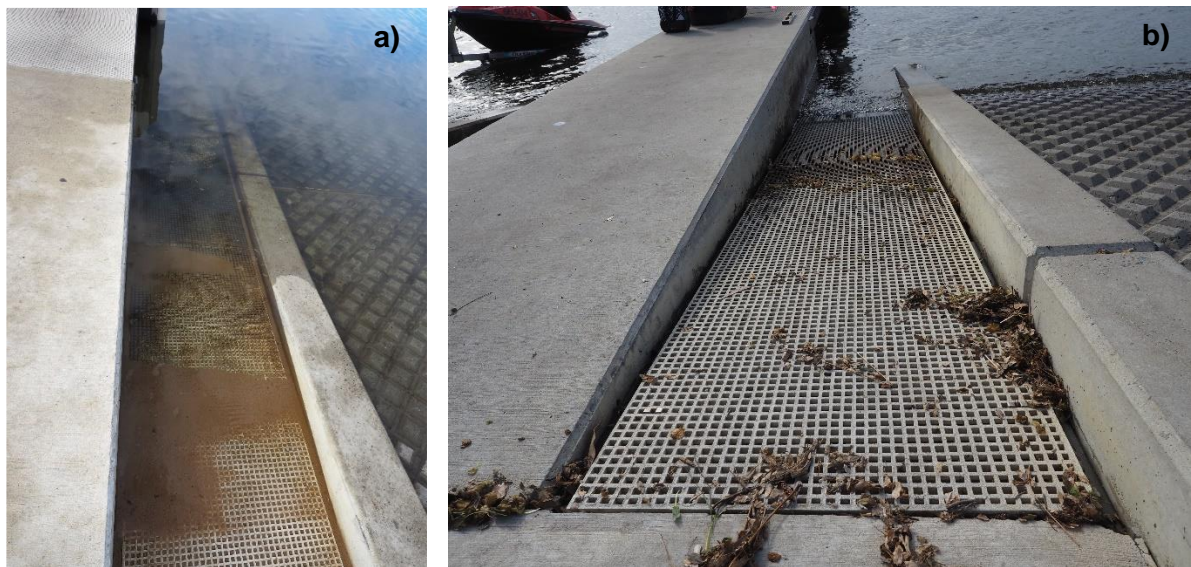
Figure 34. Examples of fibre reinforced plastic exposed to wet and dry cycling at Deep Water Point (a) and Point Walter boat ramps (b).

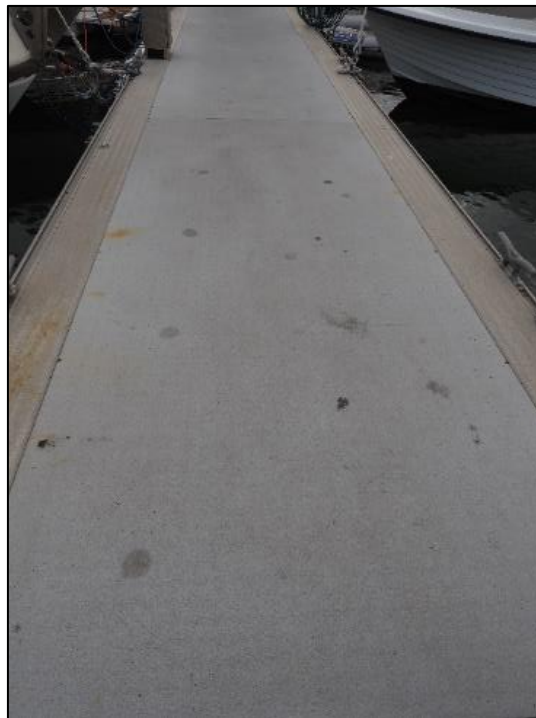
Figure 35. Staining of solid top fibre reinforced plastic decking on jetty at Swan Yacht Club.

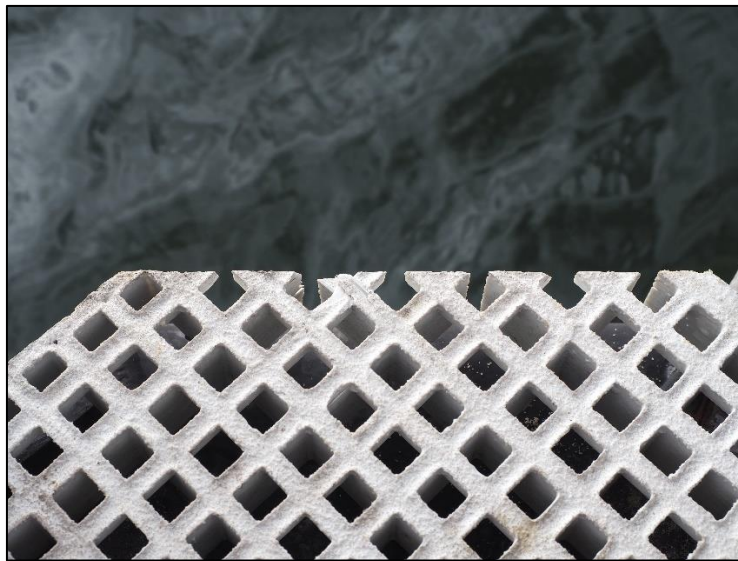
Figure 36. Fibre reinforced plastic decking cut on an angle and showing chipping at the end of Deep Water Point finger jetty.

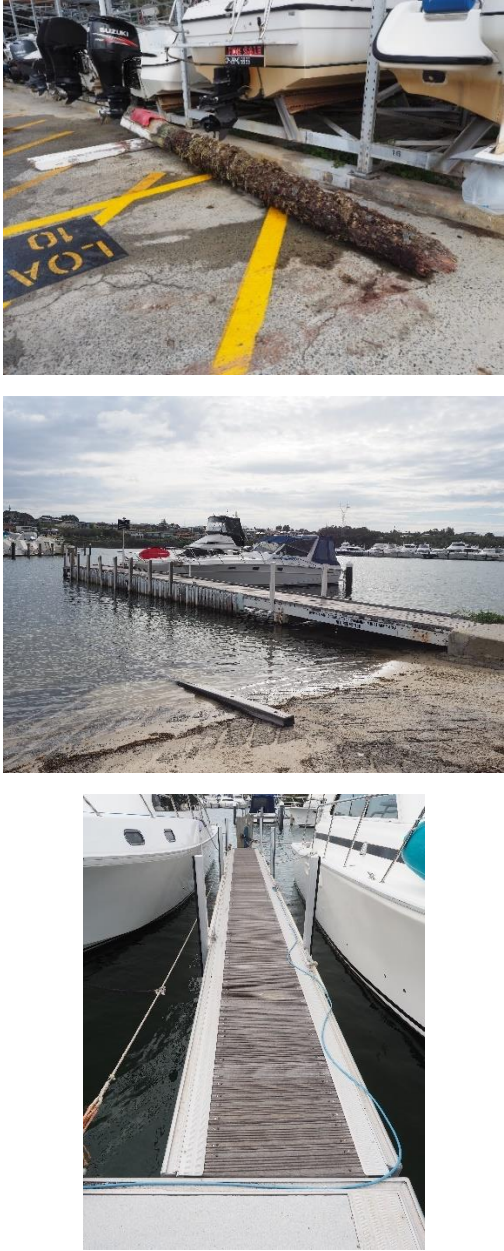
<p><i>Wooden pile removed at Aquarama Marina to be replaced with steel pile and polyethylene sleeve (top) and wooden jetty to be replaced (middle) and side boat access jetty (bottom) at Swan Yacht Club.</i></p>	<ul style="list-style-type: none"> • Resource shortages (not a long-term sustainable alternative). • Requires ongoing maintenance and repair. • Observed as being replaced at some locations (e.g. Swan Yacht club is replacing a fixed wooden jetty with plastic floating jetty in 2023; wooden piles from 1985 at Aquarama have almost all been replaced). Aquarama Marina GM comments: switched to plastic chaffers eight - 10 years ago because timber was difficult to source. Timber pylons obsolete now so they use steel pen piles covered with HDPE black plastic sleeve.

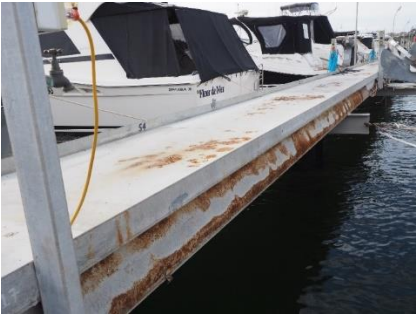
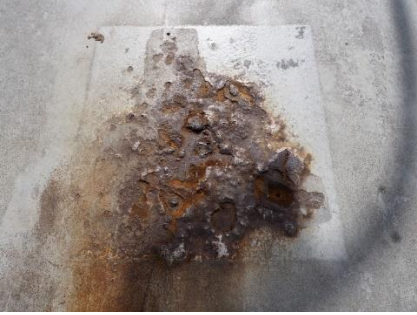
<p><i>Steel jetty built in 1985 that needs replacing at Aquarama Marina.</i></p>	<ul style="list-style-type: none"> • Long lasting when maintained but can rust over time. • Energy intensive to manufacture. • Probably not feasible to use for marine infrastructure but can potentially be used for edge protection.
