Final report on erosion mitigation projects at Deep Reach Pool (Nhanggangunha), October 2014 – July 2015 and future recommendations

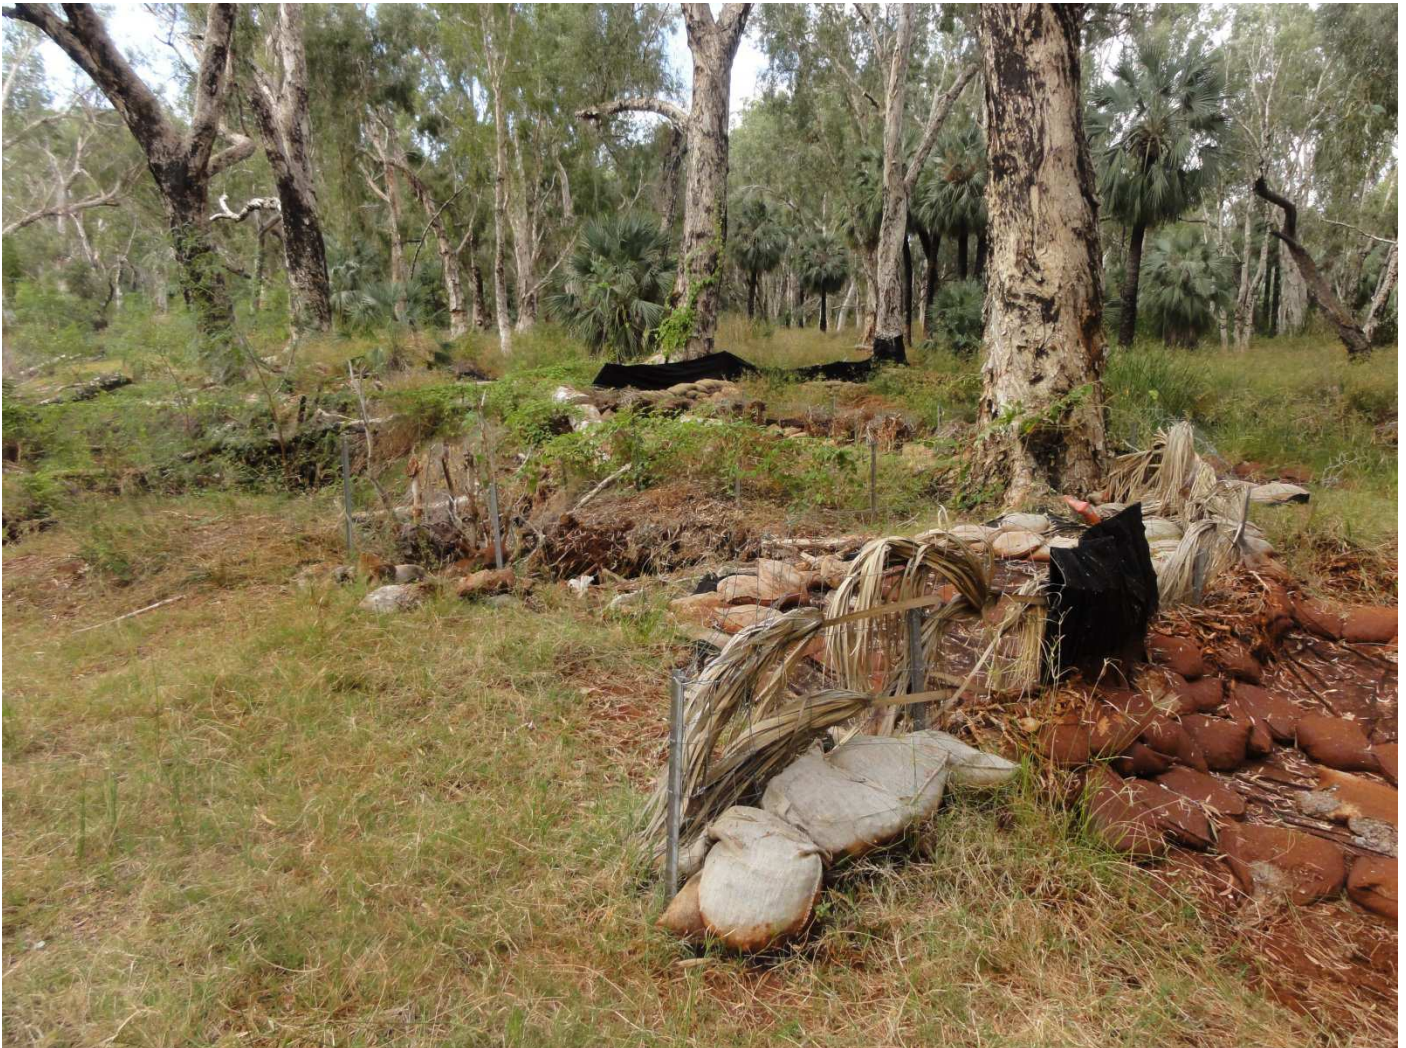
3.1.1 Structure A

Structure A is placed on a headcut about 20m from the pool edge in a direct line. The initial October 2014 structure A failed completely (resulting in a loss of 3-5m of soil) and was remodelled based on structure B. The new structure survived three discharge events with no removal of dirt and no requirement for maintenance. The new structure A shifted erosion downstream, showing its efficacy in redirecting erosional energy. The newly eroded area is of little concern at present being on the far side of the gully. The initial structure A was intentionally collapsed onto the gully floor in July 2015 adding to materials within the gully.

When structure A failed in the first instance, material placed in the erosion gully in October 14 prevented the loss of the dirt, which subsequently assisted gully rehabilitation.

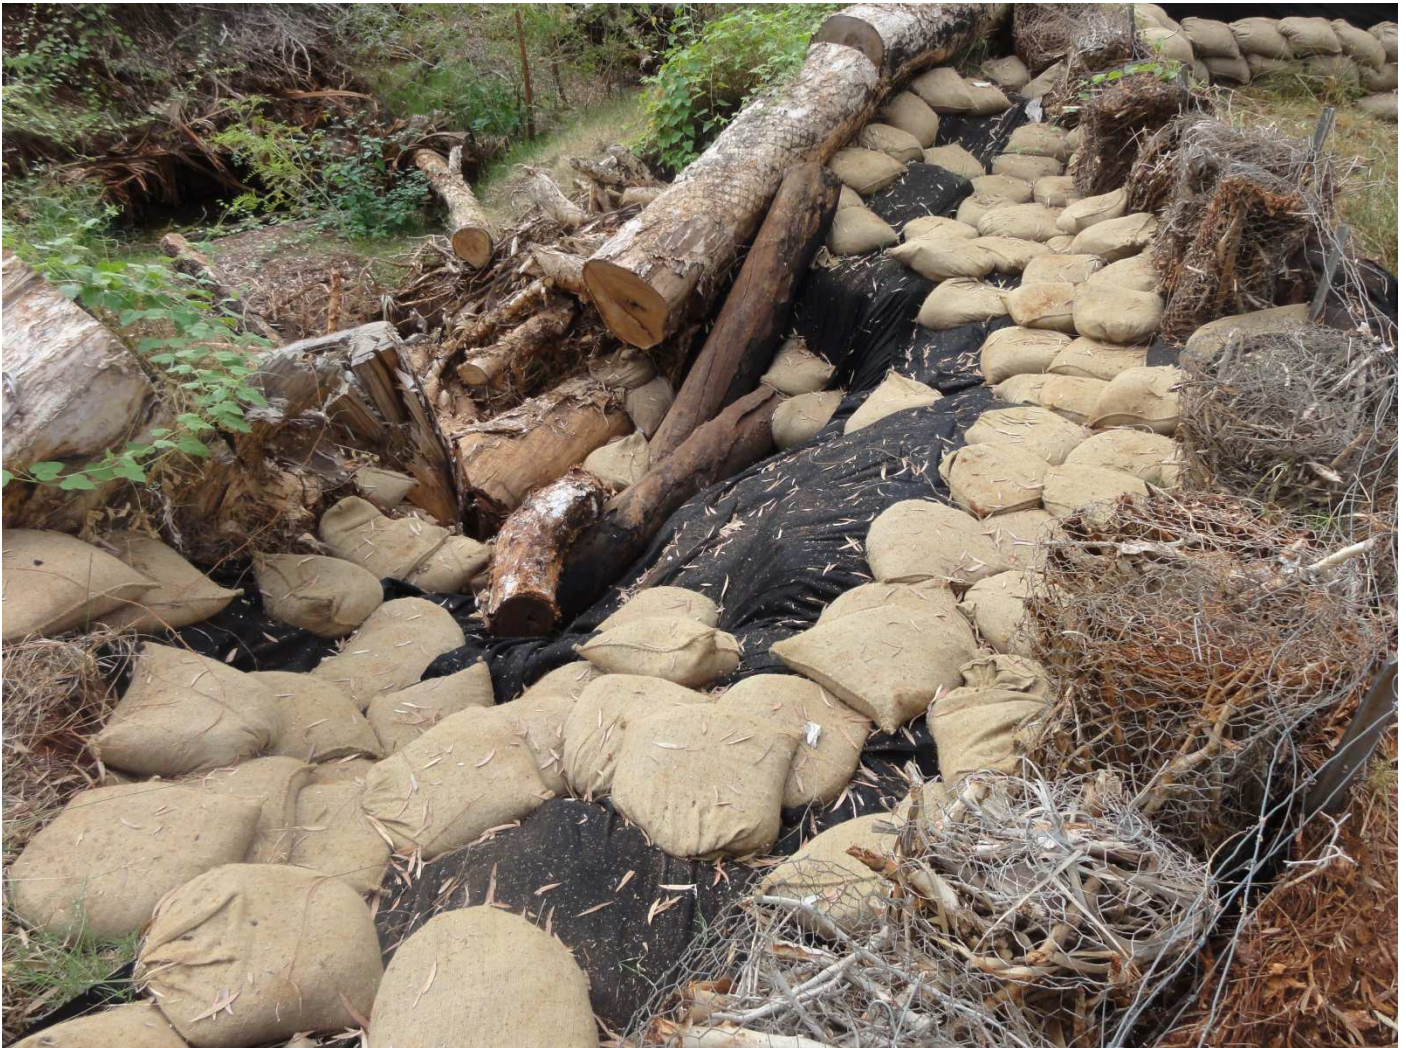
^^ note how the geotextile follows the contour of the soil underneath. The sandbags and textile are 'tucked in' at the bottom to prevent undercutting. The logs in the middle of the picture originally sat on soil, which was subsequently removed by discharge events; these were collapsed in July 2015. The intention is to have water run off the structure without the removal of any soil

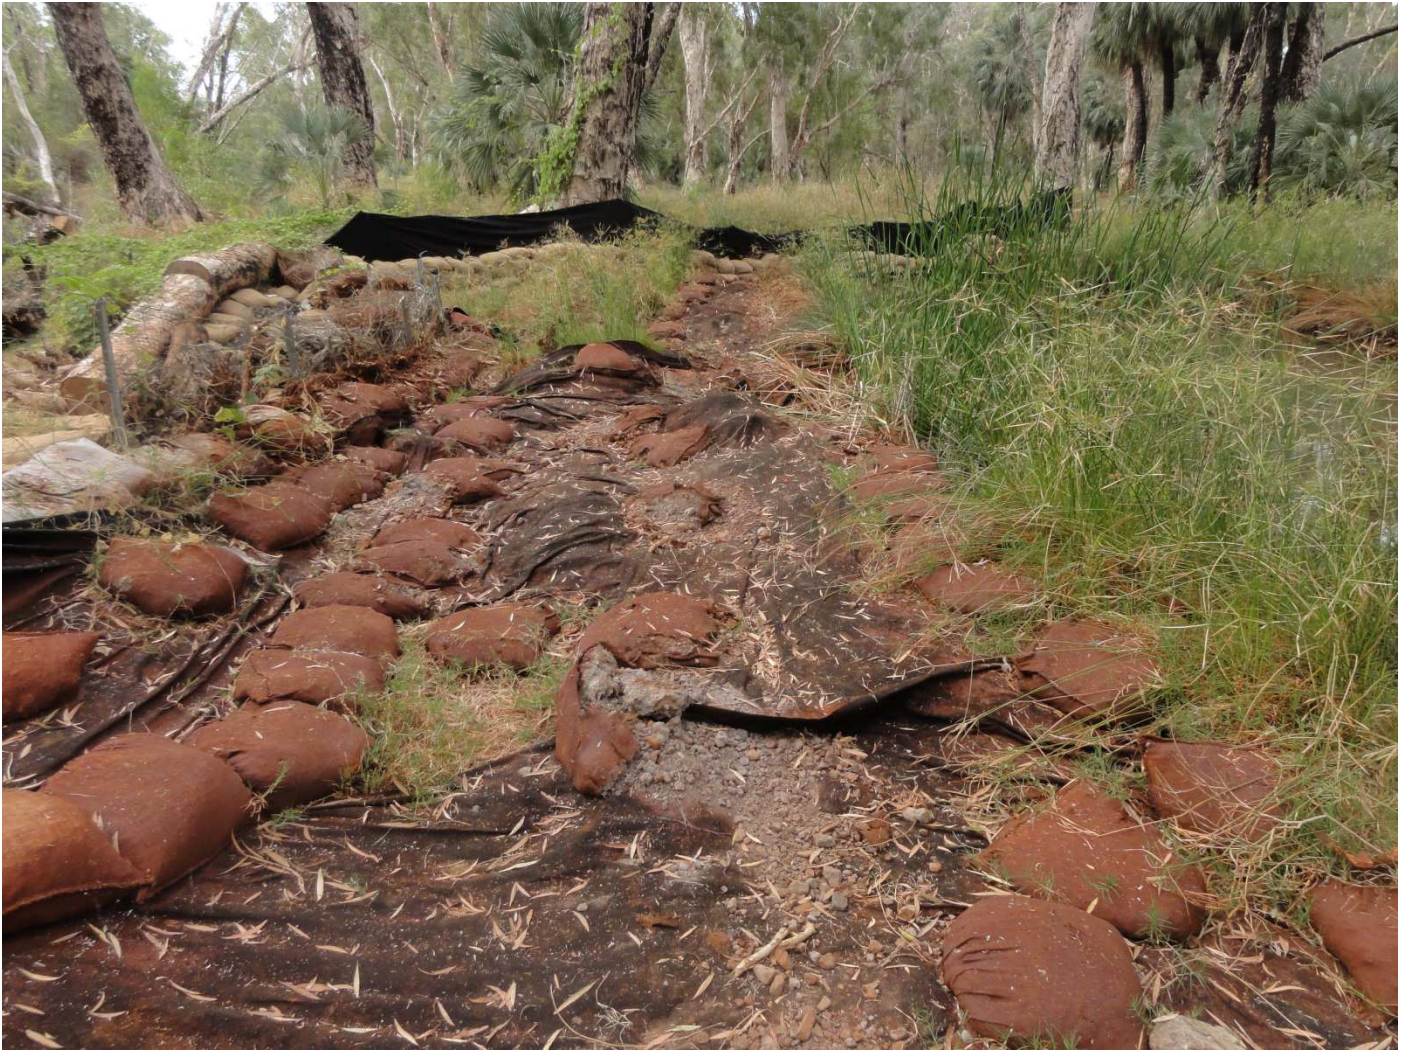
^^ structure B at left with pool edge hardening at right (the pool edge is marked by the sedges and typha). The geotextile 'carpet' was designed to prevent soil trampling by cattle, which can only easily cross the river at this point between Deep Reach and Crossing Pool due to the wide, deep and steep erosion gullies between the two pools. It has performed very well. Note that some of the bags are splitting open and in some cases crumbling. The bags are dirt/pebbles/rock mixed with cement; how well the inside of the bags have remained consolidated when the hessian has split has been variable. They have a lifespan of 2-5 years. Future bags should probably have the cement ratio increased from 10% to 20-25%.

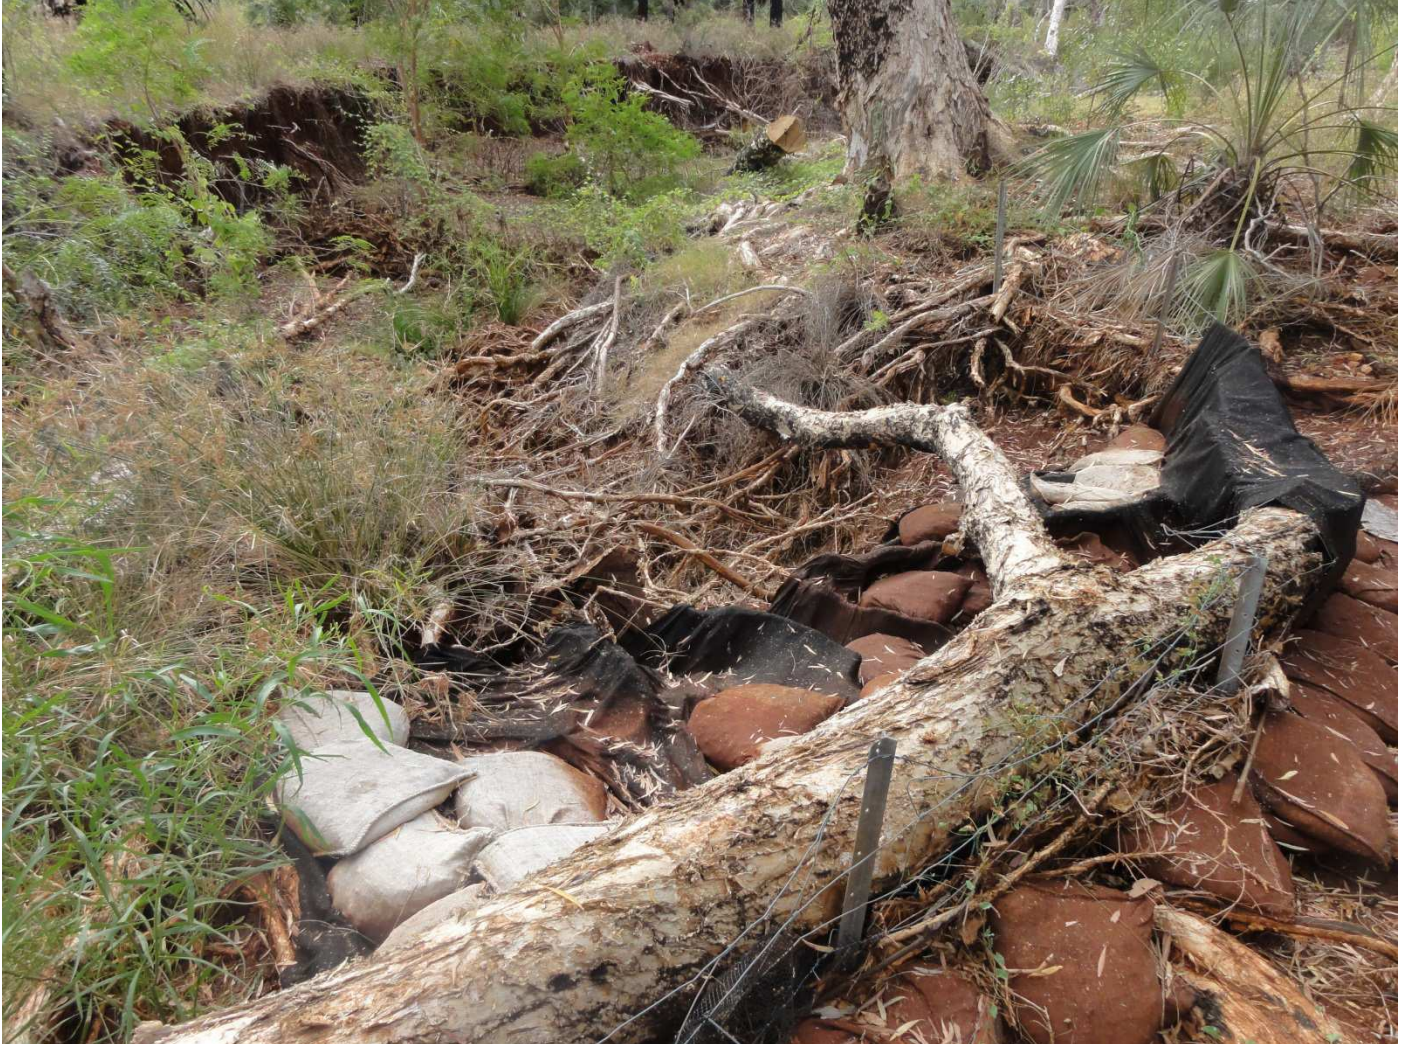
Structure C was designed to prevent erosion downstream of structure B, which diverted water energy to this point. The erosion at structure C is not a defined channel/headcut as at A and B however it has the potential to form an incised channel and intersect the pool. It is currently around 8-10m from the toe of the pool. During discharge events in May 2015 structure C failed in a number of places and although repairable to an appropriate standard with not too much effort, due to erosional energy in alternate places, an entirely new structure (D) was implemented that should effectively reduce the energy at structure C by redirecting water energy away from this point.

^^ structure C showing failure in the top right and on the 'floor' (note exposed tree roots indicating a loss of soil)

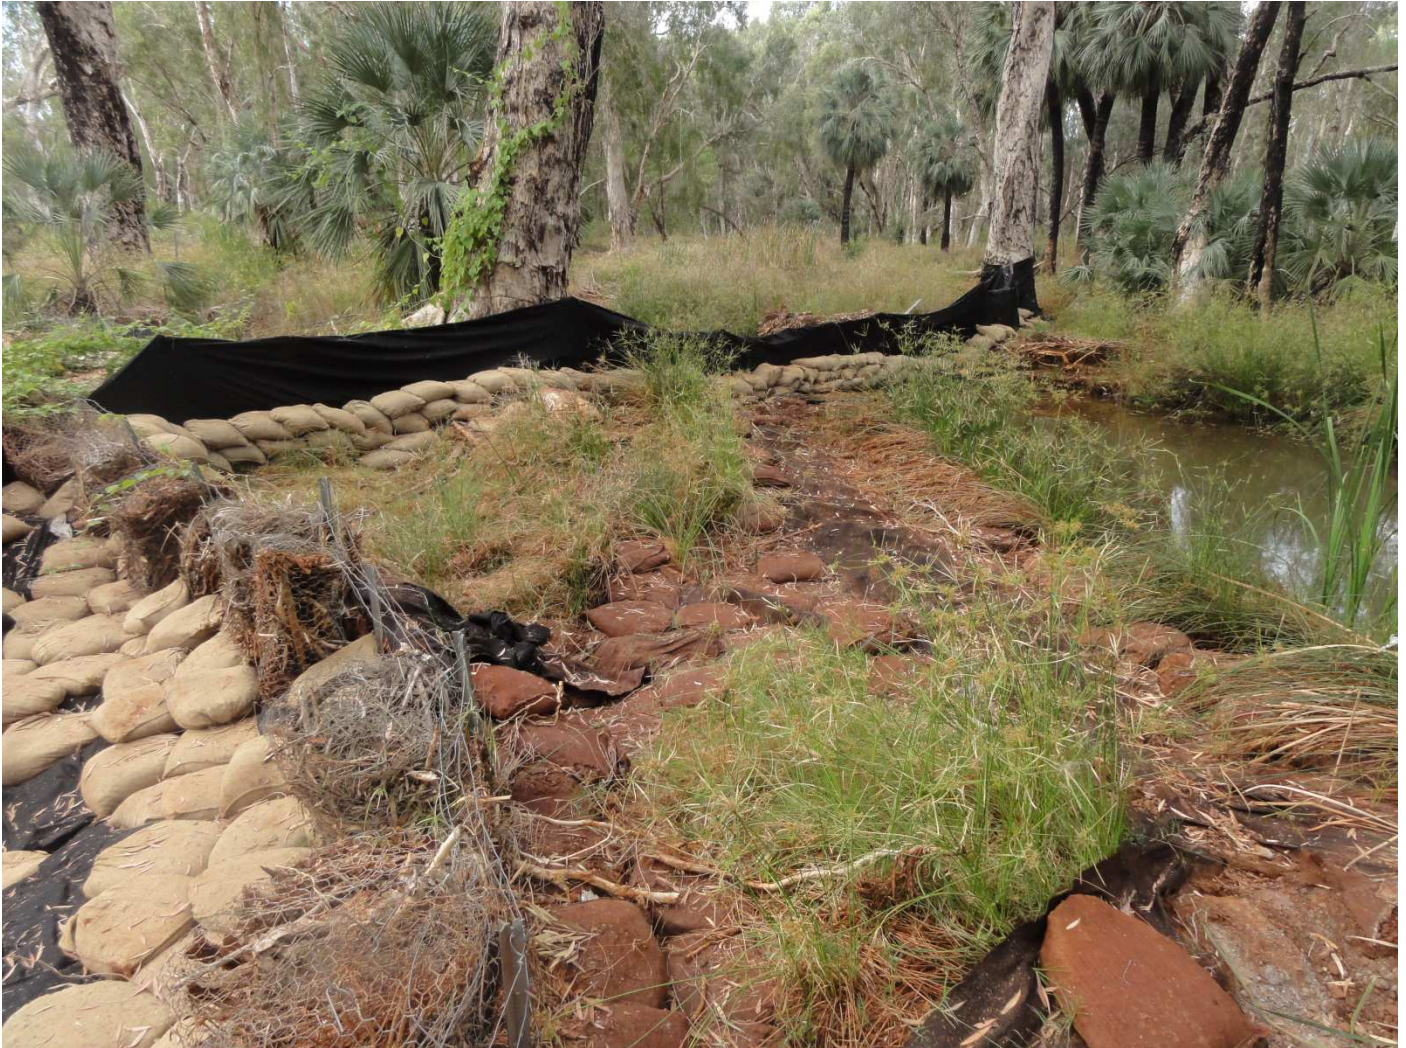
^^ Structure B (left) and D (centre). Structure D hides structure C (behind fence at left). The toe of the pool is at right. When the pool discharges the areas of main overflow are to the left over structure A (not shown), over structure B and in the entire area covered by structure D. This new structure is designed to take the water/energy form left to right, away from critical areas of erosion. It needs to be monitored closely. Based on the effect of previous structures, structure D will certainly have some effect on water flow, and hopefully in the way intended

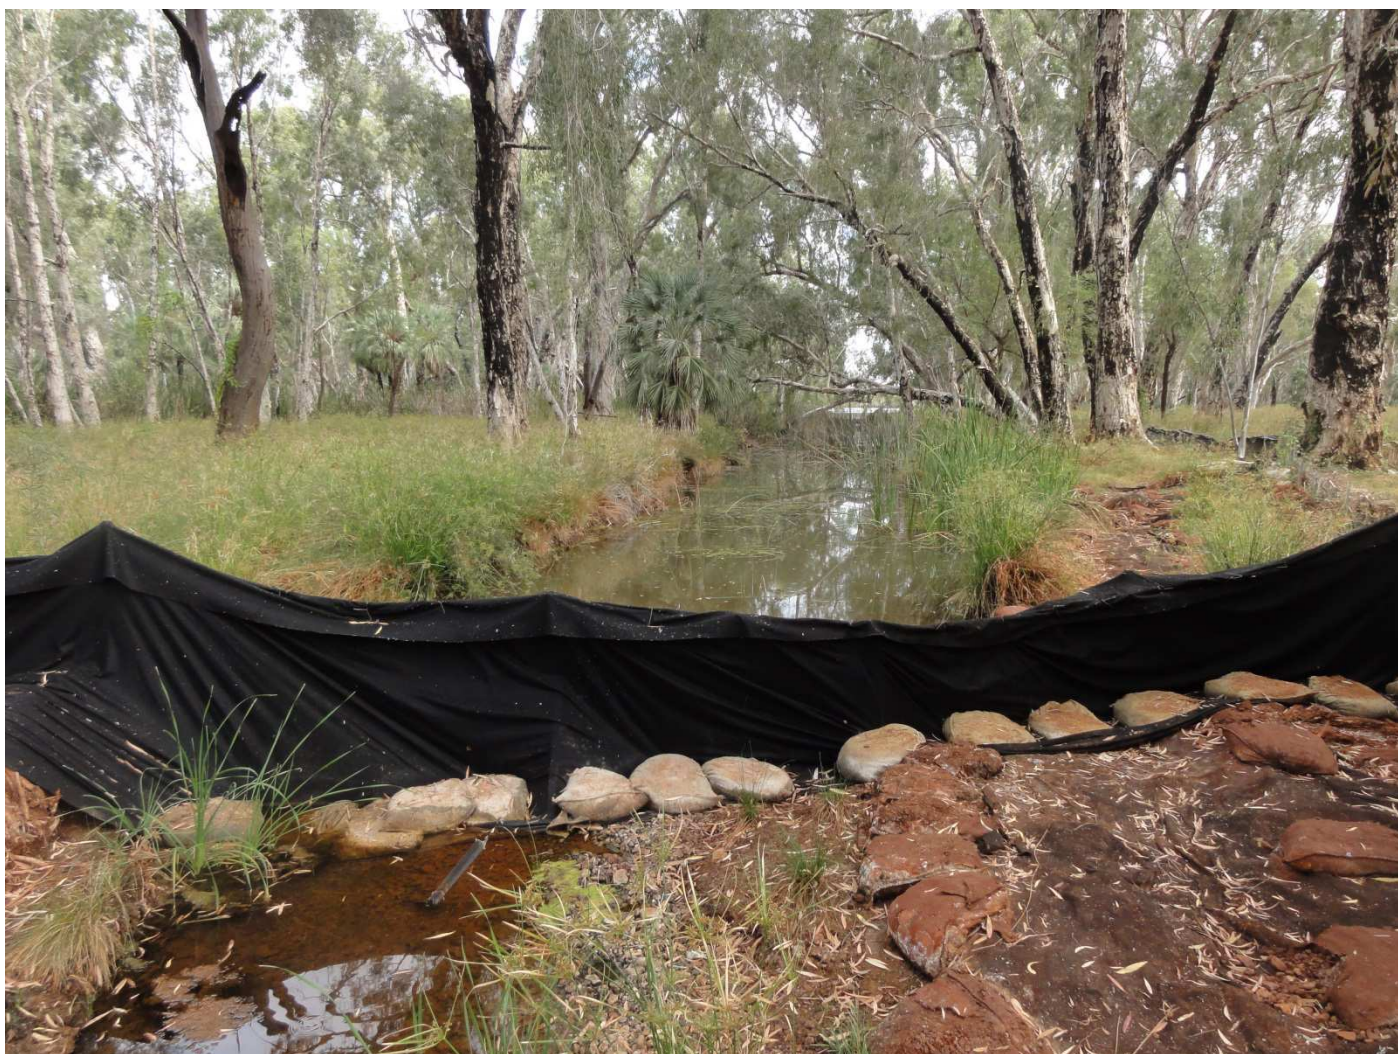
^^ Structure D looking downstream

Structure D is a completely new structure constructed in July 2015. This is a low sandbag wall in front of a ring-lock fence draped with geotextile. The purpose of this structure is to divert water energy away from the long, shallow erosion gully that has been slowly progressing toward the toe of the pool on the opposite side of the fence. This channel has a very mild gradient but if left unchecked it could intersect the pool and then deepen. Structure D has the added benefit of directing water away from structure C and redirecting water away from the erosion gully more generally. The success of this structure may prove to be pivotal in ongoing success. How it performs during its first discharge event needs to be closely monitored. It may require better contouring to get the water to redirect into the most appropriate places, which is ideally toward the current natural pool outflow channels on the north side of the pool.

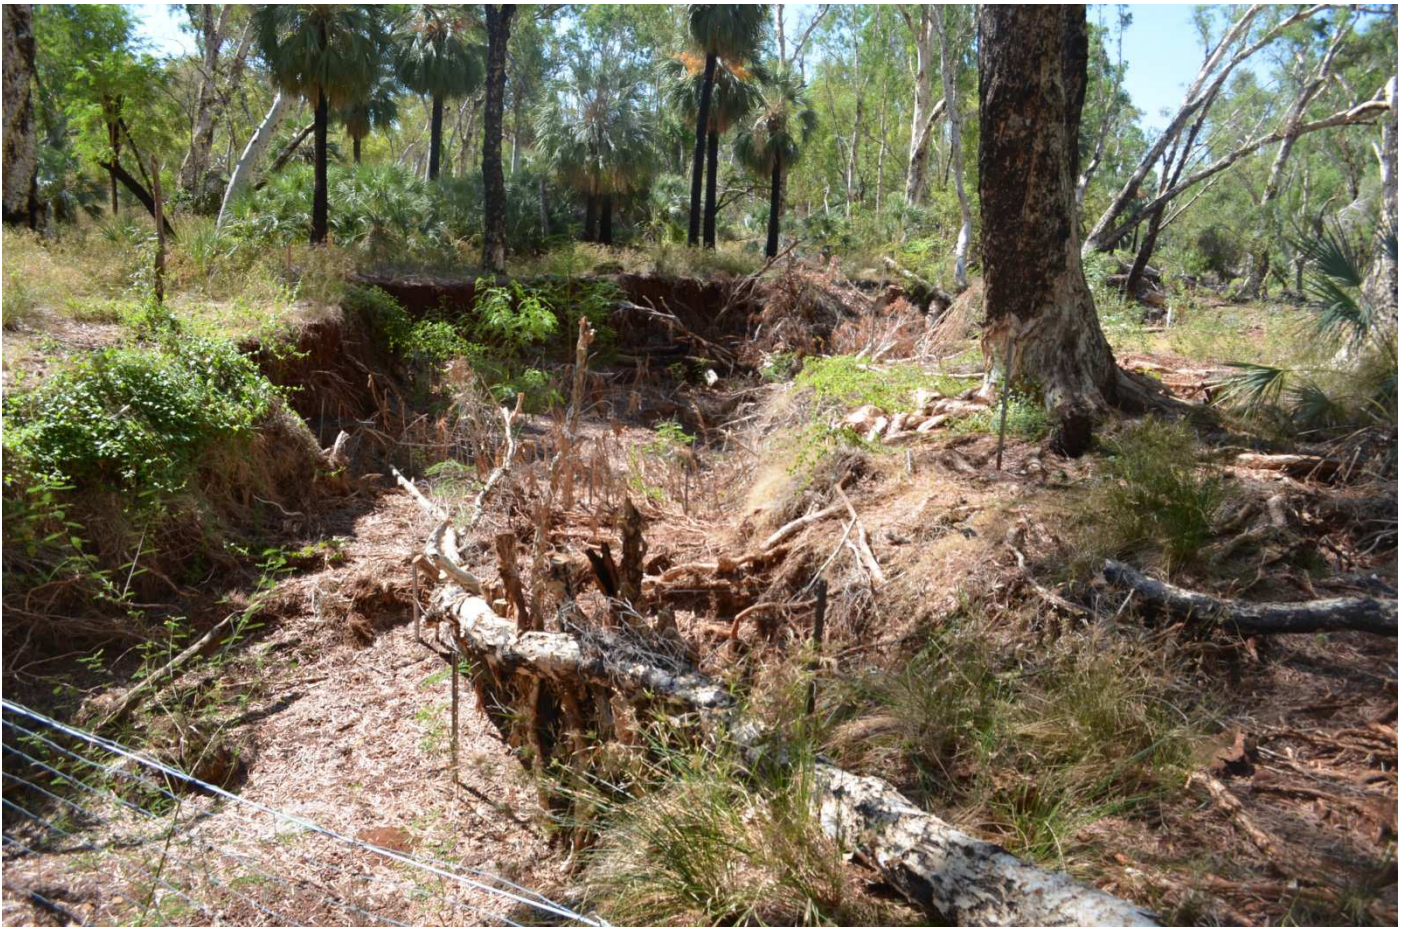
^^ Main erosion gully 20m from headcut looking downstream following initial works Oct 14, note tree on right as reference

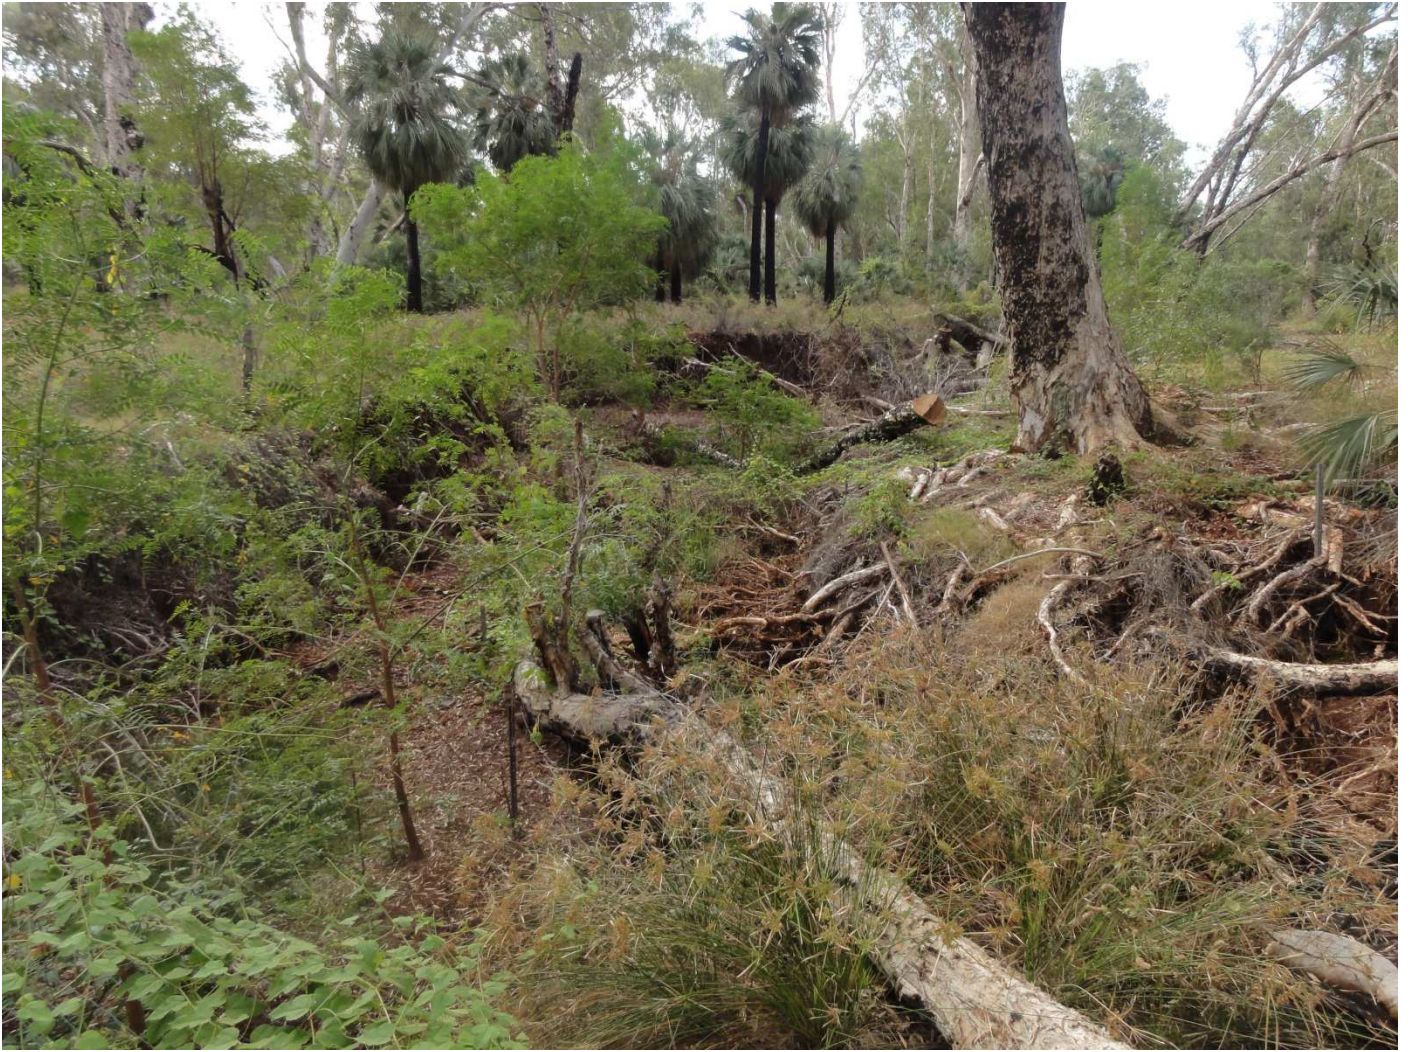
^^ Main erosion gully following final works July 15

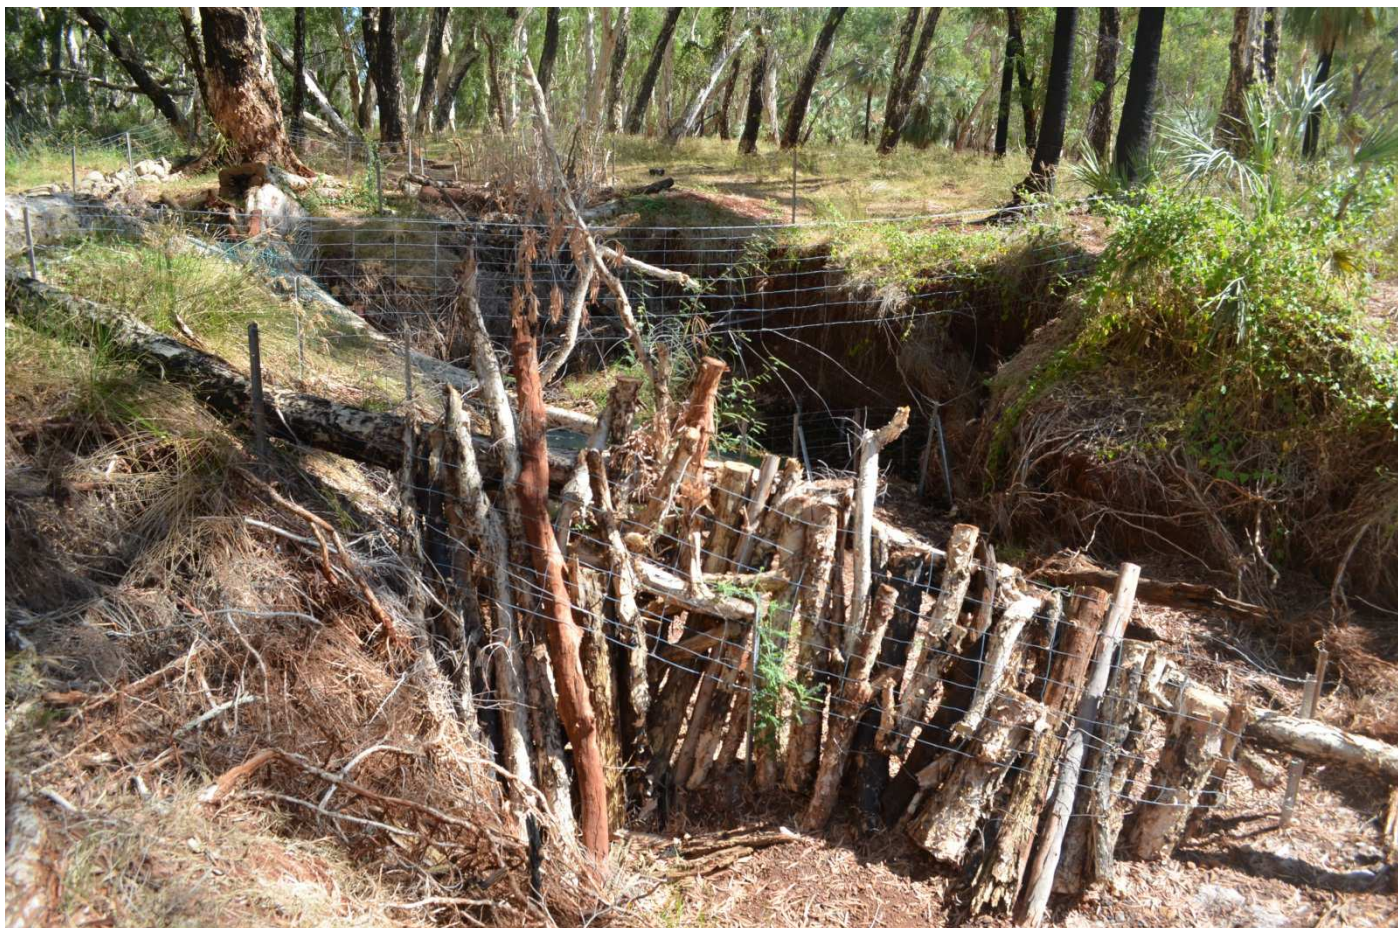
^^ Main erosion gully looking upstream toward headcut, Oct 14

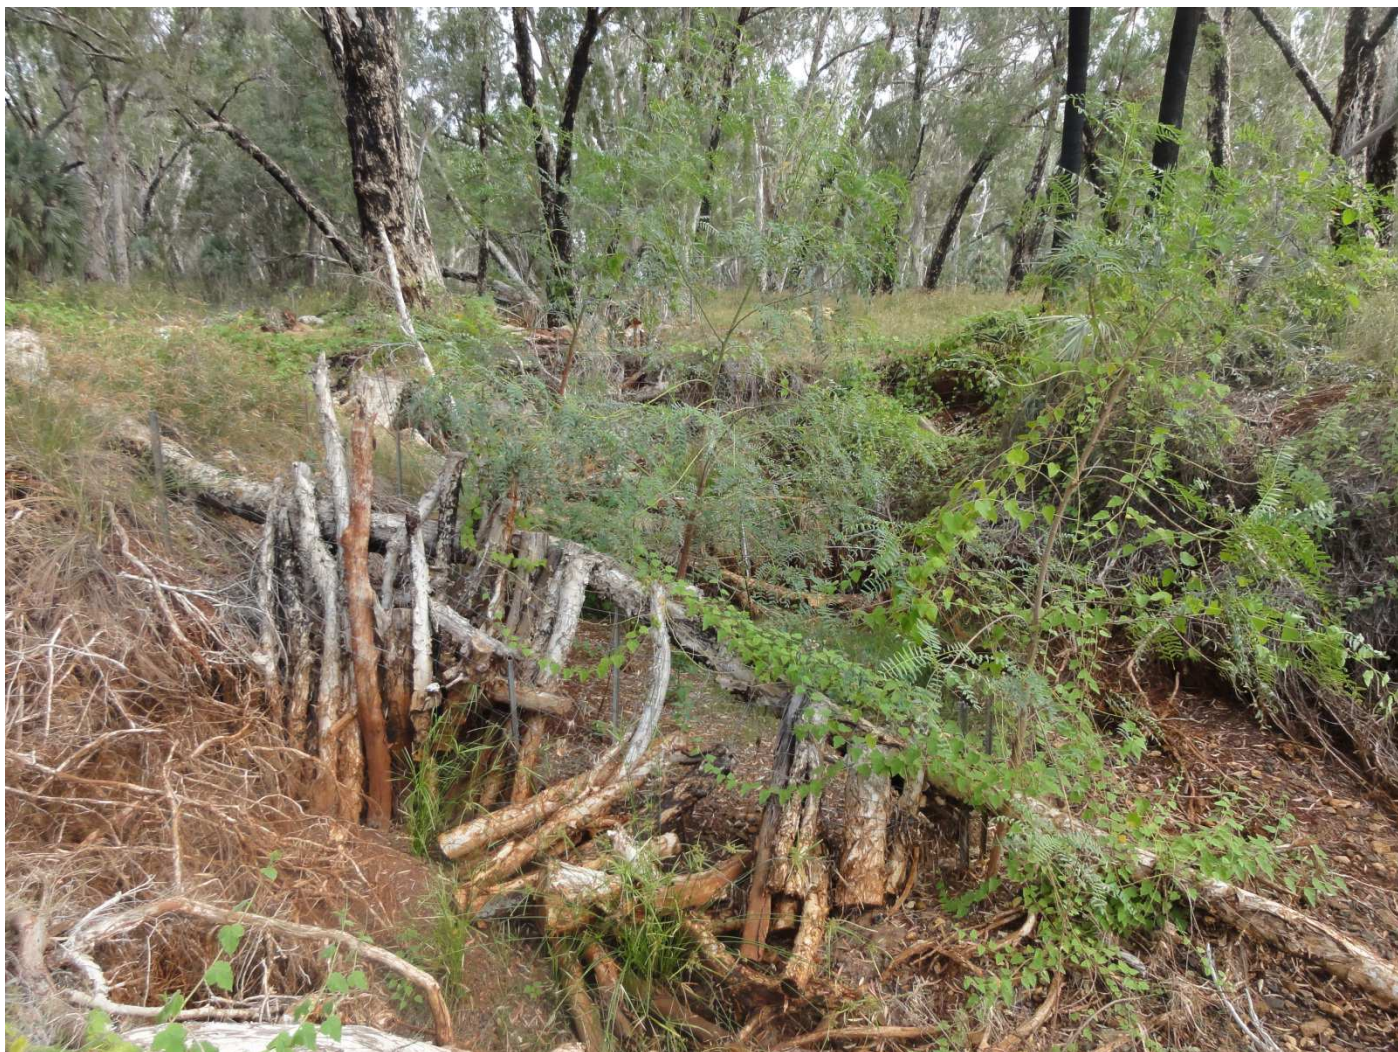
^^ Main erosion gully looking upstream toward headcut, July 15. Some collapse of log dam.

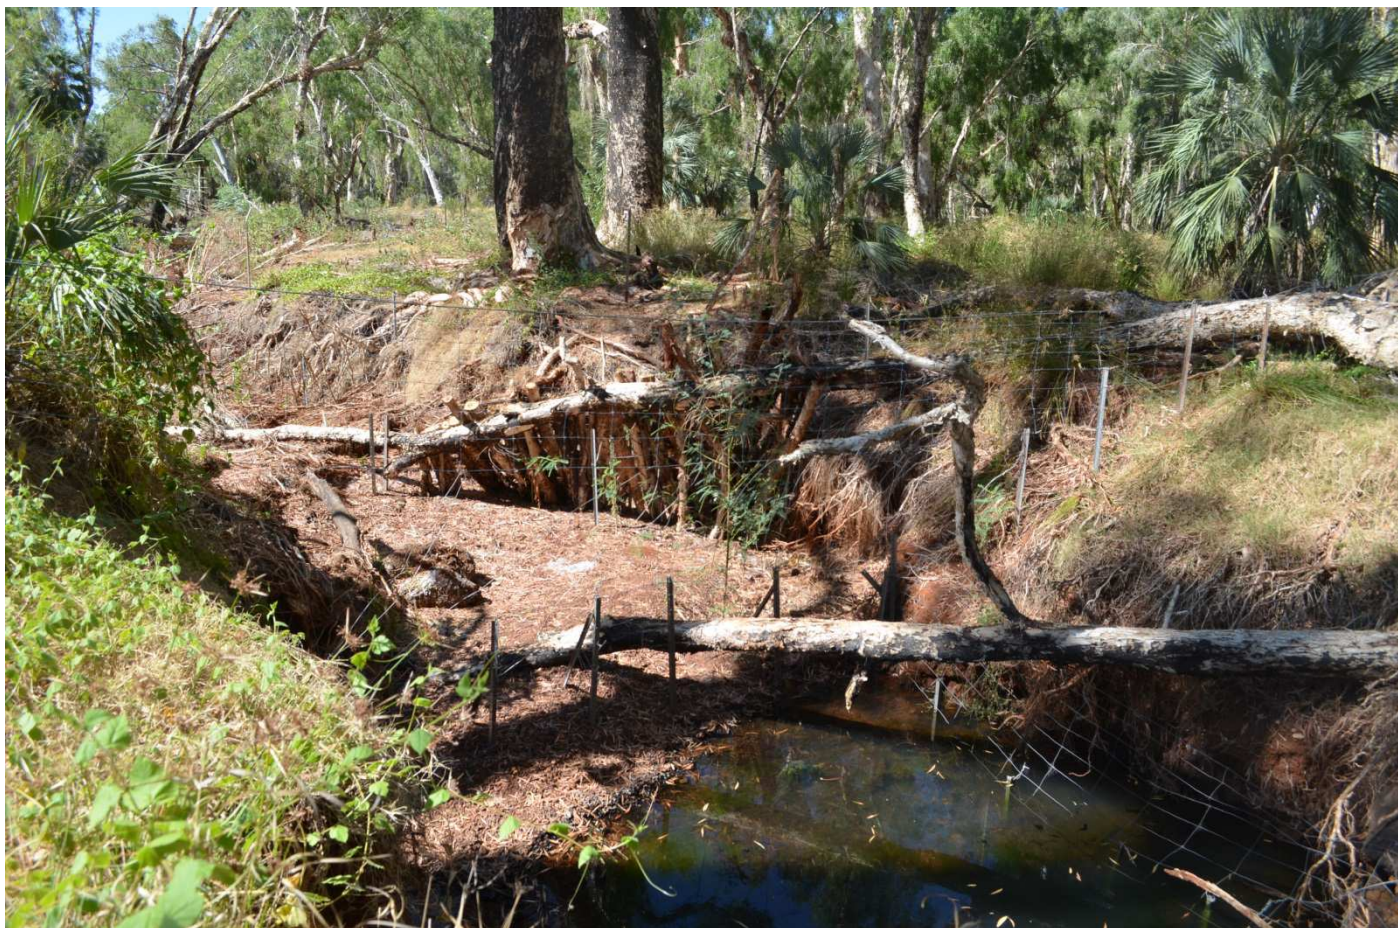
^^ Main erosion gully looking downstream from headcut, Oct 14. Note log diagonal from bottom right to centre as reference, and Millstream palm top right for scale

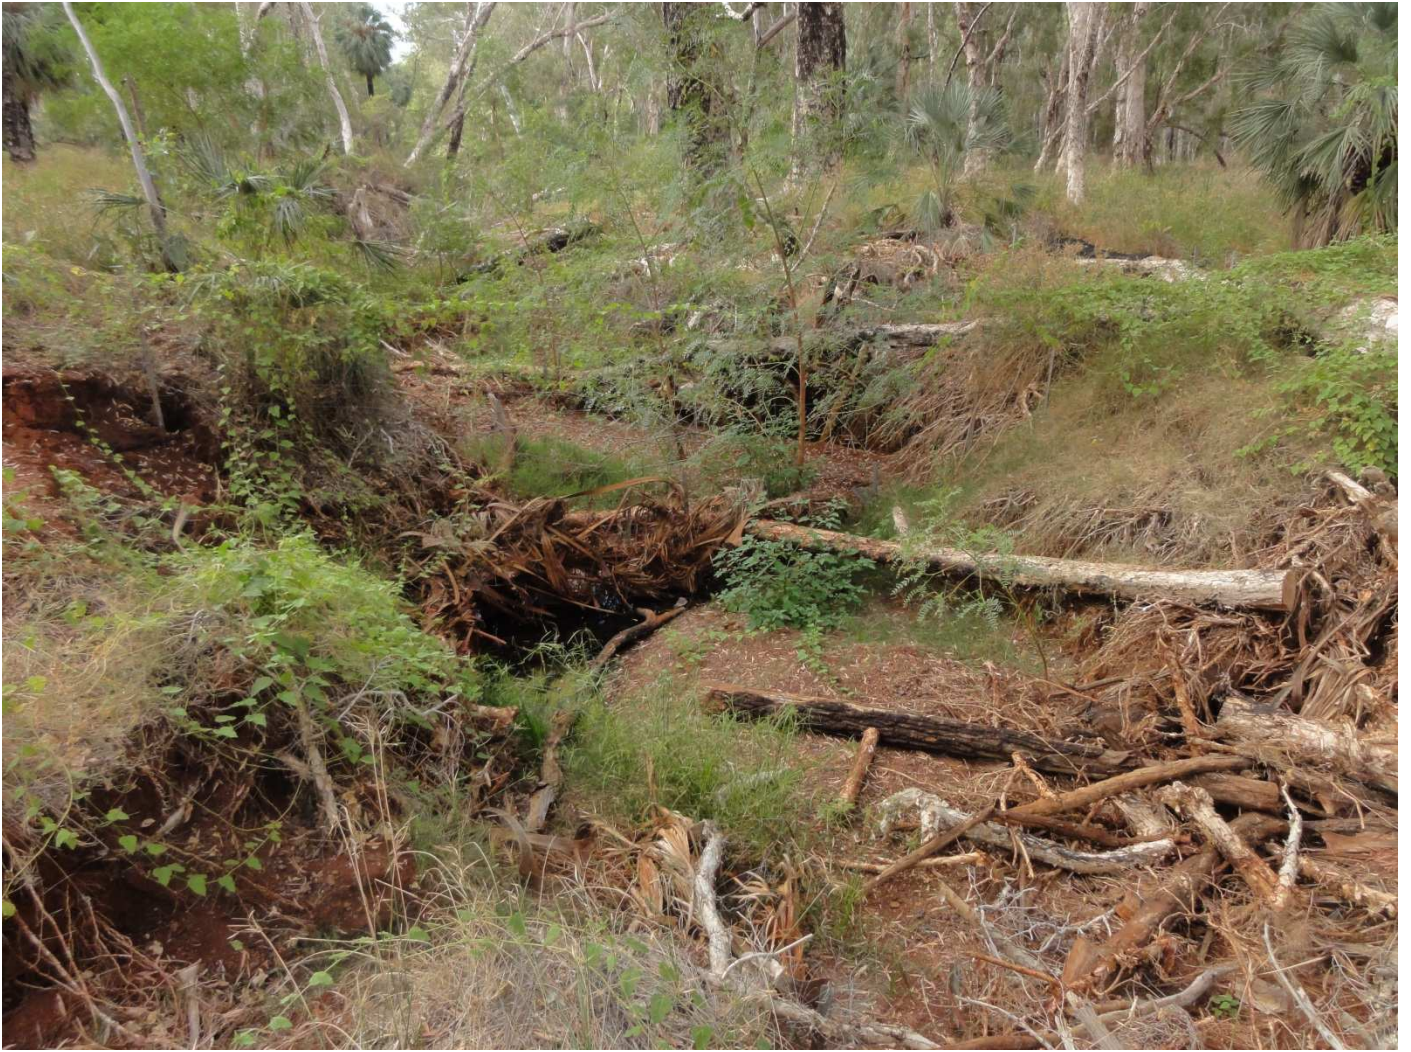
^^ Main erosion gully looking downstream from headcut, July 15. Diagonal log was cut in July 15

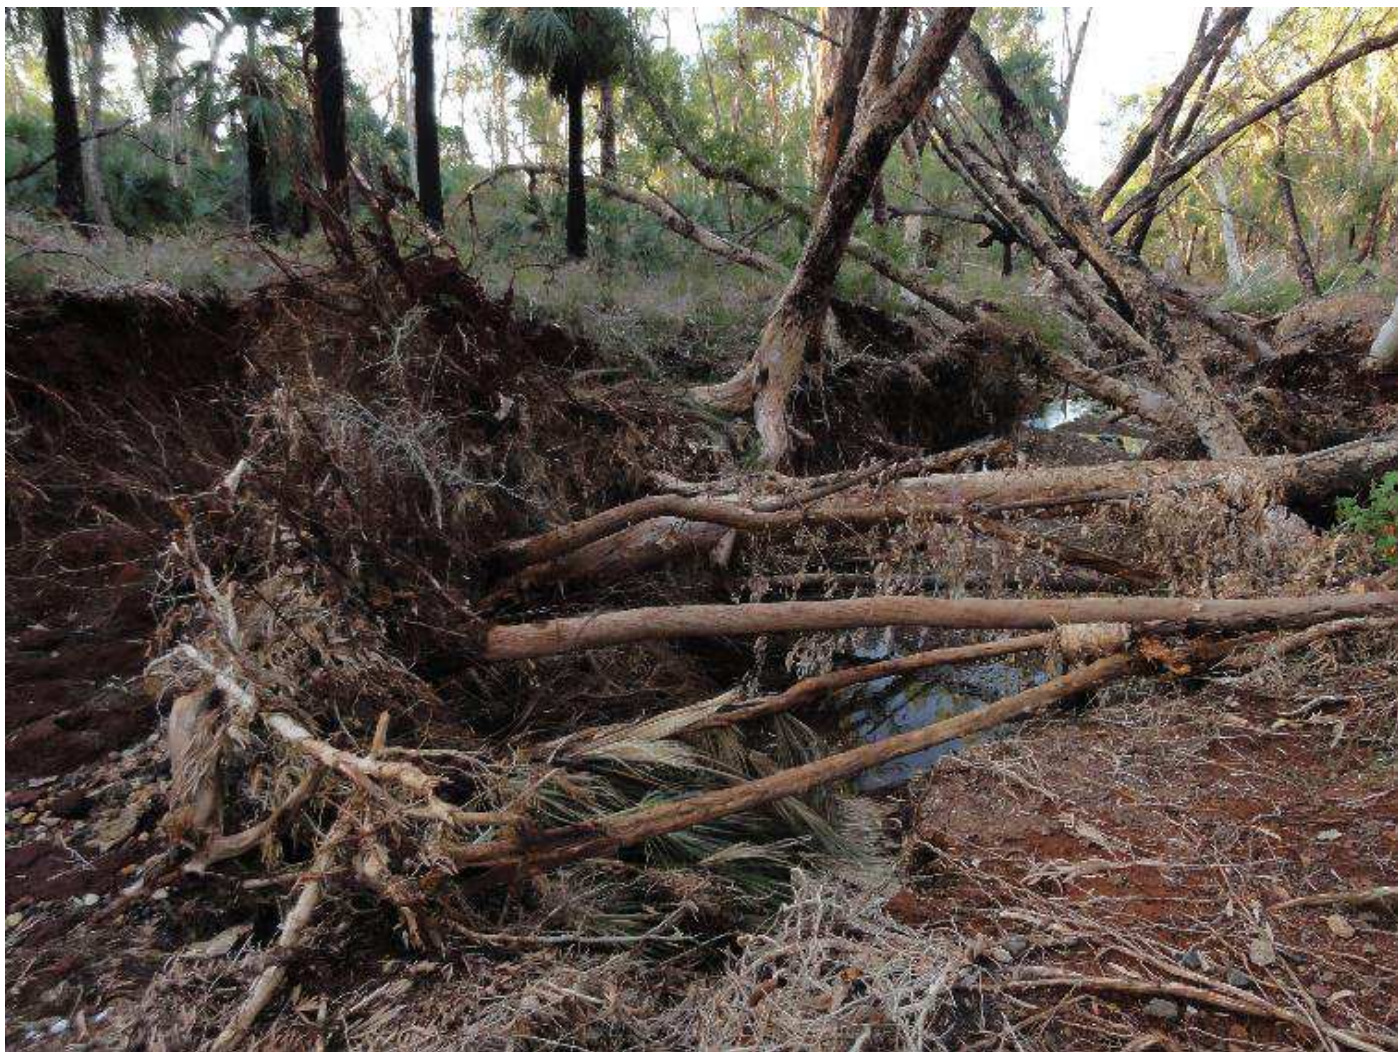
^^ Main erosion gully 60m from headcut prior to any works, September 14. Note cluster of Millstream palms at top left as reference. Note deeply incised channel on the gully floor

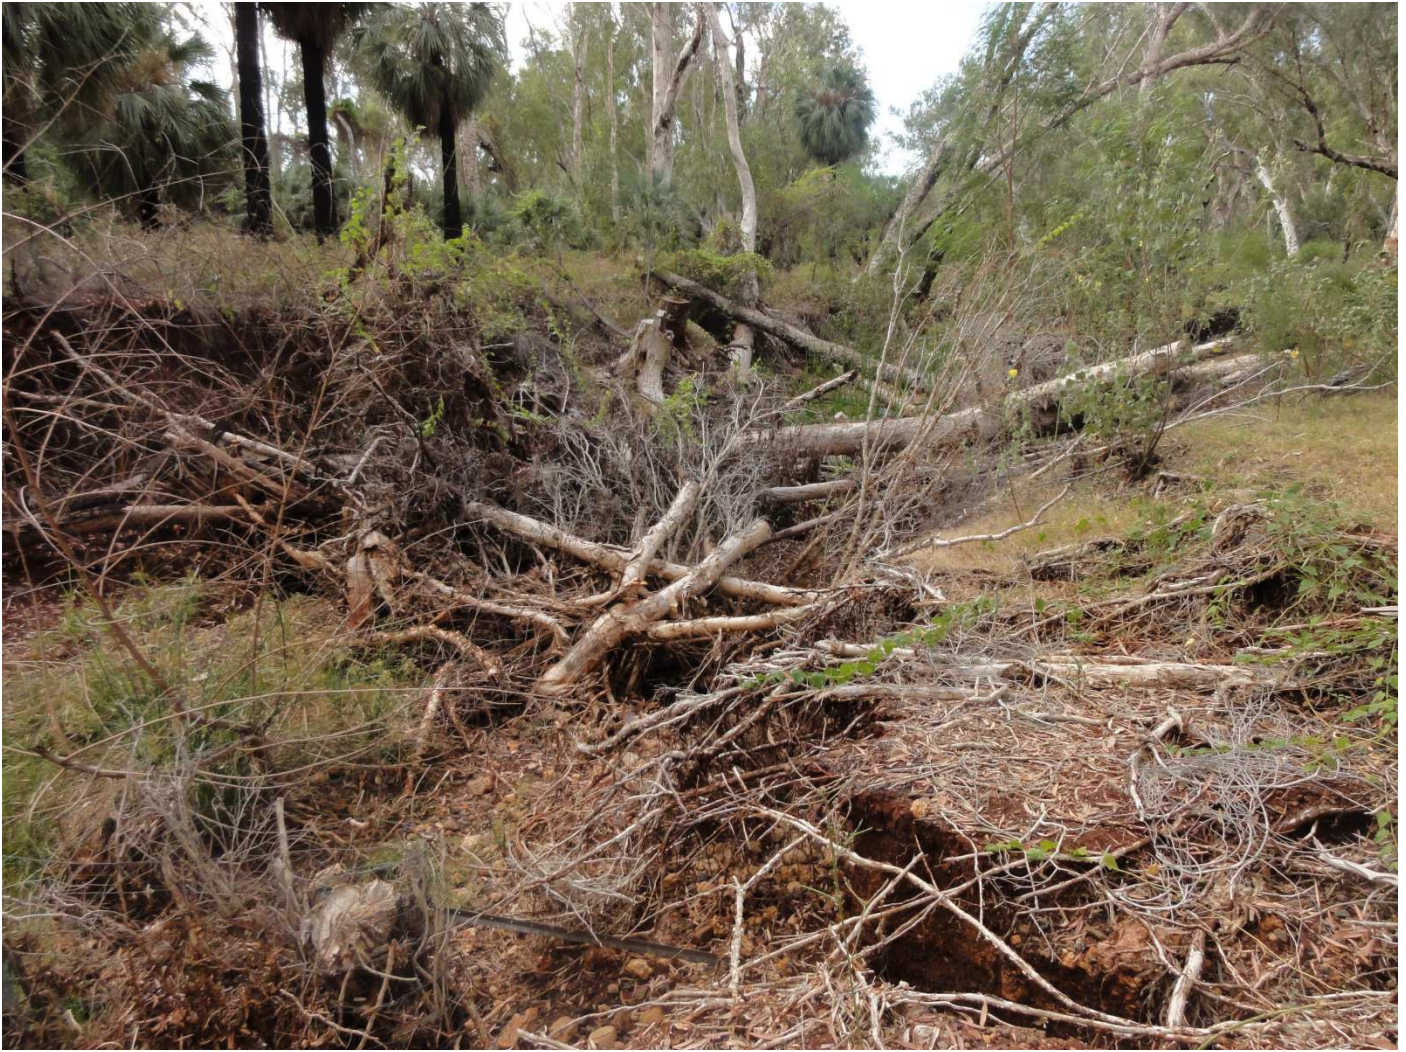
^^ Main erosion gully 60m from headcut, July 15. Trees have been felled (Oct 14) and log dams constructed. Note rehabilitation of incised channel

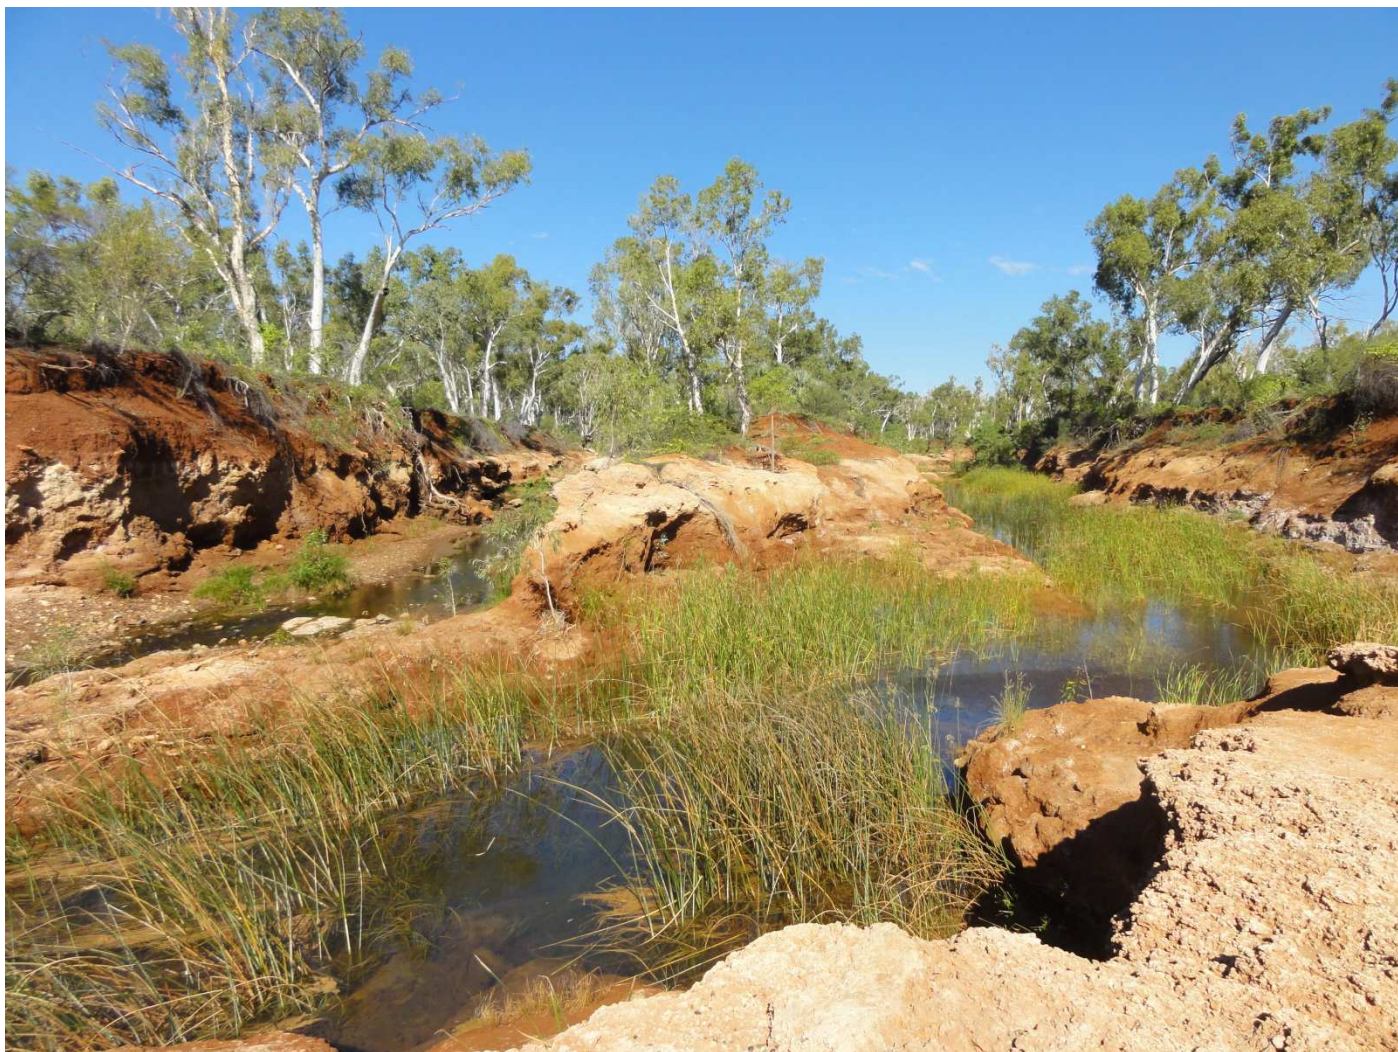
^^ Main erosion gully (channel IV), 1km downstream of the toe of Deep Reach Pool. Eventually works could begin in these downstream areas
