Final report on erosion mitigation projects at Deep Reach Pool (Nhanggangunha), October 2014 – July 2015 and future recommendations

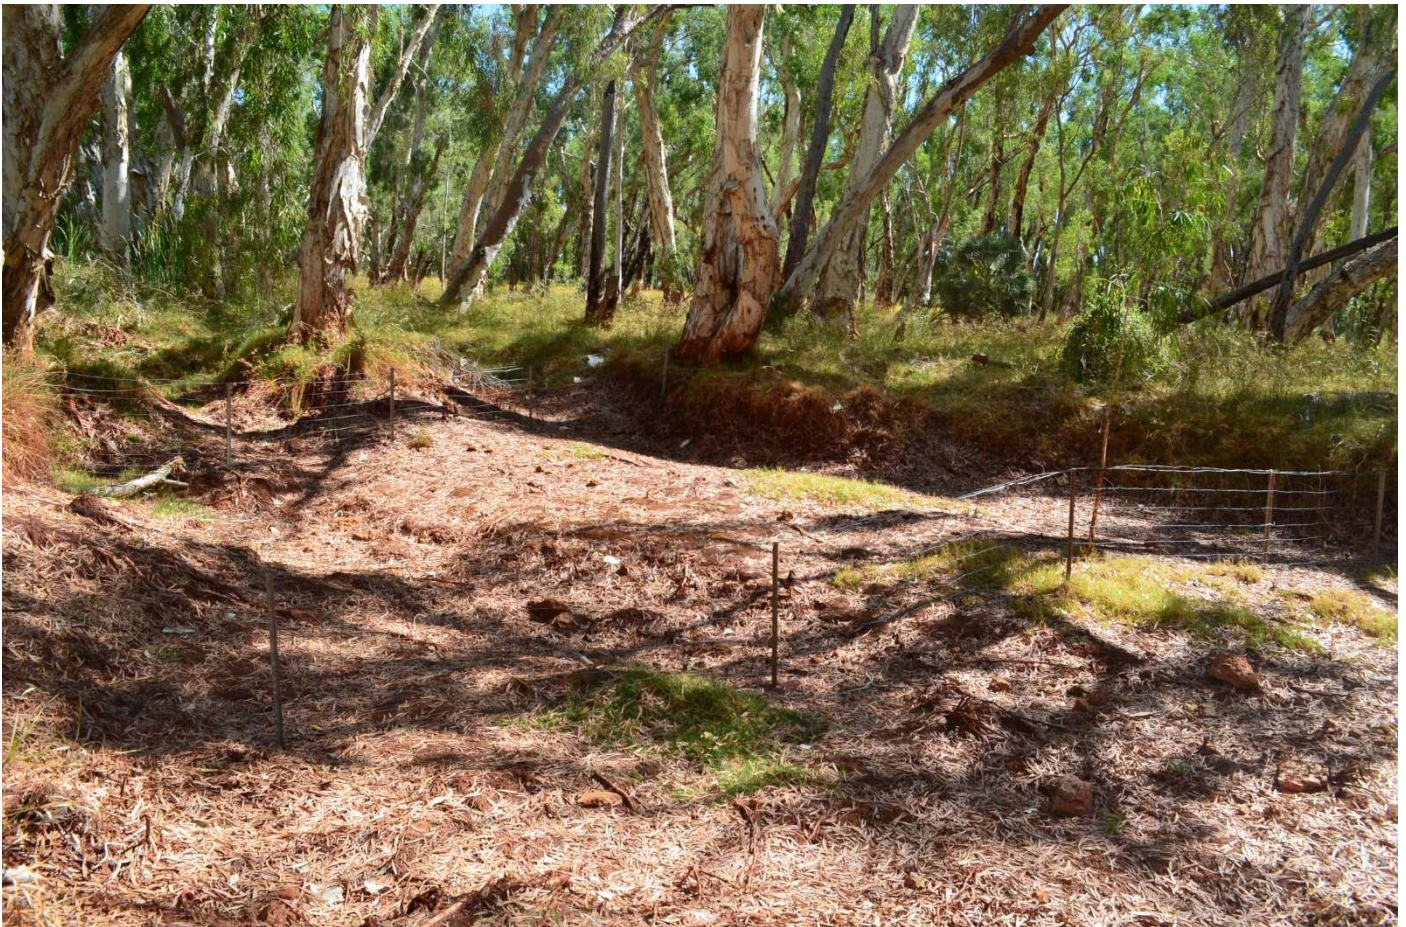
^^ Main side gully, Oct 14. Toe of pool is top left corner

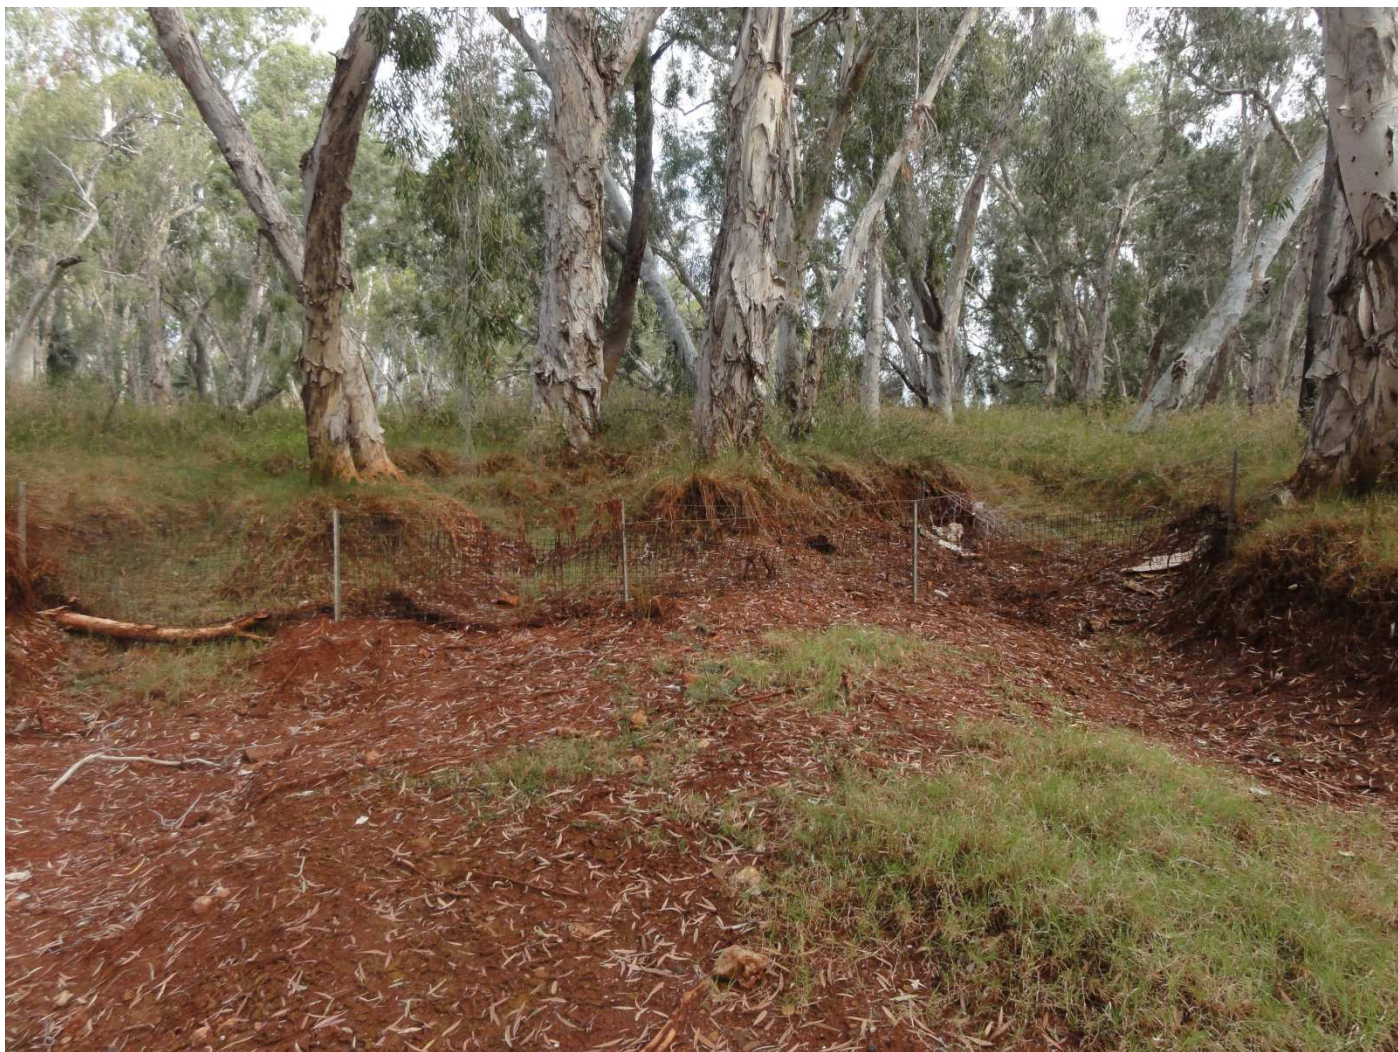
^^ Main side gully no significant change, July 15
