HUTT RIVER FORESHORE ASSESSMENT

Prepared by
Regional Operations
Department of Environment

DEPARTMENT OF ENVIRONMENT
WATER RESOURCE MANAGEMENT SERIES
REPORT NO WRM 45
FEBRUARY 2005

February, 2005

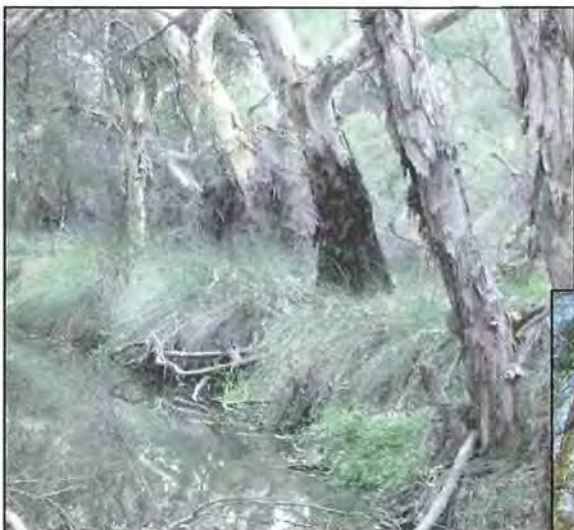
A grade foreshore: Fringing vegetation provides habitat, shade and leaf litter, important elements of a healthy river system.

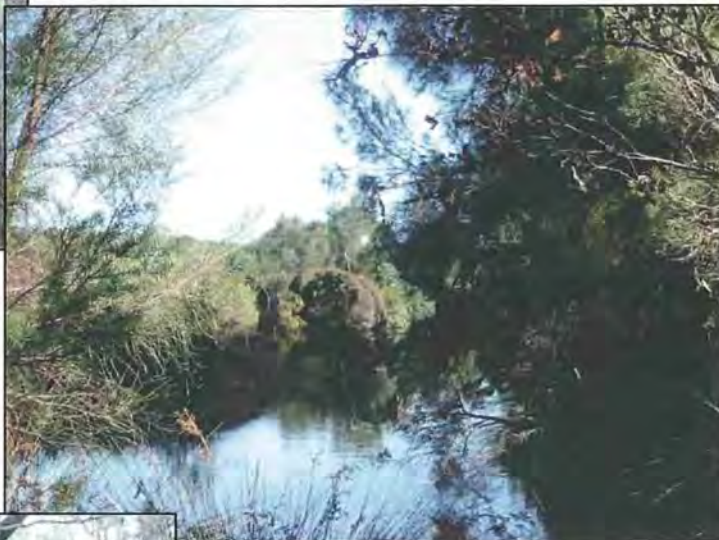
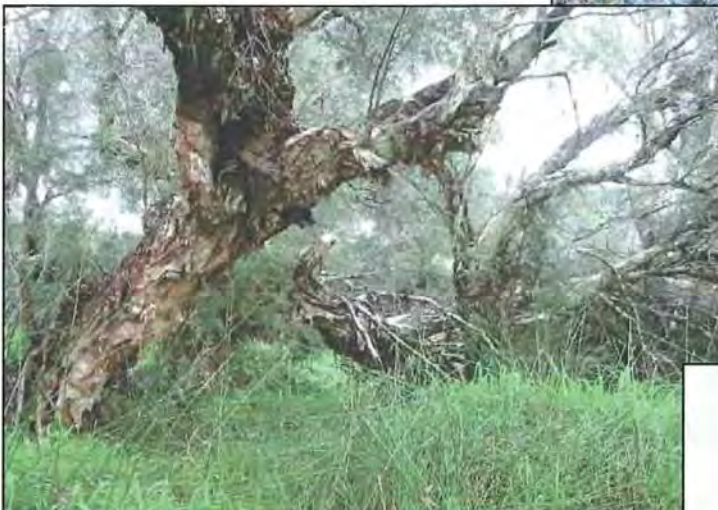
A grade foreshore: Native fringing vegetation protects the banks from erosion, as well as trapping sediment and organic matter before it reaches the river.

B grade foreshore: Although sedges are abundant, weeds have become a significant component of the understorey vegetation.

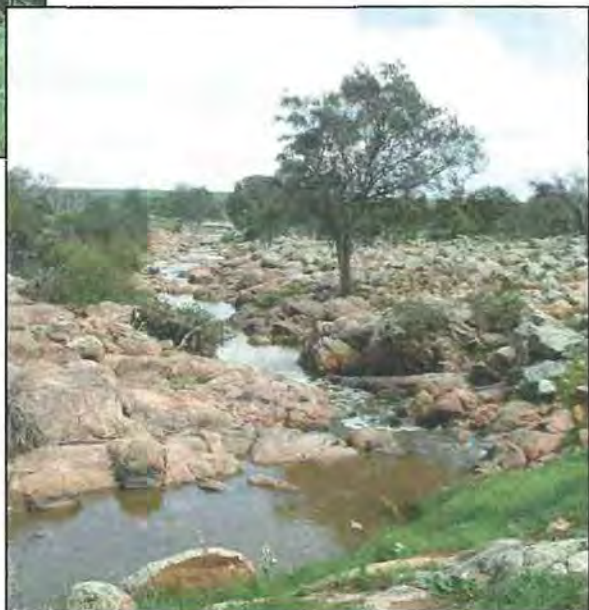
B grade foreshore: Rocky areas exhibit excellent bank stability.

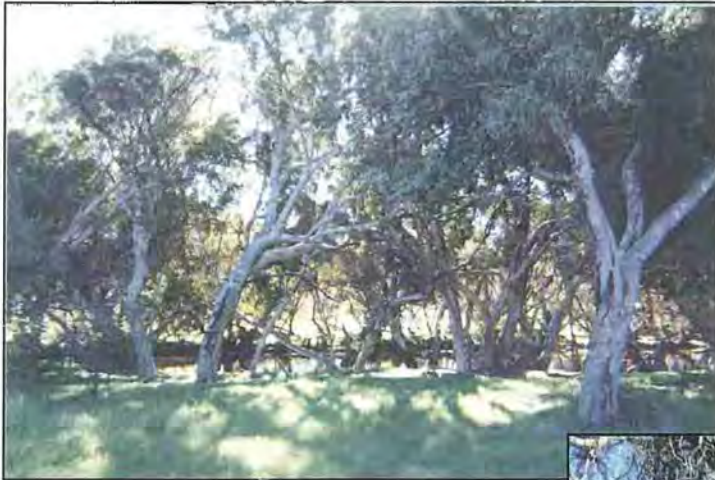
C grade foreshore: Trees remain though there is little evidence of regeneration. The shallow-rooted weedy understorey provides no support to the soil, making the banks vulnerable to erosion.

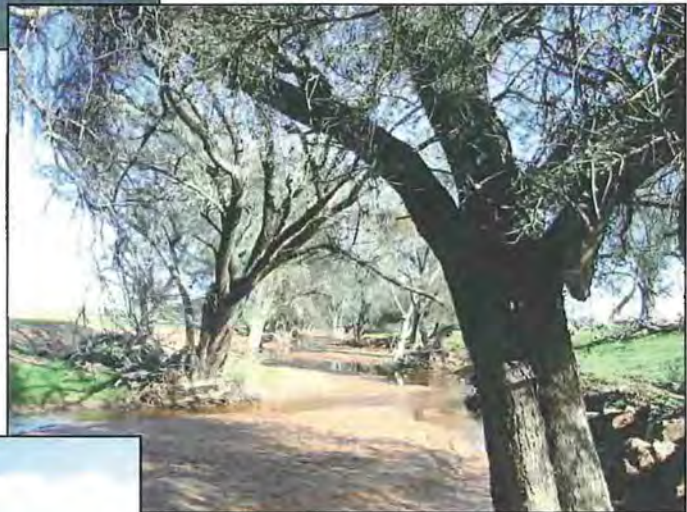
C grade foreshore: Soil is being washed away from between tree roots and the undermined trees are at risk of falling into the river. This will cause ongoing erosion problems.

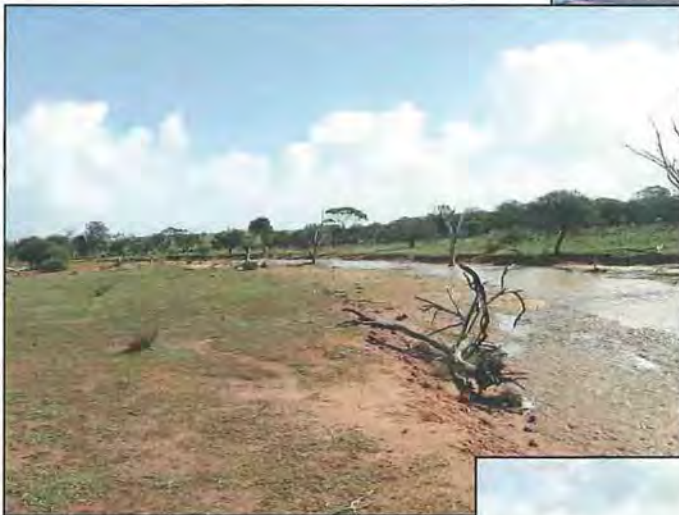
D grade foreshore: Deposits of sediment are accumulating along the river and the river channel is widening and eroding back into farmland.

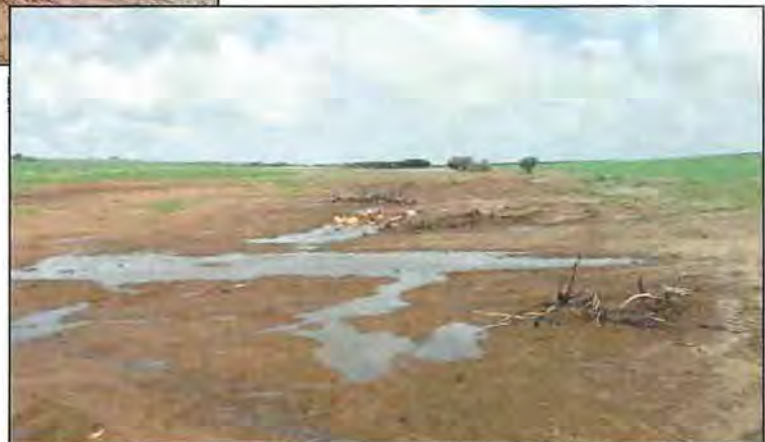
D grade foreshore: The waterlogged area is wide due to the lack of vegetation to confine and take up water.

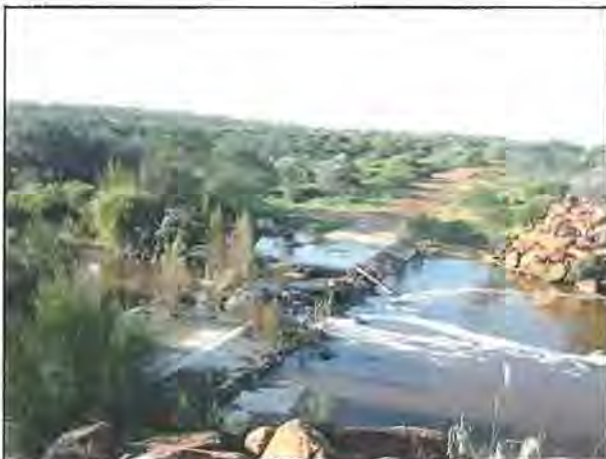
Photograph 3: The old Port Gregory Road crossing although slowly eroding away is still obstructing small to medium flows

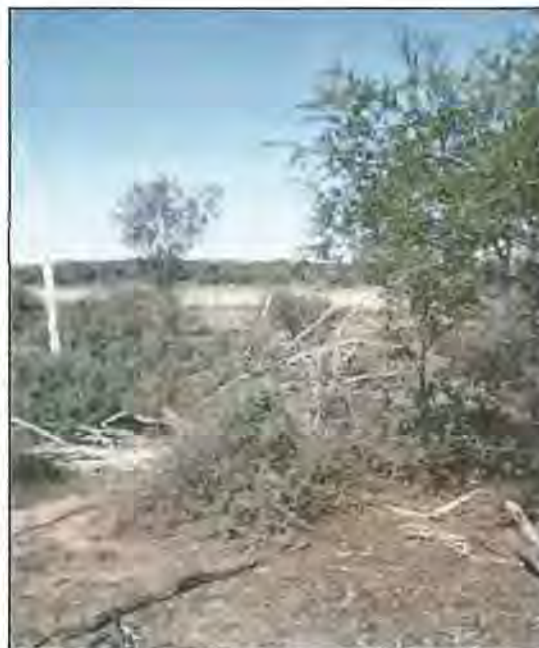
Photograph 8: Where stock has been excluded the foreshore is graded B. Here the stream cover and fringing vegetation slows evaporation and provides habitat.

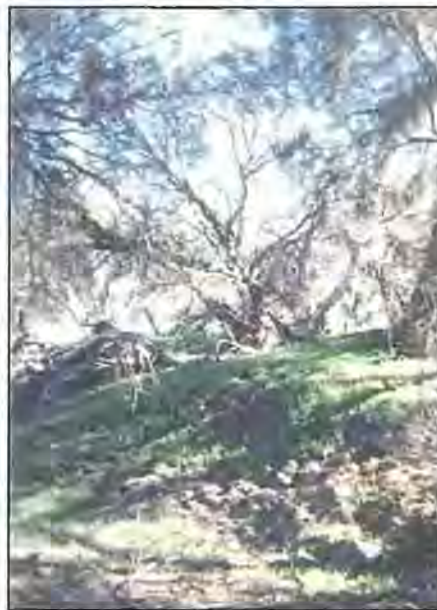
Photograph 9: Stock movement in the river adversely affects water quality. Stock mobilise plant nutrients via their faeces, limit growth of understorey plants that are important to good water quality and promote erosion by breaking down the bed and banks.

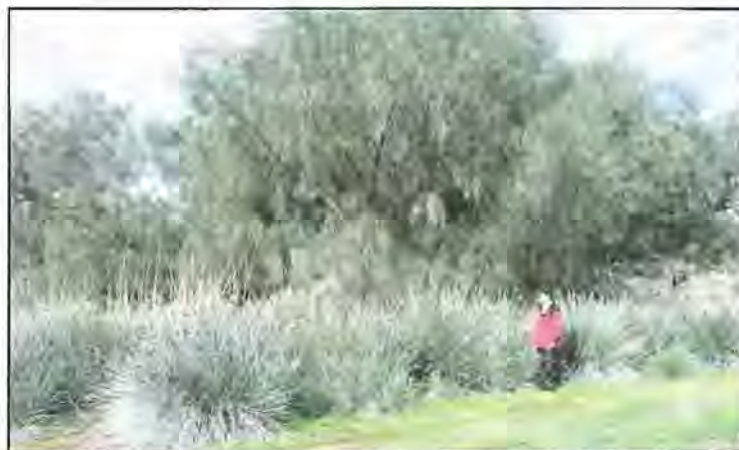
Photograph 10: Spiny rush (*Juncus acutus*) infestation along a tributary of the Hutt River. Spiny rush is an aggressive weed that is not readily eaten by grazing animals. Once established it covers an area and eliminates almost all other vegetation. Stands can become impenetrable to livestock and humans and the sharp spikes are a danger to animals' eyes.

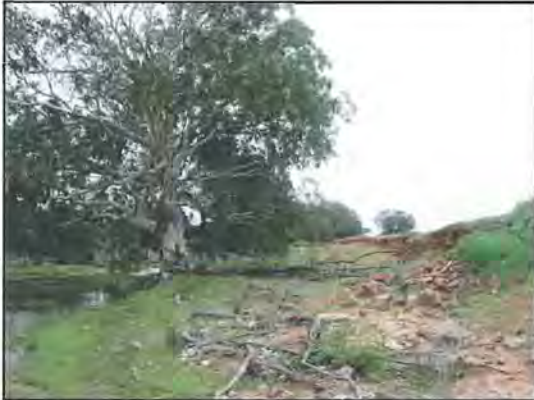
Erosion: Erosion leads to widening of the river, loss of adjacent land, disturbance of vegetation and increased sediment. Sediment then causes the river to get shallower, fills pools and covers rocks, vegetation and other habitat.

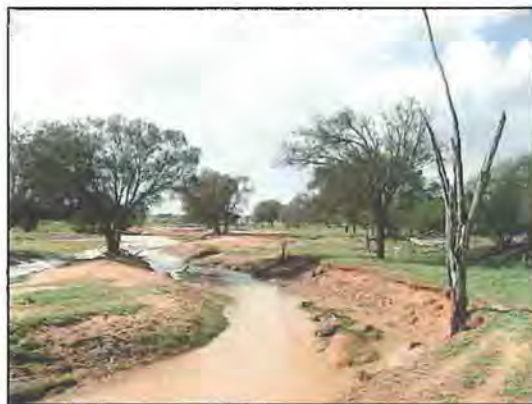
Lack of vegetation: Riparian vegetation protects the banks from erosion, provides shade and habitat and prevents nutrient and sediment runoff from adjacent paddocks reaching the river. Verge vegetation protects soil in the floodway from being washed away during large flow events.

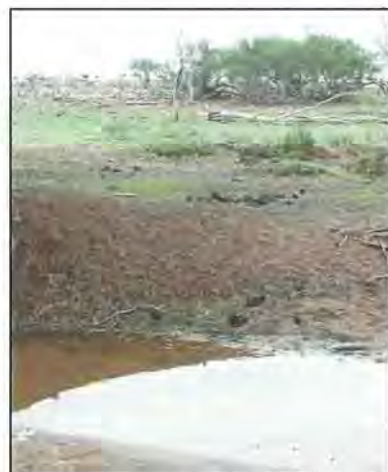
Stock Access: Stock movement in the floodway limits regeneration, disturbs the banks making them prone to erosion and mobilises nutrients.

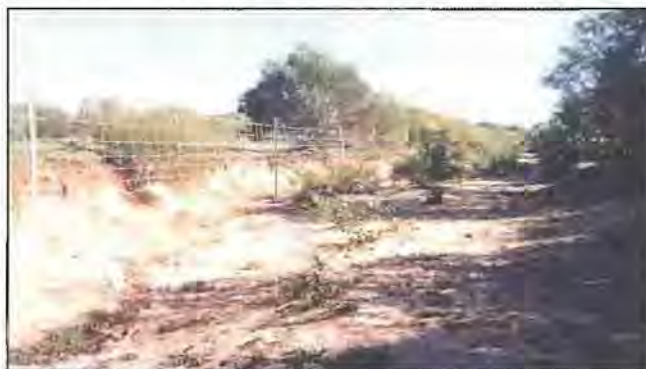
Photograph 14: Fence too close to the floodway which was not protected from washouts in large flows

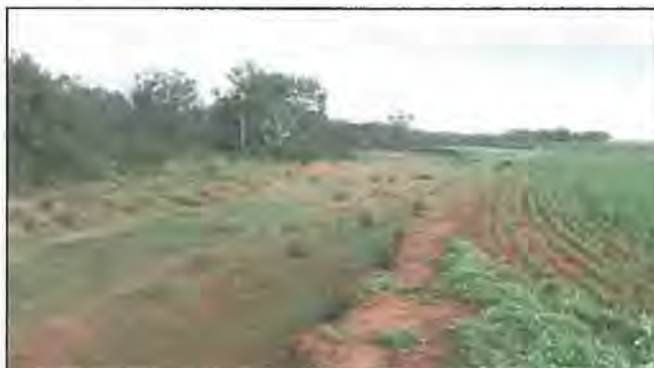
Photograph 15: Thin band of riparian vegetation along the river has allowed large flows to go around and cause a large washout of vulnerable unprotected land. Resulting in a greater loss of cropping land.
