## Foreshore and channel assessment of the Dale River South Branch

Water resource management series

Report No. WRM 50  
June 2008

Prepared by  
BlueSands Environmental for  
Department of Water

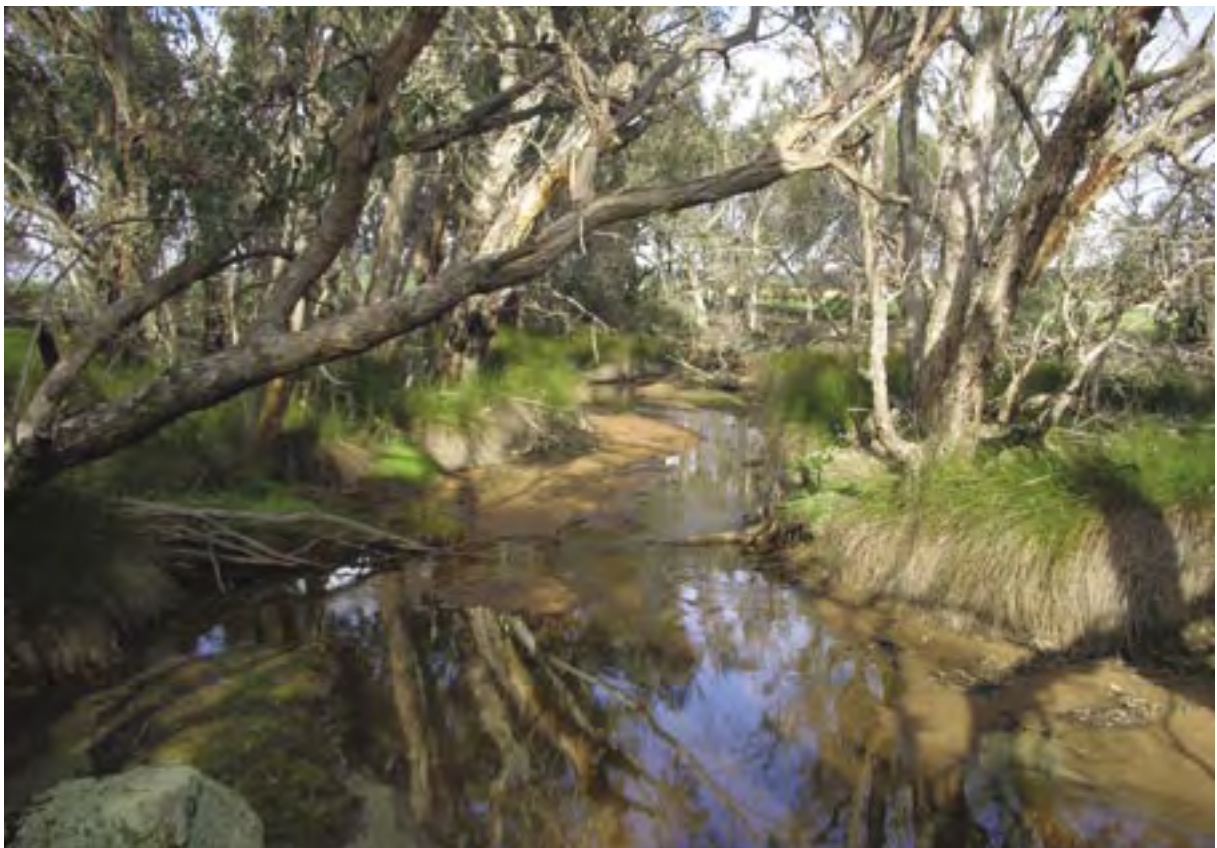
**Photo 2** A B-grade reach of the Dale River South

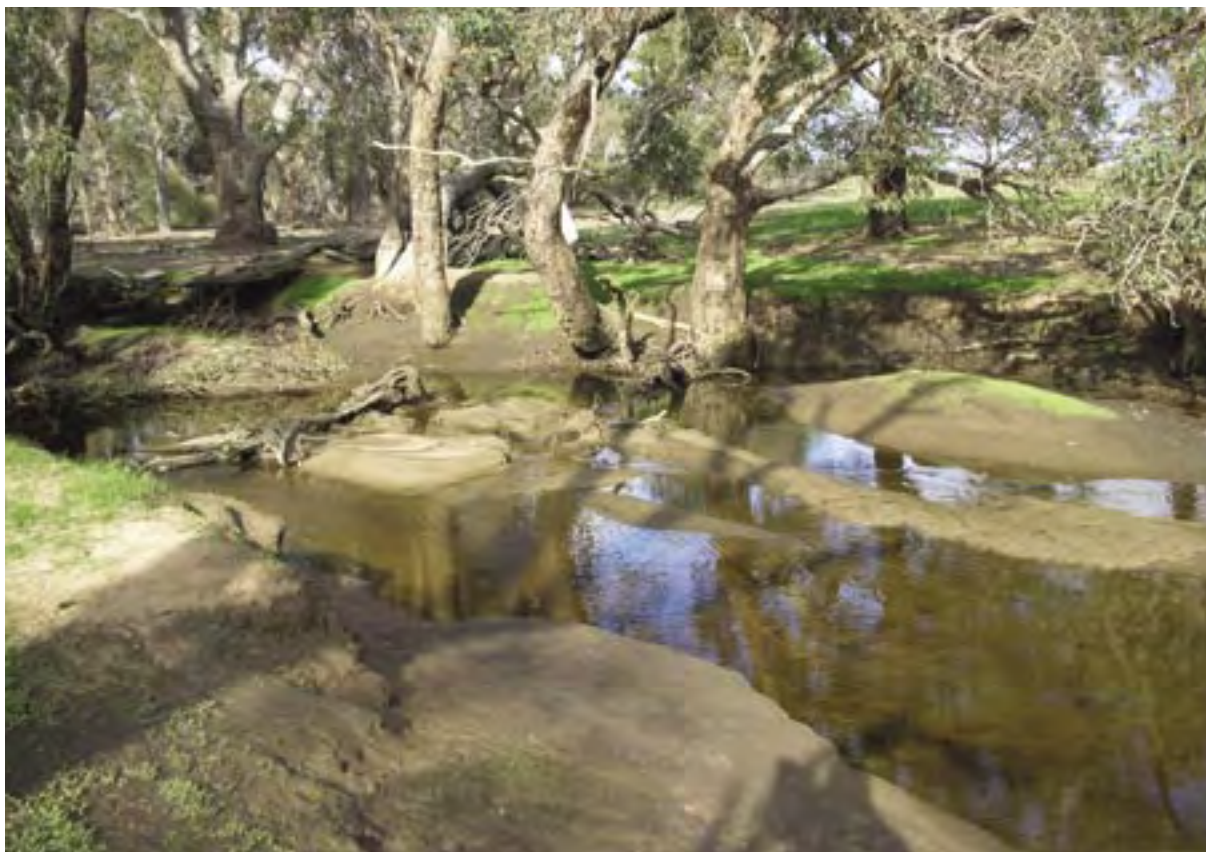
**Photo 3** C-grade foreshore along the Dale River South

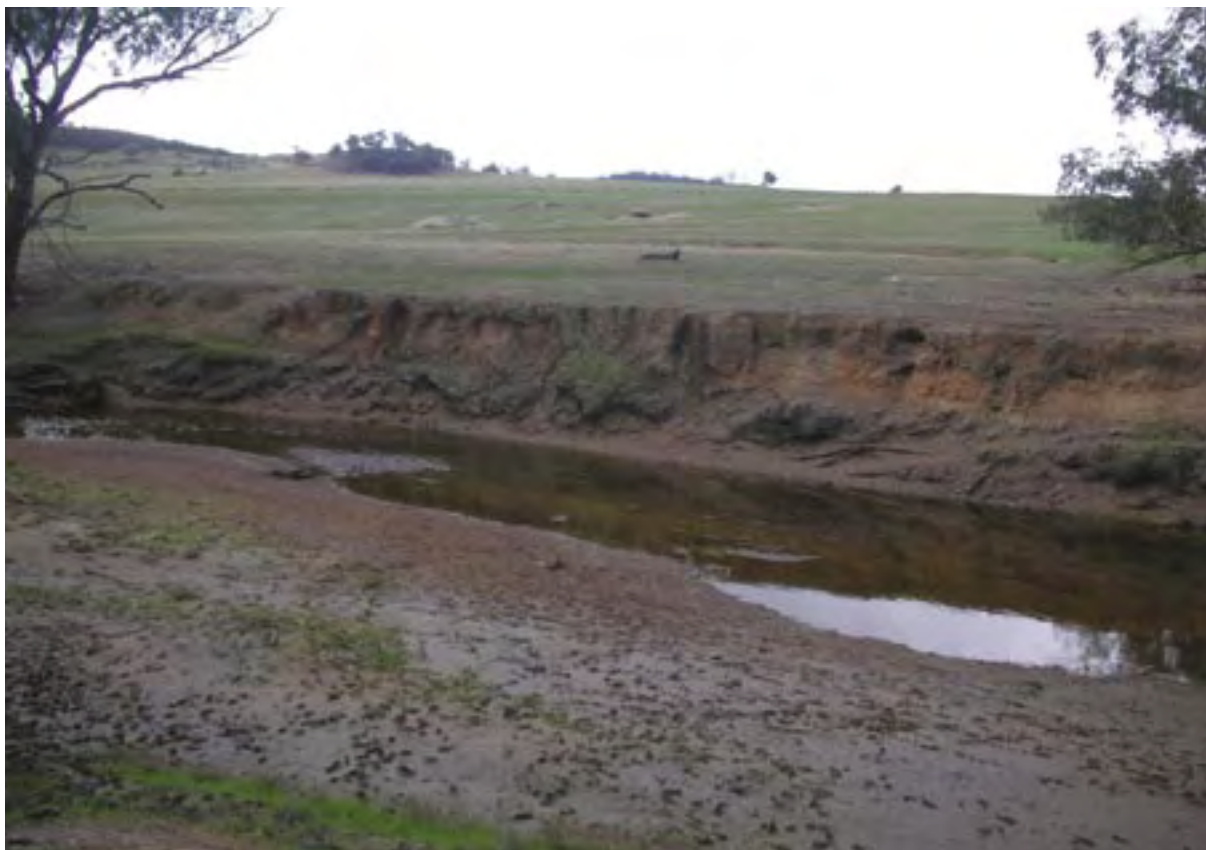
**Photo 4** D-grade foreshore along the Dale River South

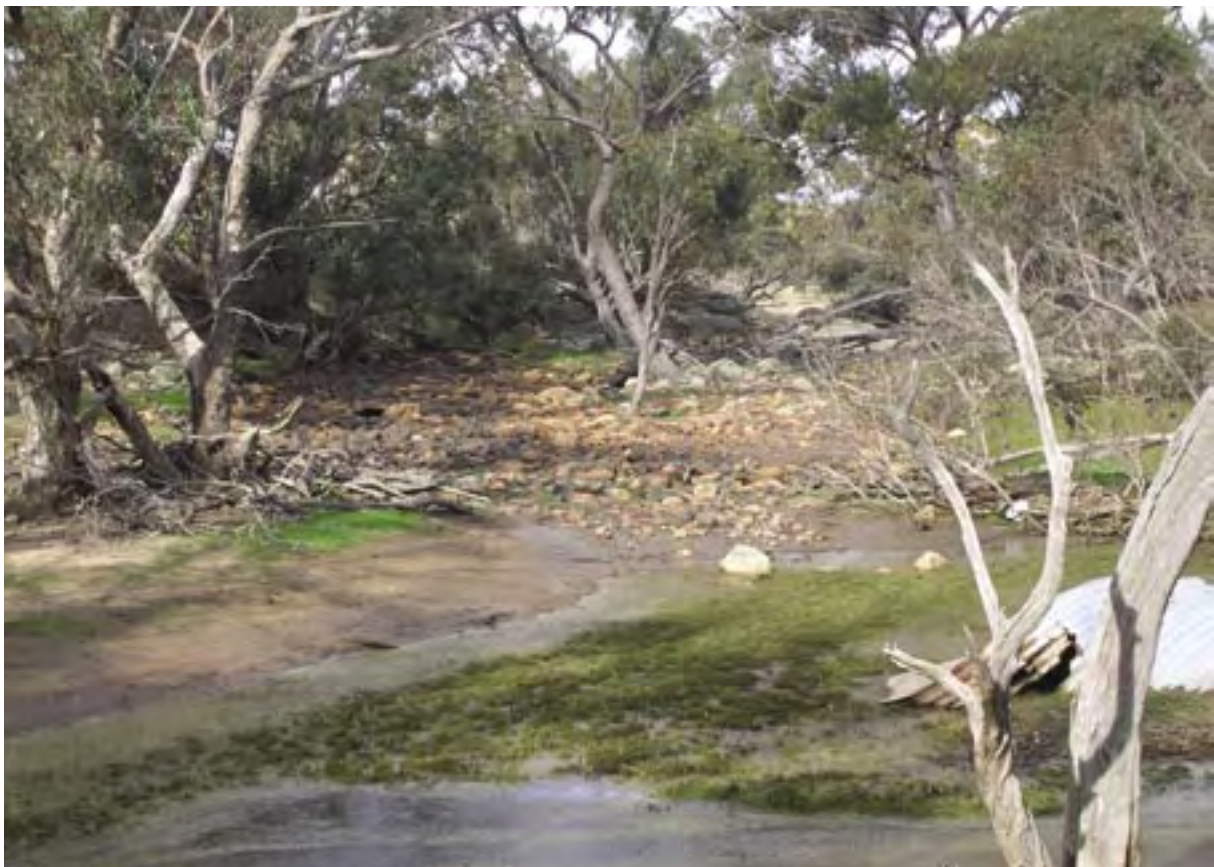
Riffles also act to trap sediment, which is later removed by flushing flows. However, much of the Dale River South is actively eroding, therefore it is assumed that many of the cobble and pebble riffles that once existed along this waterway are now completely covered with sediment.

**Photo 5** Significant riffle in survey section DRS26

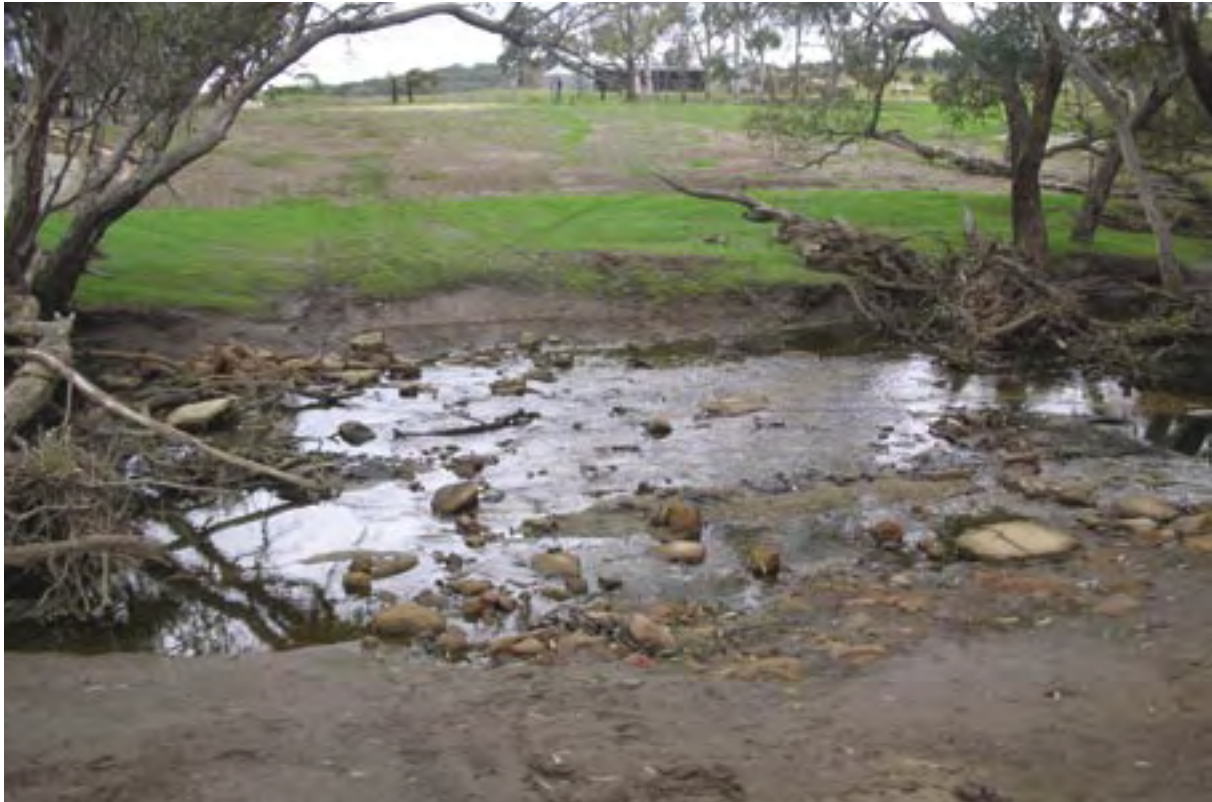
There were also numerous other farm crossings which were designed to enable stock and vehicle access. Many of these crossings have been stabilised with field stone, which means they double as a constructed riffle, allowing oxygenation of the water.

**Photo 6** Farm crossing stabilised with field stone

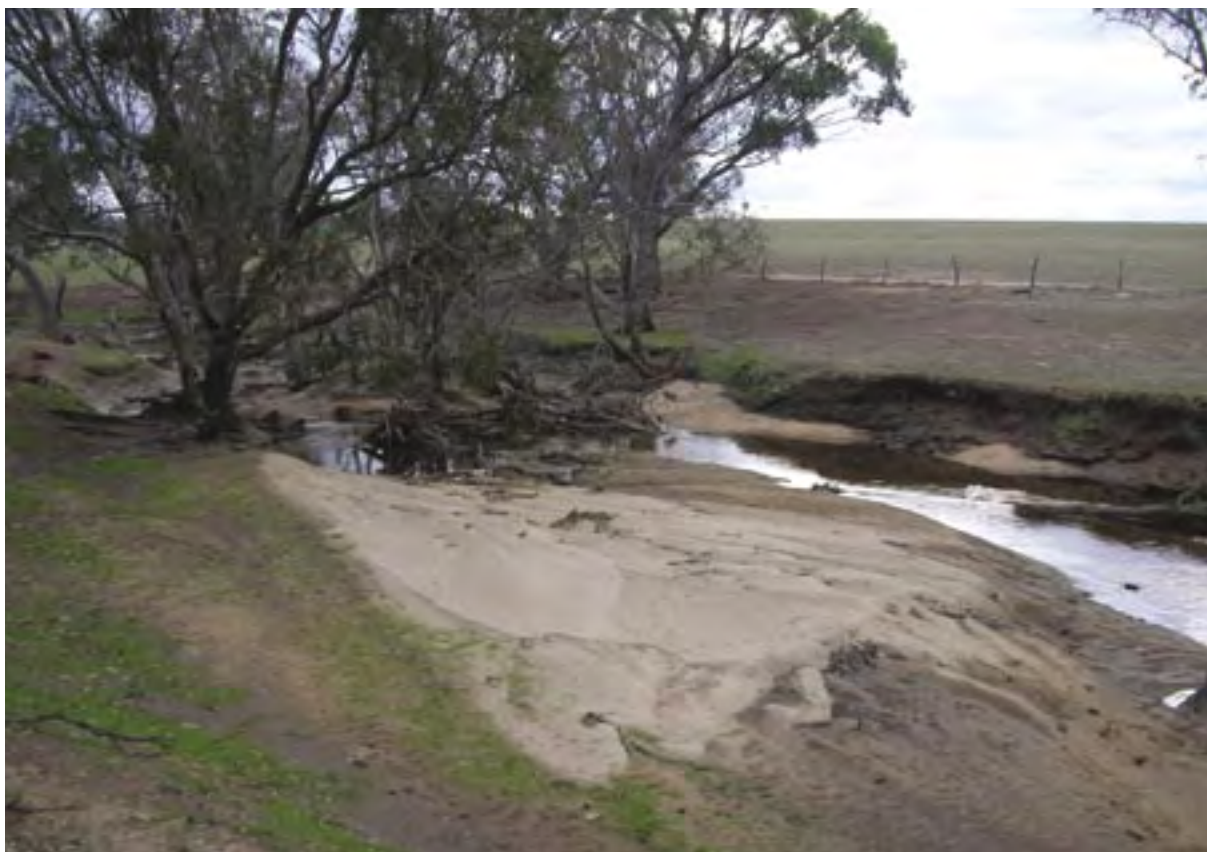
**Photo 7** Sedimentation deposit in a degraded section of the Dale River South

The Dale River South has a high level of bank undercutting, in many instances near large trees, which over time will cause the trees to collapse into the channel. Sedimentation is also significant, which leads to the infilling of pools and smothering of aquatic habitat.

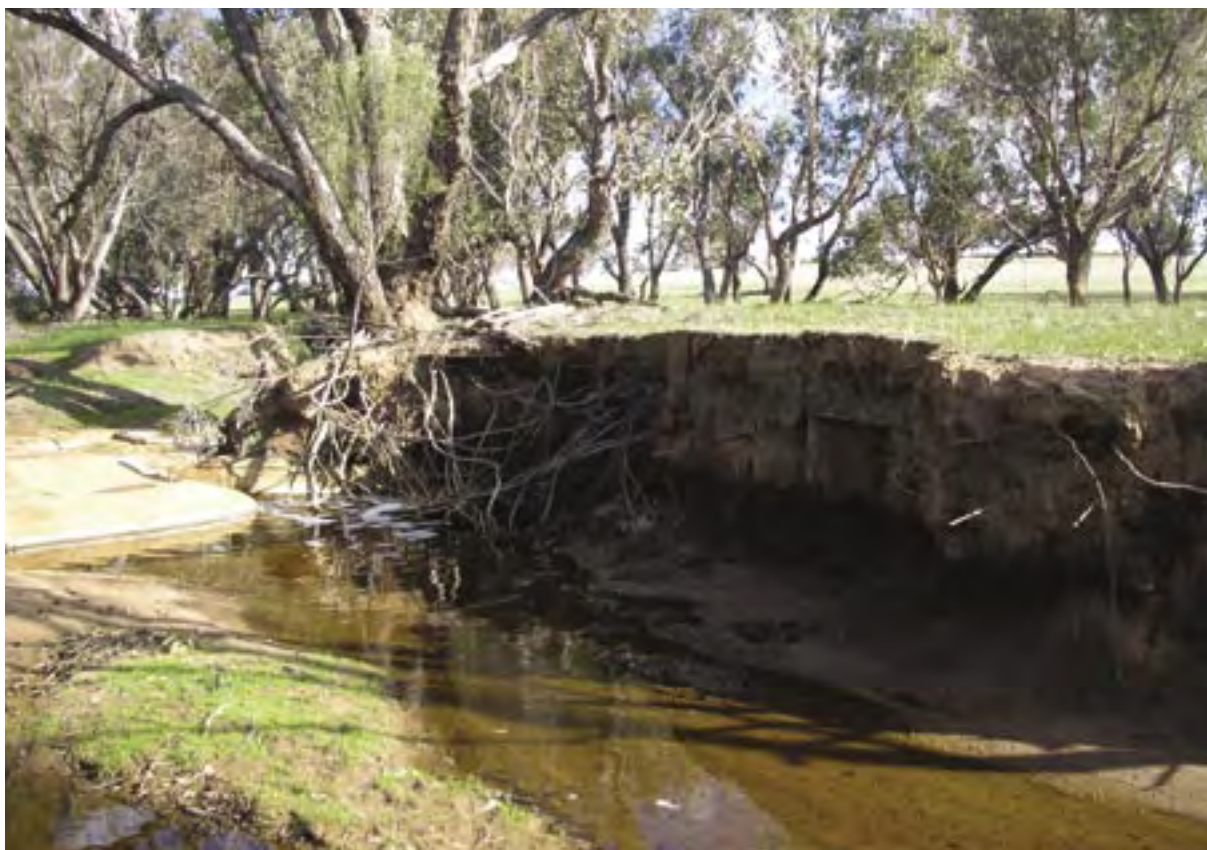
**Photo 8** Significant undercutting of a flooded gum (*Eucalyptus rudis*)

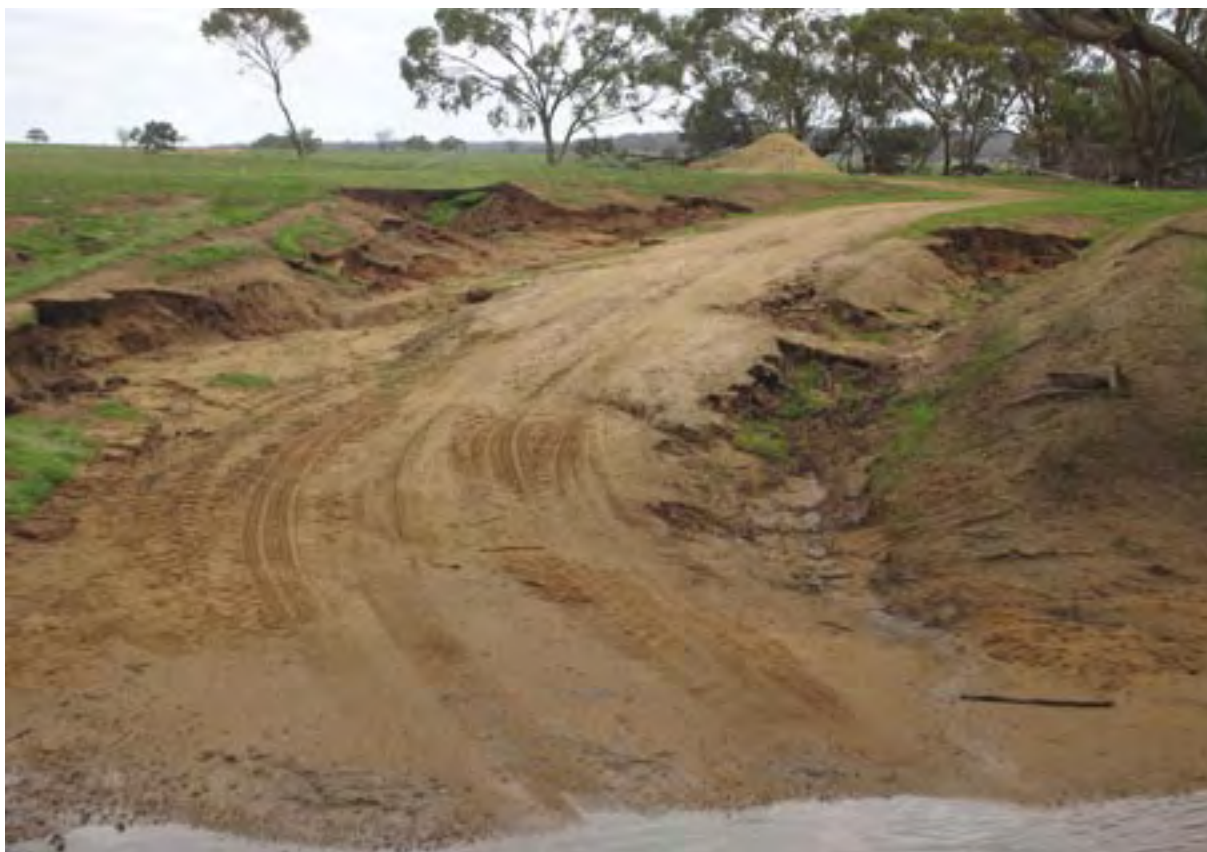
Track washouts and gully erosion were either absent or localised along all of the Dale River South. Most of the track washouts were restricted to a few farm crossings, where soil was soft along the sides of the track, and had been washed away. Gully erosion was restricted to the confluence of a few tributaries or within the tributaries themselves.

**Photo 9** Erosion and washout of a track crossing the Dale River South

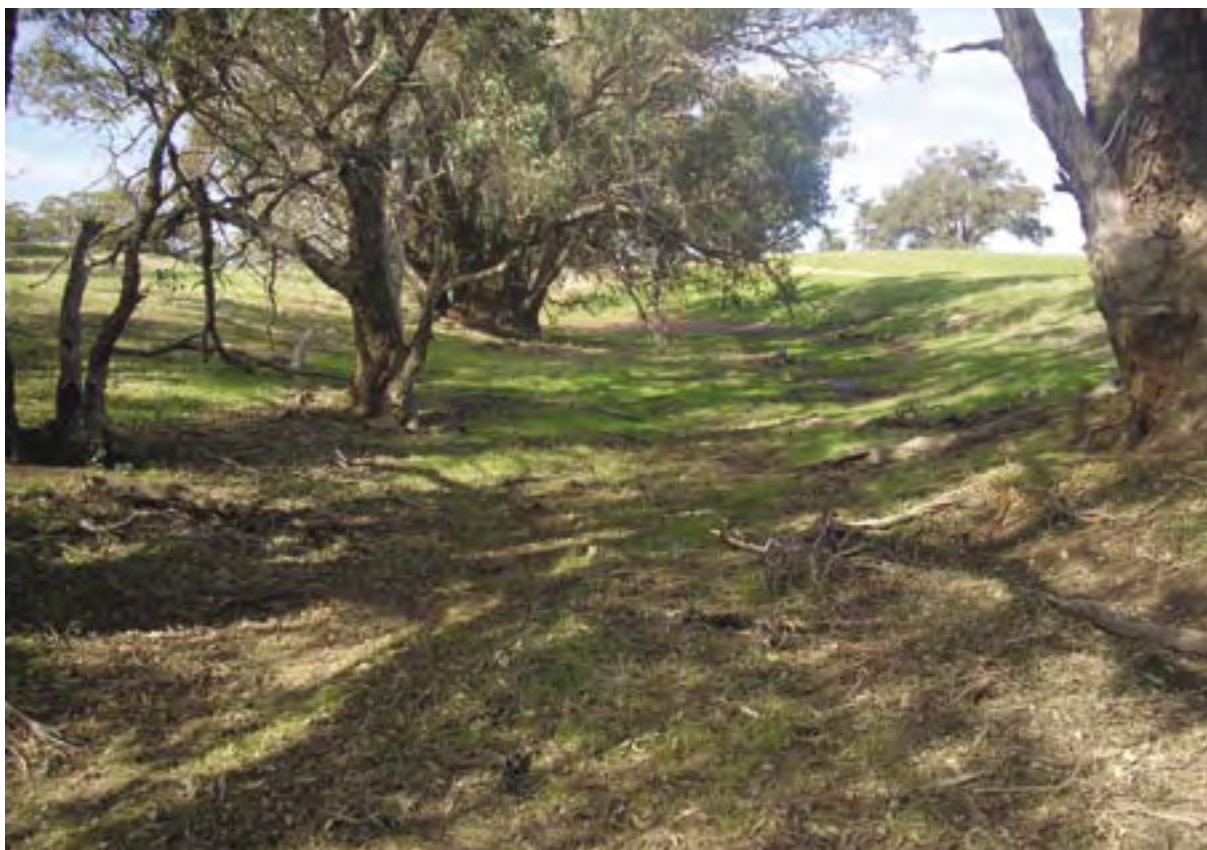
The stability of the tributaries varied (Table 9). Some of the tributaries had no flow, very broad channels and moderately sloping banks, making them quite stable. Others had steep, exposed banks making them vulnerable to undercutting and subsidence. The majority of tributaries were unfenced and grazed with little riparian vegetation, so even if they had little active erosion, they would be contributing sediment via overland flow into the main channel.

**Photo 10** Tributary with moderately sloping, stable banks

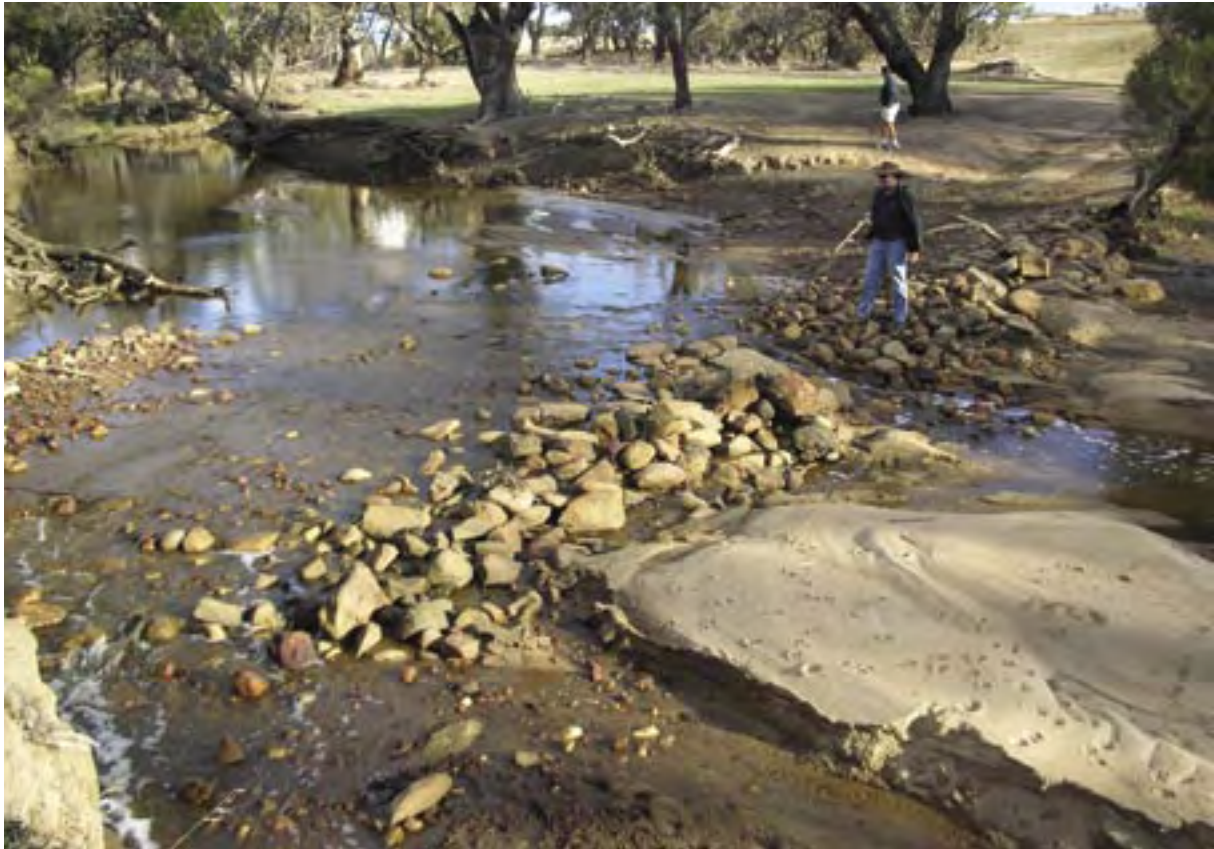
*Photo 11 Vehicle crossing which doubles as a riffle*

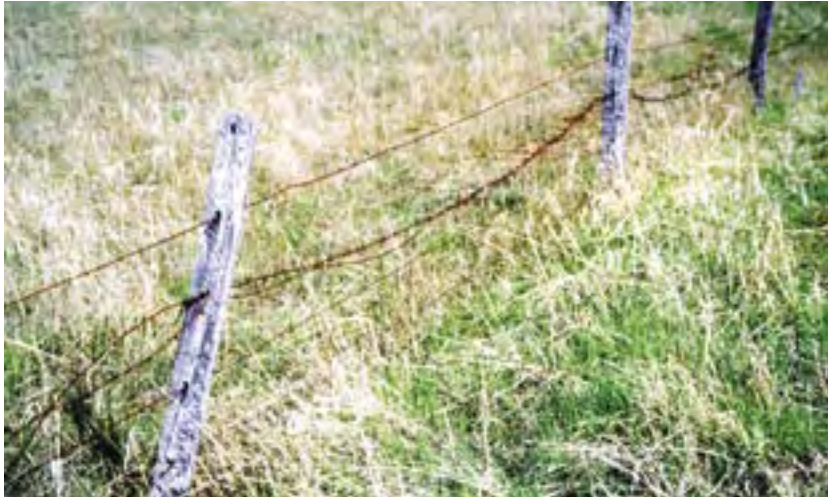
*Fence in poor condition*

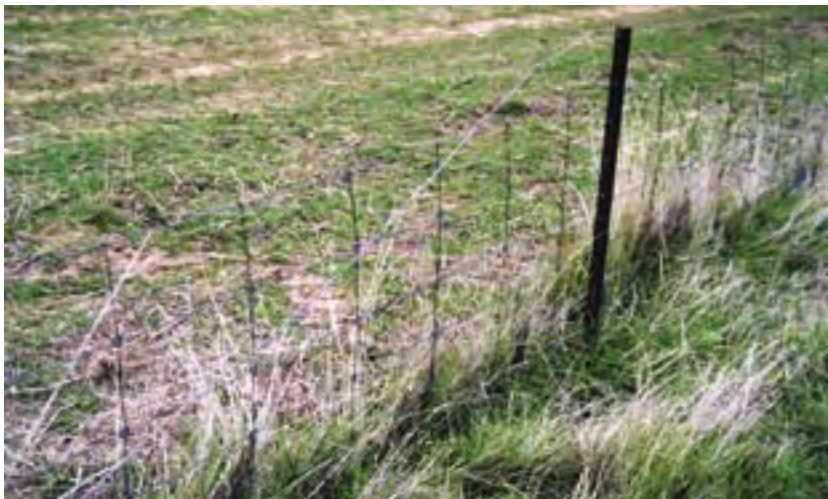
*Fence in moderate condition*

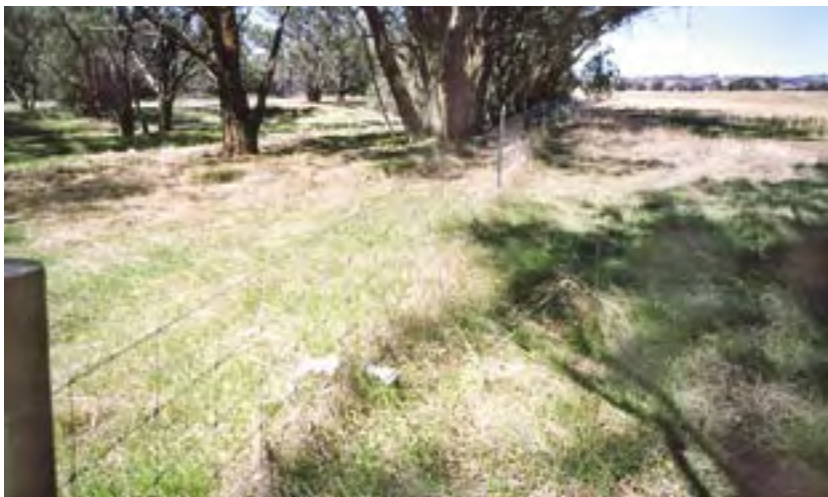
*Fence in good condition*
