# POST INCIDENT ANALYSIS

## Bridgetown Complex

**Fire 23 (Peninsula)**

**Thursday January 15<sup>th</sup> 2009**  
**to**  
**Tuesday January 20<sup>th</sup> 2009**

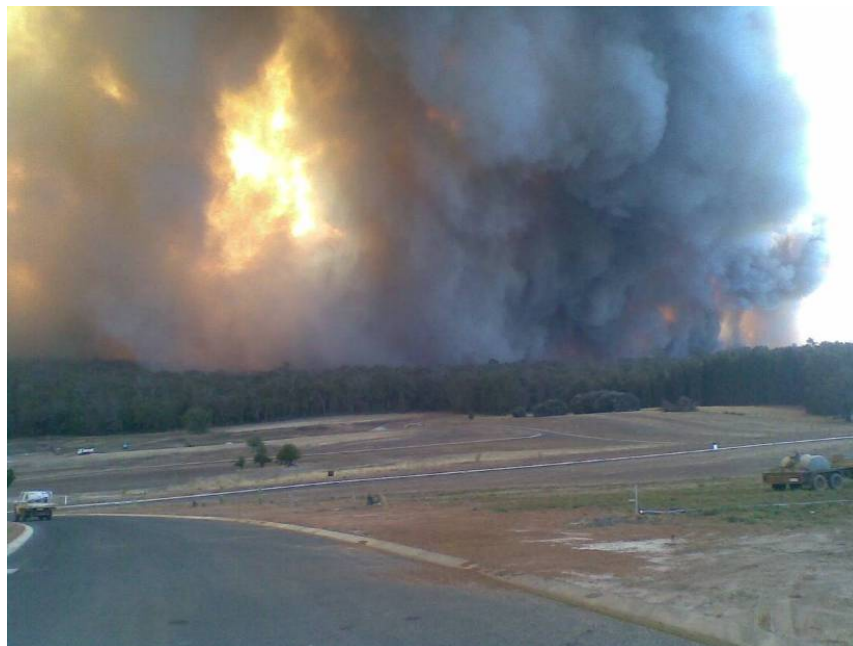
Figure 8. Fire behaviour as the fire approaches Highlands Estate on the western outskirts of Bridgetown

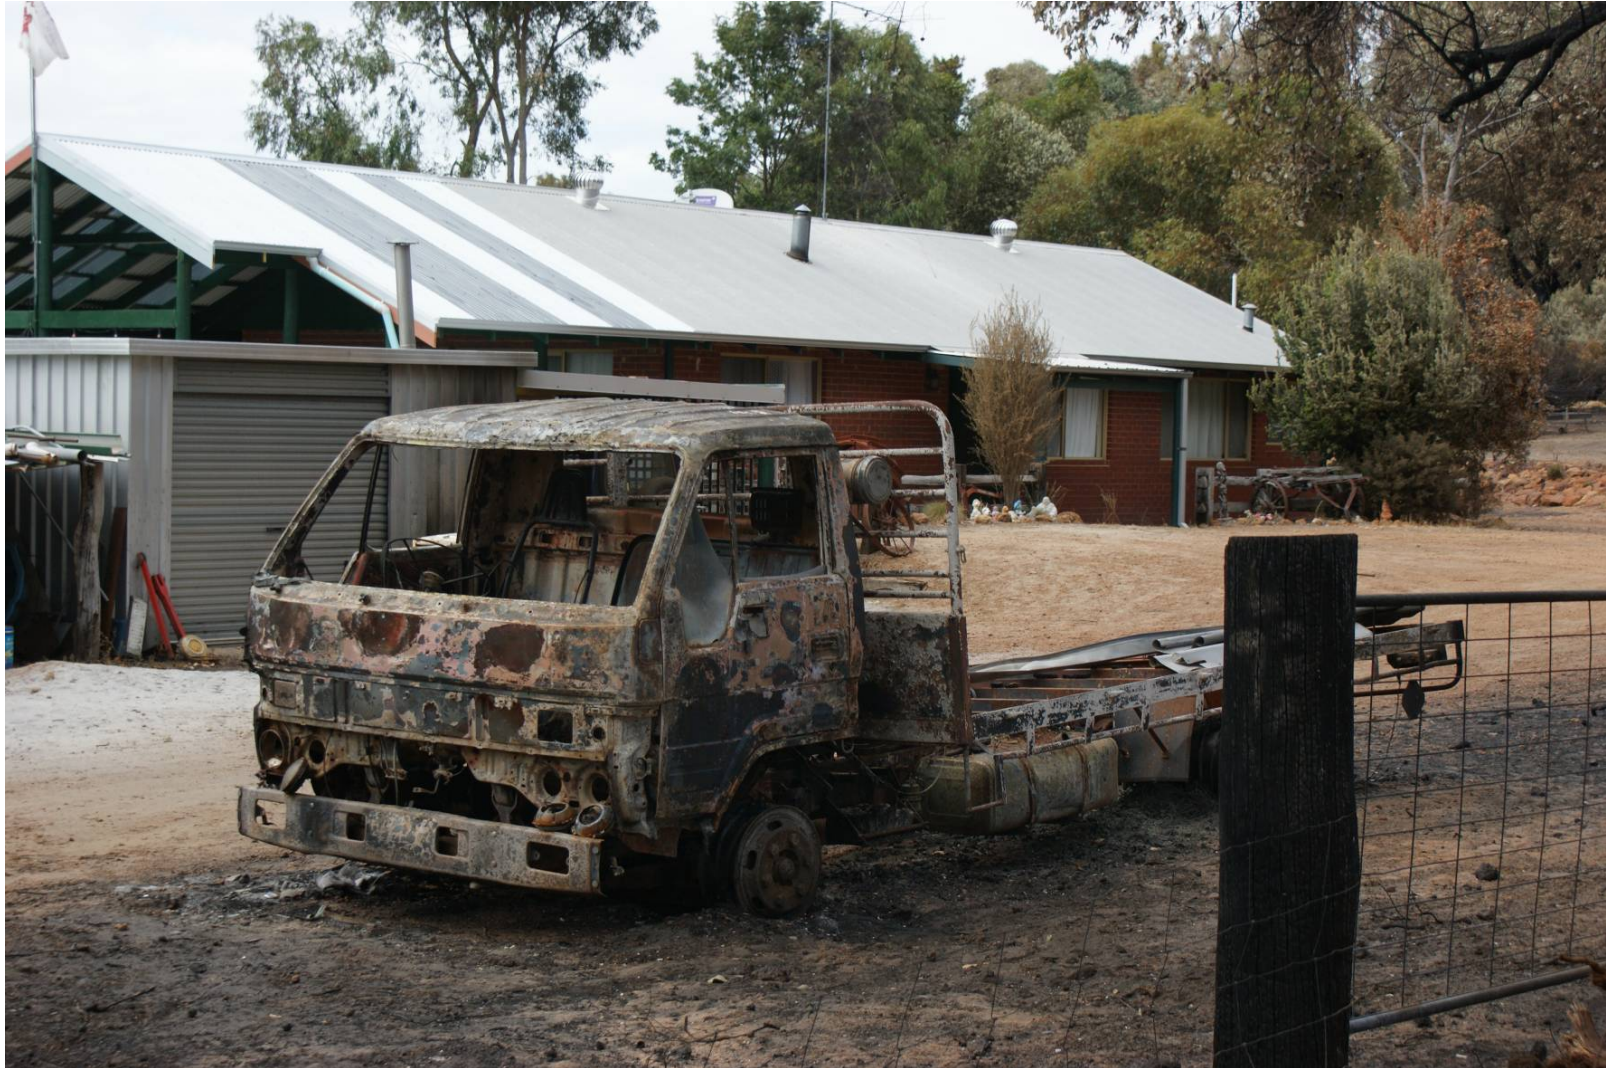
Figure 10 Burnt truck in Highlands Estate. Note minimal damage to house structure due to preparedness of occupants and defense by occupants during the fire event.

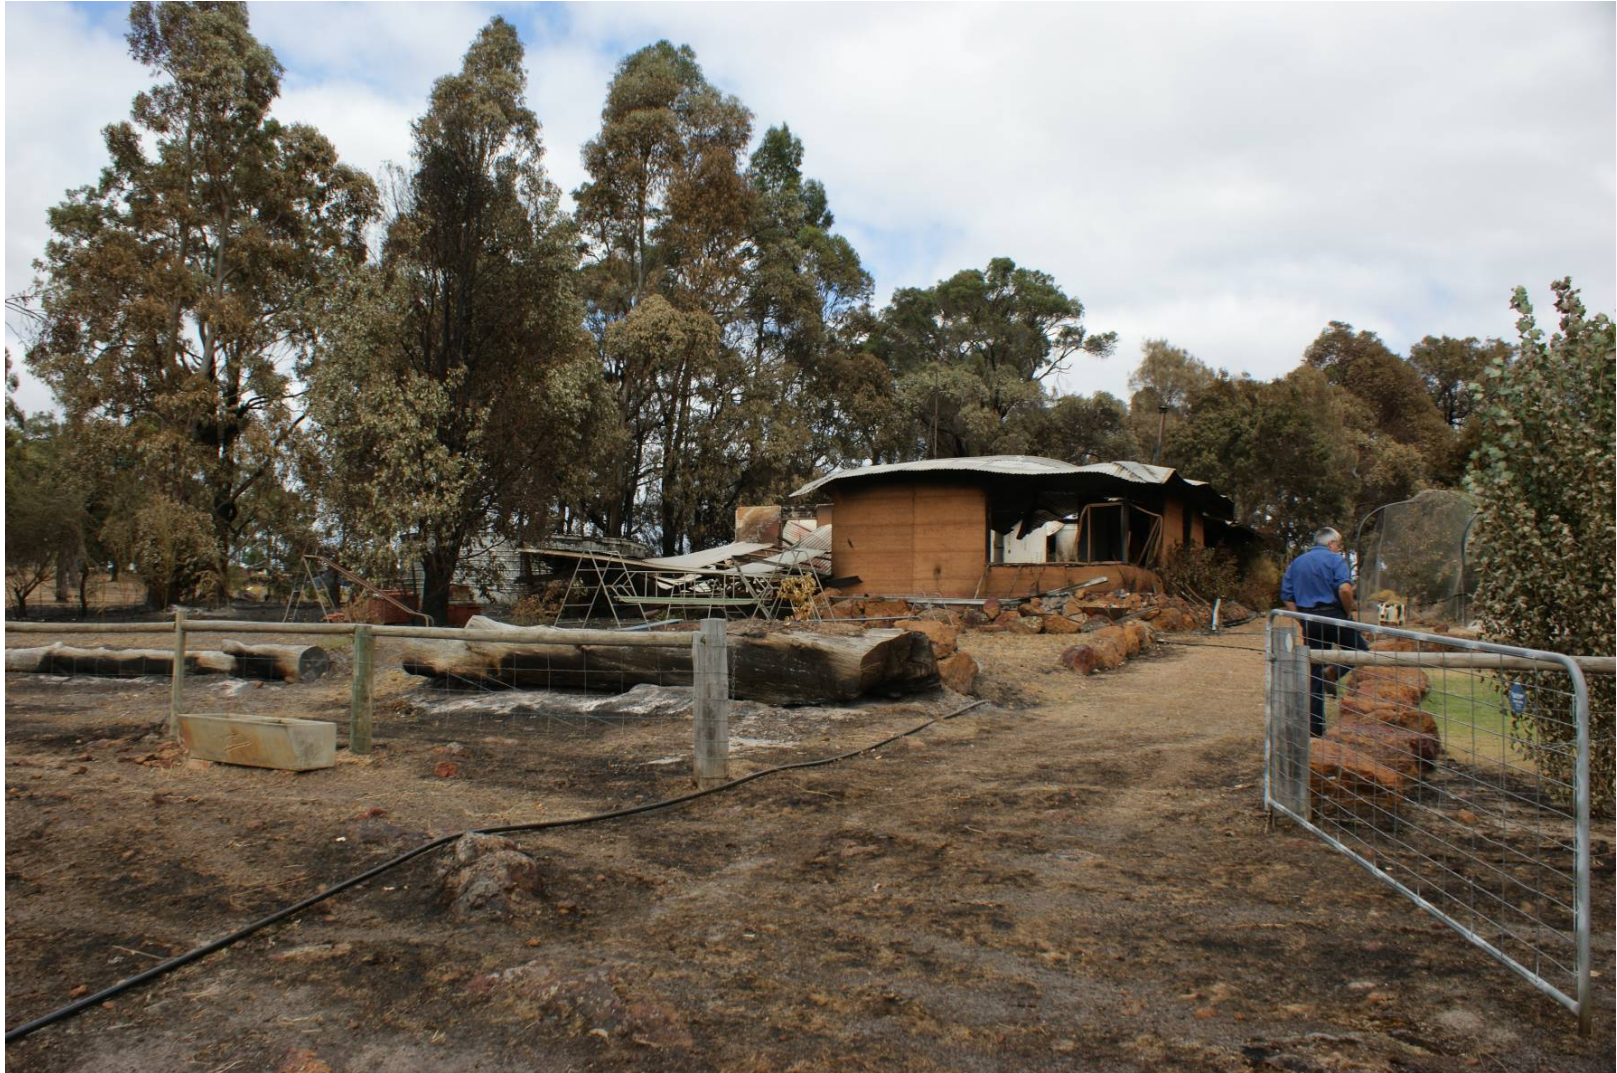
Figure 11 Burnt house in Highlands Estate. The occupant was not at home when the fire arrived. Ignition was probably due to ember attack.
