stephen  
carrick  
architects

# CONSERVATION MANAGEMENT STRATEGY

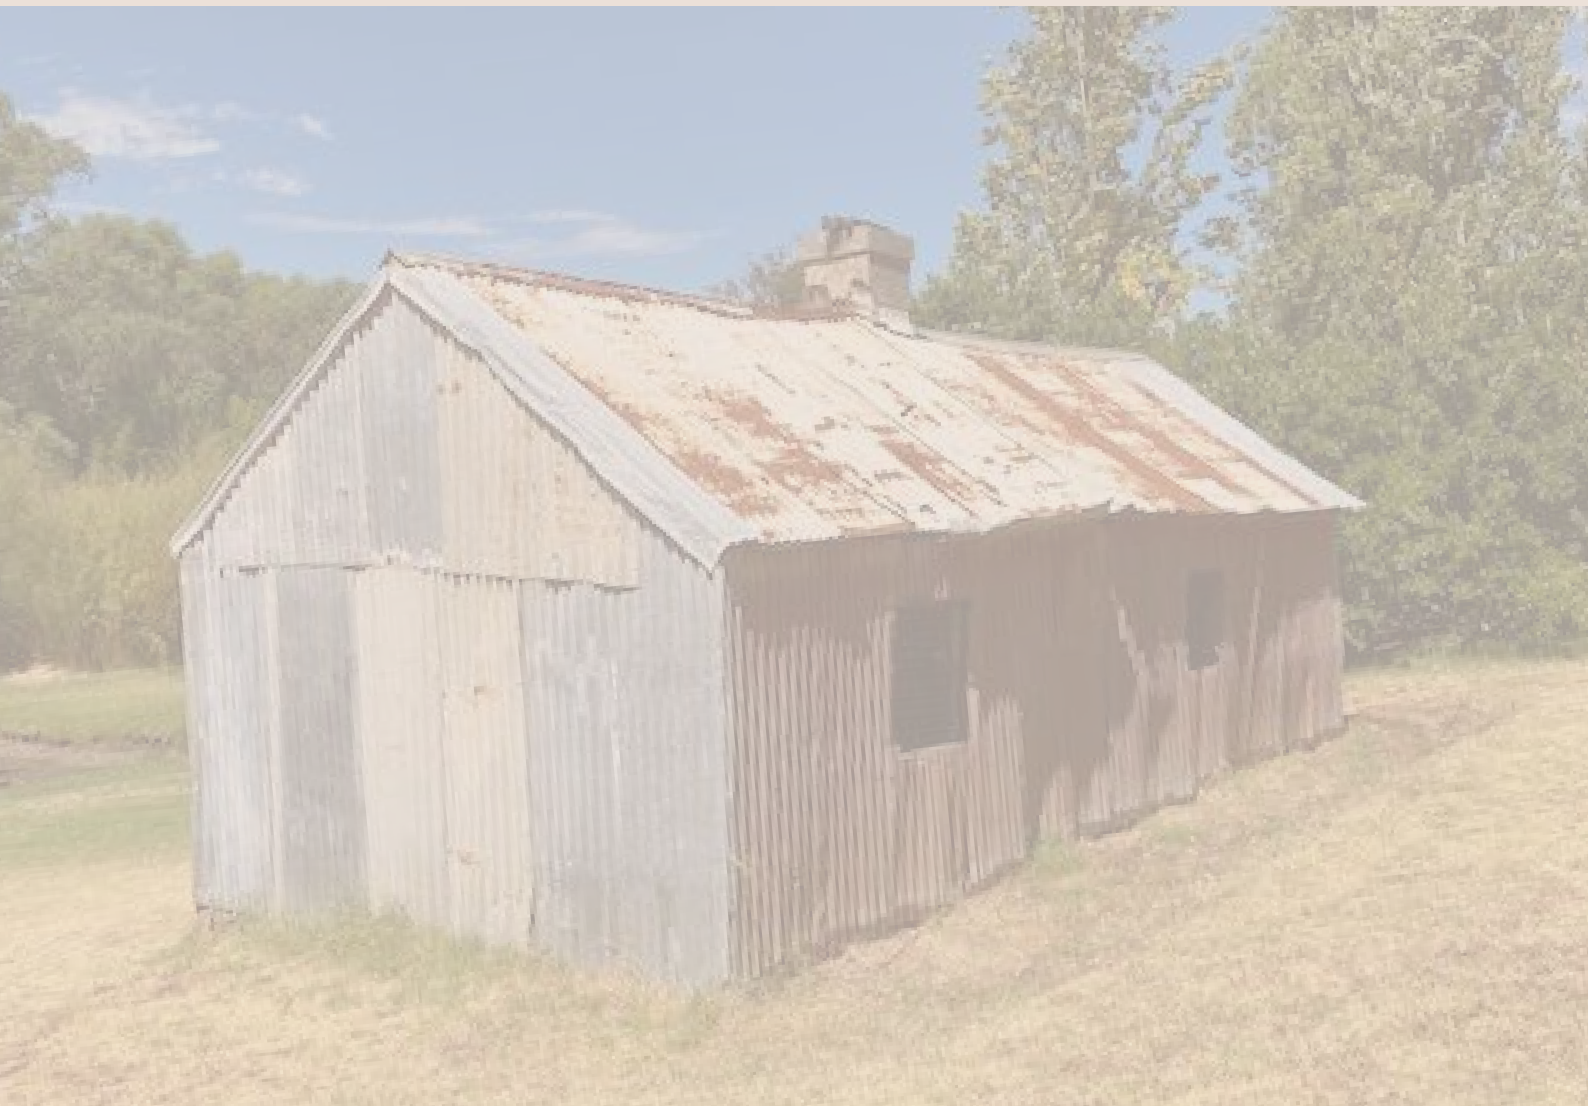
This Conservation Management Strategy has been prepared in accordance with the scope of services described in the contract or agreement between Stephen Carrick Architects and the Client. The report relies upon data collected upon the site visit, referenced documents and photographs taken at or under the particular times and conditions specified herein.

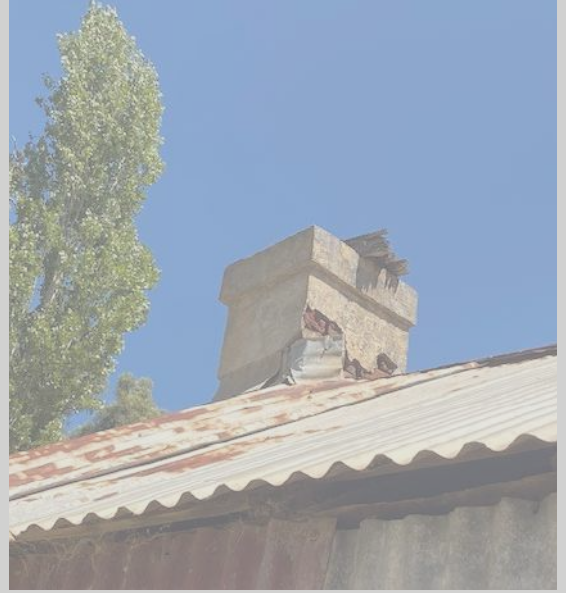
<b>1_INTRODUCTION</b>	<b>4</b>
1.1 ACKNOWLEDGEMENTS	4
1.2 LOCATION PLAN	5
1.3 CURRENT HERITAGE LISTINGS	6
1.4 STATEMENT OF SIGNIFICANCE	7
<b>2_BACKGROUND INFORMATION</b>	<b>8</b>
2.1 DOCUMENTARY EVIDENCE	8
2.2 HISTORICAL CHRONOLOGY	14
2.3 PHYSICAL DESCRIPTION	15
2.3.1 CONTEXT	15
2.3.2 EXTERIOR	15
2.3.3 INTERIOR	16
2.3.4 CONDITION	16
<b>3_GRADED ZONES OF SIGNIFICANCE</b>	<b>18</b>
LEVELS OF SIGNIFICANCE	18
ELEMENTS OF SIGNIFICANCE	19
<b>4_CONSERVATION WORKS &amp; MAINTENANCE SCHEDULES</b>	<b>20</b>
4.1 RECOMMENDED CONSERVATION WORKS SCHEDULE	20
4.1.1 IMMEDIATE ACTION	20
4.1.2 SHORT TERM ACTION	21
4.1.3 MEDIUM TERM ACTION	21
4.1.4 LONG TERM ACTION	22
4.2 RECOMMENDED MAINTENANCE WORKS SCHEDULE	22
<b>BUILDING CONDITION ASSESSMENT REPORT</b>	<b>23</b>
<b>APPENDIX A: PHOTOGRAPHS</b>	<b>42</b>

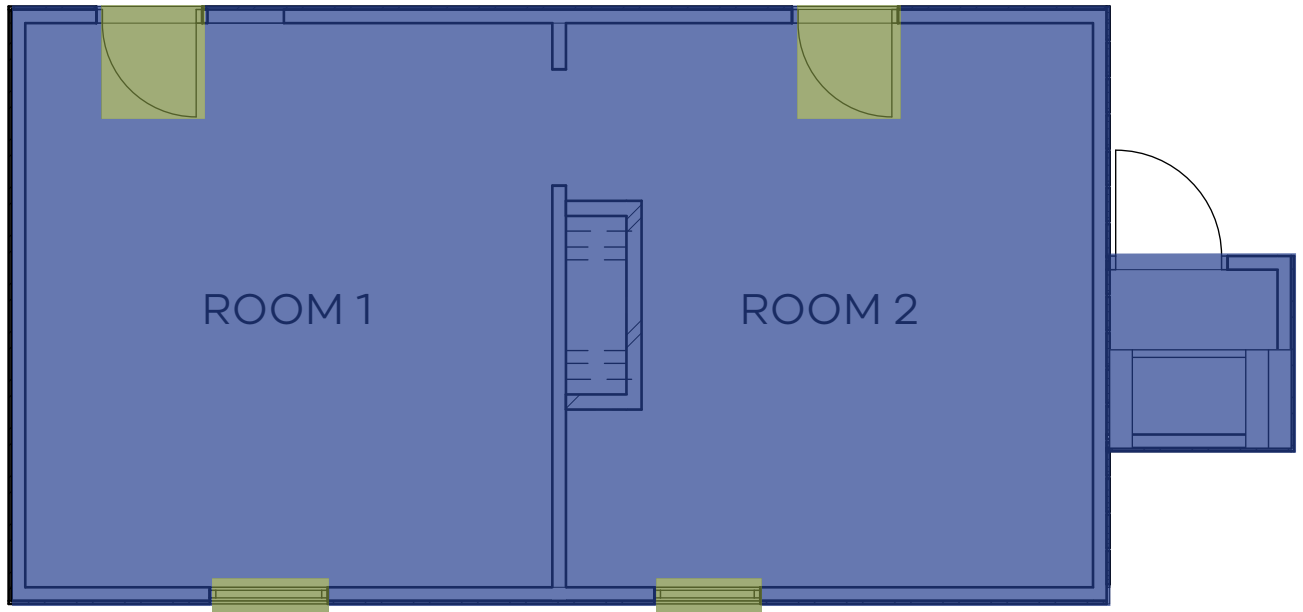
### LEVELS OF SIGNIFICANCE

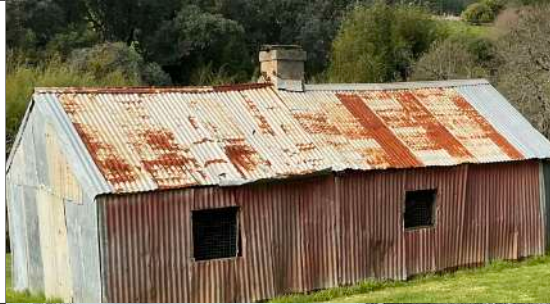
ROOF SHEETS (EAST)	<ul style="list-style-type: none"> <li>The corrugated steel roof sheets are in poor condition towards the southern end with a substantial amount of rust and warping.</li> <li>Some sheets towards the north appear newer</li> </ul>	Fair-Poor	<ul style="list-style-type: none"> <li>Repair, flatten and refix existing corrugated roof sheets</li> <li>Lap new sheets over damaged sheets (allow for approximately 3 new sheets)</li> </ul>	2

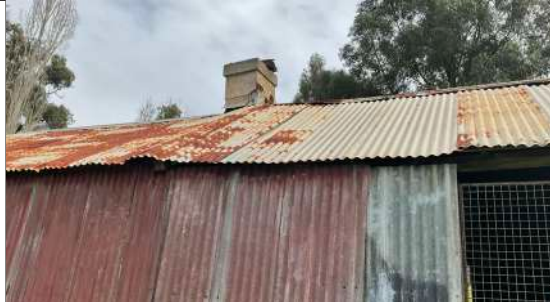
FLASHINGS AND CAPPINGS	<ul style="list-style-type: none"> <li>Northern section of ridge capping is rusted and damaged</li> <li>Flashing to northern elevation is a piece of corrugated sheet</li> </ul>	Poor	<ul style="list-style-type: none"> <li>Remove all existing ridge capping install new galvanised ridge capping</li> <li>Repair flashing to northern wall ridge</li> </ul>	2

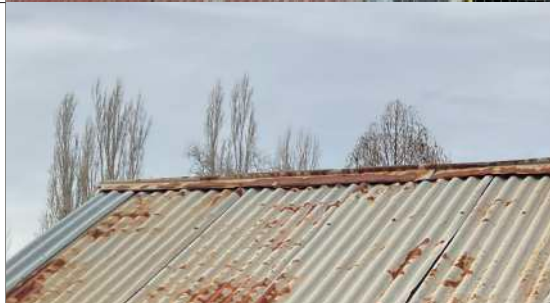
RAINWATER GOODS	<ul style="list-style-type: none"> <li>Small section of damaged guttering located along the western side of the building.</li> </ul>	Poor	<ul style="list-style-type: none"> <li>Remove section of existing guttering</li> <li>Do not reinstate rainwater goods</li> </ul>	2

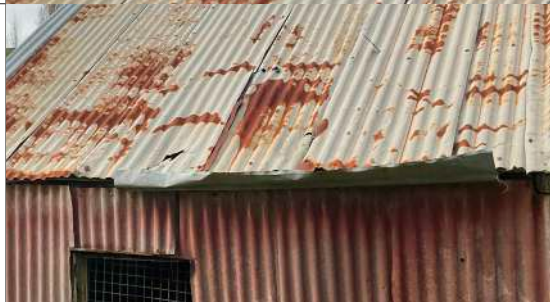
ITEM/ LOCATION	DEFECT DESCRIPTION	CONDITION	PROPOSED WORKS	PRIORITY	PHOTOGRAPH
CHIMNEY	<ul style="list-style-type: none"> <li>Damaged render with exposed brickwork to the north and south sides</li> <li>Existing flashings are in very poor condition</li> </ul>	Poor	<ul style="list-style-type: none"> <li>Remove existing flashing and replace with new appropriate under and over flashing</li> <li>Remove loose render (confirm render material)</li> <li>Render material to be tested</li> <li>Repair damaged brick and re-render chimney following testing</li> <li>New capping to chimney top to prevent water ingress</li> </ul>	1

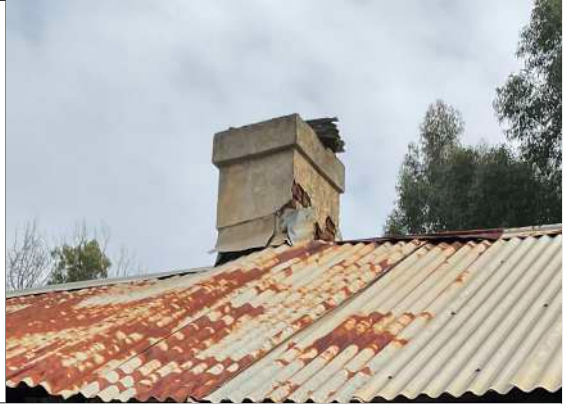
<b>EXTERNAL WALLS</b>					
NORTH ELEVATION	<ul style="list-style-type: none"> <li>North wall clad with corrugated sheets</li> <li>The sheets feature a number of rust spots and holes</li> <li>Base of sheets are impacted by the overgrown grass and soil</li> </ul>	Fair	<ul style="list-style-type: none"> <li>Retain existing corrugated steel wall sheets</li> <li>Repair flashing to wall ridge</li> <li>Sharp edges to receive galvanised capping</li> <li>New protective flashing to base of wall</li> <li>Remove grass around base</li> </ul>	2

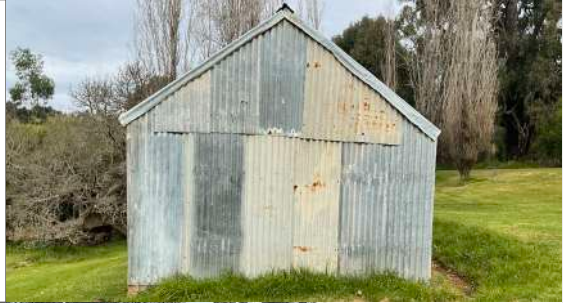
EAST ELEVATION	<ul style="list-style-type: none"> <li>The eastern elevation is clad with corrugated steel sheets that feature a faded red patina</li> <li>The sheets are warped in places with some damage and rust along the base</li> </ul>	Fair	<ul style="list-style-type: none"> <li>Retain existing corrugated steel wall sheets</li> <li>Repair where necessary</li> <li>Sharp edges to receive galvanised capping</li> <li>New protective flashing to base of wall</li> <li>Remove grass around base</li> </ul>	2

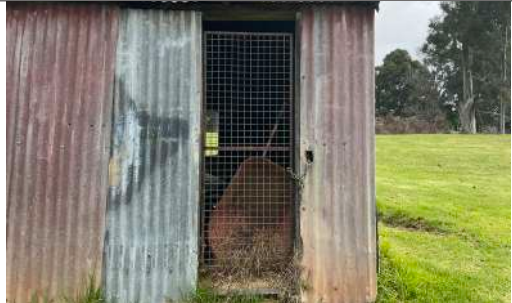
DOOR 2 (SOUTH EAST)	<ul style="list-style-type: none"> <li>Existing steel gate door is in fair condition however does not mitigate weathering, debris or animals</li> </ul>	Fair	<ul style="list-style-type: none"> <li>Repair timber door frame</li> <li>Enclose and/or secure door</li> <li>Consider new ledged and braced door</li> </ul>	2,3

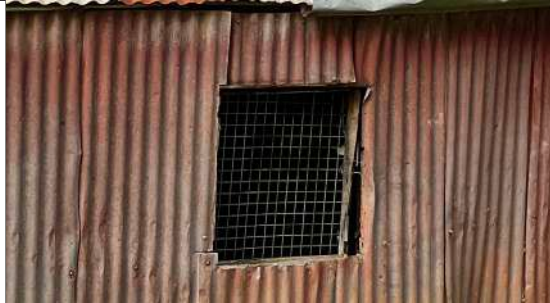
WINDOW 2 (SOUTH WEST)	<ul style="list-style-type: none"> <li>Window enclosed by steel grill</li> <li>Timber frame and sill in poor condition</li> <li>Damaged corrugated steel sheets surrounding windows</li> </ul>	Poor	<ul style="list-style-type: none"> <li>Remove chicken wire to window</li> <li>Repair timber frame and window sill</li> <li>Repair steel grill</li> <li>Enclose and/ or secure opening</li> </ul>	2

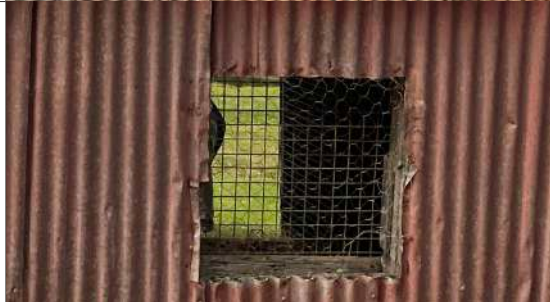
<b>EARTH CLOSET</b>					
ROOF SHEETS	<ul style="list-style-type: none"> <li>Roof sheets folding and warping towards the edges</li> </ul>	Fair	<ul style="list-style-type: none"> <li>Check fixings and secure roof sheets</li> </ul>	2

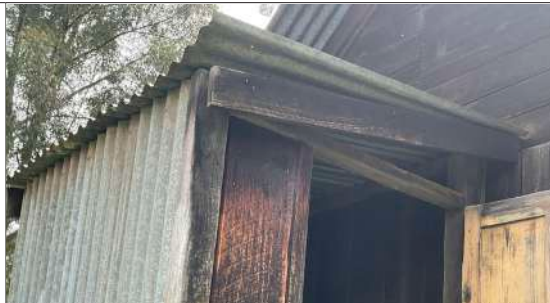
WALLS	<ul style="list-style-type: none"> <li>Corrugated steel wall sheets to south and western walls appear in relatively good condition</li> <li>Timber boards to eastern side are weathered</li> </ul>	Fair	<ul style="list-style-type: none"> <li>Repair where necessary</li> <li>Enclose opening above door with timber piece secured internally</li> <li>Apply timber oil mix for protection of timber</li> <li>Remove grass around base</li> <li>New protective flashing to base of wall</li> </ul>	2

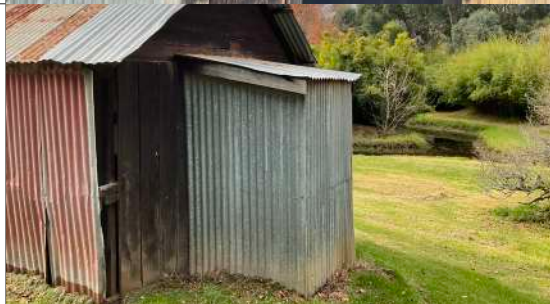
ITEM/ LOCATION	DEFECT DESCRIPTION	CONDITION	PROPOSED WORKS	PRIORITY	PHOTOGRAPH
DOOR	<ul style="list-style-type: none"> <li>Timber door is in fair condition with visible weathering to the paint.</li> </ul>	Fair	<ul style="list-style-type: none"> <li>Enclose opening above door with timber piece secured internally</li> <li>Repair and patch damage to door</li> <li>Door to be made secure</li> </ul>	2

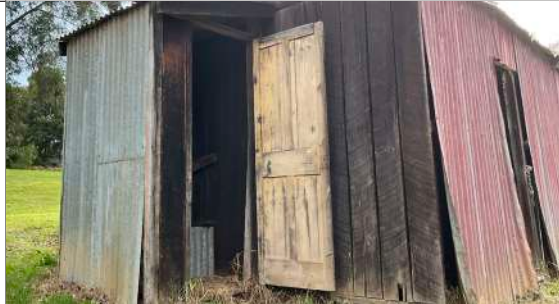
<b>LANDSCAPE</b>					
PERIMETER GRASS	<ul style="list-style-type: none"> <li>The perimeter walls of the building have over grown grass and build up of soil which is increasing damage to steel walls</li> </ul>	Poor	<ul style="list-style-type: none"> <li>Remove grass and soil around perimeter of building</li> <li>Install protective flashing to base of walls</li> </ul>	1

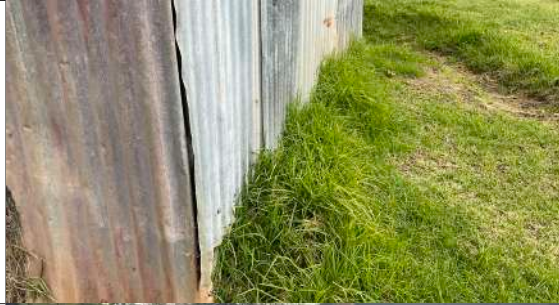
TRENCH (WEST)	<ul style="list-style-type: none"> <li>Existing trench along the western side is insufficient to prevent water runoff and damage to the base of the building</li> </ul>	Fair	<ul style="list-style-type: none"> <li>Increase trench around perimeter of the building to allow for runoff</li> <li>Install brick drain along western side (drain to fall south to north)</li> </ul>	1

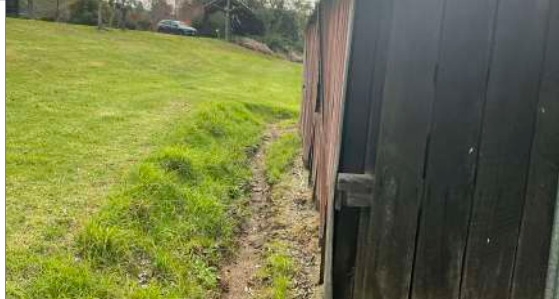
ITEM/ LOCATION	DEFECT DESCRIPTION	CONDITION	PROPOSED WORKS	PRIORITY	PHOTOGRAPH
<b>INTERIOR</b>					
<b>ROOM 1</b>					
FLOOR	<ul style="list-style-type: none"> <li>Internal floor boards are in very poor condition</li> <li>The floors are partially buried by soil, sand and overgrown grass and there is evidence of animal activity (burrows visible).</li> </ul>	Poor	<ul style="list-style-type: none"> <li>Gently remove all soil, sand and overgrown grass</li> <li>Assess timber sub structure</li> <li>Earth to be recompacted to the interior</li> <li>Timber floor boards to be reinstated on top in sections</li> </ul>	1,3

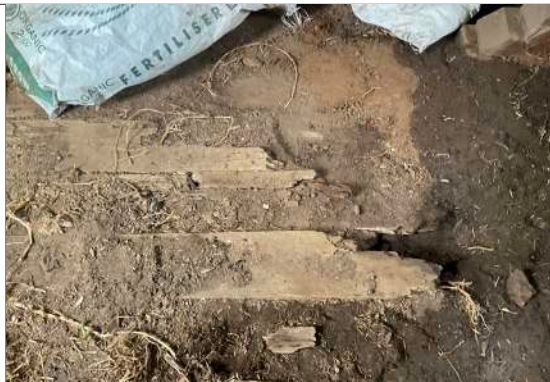
SKIRTING	<ul style="list-style-type: none"> <li>Skirting is visible to some areas however is damaged and missing in other areas</li> </ul>	Fair-Poor	<ul style="list-style-type: none"> <li>Gently remove all soil, sand and overgrown grass to reveal extent of skirting</li> <li>Existing skirting to be repaired</li> <li>Damaged skirting to be replaced</li> </ul>	3

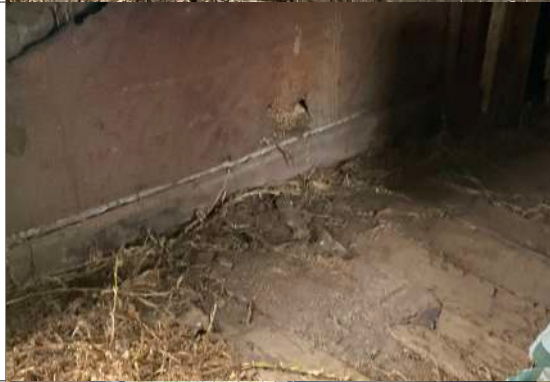
WALL (EAST)	<ul style="list-style-type: none"> <li>Missing internal wall cladding adjacent to door</li> <li>Damage to pressed metal dado</li> <li>Damage to fibrous plaster wall sheets</li> </ul>	Poor	<ul style="list-style-type: none"> <li>Consider new simple detailing to damaged dado</li> <li>Retain as much pressed metal dado material as possible</li> <li>Repair patch and paint plaster walls to match</li> <li>Repair and replace missing wall plate</li> </ul>	3

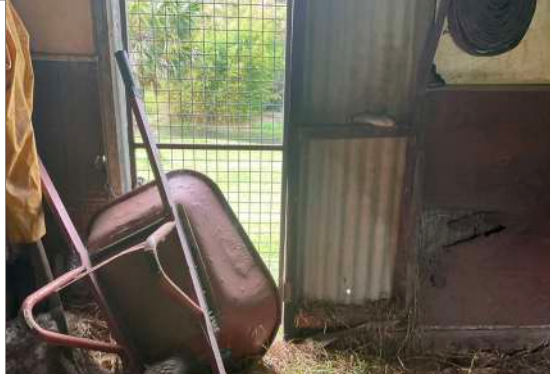
ITEM/ LOCATION	DEFECT DESCRIPTION	CONDITION	PROPOSED WORKS	PRIORITY	PHOTOGRAPH
WALL (SOUTH)	<ul style="list-style-type: none"> <li>Central wall significantly impacted by damage to chimney</li> <li>Significant damage to fibrous plaster walls</li> <li>Metal sheet appears to be enclosing former fireplace</li> </ul>	Poor	<ul style="list-style-type: none"> <li>Address and repair damaged brick work to chimney</li> <li>Remove additional metal sheets to base of wall and reinstate fire place</li> <li>Retain as much pressed metal dado material as possible</li> <li>Repair patch and paint plaster walls to match</li> <li>Repair timber door frame</li> </ul>	1,2,3

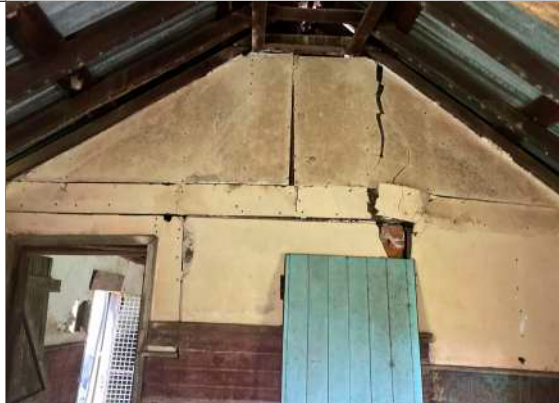
WALL (WEST)	<ul style="list-style-type: none"> <li>Damage to pressed metal dado</li> <li>Damage to fibrous plaster wall sheets above and below window</li> <li>Window frame, sill and metal grill is damaged</li> </ul>	Poor	<ul style="list-style-type: none"> <li>Repair window frame, sill and metal grill</li> <li>Enclose and/ or secure opening (consider new glass window)</li> <li>Consider new simple detailing to damaged dado</li> <li>Retain as much pressed metal dado material as possible</li> <li>Repair patch and paint plaster walls to match</li> </ul>	2,3

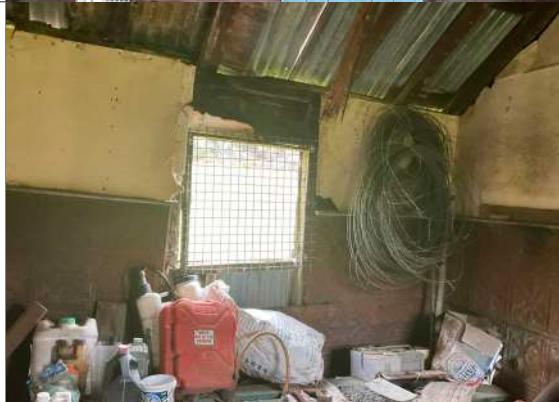
WALL (NORTH)	<ul style="list-style-type: none"> <li>Damage to pressed metal dado</li> <li>Damage to fibrous plaster wall sheets</li> </ul>	Fair-Poor	<ul style="list-style-type: none"> <li>Consider new simple detailing to damaged dado</li> <li>Retain as much pressed metal dado material as possible</li> <li>Repair patch and paint plaster walls to match</li> </ul>	3

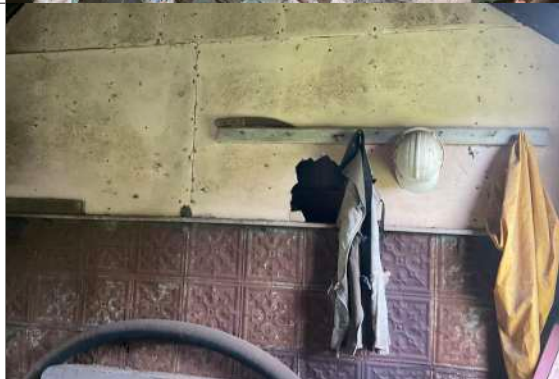
ITEM/ LOCATION	DEFECT DESCRIPTION	CONDITION	PROPOSED WORKS	PRIORITY	PHOTOGRAPH
CEILING/ ROOF STRUCTURE	<ul style="list-style-type: none"> <li>Some damaged timber rafters to western ceiling structure</li> <li>Ceiling has at one point been removed</li> </ul>	Fair	<ul style="list-style-type: none"> <li>Repair and replace damaged timber rafters</li> <li>Repair existing wall plate along eastern wall</li> <li>Clean existing structure and retain exposed ceiling</li> </ul>	1

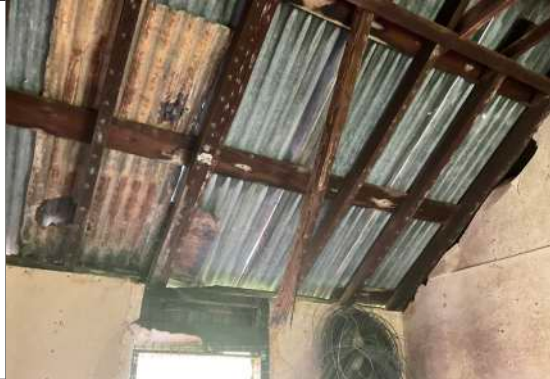
<b>ROOM 2</b>					
FLOOR	<ul style="list-style-type: none"> <li>Internal floor boards are in very poor condition</li> <li>The floors are partially buried by soil, sand and overgrown grass and there is evidence of animal activity (burrows visible).</li> </ul>	Poor	<ul style="list-style-type: none"> <li>Gently remove all soil, sand and overgrown grass</li> <li>Assess timber sub structure</li> <li>Earth to be recompactd to the interior</li> <li>Timber floor boards to be reinstated on top in sections</li> </ul>	1,3

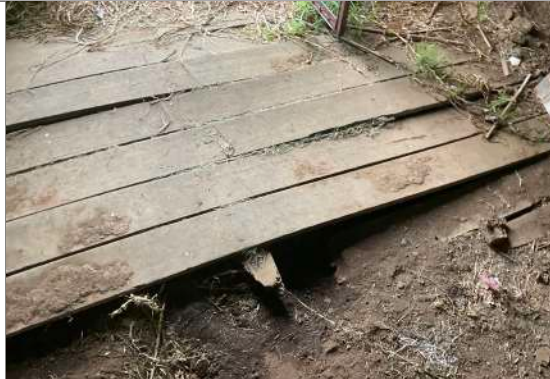
SKIRTING	<ul style="list-style-type: none"> <li>Skirting is visible to some areas however is damaged and missing in other areas</li> </ul>	Fair-Poor	<ul style="list-style-type: none"> <li>Gently remove all soil, sand and overgrown grass to reveal extent of skirting</li> <li>Existing skirting to be repaired</li> <li>Damaged skirting to be replaced</li> </ul>	3

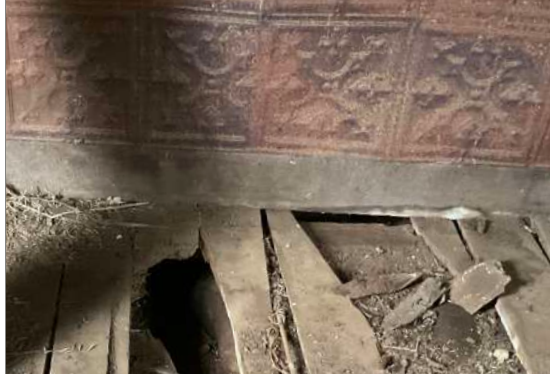
ITEM/ LOCATION	DEFECT DESCRIPTION	CONDITION	PROPOSED WORKS	PRIORITY	PHOTOGRAPH
WALL (EAST)	<ul style="list-style-type: none"> <li>Missing internal wall cladding adjacent to door</li> <li>Damage to pressed metal dado</li> <li>Damage to fibrous plaster wall sheets</li> </ul>	Fair-Poor	<ul style="list-style-type: none"> <li>Consider new simple detailing to damaged dado</li> <li>Retain as much pressed metal dado material as possible</li> <li>Repair patch and paint plaster walls to match</li> <li>Repair and replace missing wall plate</li> </ul>	3

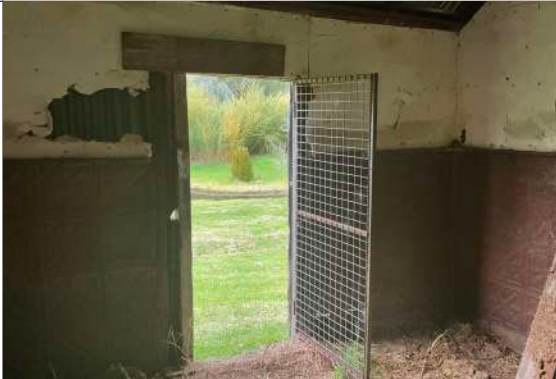
WALL (SOUTH)	<ul style="list-style-type: none"> <li>Damage to pressed metal dado</li> <li>Damage to fibrous plaster wall sheets</li> </ul>	Poor	<ul style="list-style-type: none"> <li>Consider new simple detailing to damaged dado</li> <li>Retain as much pressed metal dado material as possible</li> <li>Repair patch and paint plaster walls to match</li> </ul>	3

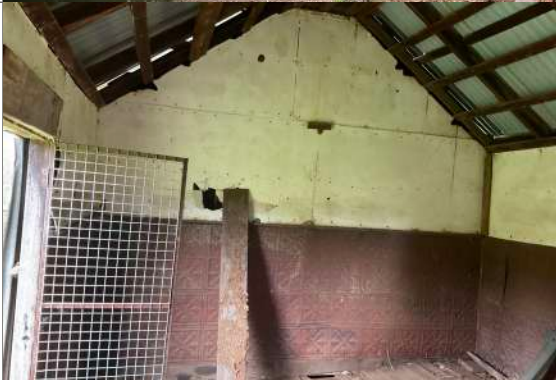
WALL (WEST)	<ul style="list-style-type: none"> <li>Damage to pressed metal dado</li> <li>Damage to fibrous plaster wall sheets above and below window</li> <li>Window frame, sill and metal grill is damaged</li> </ul>	Poor	<ul style="list-style-type: none"> <li>Repair window frame, sill and metal grill</li> <li>Enclose and/ or secure opening (consider new glass window)</li> <li>Consider new simple detailing to damaged dado</li> <li>Retain as much pressed metal dado material as possible</li> <li>Repair patch and paint plaster walls to match</li> </ul>	3

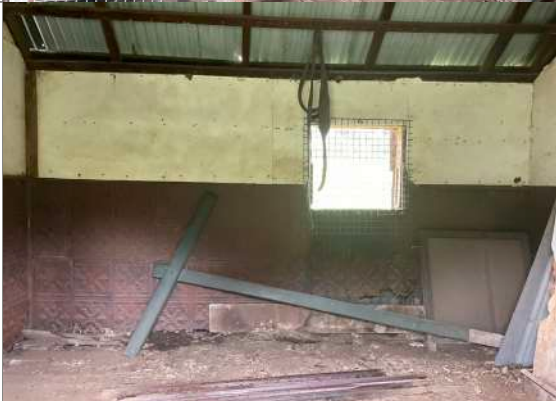
ITEM/ LOCATION	DEFECT DESCRIPTION	CONDITION	PROPOSED WORKS	PRIORITY	PHOTOGRAPH
WALL (NORTH)	<ul style="list-style-type: none"> <li>Central wall significantly impacted by damage to chimney</li> <li>The chimney is in very poor condition.</li> <li>The structure is significantly damaged and requires immediate attention.</li> <li>The render is damaged and exposed in a number of areas.</li> <li>The bricks beneath have little to no mortar.</li> </ul>	Very Poor	<ul style="list-style-type: none"> <li>Structural assessment</li> <li>Remove existing render</li> <li>Structurally secure and repoint brickwork</li> <li>Re-render chimney with soft lime render</li> <li>Consider new simple detailing to damaged dado</li> <li>Retain as much pressed metal dado material as possible</li> <li>Repair patch and paint plaster walls to match</li> </ul>	1

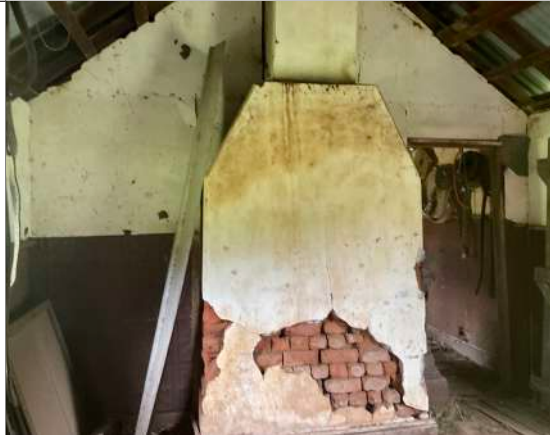
CEILING/ ROOF STRUCTURE	<ul style="list-style-type: none"> <li>Some damaged timber rafters to western ceiling structure</li> <li>Ceiling has at one point been removed</li> </ul>	Fair	<ul style="list-style-type: none"> <li>Repair and replace damaged timber rafters</li> <li>Repair existing wall plate along eastern wall</li> <li>Clean existing structure and retain exposed ceiling</li> </ul>	1

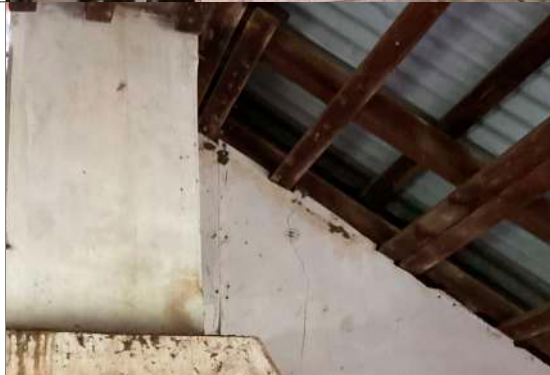
- RETAIN EXISTING CORRUGATED STEEL WALL SHEETS
- REPAIR WHERE NECESSARY
- SHARP EDGES TO RECEIVE GALVANISED CAPPING
- INSTALL PROTECTIVE FLASHING TO BASE OF WALL SHEETS
- REMOVE GRASS AROUND BASE

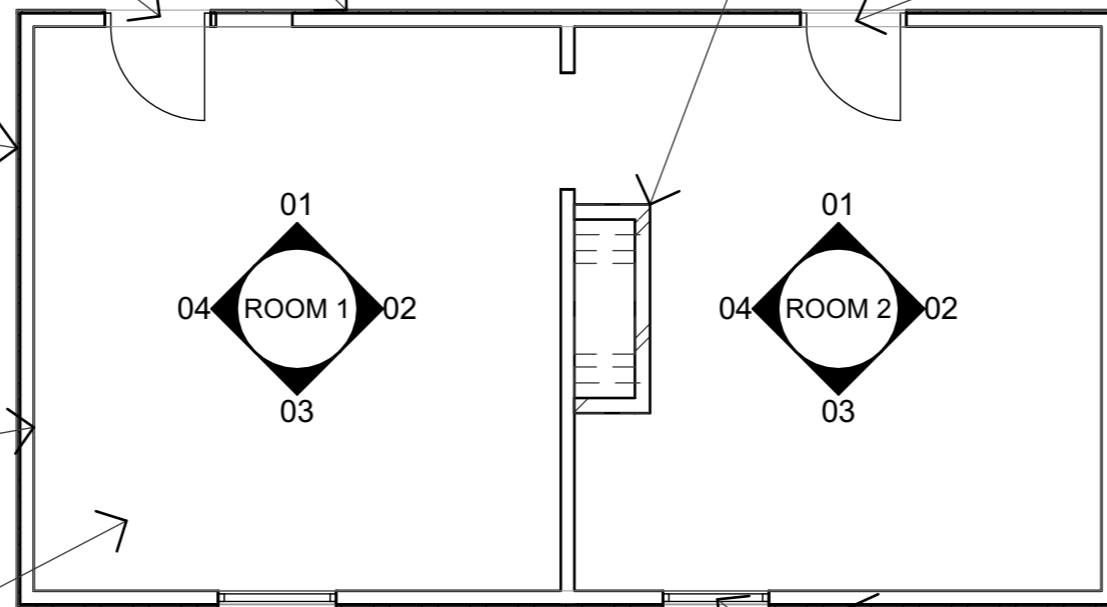
DRAWINGS ARE NOT TO BE USED FOR CONSTRUCTION.

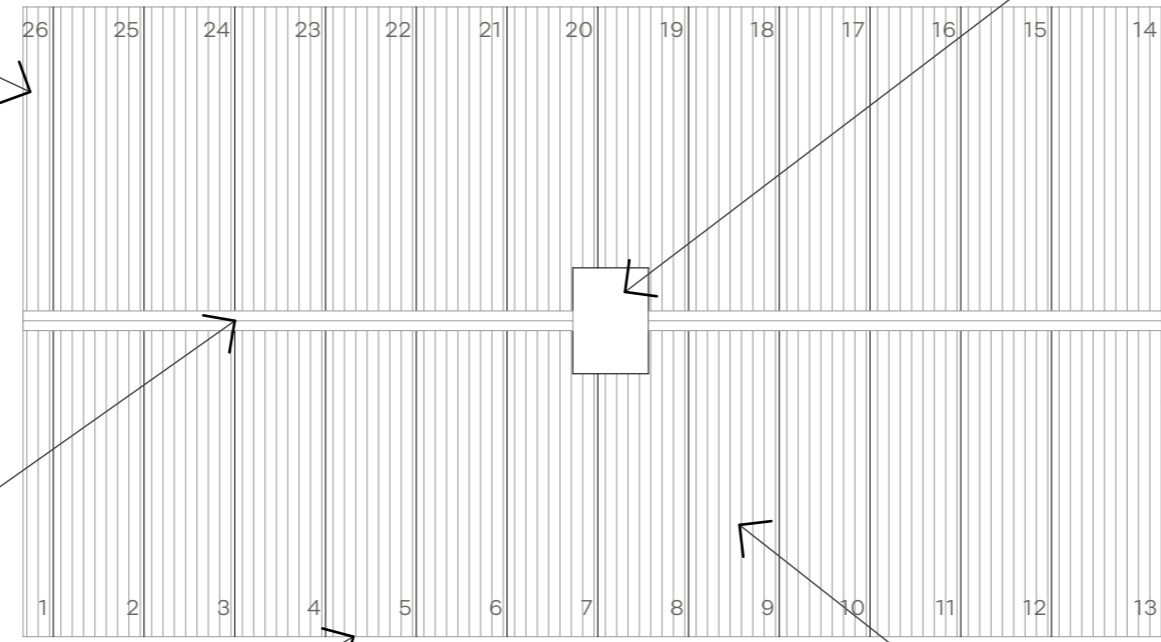
- REPAIR FLASHING TO NORTHERN WALL RIDGE
- SHARP EDGES TO RECEIVE GALVANISED CAPPING

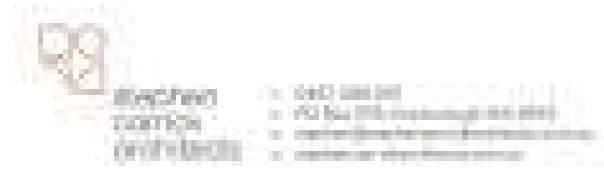
- INTRODUCE CONTEMPORARY OPENING TO CONNECT INTERIOR WITH EXTERIOR VIEWS OF PARK (OPTIONAL INTERPRETATION/ FUTURE USE)

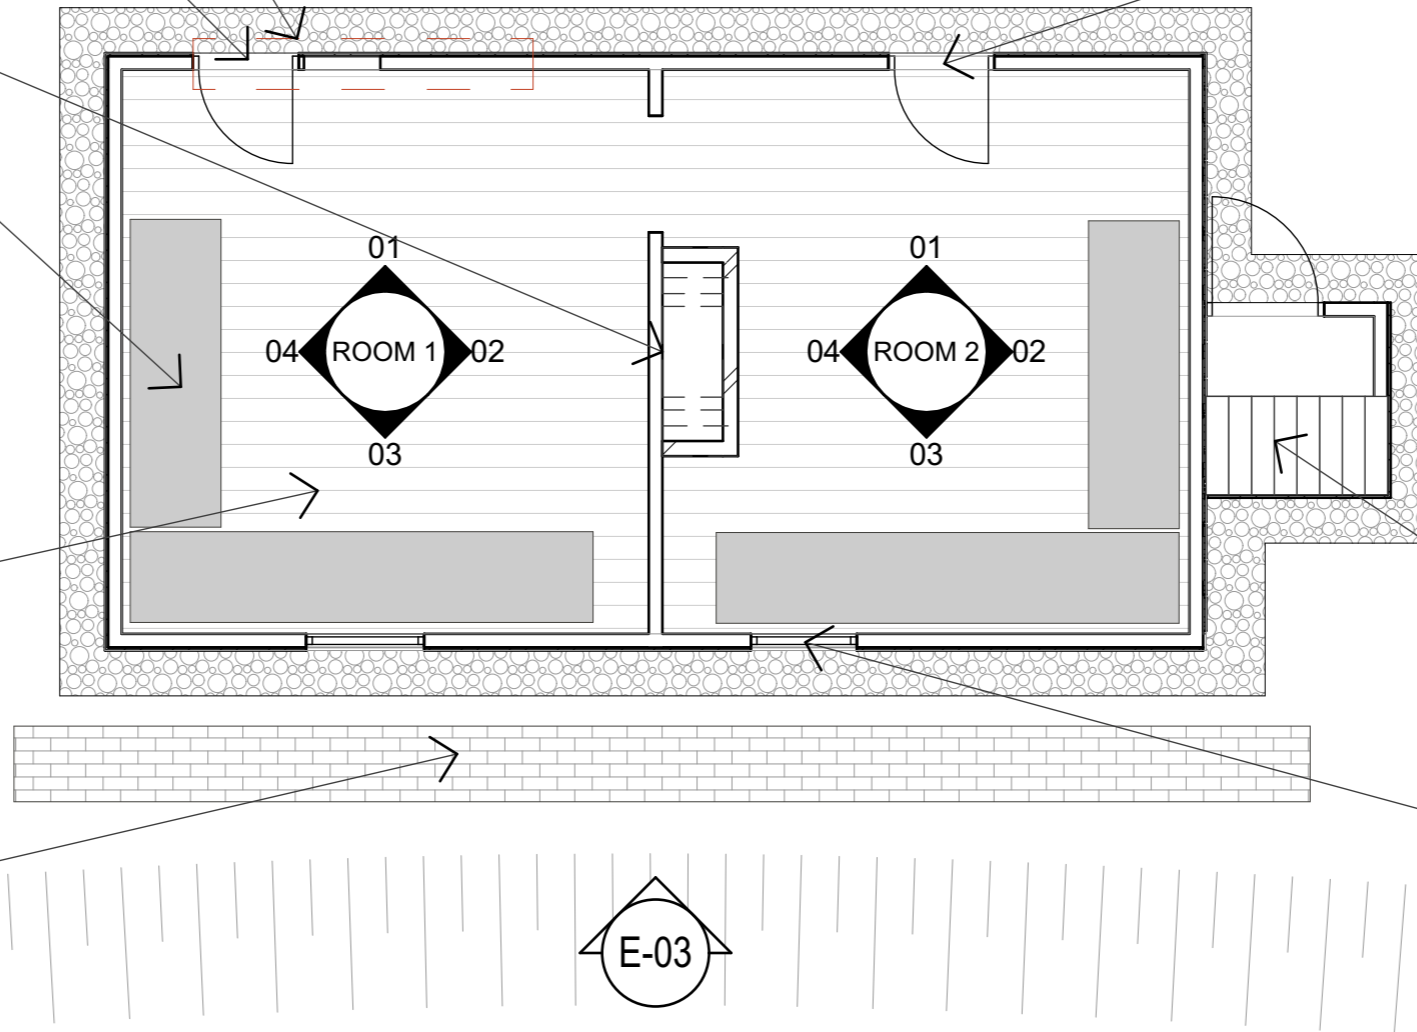
- CONSIDER INSTALLING NEW FRAME AND GLASS TO WINDOWS

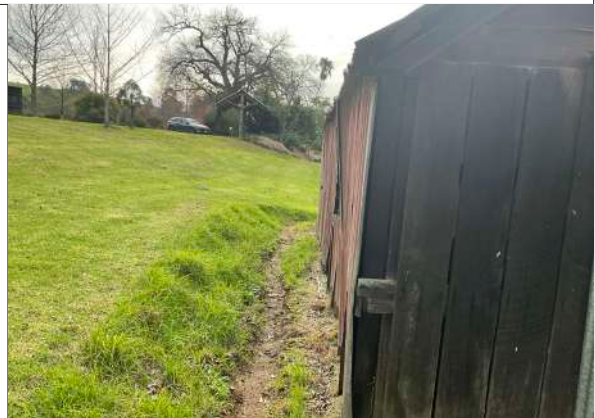
South west corner with missing timber board

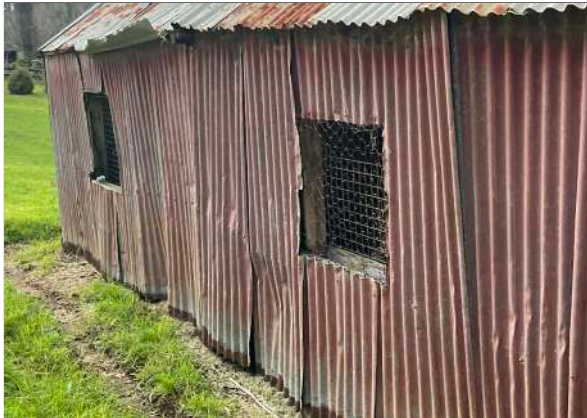
Window and damaged steel sheets along western elevation

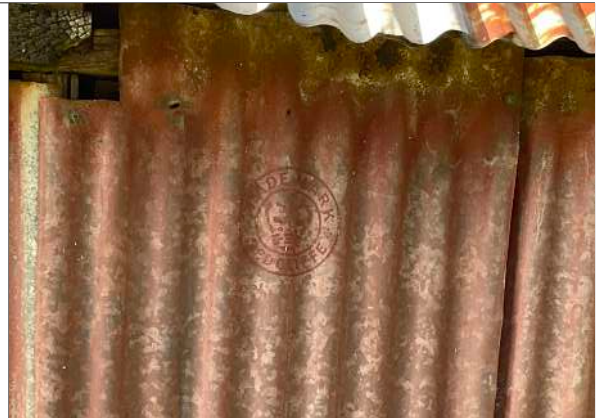
'Trademark Redcliffe' stamp on western corrugated steel sheets

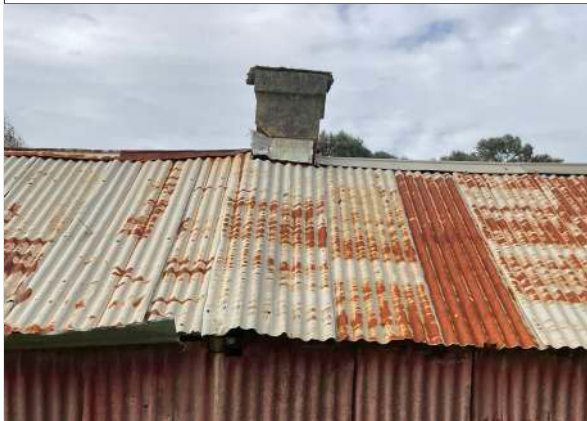
Rusted roof sheets and chimney

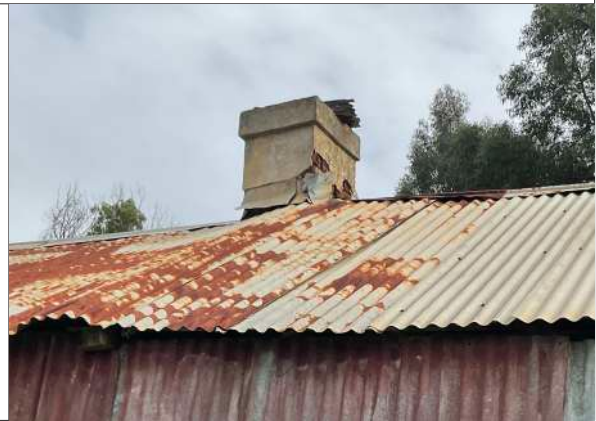
Damaged render to chimney

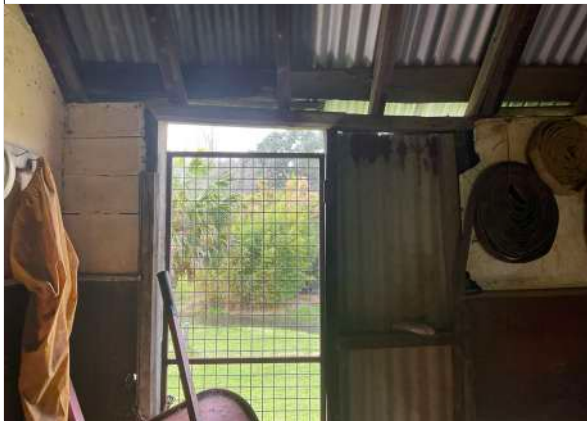
Room 1 east internal elevation

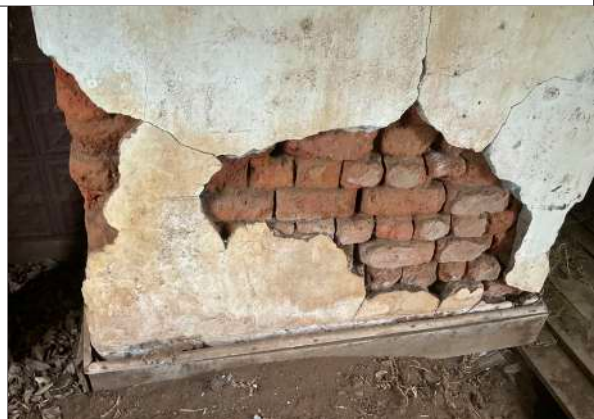
Damage to render at base of chimney

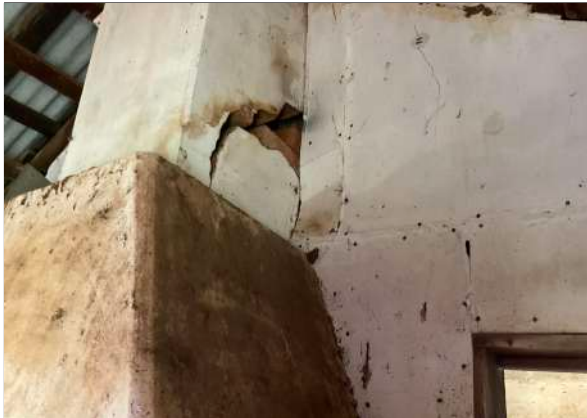
Damage to brick chimney

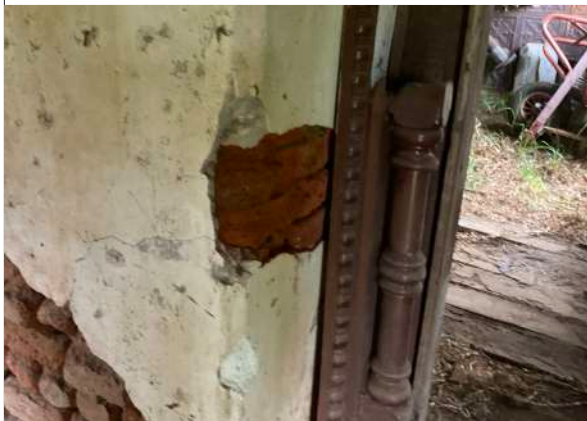
Damaged timber detailing to door frame

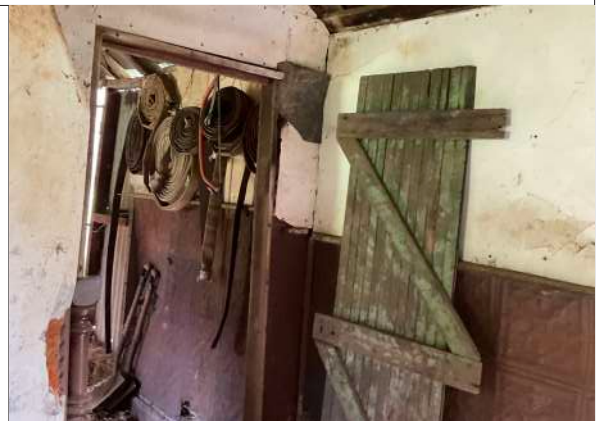
Internal door damaged and removed

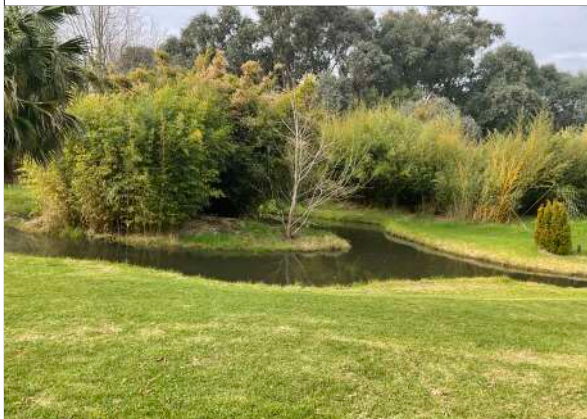
Man made lake to the north of the building
