Worker's Accommodation, Golden Valley Tree Park,
164 Old Padbury Road, Balingup WA
Structural Engineering Services Assessment

Department of Biodiversity, Conservation and Attractions

Date: February 2023

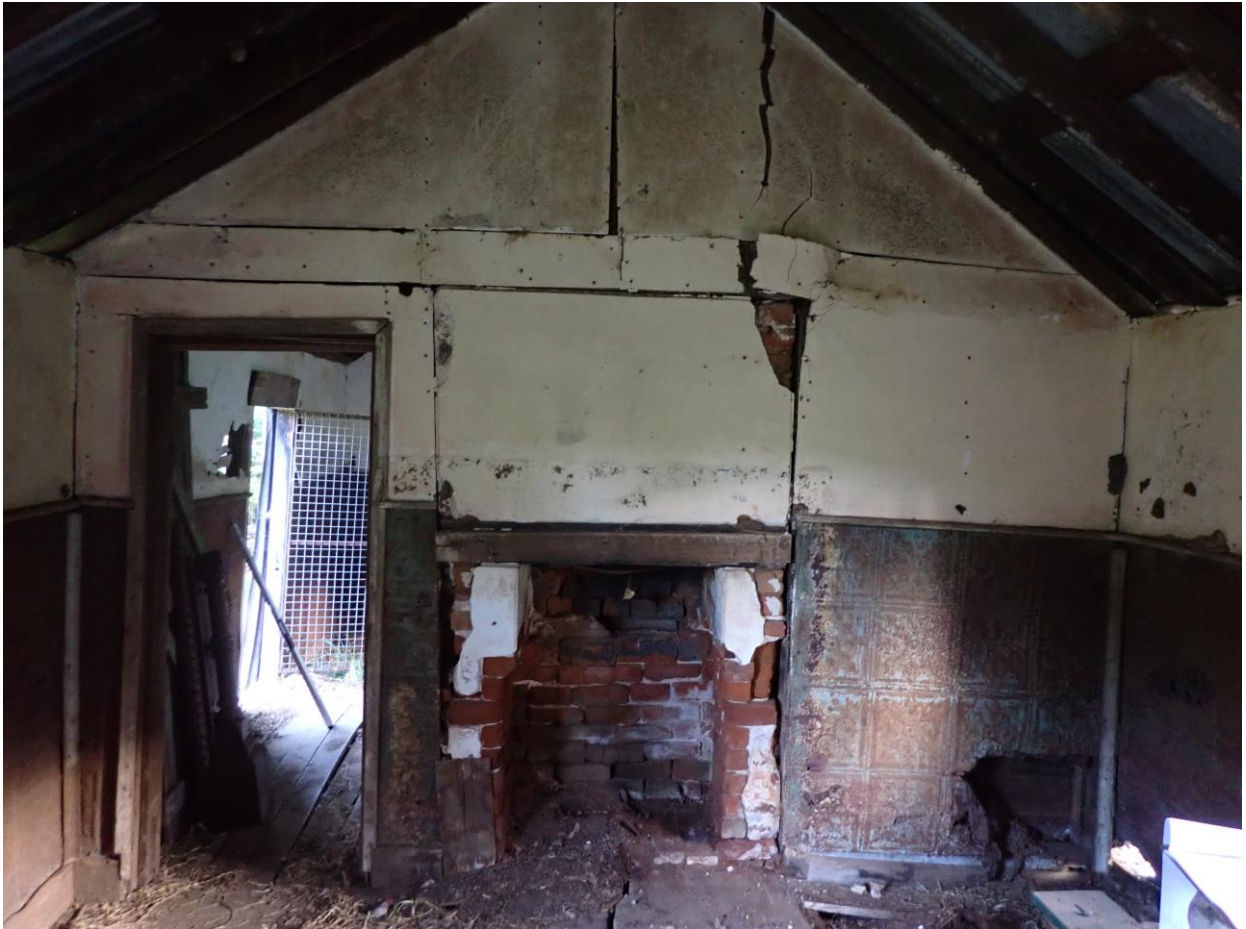
- The brickwork of the chimney breast is recessed into the timber framing of the internal wall to present a flush surface on the Room 1 side. Each side wall of the breast recess around a heavy post. These two posts extend up above door height where they tenon into a transverse heavy beam spanning from eaves to eaves across the width of the building. The front wall of the breast, above the fireplace mantle, is built up to the underside of the beam. These elements can be discerned in the wall finishes in elevation, refer to photograph from Room 1 below.

- This arrangement of interlock, as well as presenting a flat wall face to Room 1, also aids stability of the building well in the east-west direction, using the chimney brickwork as a self-stable mass.
- As reported in the CMS and clear to any visitor, the chimney breast is displaying stability issues in the north-south direction with a 5 degree lean to the north developed over time. The movement has inflicted a horizontal bending failure in the transverse beam at the mortice receiving the western post – the tear in the fibrous plaster sheet on the beam face in the photograph indicates this location, the jagged tear in sheets above also a symptom of the failure.
- As the chimney breast has undertaken the rotation, the stack above has followed its movement but has been resisted by the abutting roof ridge framing. The result is a sizeable diagonal tear in the base of the stack brickwork.

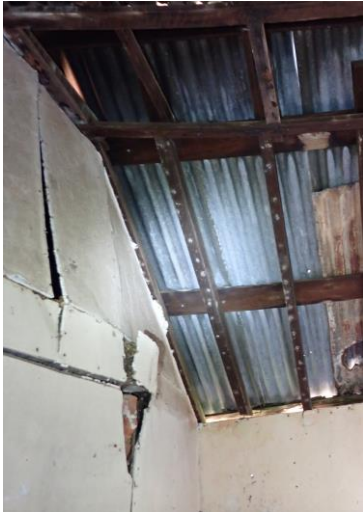
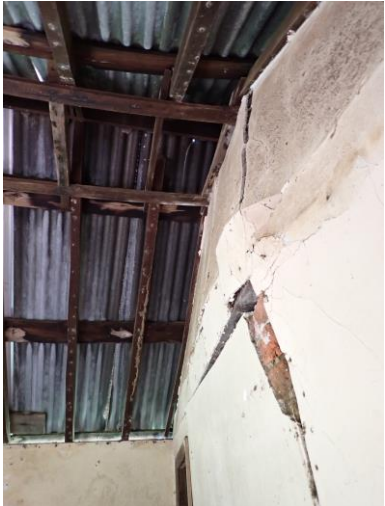
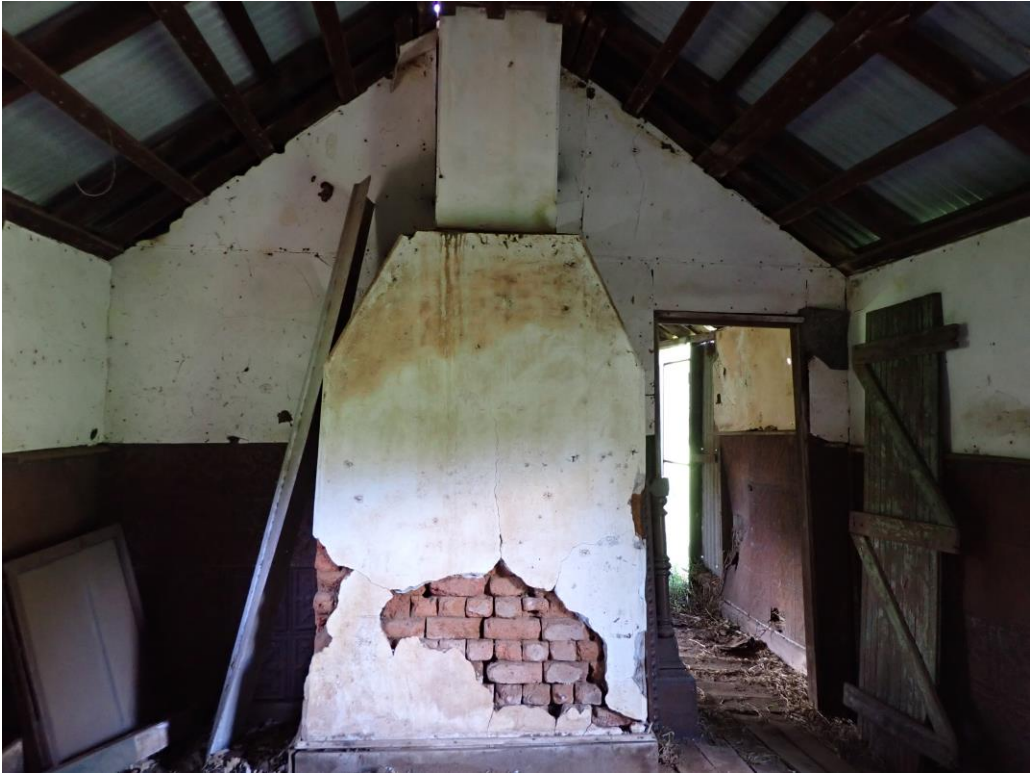
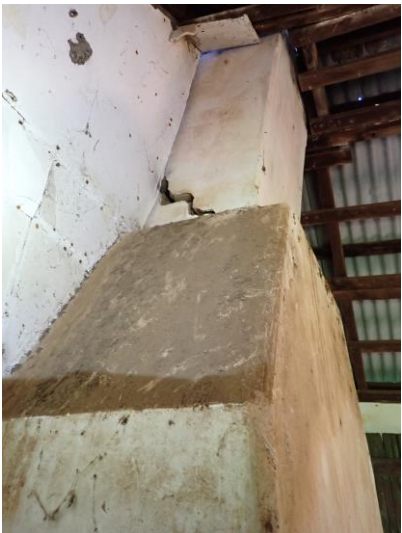
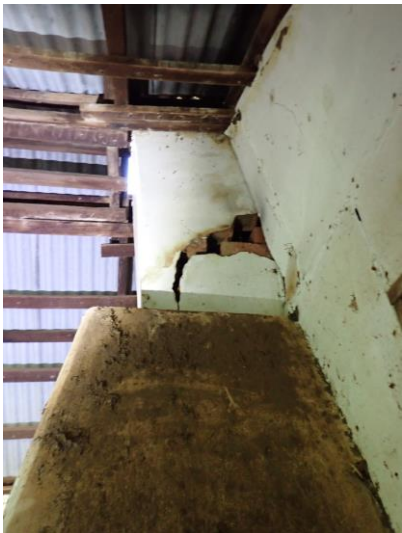
- The cause for movement in the chimney is considered a combination of factors. Key to the structure's stability is the wellbeing of fireplace cheek walls, both the condition of the masonry and the condition of support, ie. foundation and supporting soil to foundation. Each of these components has deteriorated such that self-compaction is able to take place. Historic moisture hold up in the soil has impacted on soil strength and the material health of the brickwork and mortar loss. Construction detail is simple reflecting the time of construction, there is no damp proof course, foundations will be simple continuation of wall brickwork below ground. Rabbit or other wild life burrowing is clearly a further action affecting the site. Any of these factors causing a small settlement within or below the cheek walls can produce a large rotation in the tall structure above. Soil erosion or undermining below the threshold slab has induced a significant slab crack.

- Previously independent, the chimney has progressively and inadvertently taken a level of lateral support from the timber wall and roof framing of the building. This level has increased and continues to increase as masonry deterioration continues. It is now time to slow this process with concerted conservation works to the lower masonry and assistance to the timber frame in its contributory role in stability.

- Masonry conservation works comprise a combination of local deep re-pointing, local rebuilding, local brick re-setting, crack filling and some replacement of heavier eroded brick units. Consideration also to be given to benefits or otherwise of returning render to areas where lost. All works to be considered in conjunction with proposed interpretation scheme for the site.

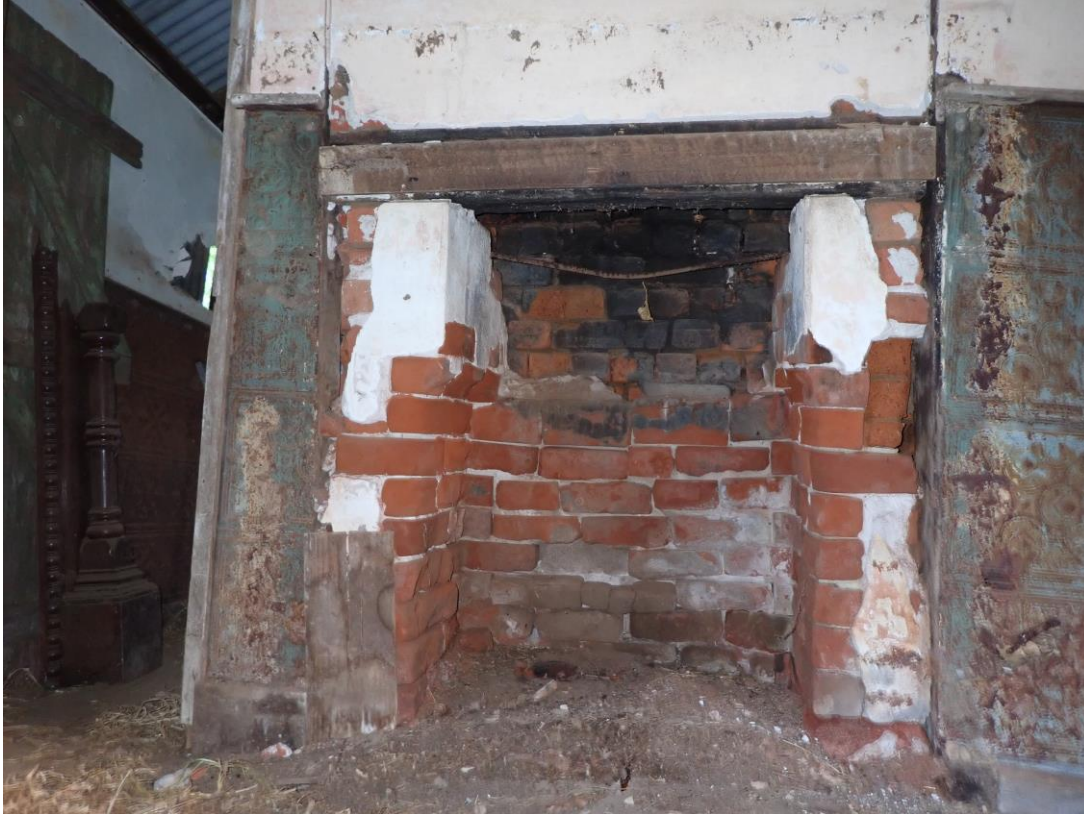
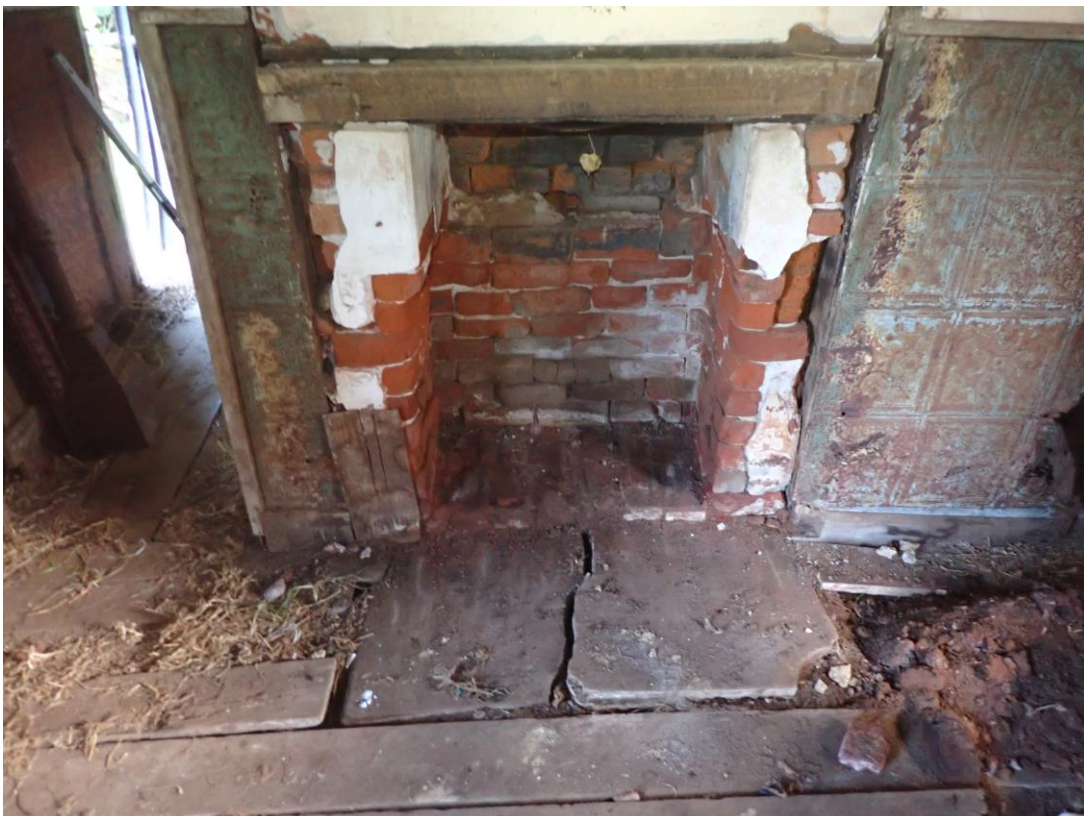
- The condition in the lower brickwork of the chimney, including the fireplace, is poor. It has suffered heavy mortar loss and material degradation through the effects of rising damp and poor maintenance. The photographs below are taken before and after clearance of debris from fireplace and threshold slab.
