Tributary Foreshore Assessment: Helena River (Mandoon)

Rivers and Estuaries Division

October 2017

Department of Biodiversity,
Conservation and Attractions

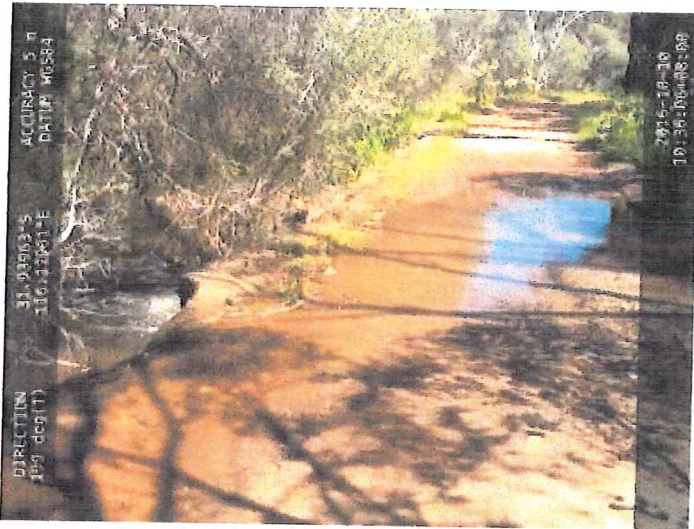
Figure 10: Localised flooding occurs above this small ford.

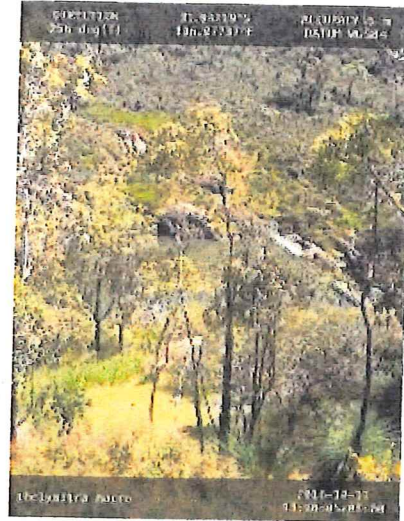
Figure 11: Steep banks above the Pumpback Dam.

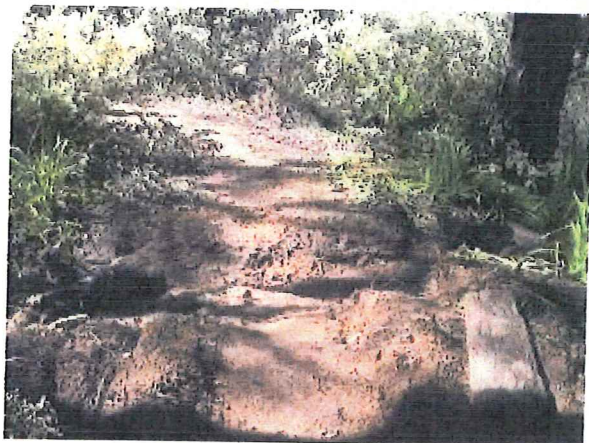
Figure 12: Localised erosion downstream of Mundaring Weir Road.

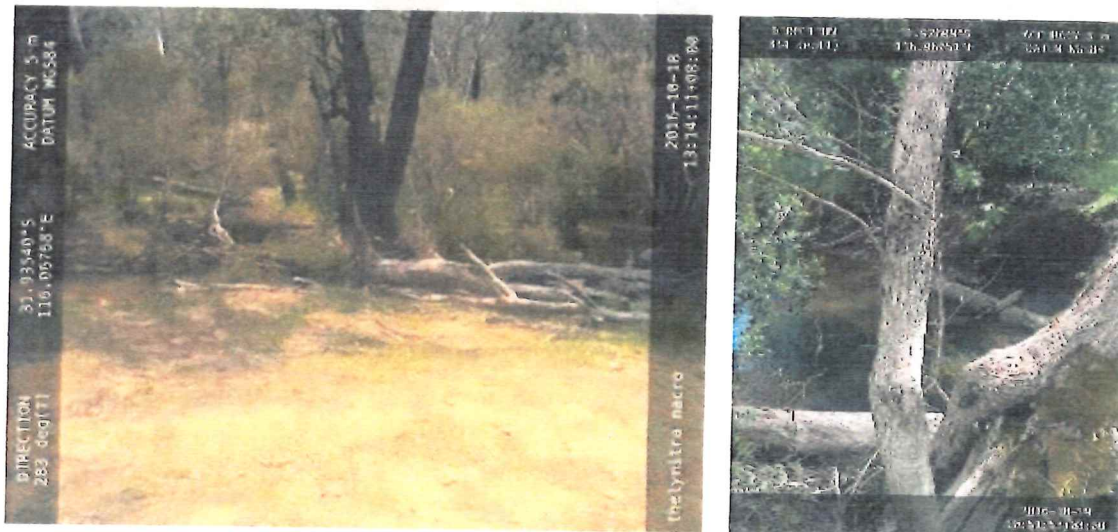
Figure 15: Exposed riverbank near Craignish Gauging Station.

Figure 16: Erosion on a riverbend on private property in Helena Valley.

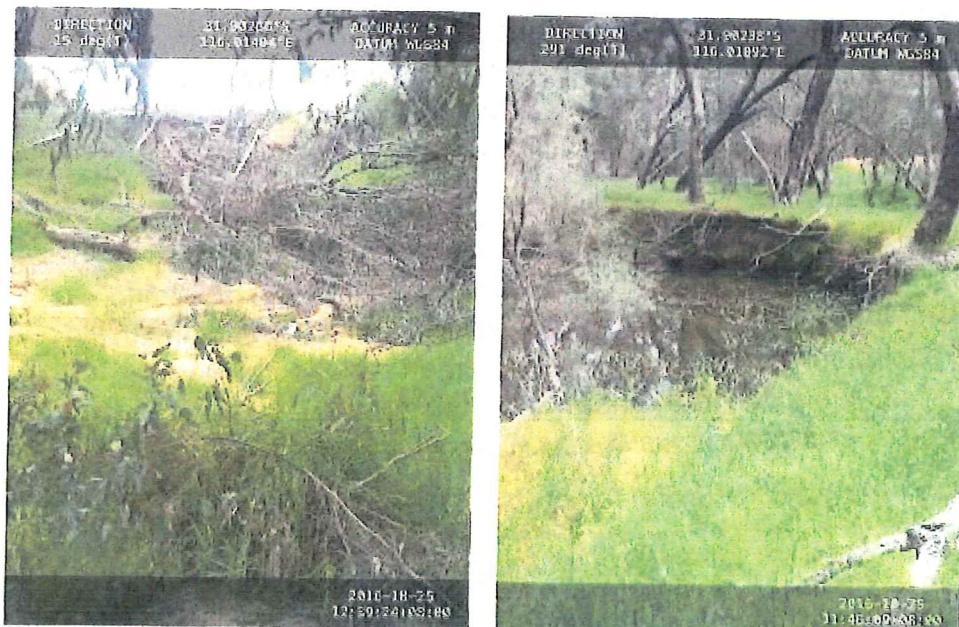
Bank stability is poor in a drain from a small wetland near an industrial property in Midland, where there is erosion and sedimentation downslope from the industrial site. A significant amount of sand has also mobilised down an embankment from another industrial property in Midland, causing both erosion and sedimentation on the floodplain.

Figure 17: Sedimentation downslope from an industrial property in Midland.

Figure 18: Incised bank on grazed floodplain in Midland.

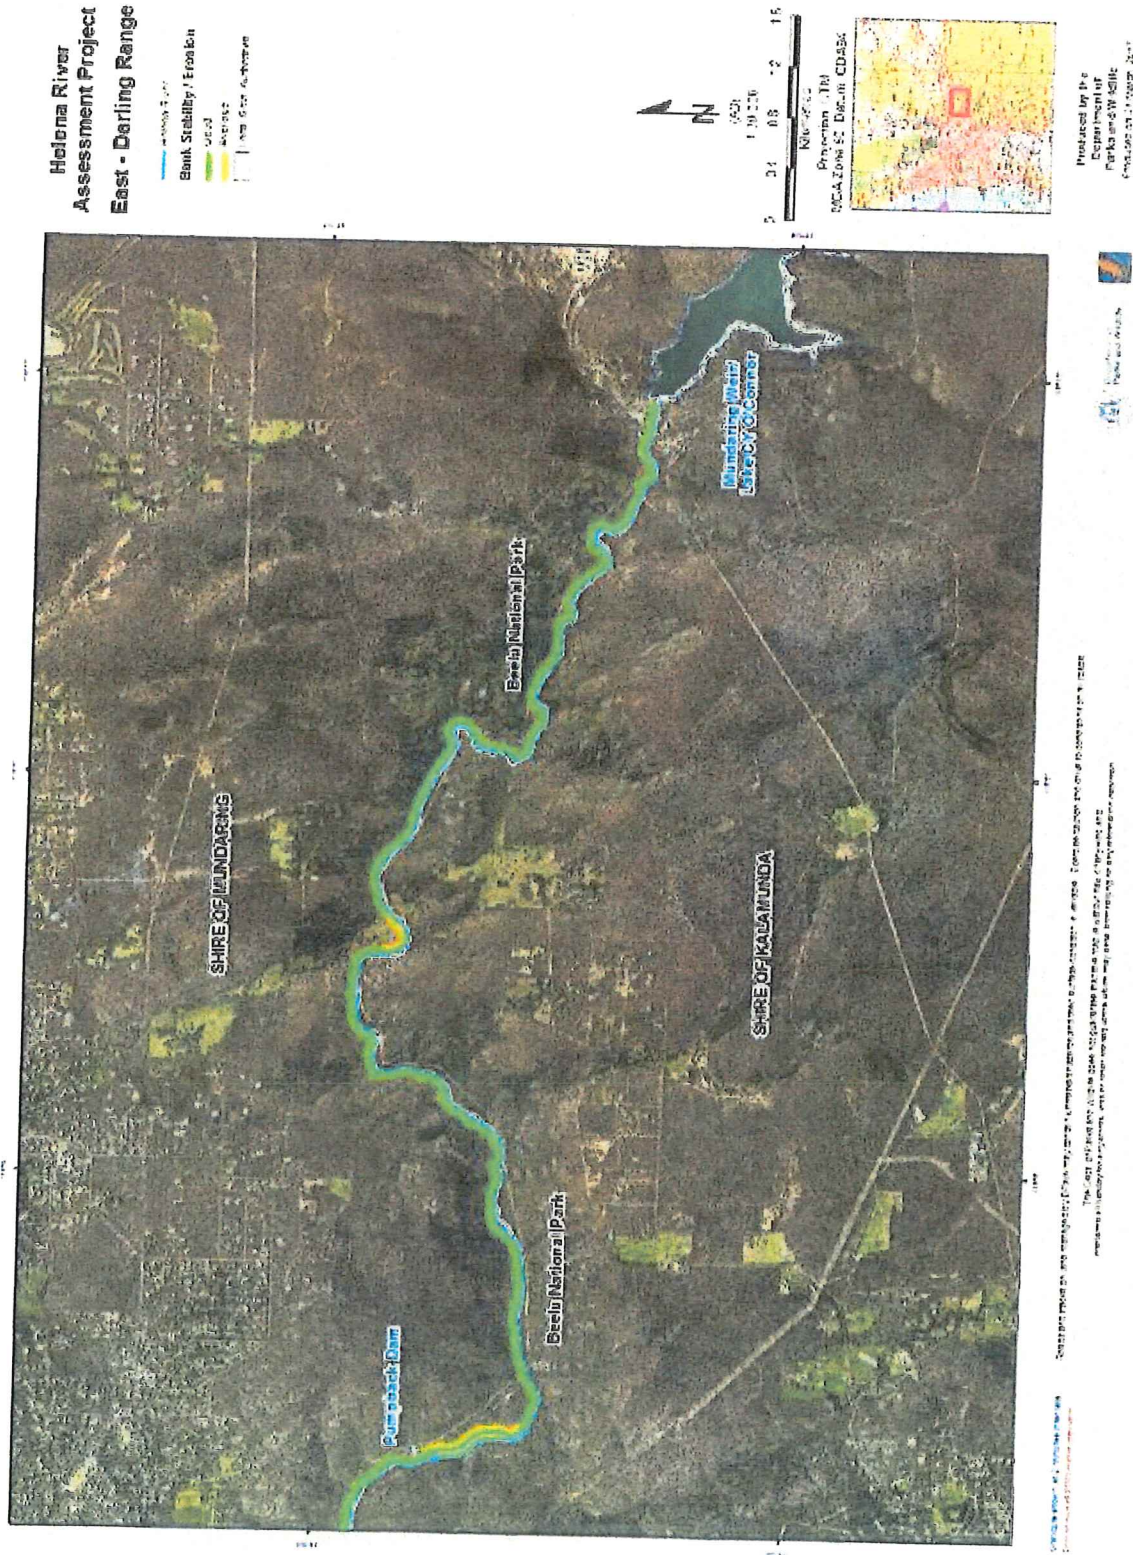
Figure 24: Bank stability, East section.

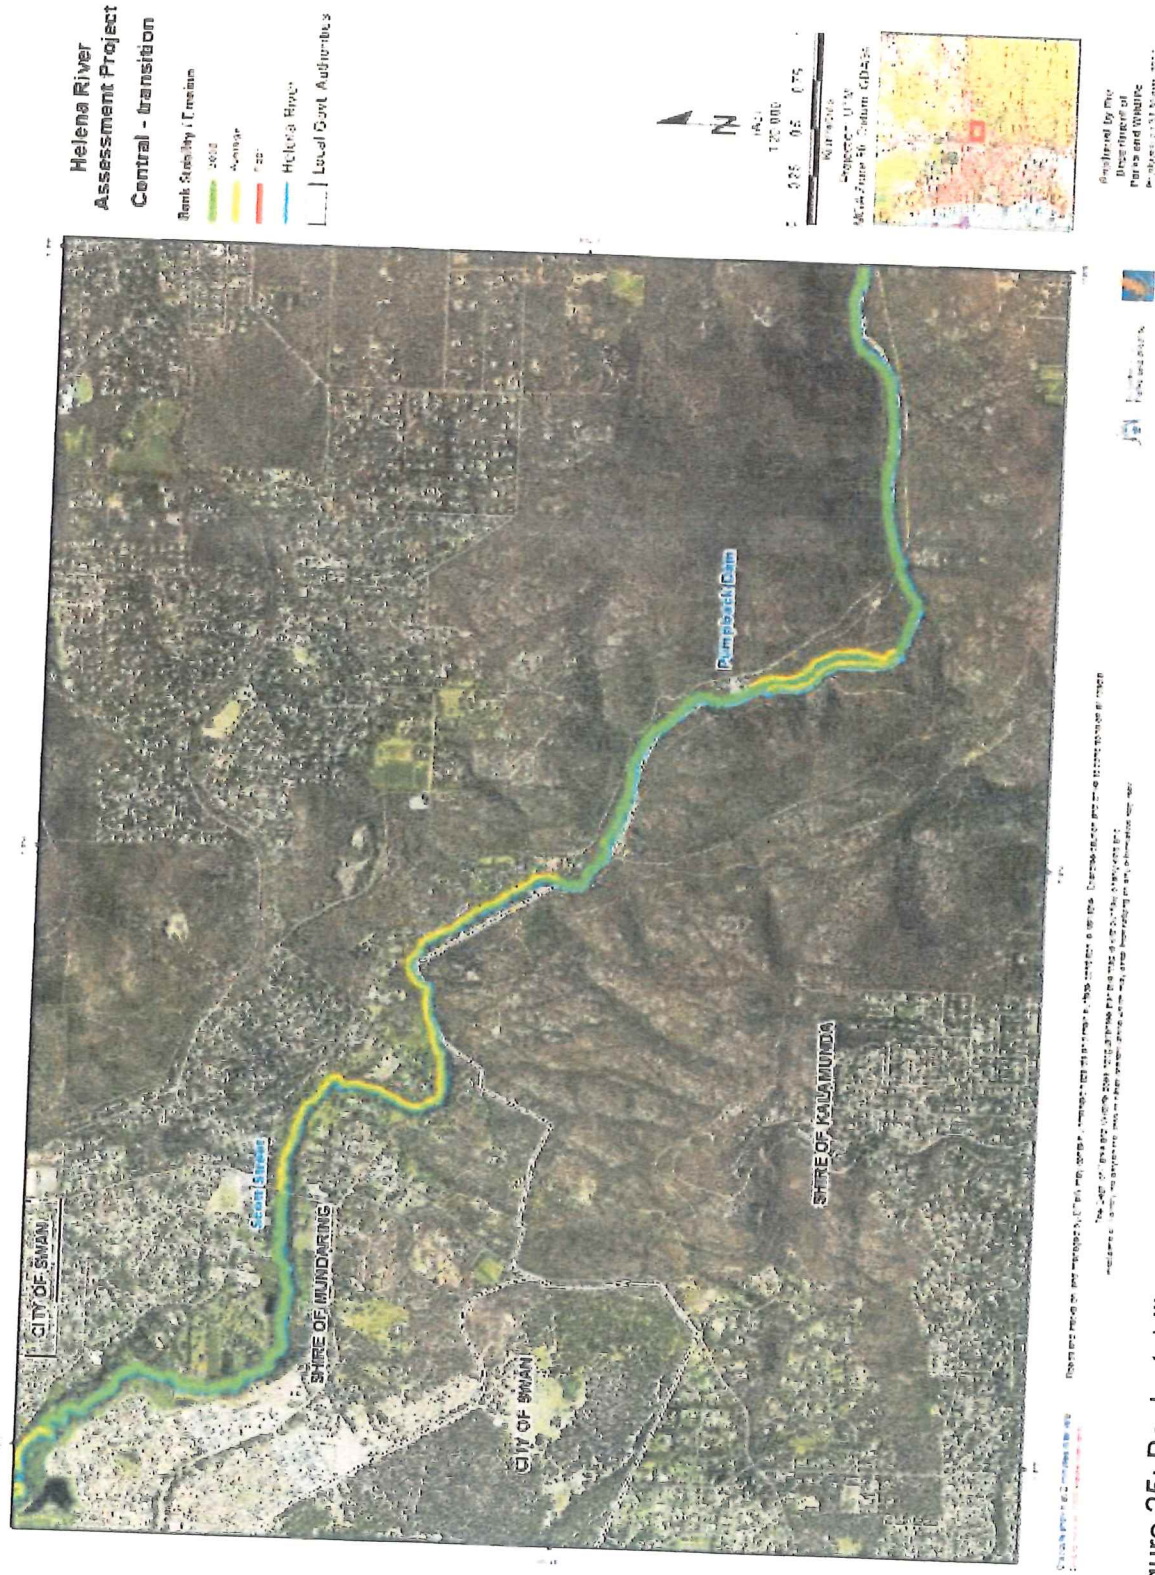
Figure 25: Bank stability, Central section.

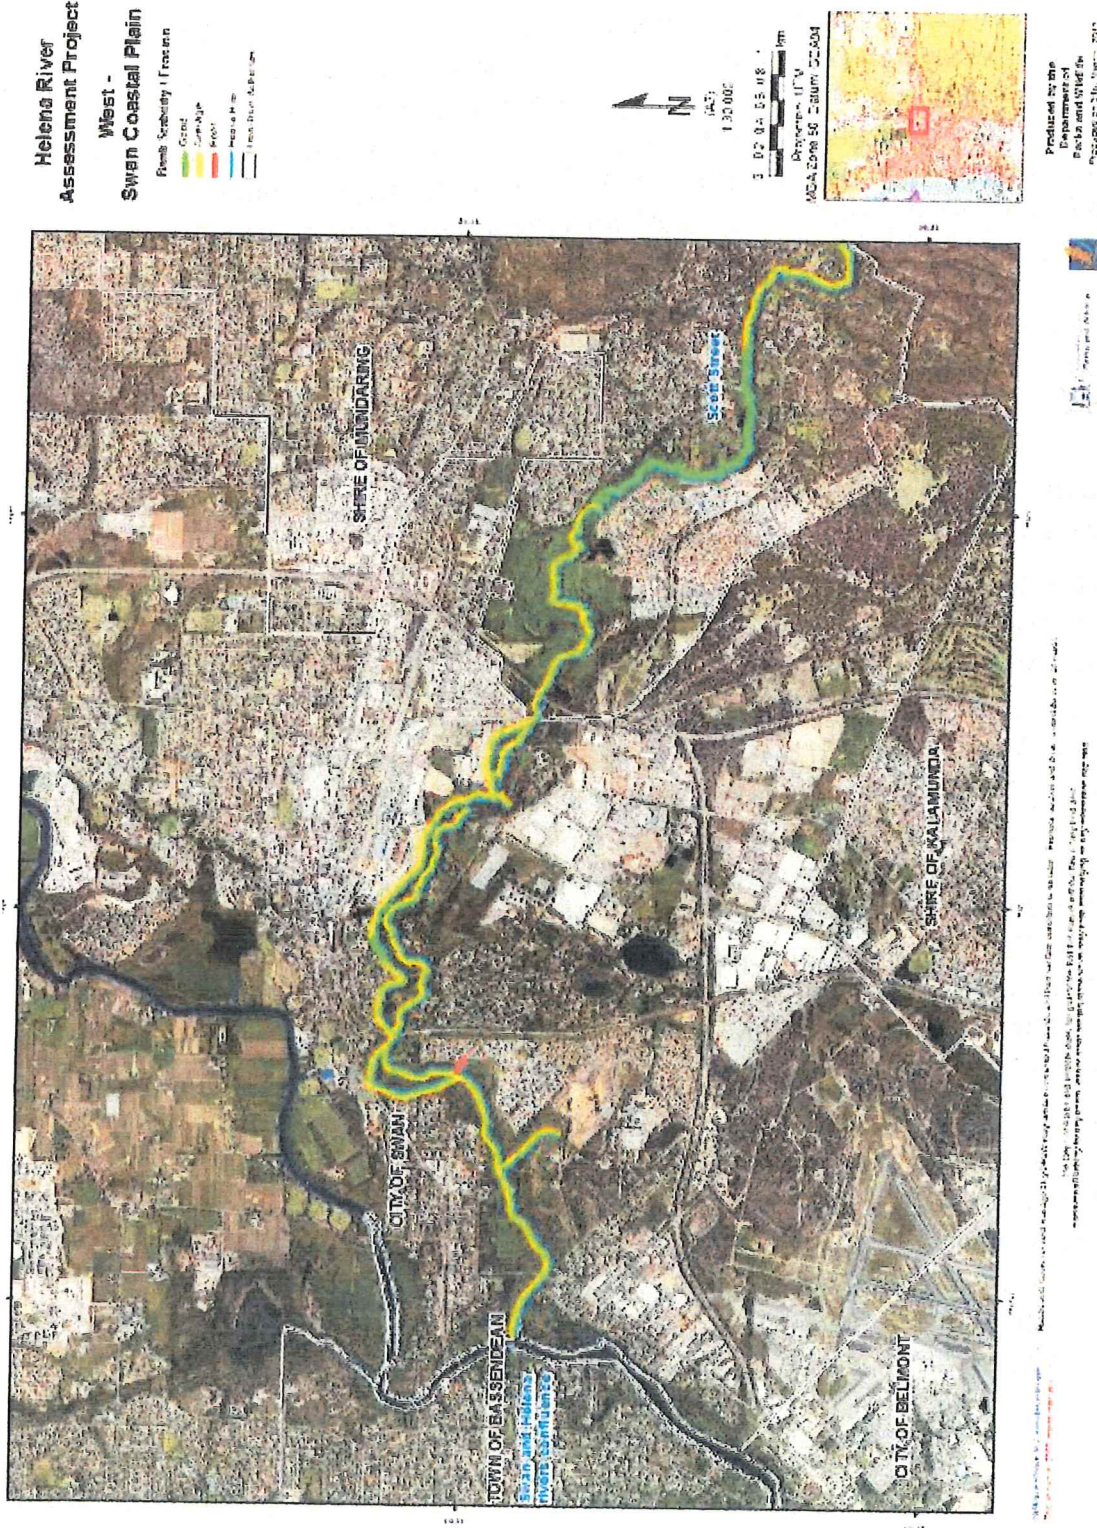
Figure 26: Bank stability, West section.

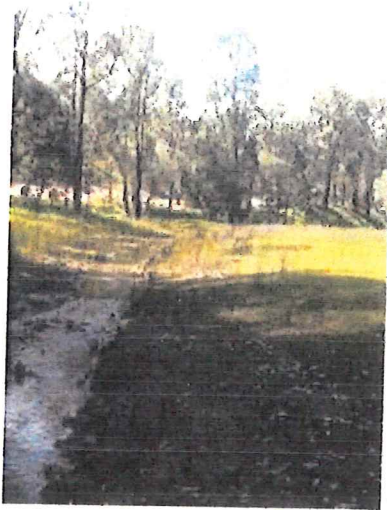
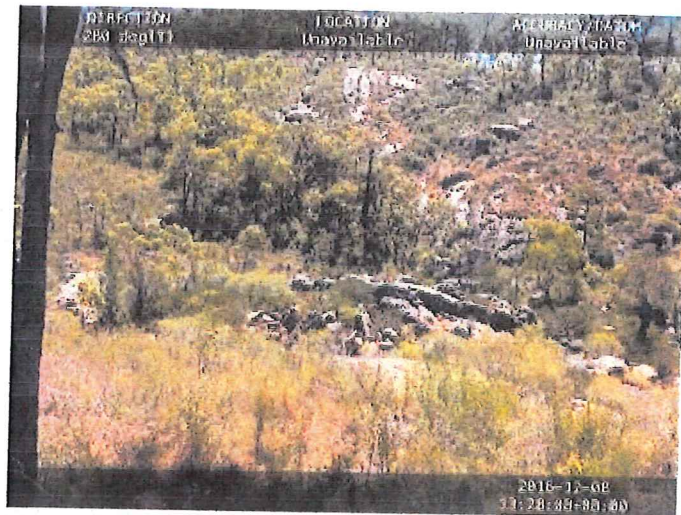
Figure 27: Poor condition vegetation immediately downstream of Mundaring Weir.
Figure 28: Granite dominated area with good condition vegetation.

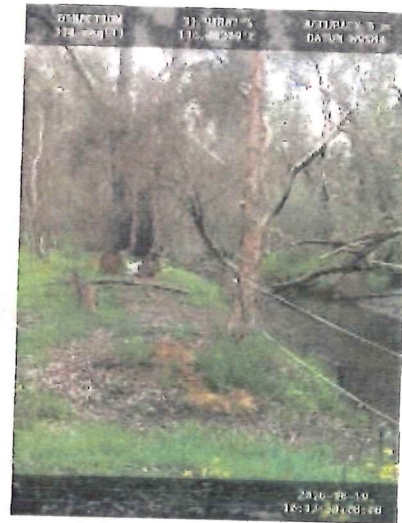
Figure 30: Understorey dominated by weedy grasses and herbs, Helena Valley.

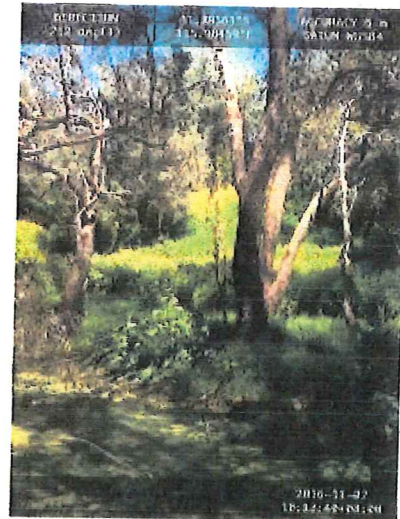
Figure 31: Connected upperstorey of *Eucalyptus rudis* in the floodplain in Midland.
 Figure 32: Understorey of arum lily and nasturtium in Guildford.

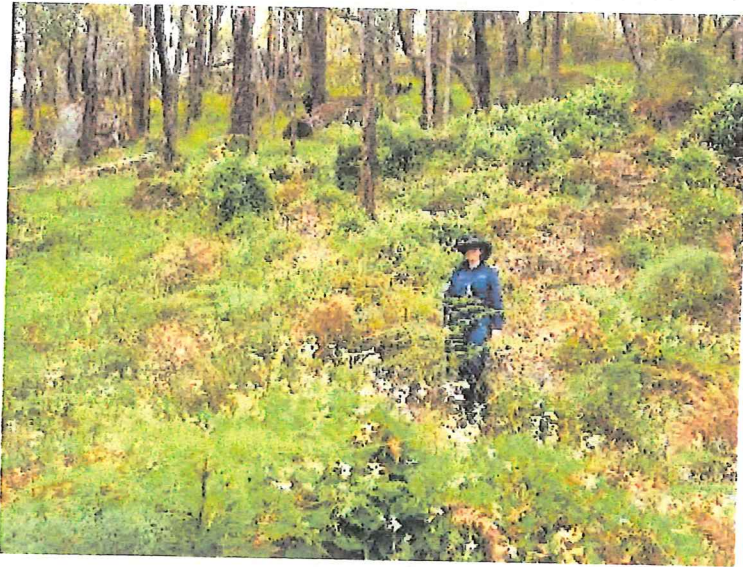
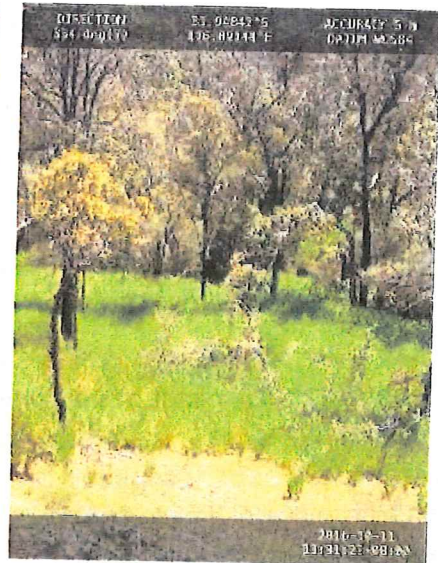
Figure 36: *Dolichos pea* infestation about 1km downstream of Mundaring Weir.
 Figure 37: Dense *watsonia* infestation above the Pumpbank Dam.

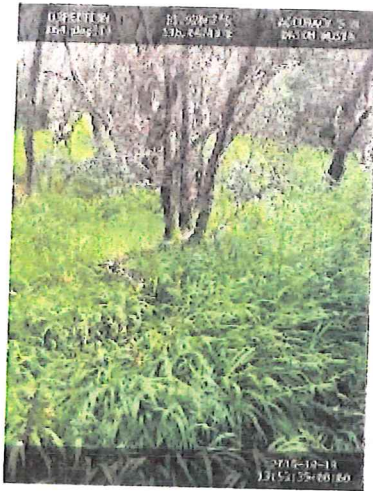
Figure 38: Dense watsonia infestation immediately downstream of Scott Street.

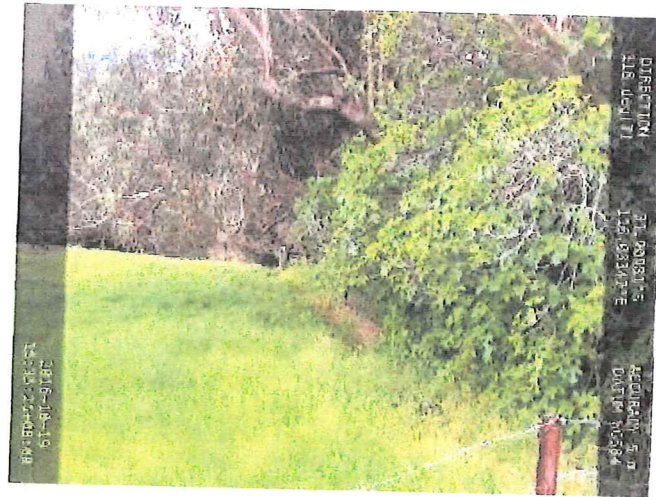
Figure 39: Narrow riparian zone with an upperstorey of flooded gum and fig.

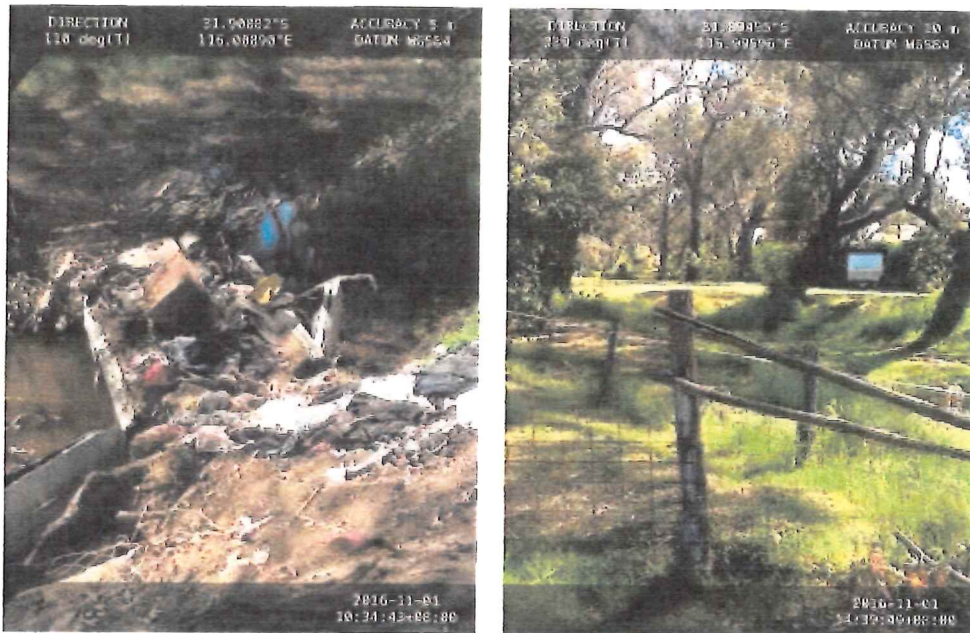
Figure 49: Dumped domestic rubbish in Midland.

Figure 50: Private gardens encroaching onto the watercourse.

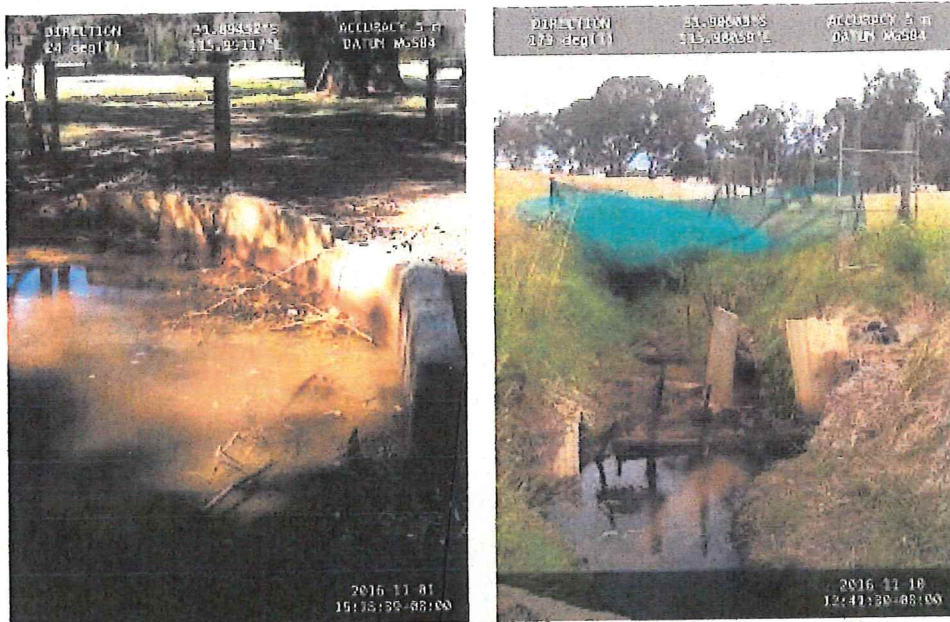
Damaged fencing is in a drain near Rosehill Waters estate, probably associated with the previous golf course. It is currently a hazard to birds, and may also impact aquatic fauna if it ends up in the Helena River.

Figure 51: Stagnant water in northern alignment of the Helena River in Woodbridge.
Figure 52: Damaged golf course fencing in drain from Rosehill Estate.

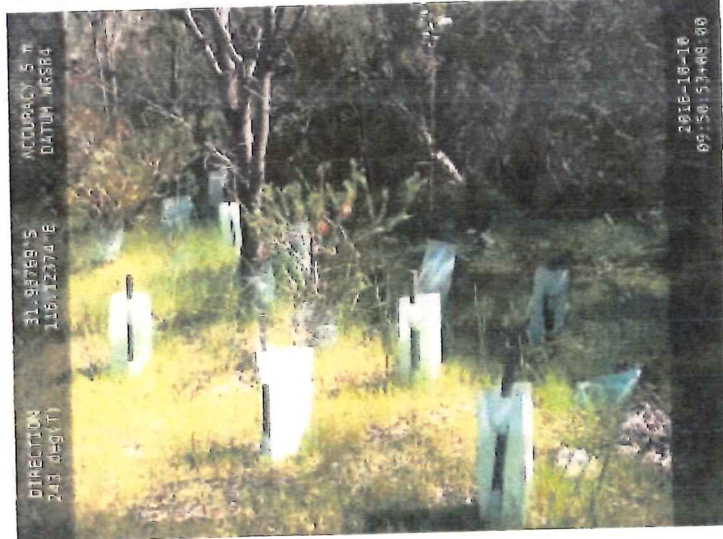
Figure 54: Small revegetation site requiring maintenance.
