PHOTOGRAPHS

TO ACCOMPANY BIG BROOK

FIRE RESEARCH REPORT

—BIG BROOK
FIRE STUDY PLOTS
AND TREES.—

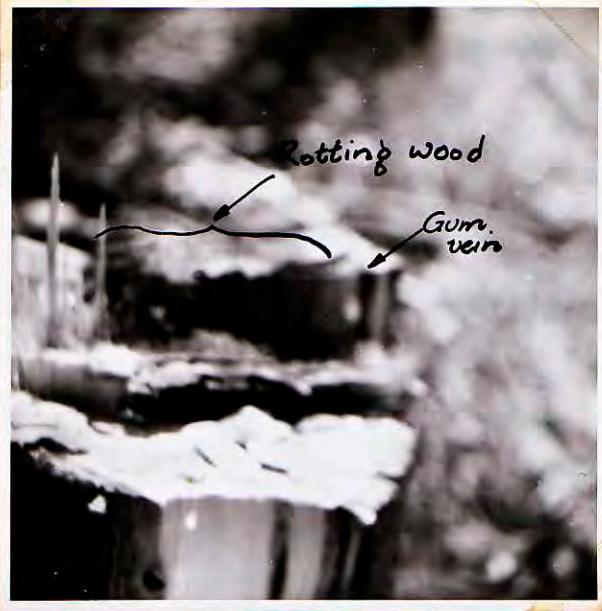
Photo 1: Tree N° 6 showing
blemishes as marked
in the stump.
(f9 $\frac{1}{50}$ sec. Tri-X film)

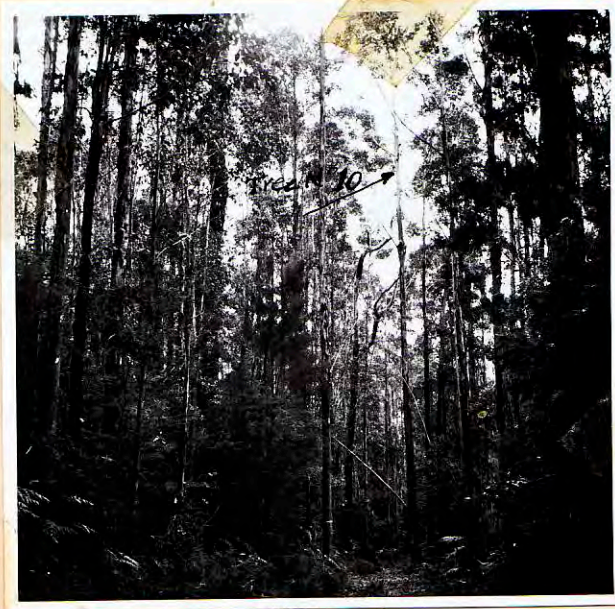
Photo 2 (Stereoscopically placed with 3).
Erect stem of Tree N° 10.
(f12 $\frac{1}{50}$ sec. Tri-X film)

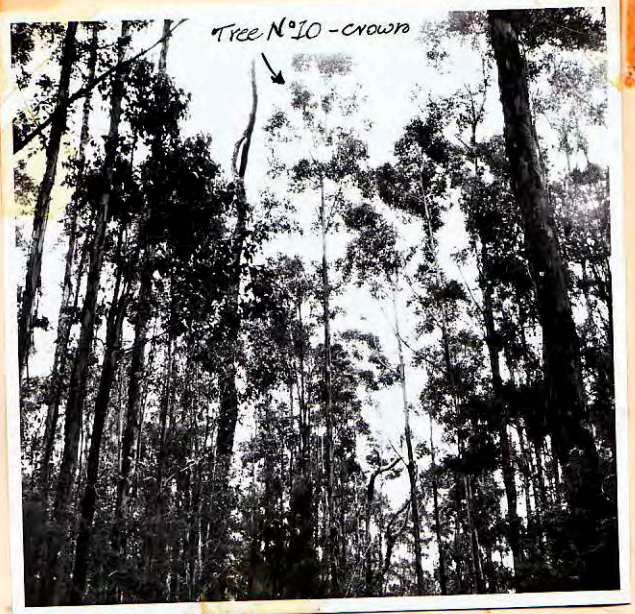
Photo 3 (Stereoscopically placed with 2).
Erect stem of Tree N° 10
(f12 $\frac{1}{50}$ sec Tri-X film)

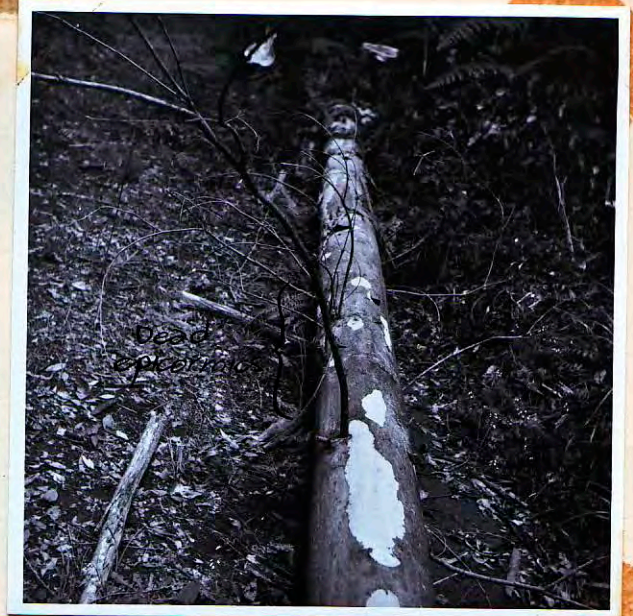
Photo 4

Tree N°45 showing
dead epicormics
(f11 $\frac{1}{50}$ sec Tri-X film)

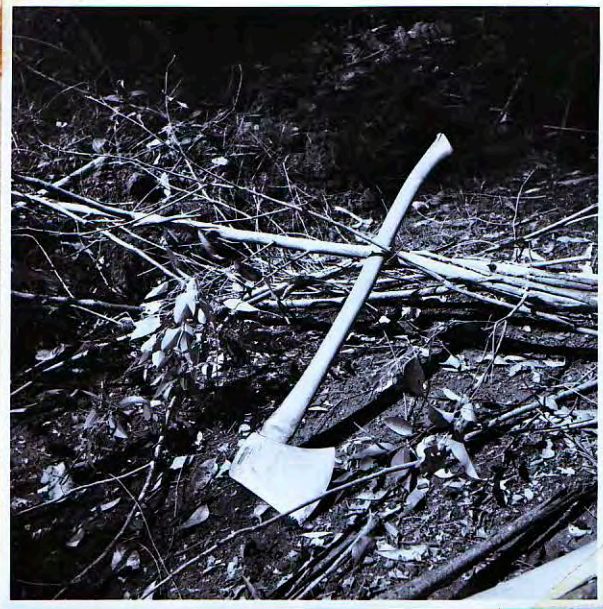
Photo 5

Tree N°45 showing
green epicormics
(f11 $\frac{1}{100}$ sec. Tri-X film)

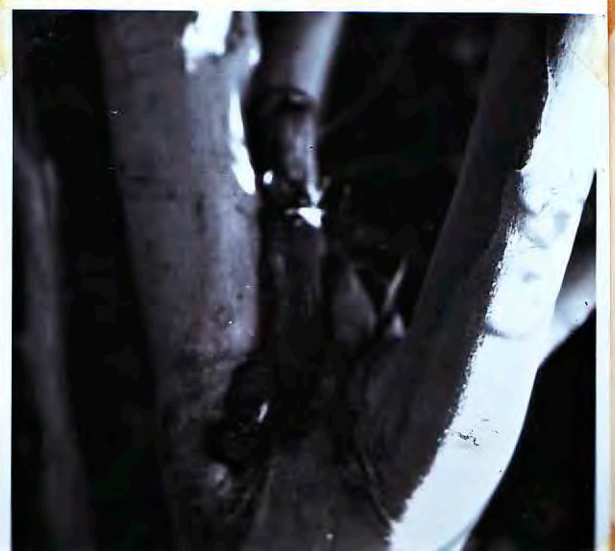
Photo 6

Tree N°42 showing
origin of bunching
of leading shoots
following fire damage
to previous leader.

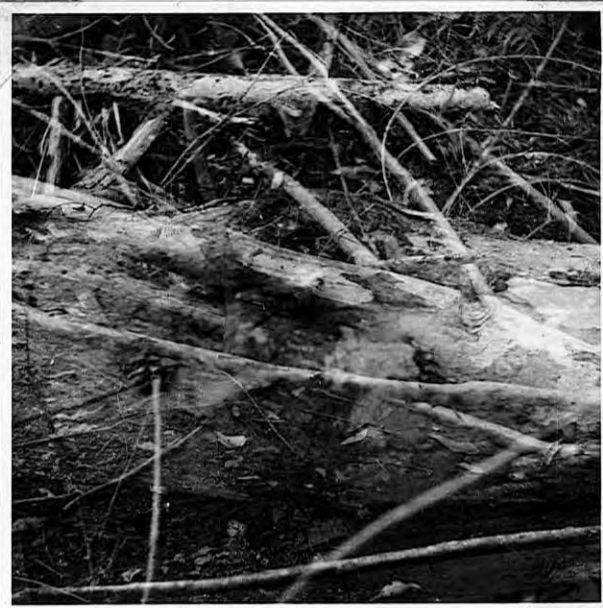
Photo 7

Double exposure
of Dry side in Tree N° 42.
($f/4$ $\frac{1}{30}$ sec Tri-X film)

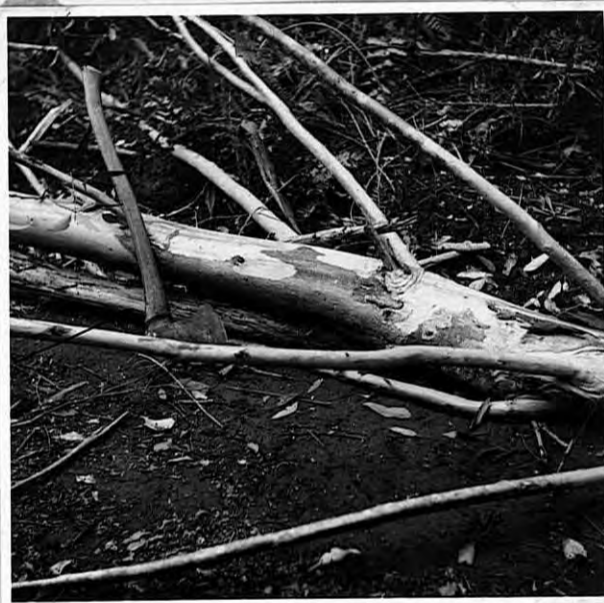
Photo 8

Tree N° 39 showing side
leader which has taken over
from now old dead leader.

Dead
leader.

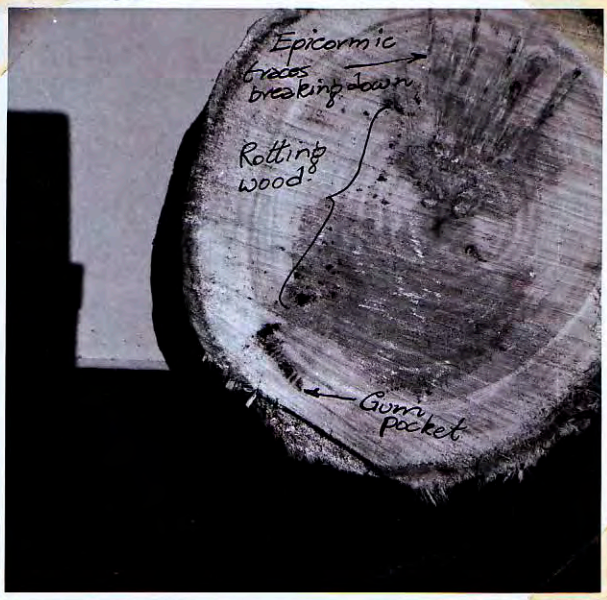
Photo 10

Cross Section of Tree N°42 at 50' showing progressive rot in the stem and gum pocket together with break down of epicormic trees.

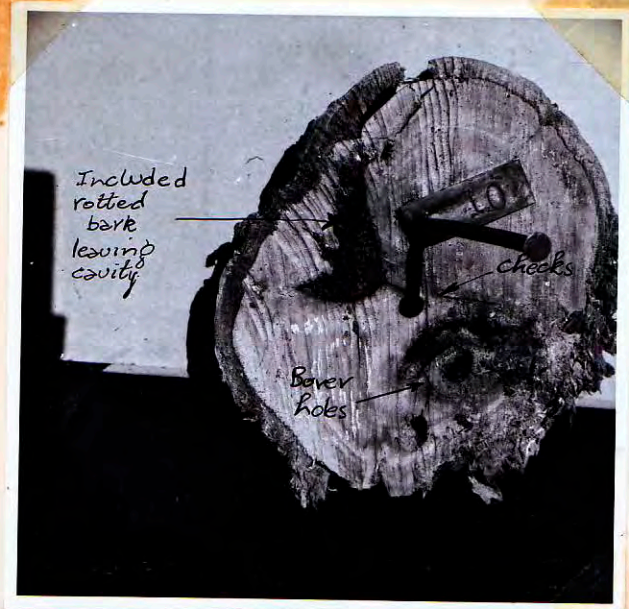
Photo 11

Cross section of Tree N°10 at 80' showing defects viz beaver holes, checks & included packets of rotted bark

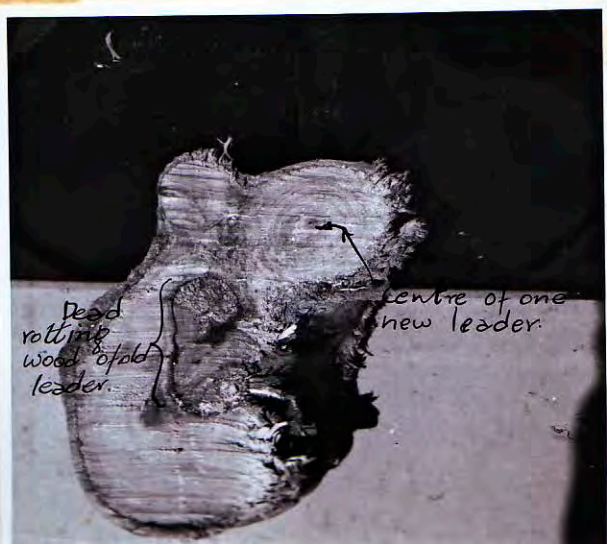
Photo 12

Cross section from Tree N°42 at 79' showing included dead leader now rotting and providing a source of infection, also centres of new leaders which have taken over.

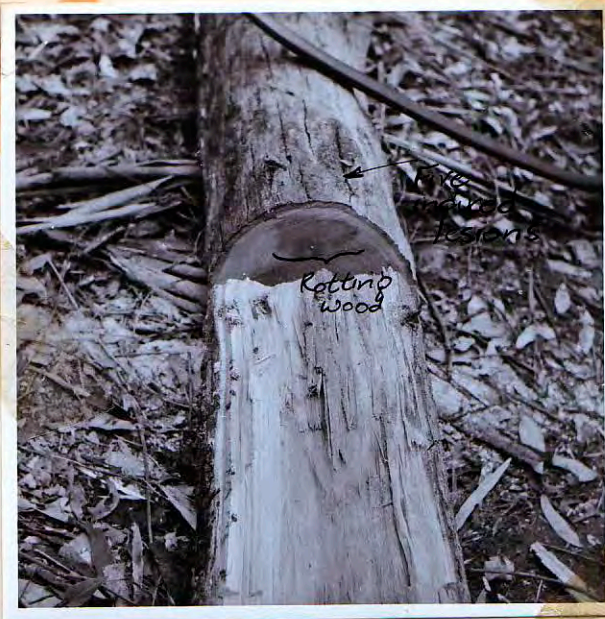
Photo 13

Tree N°6 showing rotting wood behind fire induced lesions.

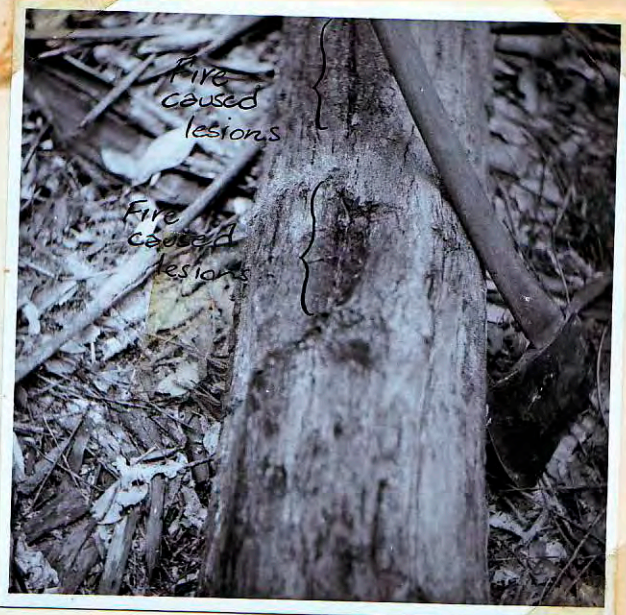
Photo 14

Present day appearance of fire lesions caused in 1953 fire. This is Tree N°6 a suppressed tree.

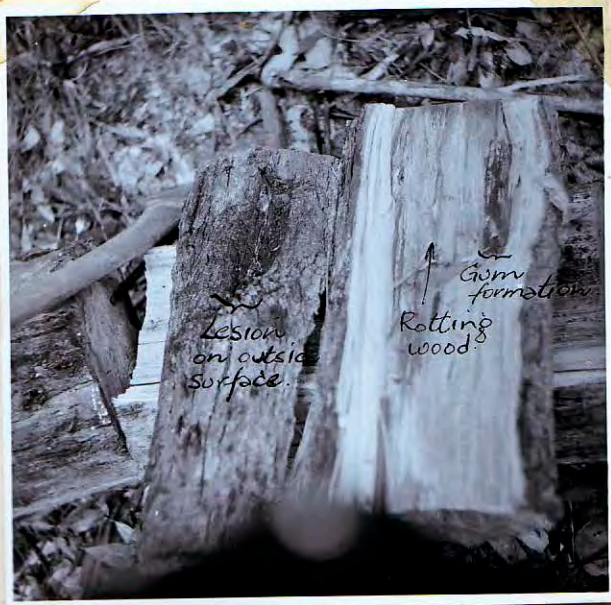
Photo 15

Tree N°6 showing fire caused lesion with resultant damage exposed alongside following splitting.

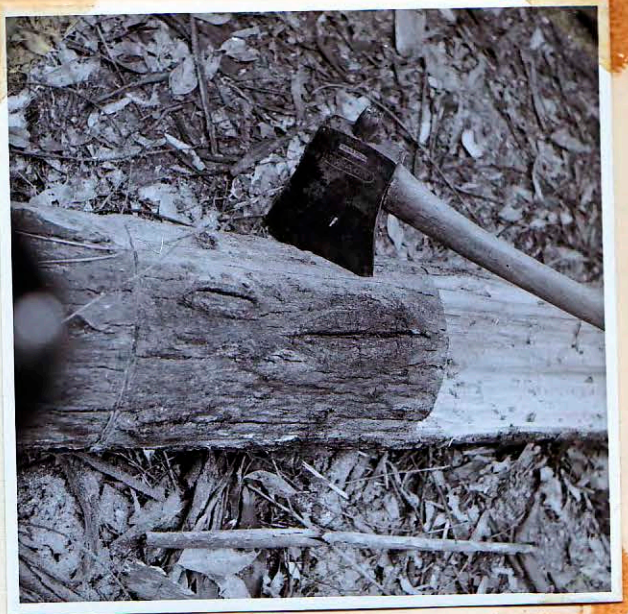
Photo 16

Tree N^o 6 showing
fire caused lesions
as they appear at present.

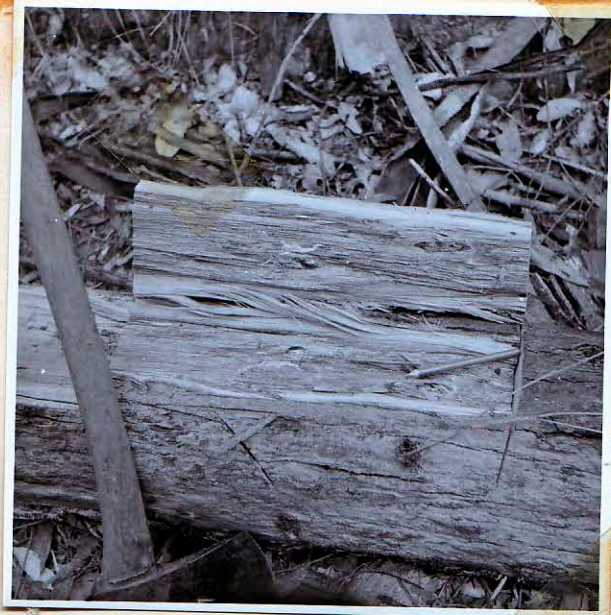
Photo 17

Tree N^o 6 showing exposed
wood behind 16 above.
Rotting can be discerned
as honeycomb appearance.

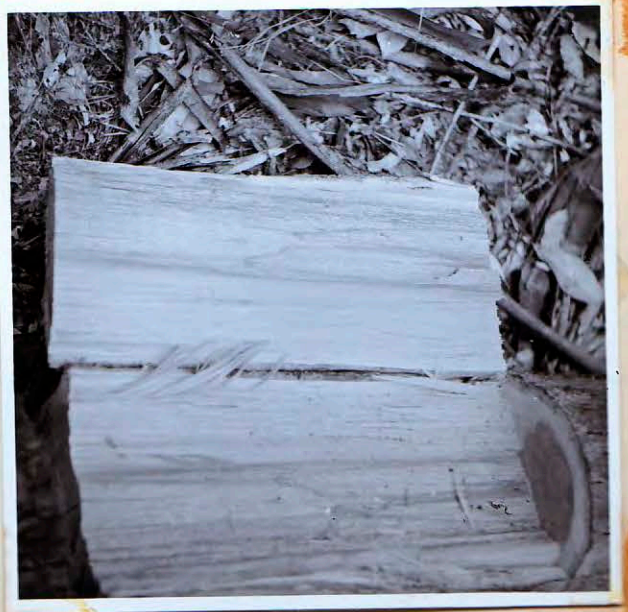
Photo 18.

Discoloured rotting
wood exposed behind
fire caused lesions on
Tree N^o 6.

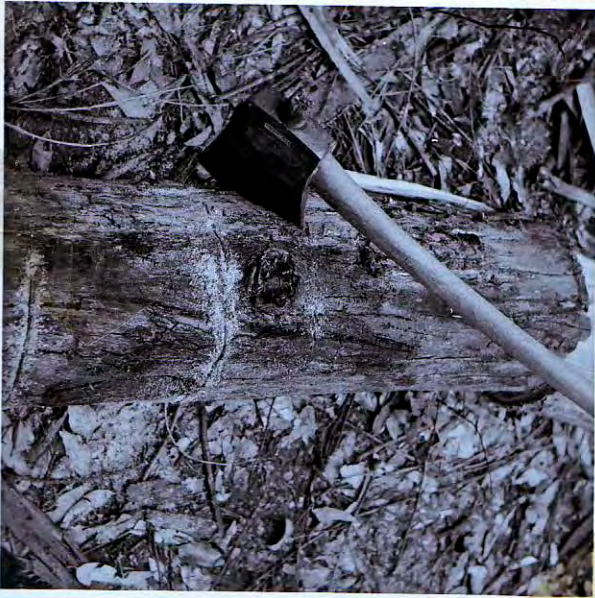
Photo 19

Tree N°6 showing outward appearance of a cluster of epicormic shoots now dead.

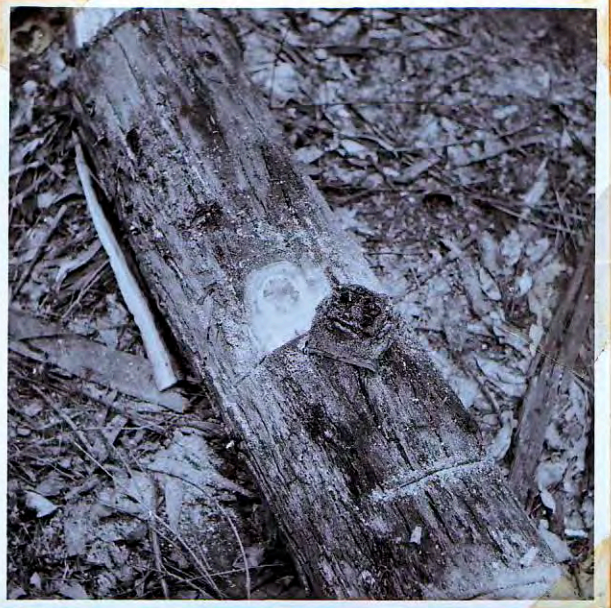
Photo 20

Tree N°6. showing section behind epicormic cluster as shown in 19 above — defect very slight indeed.

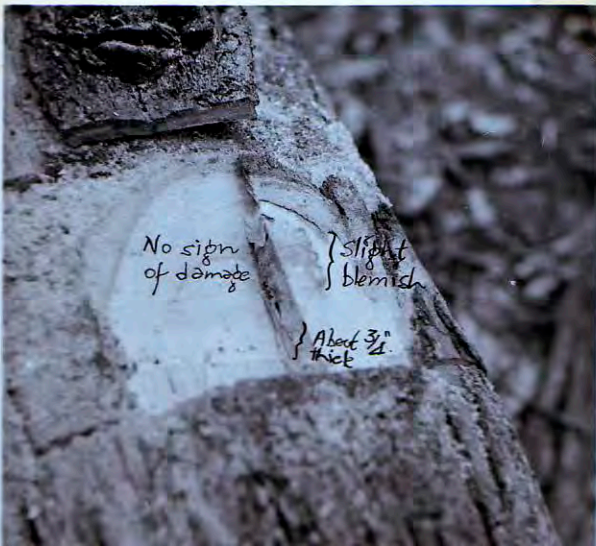
Photo 21

Tree N°6 showing close up of split section deeper again than in 20 above. No evidence of damage at deepest level.

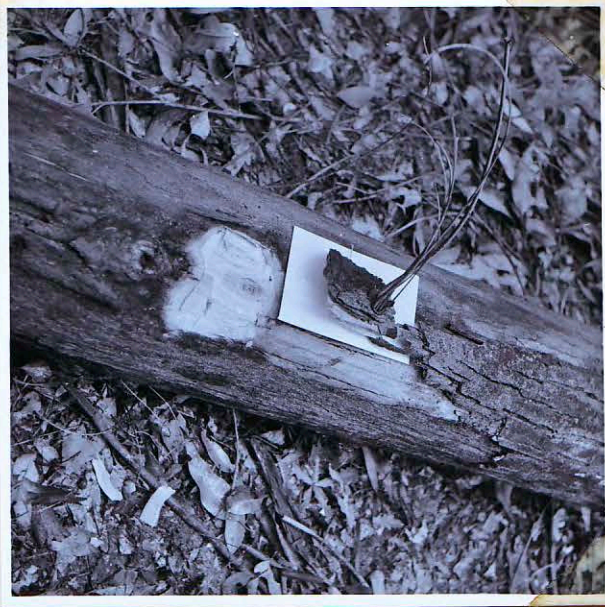
Photo 22

Tree N^o 6 showing further section behind an epicormic cluster and negligible damage caused by this agency.

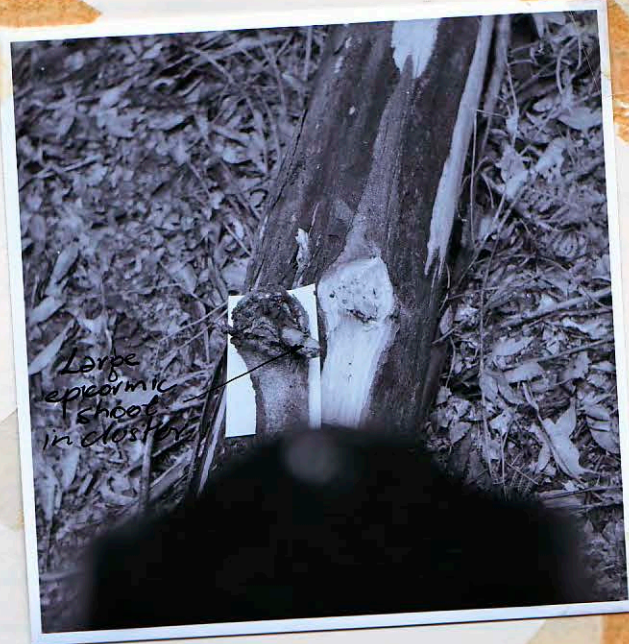
Photo 23

Tree N^o 6 showing section behind another epicormic cluster and minor damage caused in spite of size of epicormics.
