Inquiry into a Pollution Incident Involving Toluene Diisocyanate

Report and Recommendations
of the
Environmental Protection Authority

Environmental Protection Authority
Perth, Western Australia
Bulletin 401 August 1989

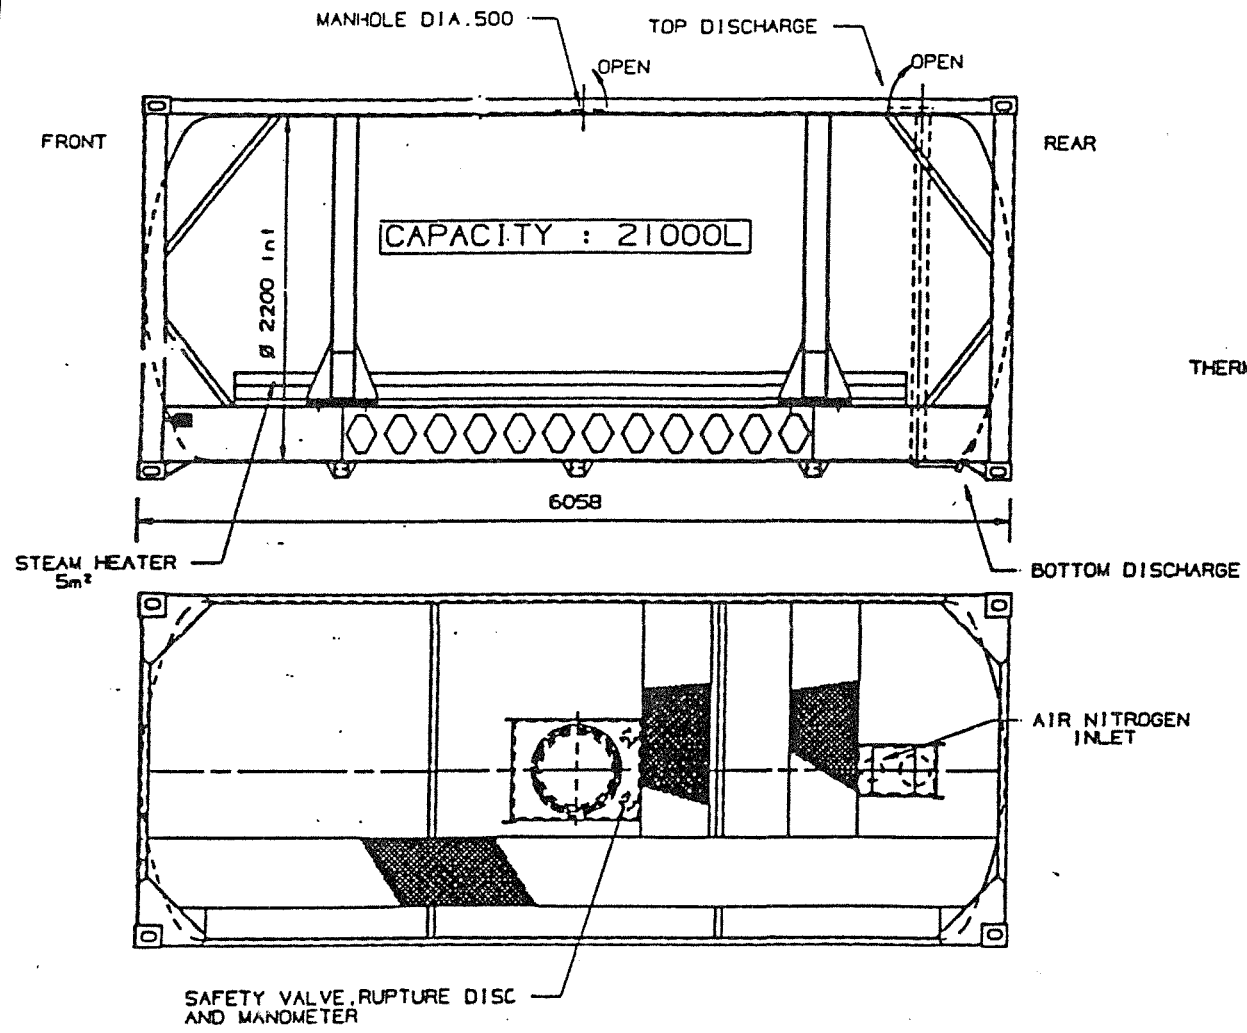
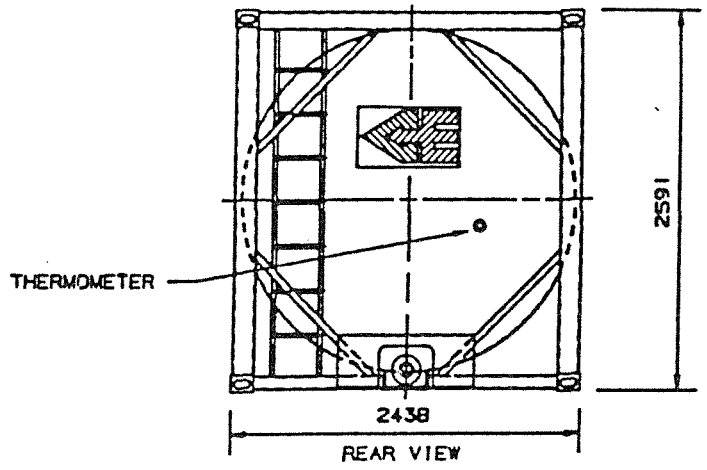
TECHNICAL DRAWINGS FOR THE TANK CONTAINER

The wagon carrying the tank container left the track and overturned onto its side, on the north side of the track. The force of this action was sufficient to cause the front twistlock mechanism to fail. (The twistlock mechanism ties the tank container to the wagon.) This resulted in the tank container parting from the wagon. Damage to the tank container indicates that both the wagon and container appear to have skidded along the ground, and the force of this was sufficient to buckle one of the longitudinal beams of the outer frame surrounding the container. When the beam buckled it was forced onto the vapour return pipe located adjacent to the beam, with sufficient force to partially shear the pipe where it joined the container body.

The tank container sustained minor damage to its outer insulation skin and ended up on its side. The container shell itself was undamaged. It was from the break where the vapour return pipe joined the container that the toluene diisocyanate leaked.

The fundamental cause of the spill was the derailment. It is likely that no leakage of toluene diisocyanate would have occurred, but for the modification made to the tank container for loading and discharge operations. The pipework for the modifications was levered by the damaged frame surrounding the tank, so that it fractured at the point of entry to the tank, allowing leakage.

In summary, if the frame had not bent, there would have been no effect on the extra pipework. As the frame did distort, it did affect the pipework, causing the leak. If the pipework had not been on the tank container during transport, no leakage would have occurred. The tank container itself remained intact, apart from some damaged insulation.

The Environmental Protection Authority recommends that to ensure tank container integrity during accidents in transport operations, the competent authorities investigate the practice of having external loading, discharge, and vapour return pipes fixed to containers.
