Water notes

ADVISORY NOTES FOR LAND MANAGERS ON RIVER AND WETLAND RESTORATION

Demonstration sites of waterways restoration in WA

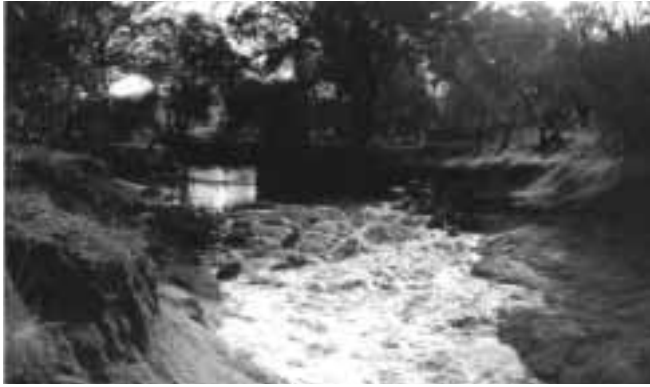
A sequence of four riffle structures has been constructed at the site to control the bed level and stabilise the channel slope. Figure 2 shows the first riffle in the sequence, built near the confluence with the Avon River. The riffle structures have been successful in achieving the objective of stabilising the riverbed by reducing the velocity of flows and the down-cutting that high velocities generate. The success of the riffles is evident by sediment trapped upstream in the brook, helping to prevent further sedimentation of the Avon River.

Figure 2. Riffle structure located 80m upstream of the Spencers Brook confluence with the Avon River in full flow during June 1998. The pool upstream extends for approximately 160m.

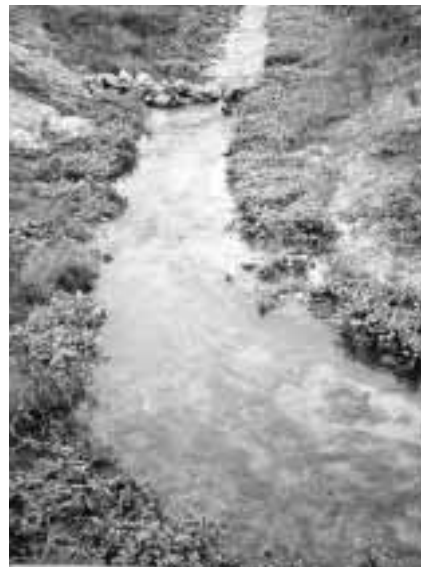
Figure 3. Realignment of Southernwood Creek.

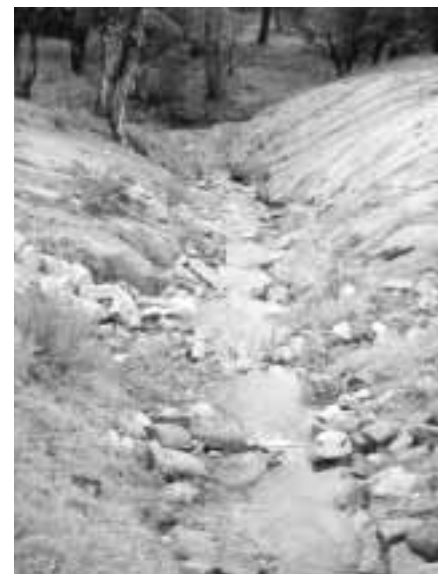
Figure 4. Rock riffles and matting installed on Southernwood Creek.

A series of riffles was constructed in the channel using broken cement curbing and stone. The riffles were installed to control erosion by gradually stepping the creek down to the river. The riffles were spaced at short intervals to reduce flow velocity along the artificially steep slope of the creek to its confluence with the Southern River (Figure 4). The site was further enhanced through revegetation, weed control and re-contouring the steep banks to control drainage (Figure 5).

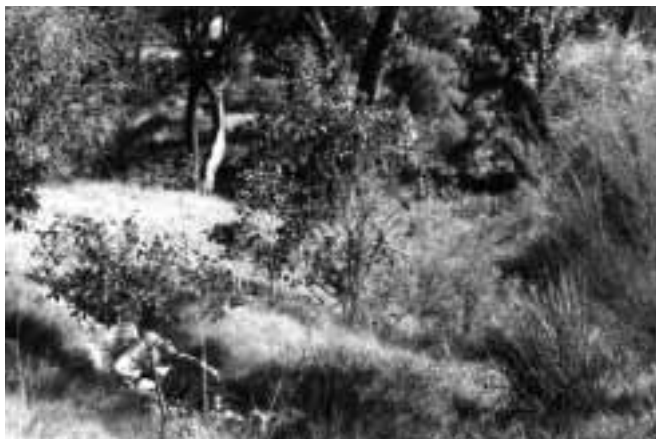
Figure 5. Southernwood Creek, four years later. The riffles have stabilised the bed and revegetation has stabilised the banks.

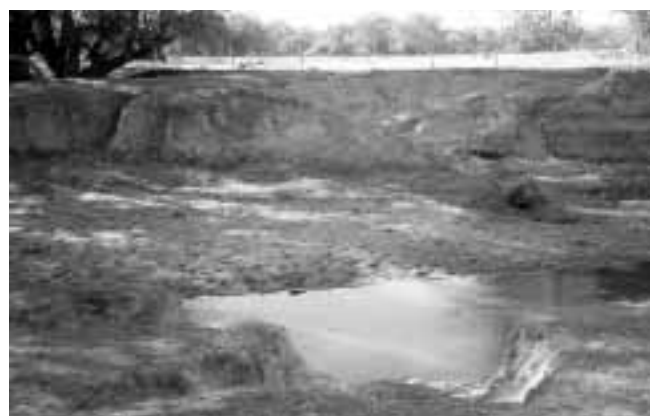
Figure 6. Dandalup River prior to installation of LWD. The site selected for one of the log riffles was severely degraded and destabilised due to cattle trampling.

The construction of the Paterson Road site was carried out over two days in May 1998. Forty large tree trunks were installed using a hydraulic excavator. At three locations, logs were placed perpendicular to the flow to form 'riffles'.

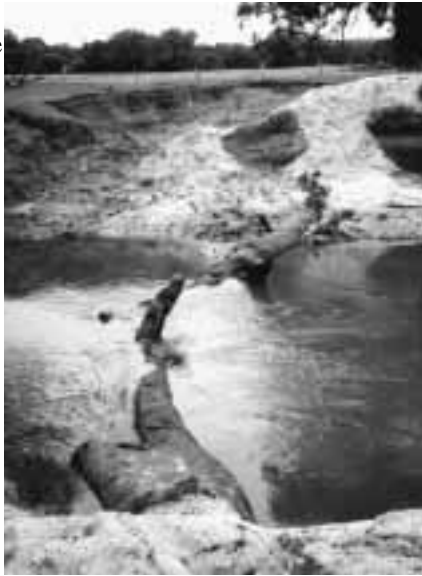
Figure 7. The riffles were constructed with the root balls of the logs buried into the bank to anchor the logs and the tapered ends pointing slightly upstream. A scour pool has formed in the centre of the channel.

Two logs were used at each site to build a V-shaped riffle across the low flow channel (Figure 7). The remainder of the logs were orientated to provide 'toe protection' to support stream banks either immediately upstream or downstream of the riffles, or on the outside of meander bends to direct flows away from the banks. Sections of the banks were stabilised with jute matting, which was pinned down. The cost for the installation and enhancement of the log riffle structures and toe protection was approximately \$10,500 (i.e. about \$260 per log placed).

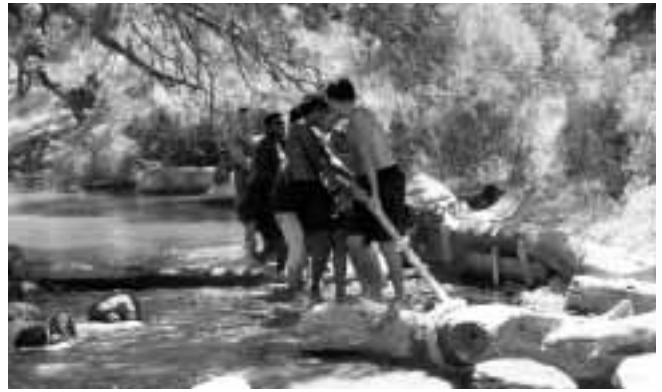
Figure 8. Landcare trainees installing logs on the South Dandalup River.

The logs were retained by wiring and bracing to pine posts and galvanised fencing droppers jettted or driven into the bed. Sedges and rushes were also transplanted and brushing installed to protect banks from undercutting. Some minor movement of logs occurred during the high flows of the 1999 winter. The movement was due to some of the pine posts being inadequately installed, which was easily rectified. The materials and construction cost of the site was approximately \$3,000 (i.e. \$100 per log placed). Additional funds were spent on surveying, site supervision, weed control and monitoring. The works were funded by both the Natural Heritage Trust and the Water and Rivers Commission.

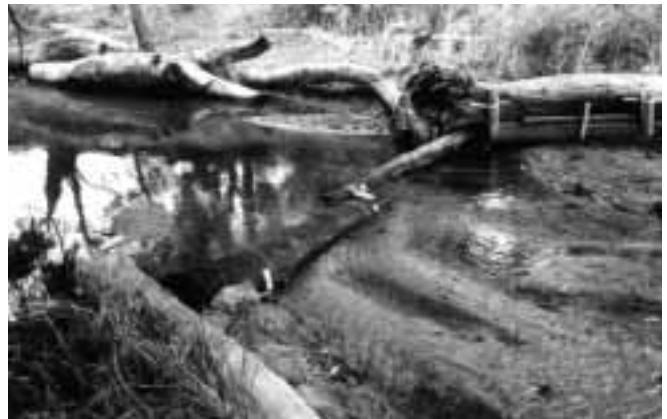
Figure 9. Log riffle and bank protection on the South Dandalup River.

The technique was evaluated and extended to the South Dandalup River project site at Fairbridge in March 1999. As the riparian vegetation is well-established along this reach, access by heavy machinery to position the logs would have caused considerable damage to the banks. In order to minimise disturbance to the riparian zone, the logs were installed manually by twelve Landcare trainees through the Fairbridge "Ecohouse Project" (Figure 8). Thirty logs of somewhat smaller size than those used at Paterson Rd were installed (Figure 9).

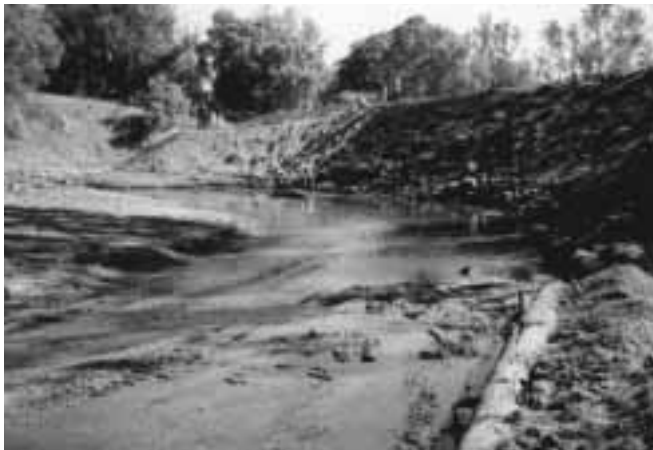
Natural Heritage Trust funding was used to establish a demonstration site along an 800 metre reach of the Brunswick River. The river reach was degraded through cattle grazing and the lack of vegetation, resulting in an incised and oversized channel, with steep, unstable banks.

Figure 10. Works in progress on the Brunswick River. Large logs and boulders were placed along the base of the eroding bank (foreground) and the face battered and covered with matting (background).

The site was surveyed and a design developed to stabilise the channel and commence rehabilitation of the river. Rock riffles were built to stabilise the river bed level. Large logs and boulders were installed along the base of the steep banks to provide toe support (Figure 10). Sediment bars that had built up on the inner bends, constricting the channel and causing erosion of the outer banks, were removed.

Approximately 24 logs ranging in size from three to nine metres long and 0.4 to 0.6 metres in diameter were installed along the outer bends of the river. The logs formed groyne structures to direct flows smoothly around the meander and to the centre of the channel, away from the toe of the bank. The logs were pegged into position by wiring them to metal stakes driven about 1.5 metres into the bed. Near vertical banks were battered to a gentler slope. Seed was scattered on the banks and erosion control matting pinned to secure the bank material. The matting is biodegradable and relies on the establishment of vegetation to provide long term protection.

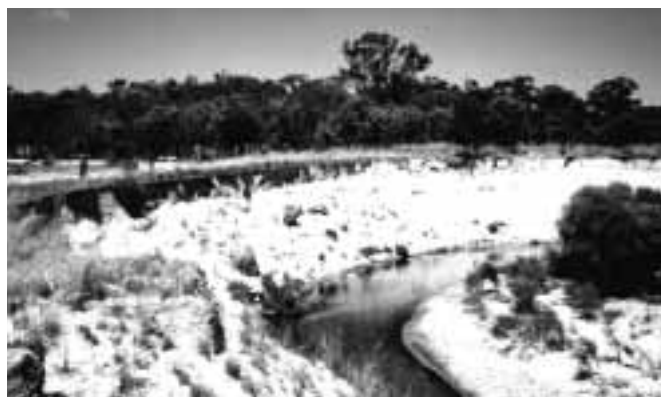
Figure 11. Side channel carved out of the sandy riverbank during the March 1999 flood.

This situation had been ongoing for over a decade and illustrates the need for action as soon as a problem arises. In this instance, action was only taken after a substantial part of the farmer's paddock had been lost. The purpose of the work was to direct flows back down the pre-existing low flow channels, and prevent further degradation of the river bank and the associated impacts on the river ecosystem.

The area was surveyed and a design developed to block the preferred offshoot channel and re-open the abandoned original main channel. The vegetation, sediment bars and timber debris constricting the main river were selectively cut back or removed to allow free flowing water down the channel. Some large debris was reoriented against the banks and placed to protect large trees on each side of the channel where major scouring had exposed root systems. Two channels were excavated along the west and central channels of the main river. The riverbed was skimmed to remove loose river sand that had accumulated along the channel. Care was taken not to lower the bed below its original level.

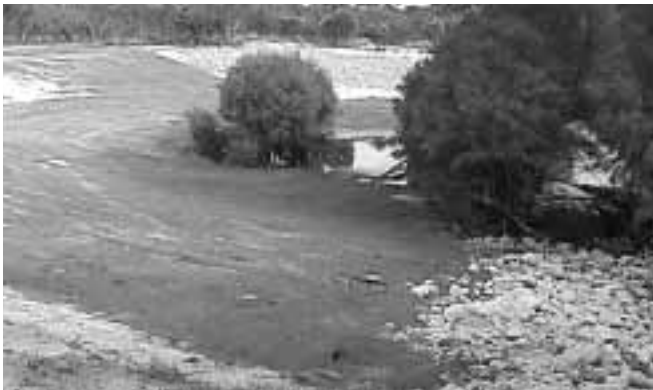
Figure 12. The channel was filled and battered in July 2000. Rock was placed to protect the entrance to the break-out channel.

The sand from the excavation was used to fill the breakout channel. The vertical banks were graded to a stable slope

of 1:6 and the channel avulsion filled with sediment. Sediment was excavated from the river pool and returned to its original location in the break-out channel. The entrance and exit of the avulsion were hardened with limestone riprap laid over filter cloth (Figure 12). The surface of the filled area was covered with a clay mix stabiliser and sections of the steep bank at the downstream end of the rehabilitated reach were covered with biodegradable matting to stabilise the area. These earthworks were carried out in March 2000 and the area was revegetated with native species prior to winter.

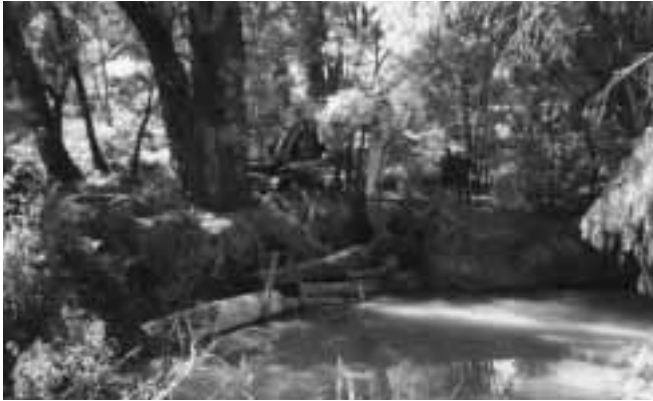
The demonstration reach is located on the Capel River, near the railway overpass in Capel. A tight bend in the river was severely eroding and threatening existing large trees on the bank. In March 2000, large logs were placed by an excavator around the erosion zone to stabilise the bank (Figure 13). The logs were held in place by driving three metre pine posts into the riverbed and wiring the logs to the posts.

Figure 13. Placement of large logs to protect the bank.

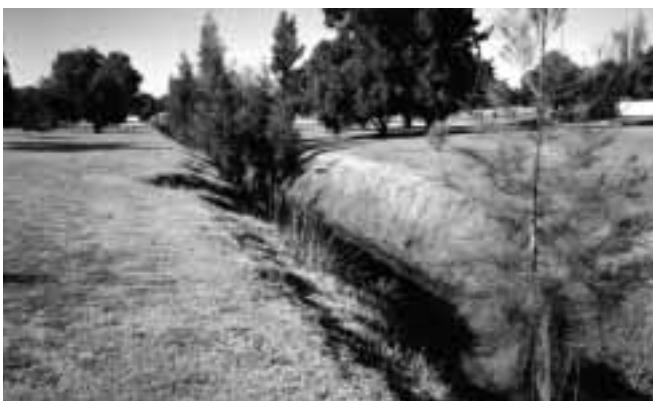
This site is located on Bannister Creek, adjacent to Bywood Way in Lynwood, Perth (southern metropolitan region). The creek was originally a series of wetlands, but has been used as a main drain since 1979. The aim of the project was to transform a straight section of the drain (Figure 14) into a living stream. The function of the waterway to convey stormwater from the urban and industrial catchment into the Canning River needed to be maintained. As the creek is within a recreational reserve, enhancement of the creek aesthetics was also an objective.

Figure 14. Bannister Creek prior to restoration works.

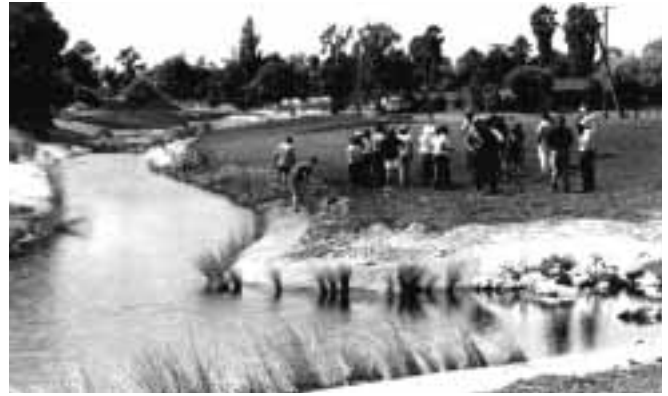
Figure 15. Channel realignment, bank stabilisation and revegetation at Bannister Creek.

The channel realignment and bank stabilisation works have been very successful. A storm event in winter 2001 caused severe damage to a main drain structure up-stream of the demonstration site, while the newly streamlined channel carried the increased flow without any problems.

In November 2000, large volumes of soil were removed from the site to 'meander' the creek and reshape the steep banks to a gentler slope, suitable for planting (Figure 15). Riffles were built to aerate flows and create habitat. Erosion control matting was used to stabilise sections of the stream banks and the area was revegetated. The Bannister Creek Catchment Group has undertaken the project with support from the City of Canning, the Water and Rivers Commission, the Water Corporation, the Swan Catchment Urban Landcare Program, ALCOA, the Natural Heritage Trust and the local community.

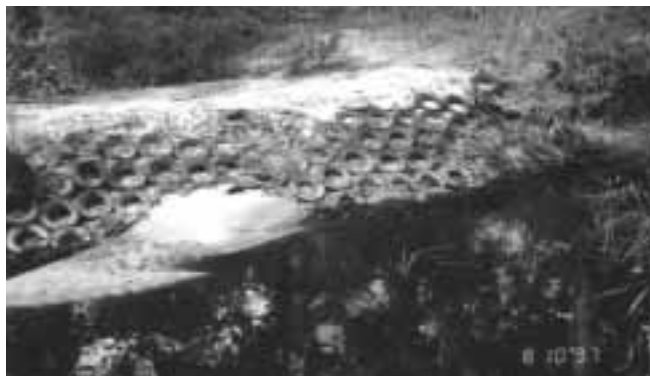
Figure 16. Sediment accumulation in car tyres placed to prevent bank erosion.

As the cost of traditional treatments was prohibitive, alternative stream stabilisation techniques were examined. A range of techniques was trialed, including the use of car tyres wired together and secured to the bank to prevent further erosion (Figure 16). This method has shown some success, with sediment accumulating in the tyres allowing vegetation to establish and stabilise the bank. Other changes to traditional drain management practices included maintaining access along only one side of the drain and allowing vegetation on the other bank to regrow (Figure 17). Rock gabions and mattresses (wire mesh cages filled with rock spalls) were laid on the banks to protect the area from erosion (Figure 18). Rock gabions were also used to build a one-metre high weir downstream of Meanwood Bridge. The weir was built to stabilise the bed level and reduce flow velocities near the bridge.

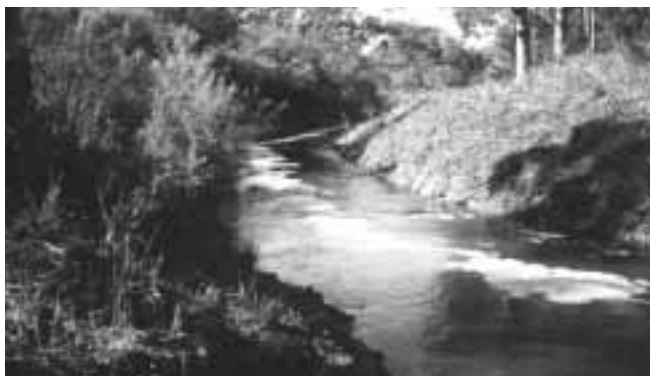
Figure 17. Revegetation along the outer bank, while access is maintained along one bank. Riffle sequence directs high flows into the centre of the channel.

A sequence of twelve riffle structures was designed and installed to provide control over about eight metres of fall in the four kilometre reach downstream of Meanwood Road. The riffles were constructed of rocks large enough to prevent them being dislodged by the flow of the river using a hydraulic excavator. The sequence was designed so that the tail-water of each riffle back-flooded to the base of the upstream riffle. This is fundamental to the success of the design, ensuring that flows are controlled by stepping down the sequence. Each riffle is built with the lowest section in the centre of the channel (Figure 19). Even at high flows, when the riffles are drowned out, the structures direct high energy flows away from the banks and to the centre of the channel, shown by the plume of bubbles in Figure 17.

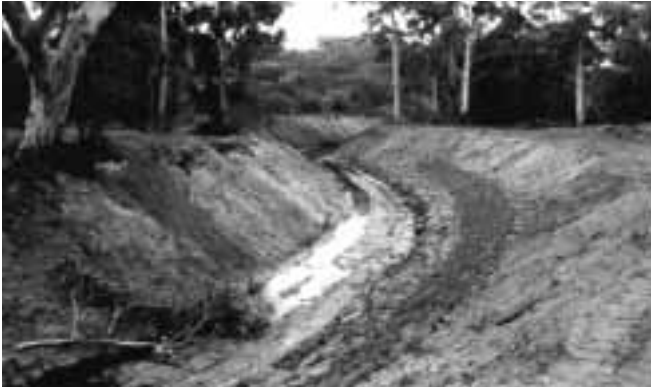
Figure 18. Rock gabions used to stabilise the outer bank.

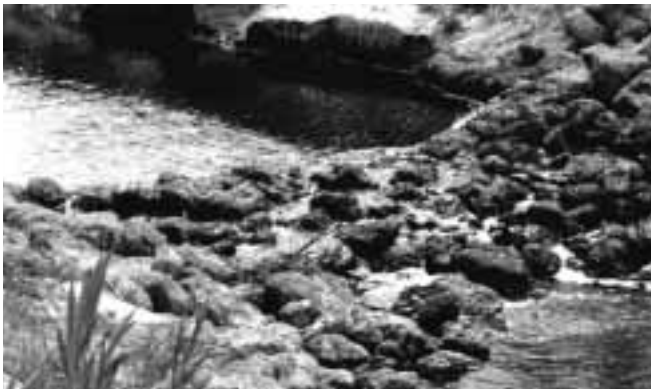
Figure 19. Riffle built on Torbay Main Drain.

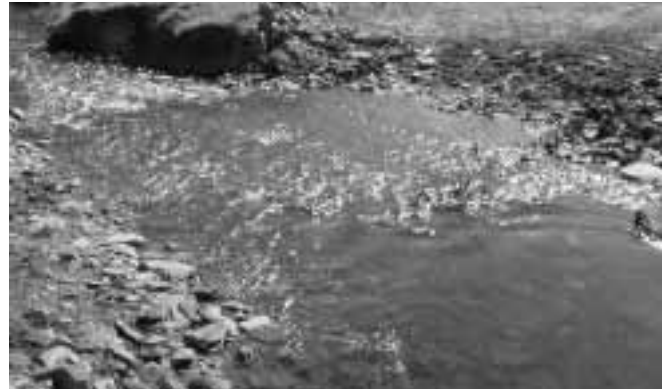
Land clearing has changed the hydrology of the catchment and resulted in greater runoff. Udumung Brook has consequently become wider and deeply incised. This transition has also resulted in an unstable alignment, changing the location of meanders on the brook.

Figure 20. Livestock crossing on Udumung Brook.

Work commenced in 2000, with the installation of five 0.5 metre high riffle structures designed to control bed erosion over the demonstration reach. Two of the riffles are used as livestock crossing points (Figure 20). The riffles also enhance the stream habitat, oxygenate the flow and improve water quality. Fallen trees that were causing flows to divert and erode into the banks were removed and realigned to protect the banks. Revegetation of the banks

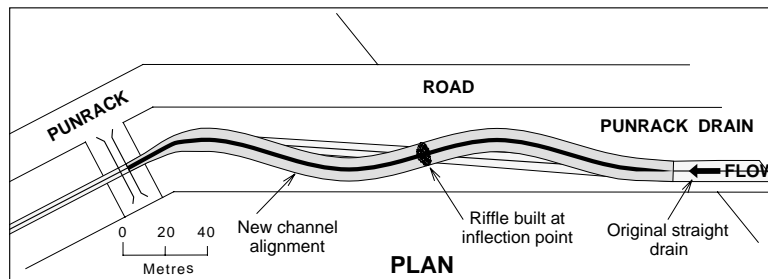
The first site is located near the headwaters of the Punrack Drain (see map, centrefold). The original channel consisted of a straight, weedy drain with steep banks. Works were implemented to create a more natural waterway, improve the habitat value and increase the opportunity for sediment and nutrient stripping along the reach.

Figure 21. Drain realignment in the Dirk Brook Catchment, site A.

Earthworks were carried out to build one and a half meanders along a 250 metre reach of the drain (Figure 21). The channel was widened and the banks graded to a gentle 1:4 slope. A 0.3 metre high riffle was built at the central inflection point along the new channel and the site was revegetated with local native species.

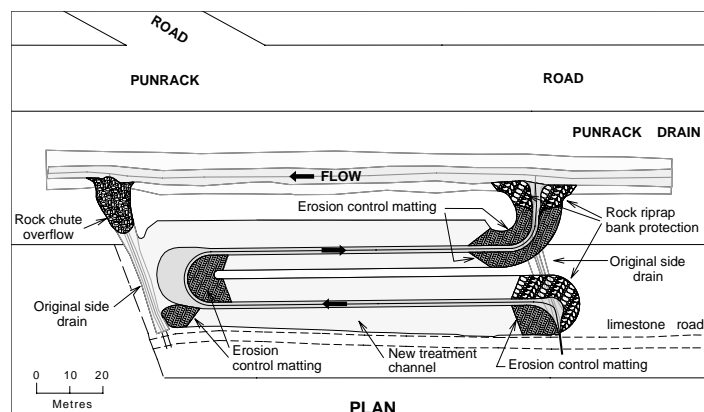
Figure 22a. Design to treat side drains prior to entering the main Punrack Drain, site B.

A 'U' bend channel was excavated through the reserve, with gently sloping banks (Figures 22a & b). The existing side drains were partially blocked and flows diverted through the excavated treatment channel. A rock chute was built at the old exit point of the downstream side drain. The chute will allow the exit point to function as a flood protection overflow to the main drain during peak flows.

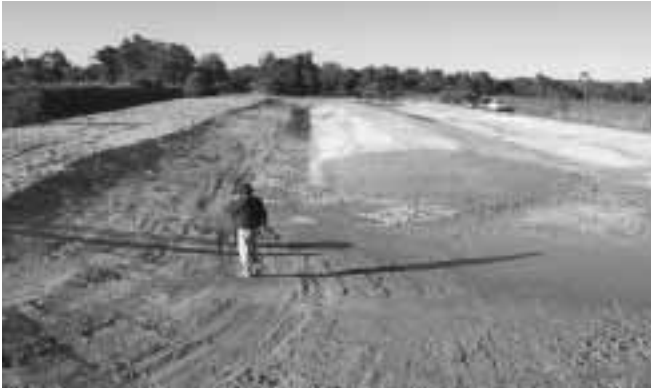
Figure 22b. Treatment channel built adjacent to the main Punrack Drain, site B.
