The assessment, monitoring and management of hiking trails: a case study from the Stirling Range National Park, Western Australia

PAMELA MENDE AND DAVID NEWSOME*

School of Environmental Science, Murdoch University, Western Australia
*Corresponding author (email: D.Newsoms@murdoch.edu.au)

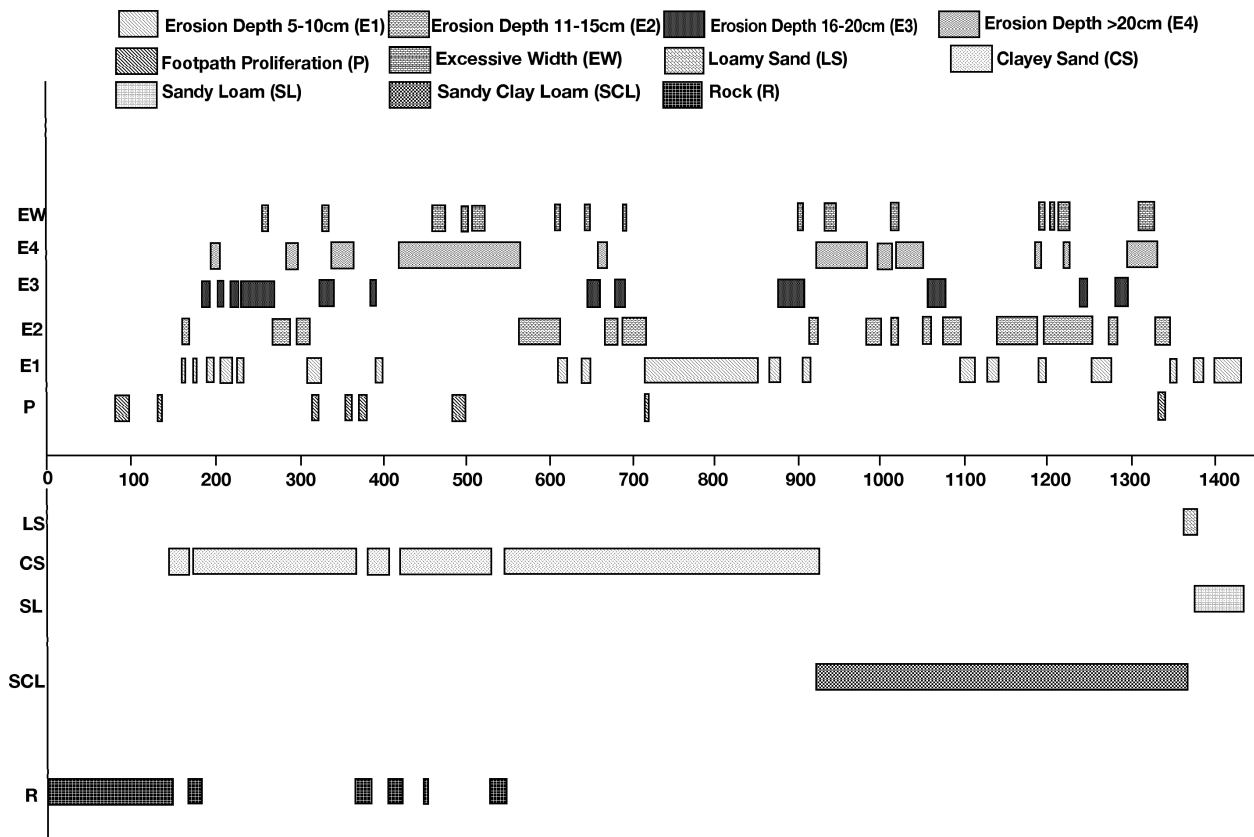
Erosion E1 was the most common degradation problem on the trails (Table 2). The Talyuberlup trail was the most eroded trail in the park (Figure 3). Talyuberlup had the highest average erosion E4 (23.8 m/100 m), E3 (10.3 m/100 m) and E2 (20.9 m/100 m), as well as the highest total erosion (78.1 m/100 m). The Red Gum Hill trail was the second most eroded trail in the park (43 m/100 m) and had the highest erosion E1 (40.3 m/100 m). The least eroded trail was the Toolbrunup trail, which had no erosion (Figure 4). Exposed roots were also found on all the trails (Table 3), mainly occurring in conjunction with erosion. Talyuberlup had the highest number of exposed roots (353), whilst Mt Trio had the least amount (43).

Figure 3. Location and lineal extent of degradation indicators and soil types on the Talyuberlup footpath. The path length is from the summit (0m) to the start of the path (1430).

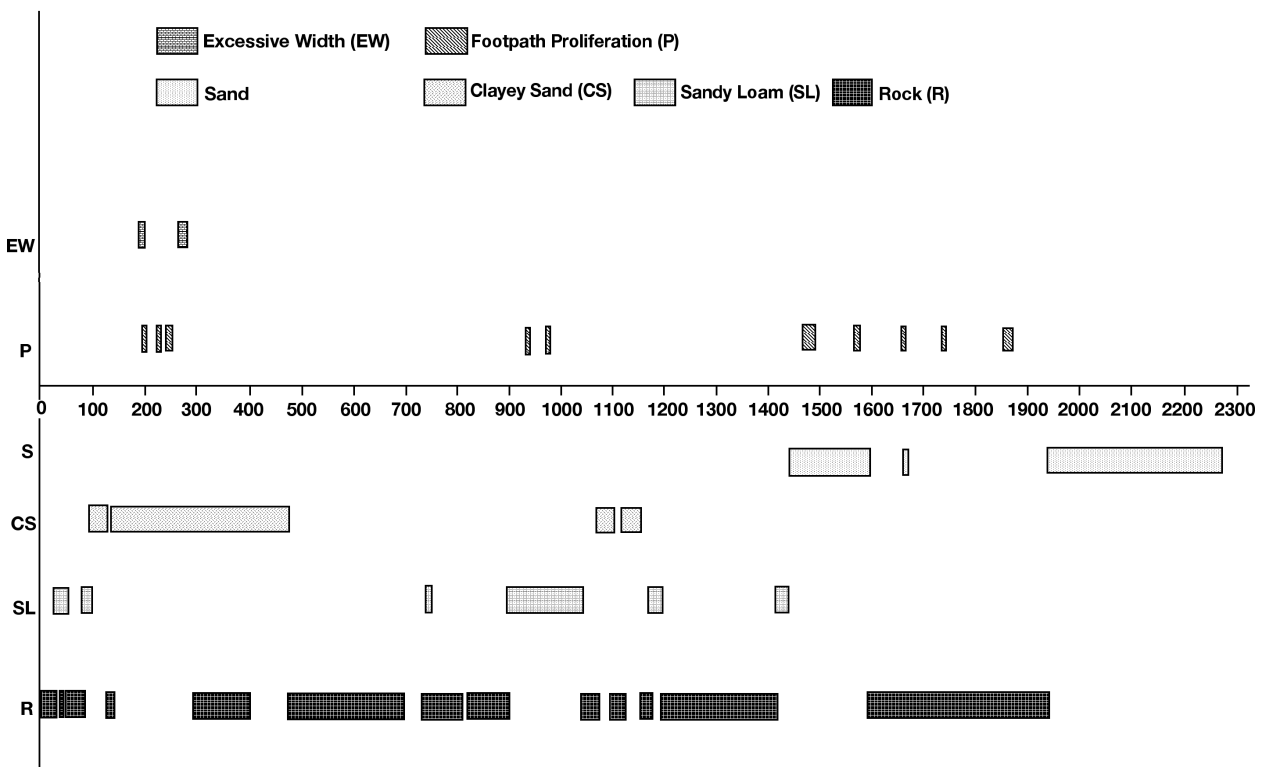
Figure 4. Location and lineal extent of degradation indicators and soil types on the Toolbrunup footpath. The path length is from the summit (0m) to the start of the path (2266m).

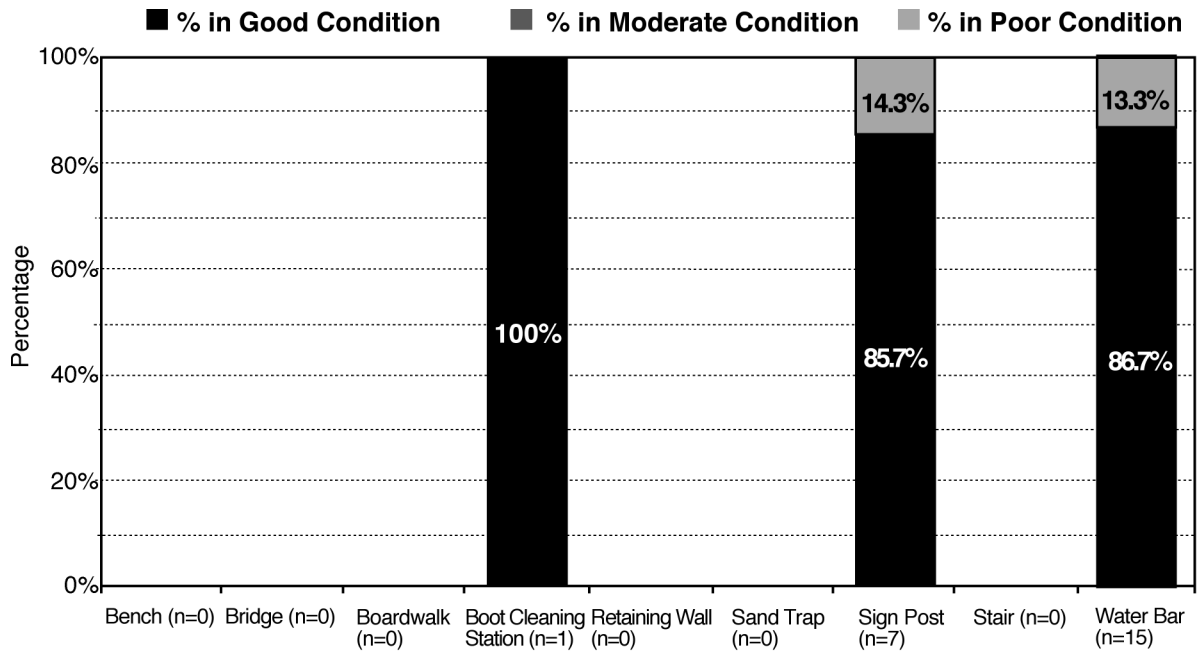
At least 79% of the constructed features found on each trail were in good condition (Table 4). The Toolbrunup trail had the highest percentage of constructed features in moderate condition (16.9%) whilst Talyuberlup (Figure 5) had the most constructed features

Figure 5. The percentage maintenance features on the Talyuberlup footpath classified as being in good condition, moderate condition and poor condition.

Regular trail maintenance should include the upkeep of constructed features, to ensure that they are in good condition and very effective. Some trails, such as Central Lookout and Talyuberlup had a high percentage of moderately effective or ineffective constructed features. This could be rectified by maintenance. For example, most of the water bars on the Central Lookout trail were moderately effective (54.8%) to ineffective (22.8%) because debris, namely gravel and small rocks, had built up around the water bars. Regular maintenance would keep water bars free of debris, making them more effective.

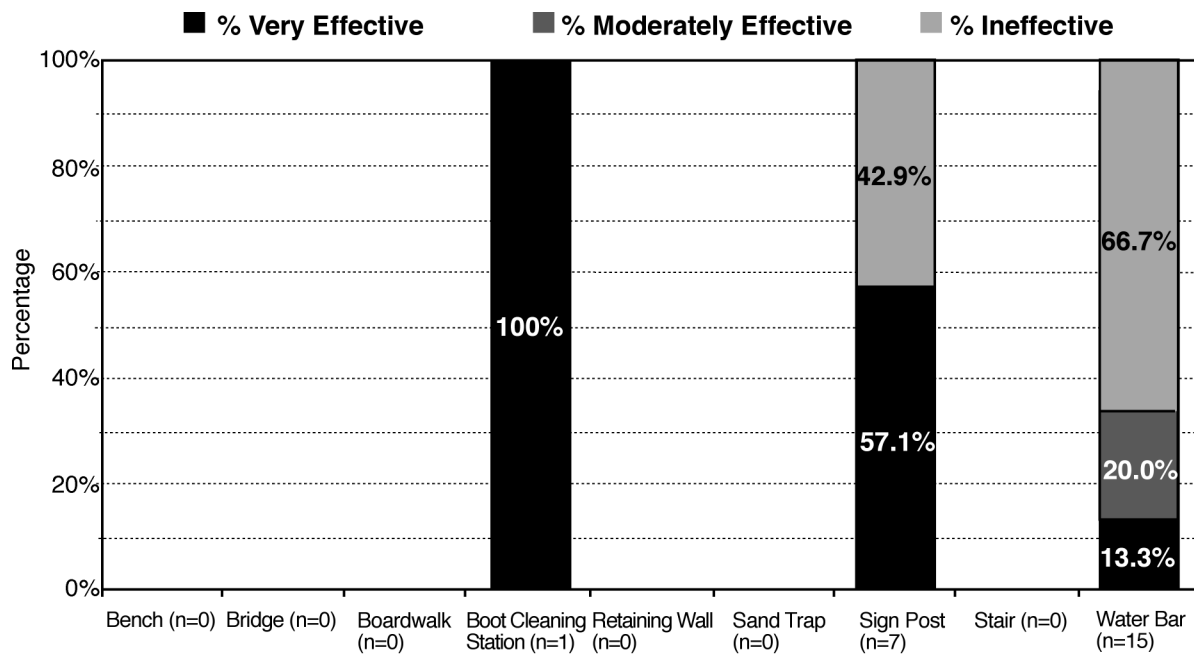
Figure 6. The percentage maintenance features on the Talyuberlup footpath classified as very effective, moderately effective and ineffective.
