SURVEY OF RIVER FORESHORES  
IN THE  
OYSTER HARBOUR CATCHMENT  
1997

WATER AND RIVERS COMMISSION REPORT WRT 17  
1997

To assist with the process of catchment repair, the Albany Waterways Management Authority commissioned APACE Green Skills to carry out a survey to assess the condition of selected foreshores of some of the Oyster Harbour Catchment's tributaries. The survey commenced in February 1997 and concluded in May 1997.

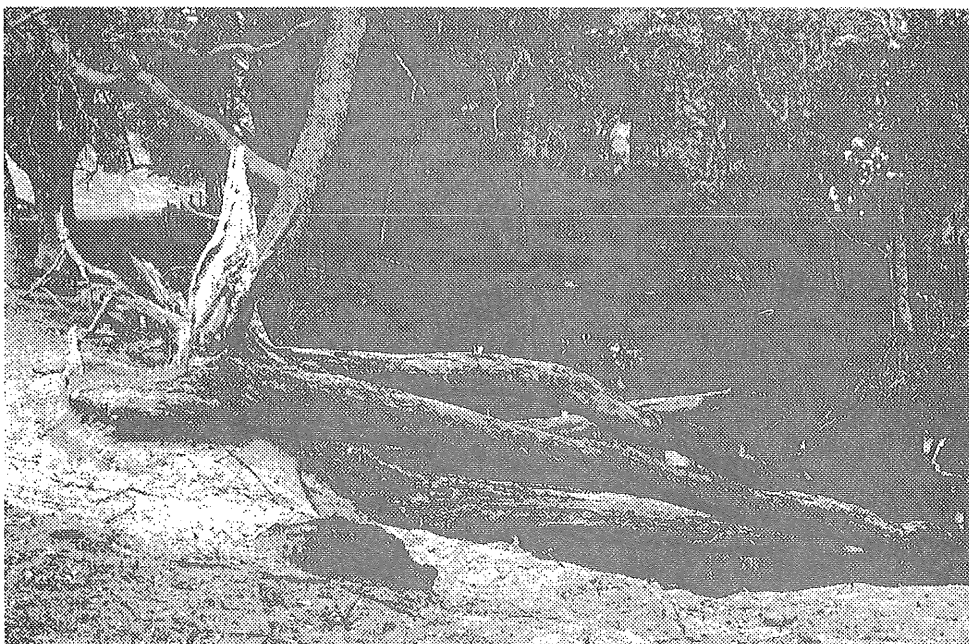
*C Grade (left bank) and A Grade (right bank) along the Napier Creek, showing logs fallen into the waterway. These snags should not be removed, as they provide aquatic habitat. However, re-alignment at a 40-degree angle to the bank would minimise bank erosion.*

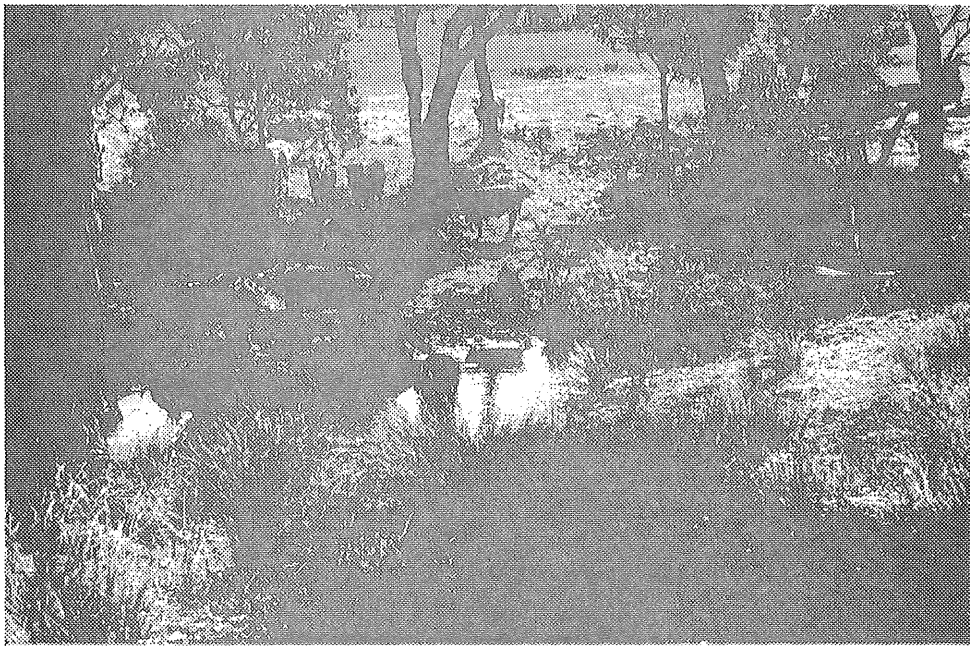
*C2 Grade foreshores along the Chelgiup Creek with stock access to waterway.*

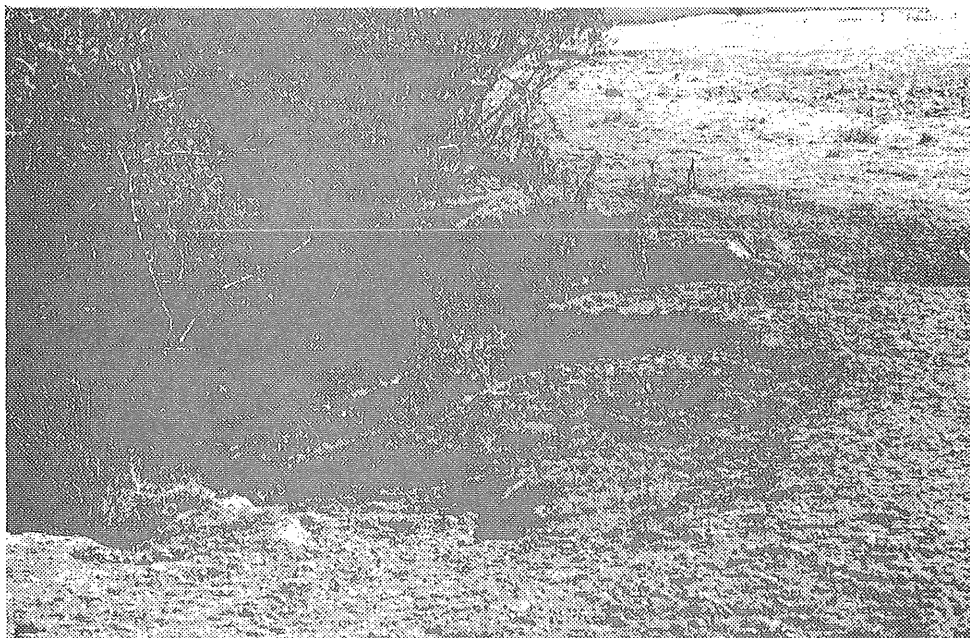
*Point source bank erosion on a C2 grade (right bank) along the Johnson Creek, with the weed Taylorina growing along waterway.*

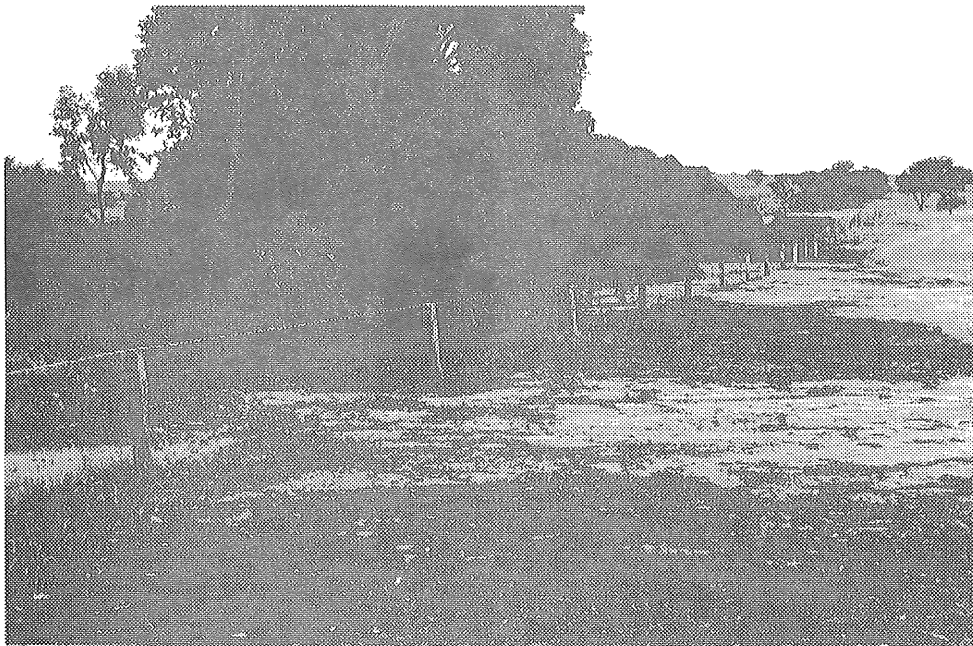
*Fenced section of the Stoney Creek with natural regeneration coming back. Such areas provide more effective bio-filters, preventing sediment and nutrient loss from farms.*

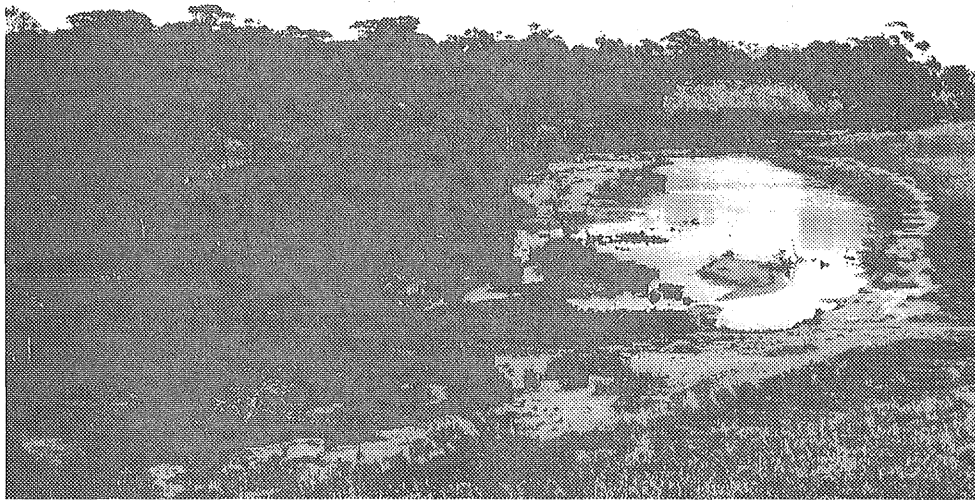
*Remnant vegetation protected by rock breakaway along the Gaalgecup Creek. C2 Foreshore (right bank) bordering farmland. Fencing and revegetation of a wide riparian belt is recommended.*

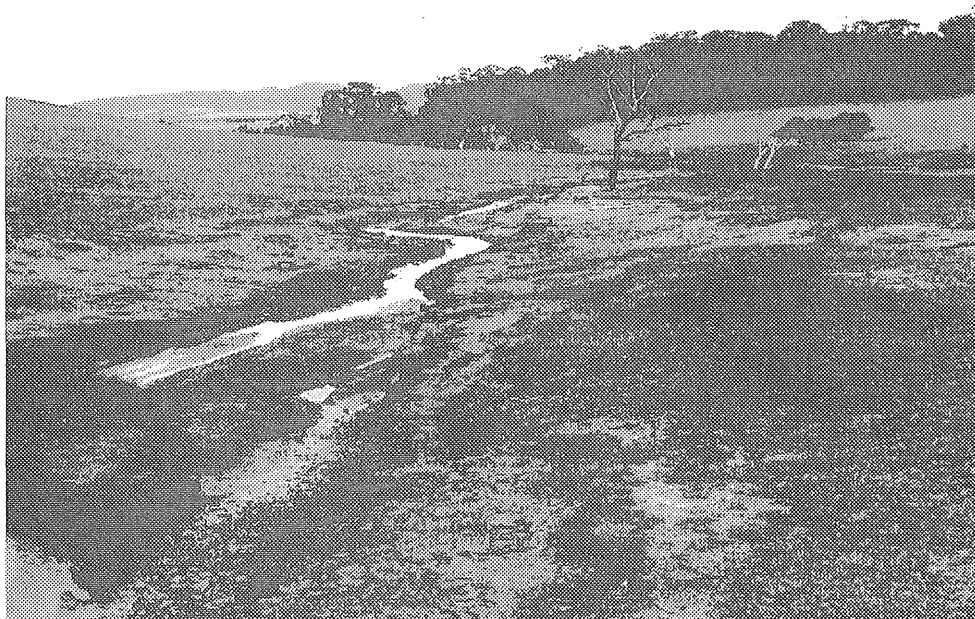
*D2 Foreshore along an actively eroding section of the Takalarup Creek. Soil compaction by stock trampling has reduced pasture cover and increased erosion.*

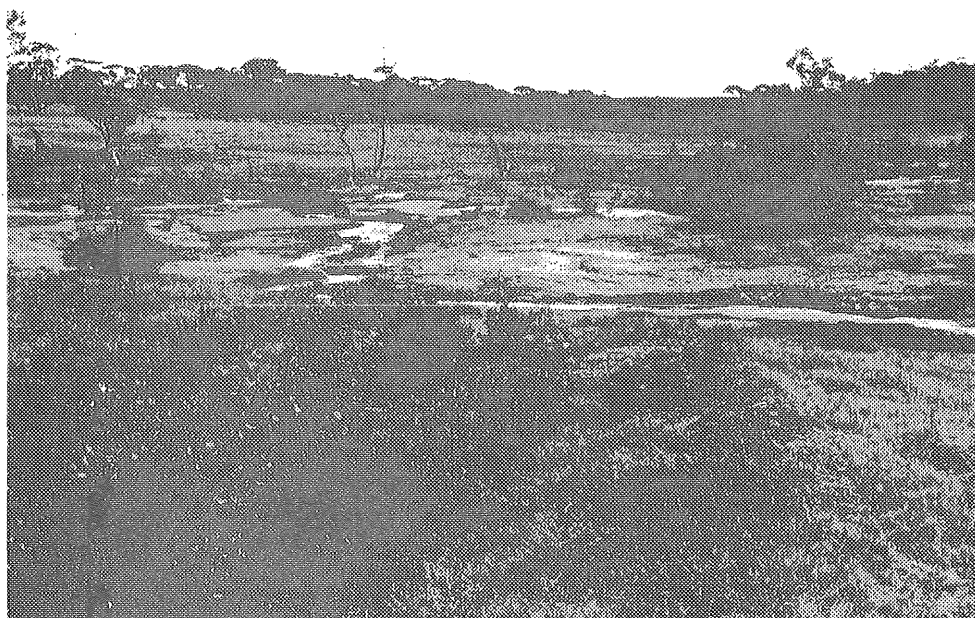
*Revegetation work carried out on a degraded section of the Takalarup Creek. Provision of small-scale structures within the waterway (ripple and rock zones) would assist with the rehabilitation of this area.*
