HOW PALLETS
WITH LAMINATED
RED OAK DECKBOARDS
PERFORMED IN USE

**U. S. D. A.
FOREST SERVICE
GEN. TECH. REP. FPL-4
1975**

**U. S. DEPARTMENT OF AGRICULTURE • FOREST SERVICE
FOREST PRODUCTS LABORATORY, MADISON, WISCONSIN**

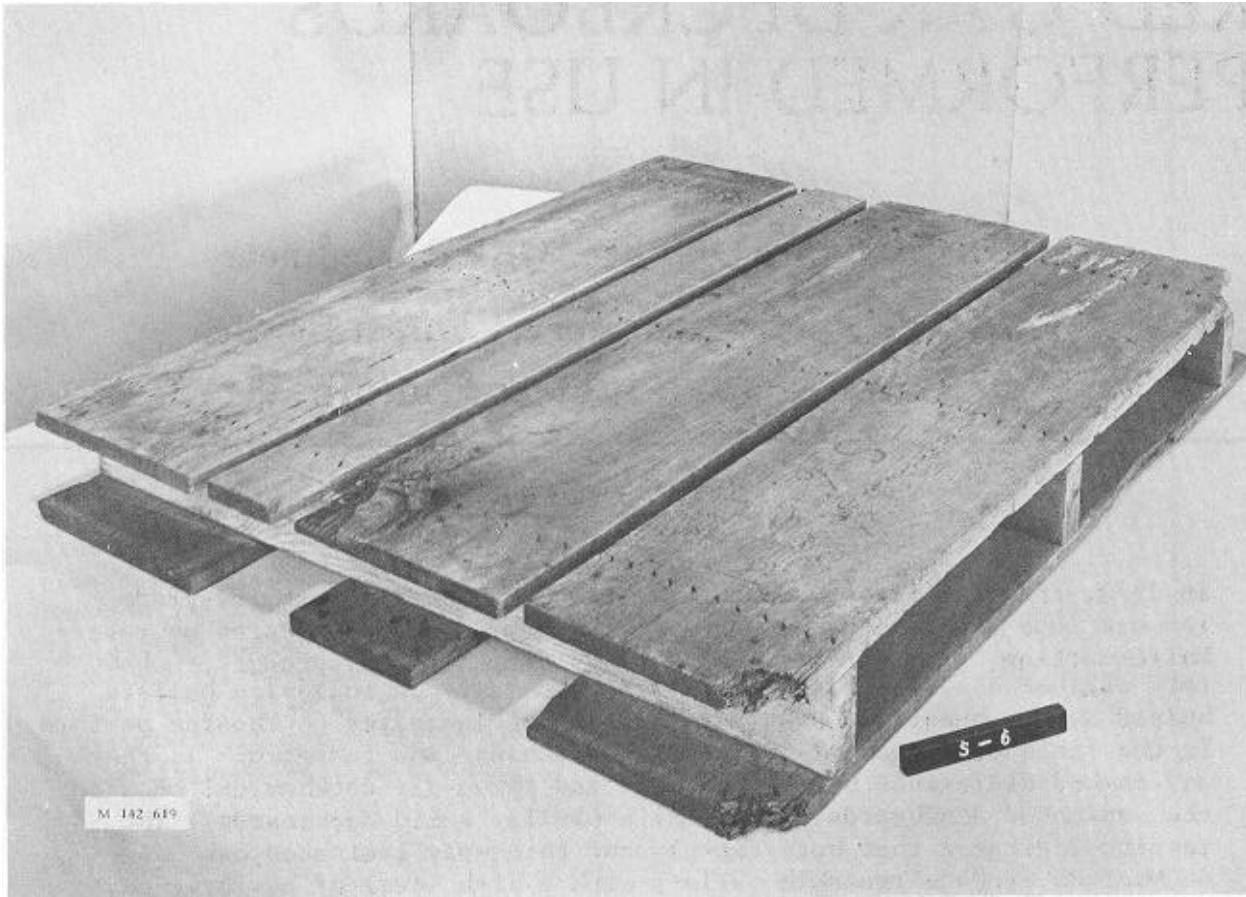
(M 142 619)

Figure 1.--The serviceable condition shown is typical of laminated deckboard pallets assembled with either staples or nails after 18 months' use in a cement block and brick yard followed by a free-fall-on-corner drop test. (Note crushed deckboard corners from the free-fall-on-corner test.)

After the drop test, all pallets had crushing of the corners of the top and bottom edge deckboard that received the impact. With laminated deckboards, crushing averaged 1 to 1-1/2 in.; with solid deckboards, crushing averaged less than 1 in. Figure 1 shows the average condition of a laminated deckboard pallet assembled with staples after approximately 18 months of service and after the free-fall-on-corner drop test from 40 in.
