# FORESHORE AND CHANNEL ASSESSMENT OF THE TOODYAY BROOK

WATER AND RIVERS COMMISSION REPORT WRM 22

2001

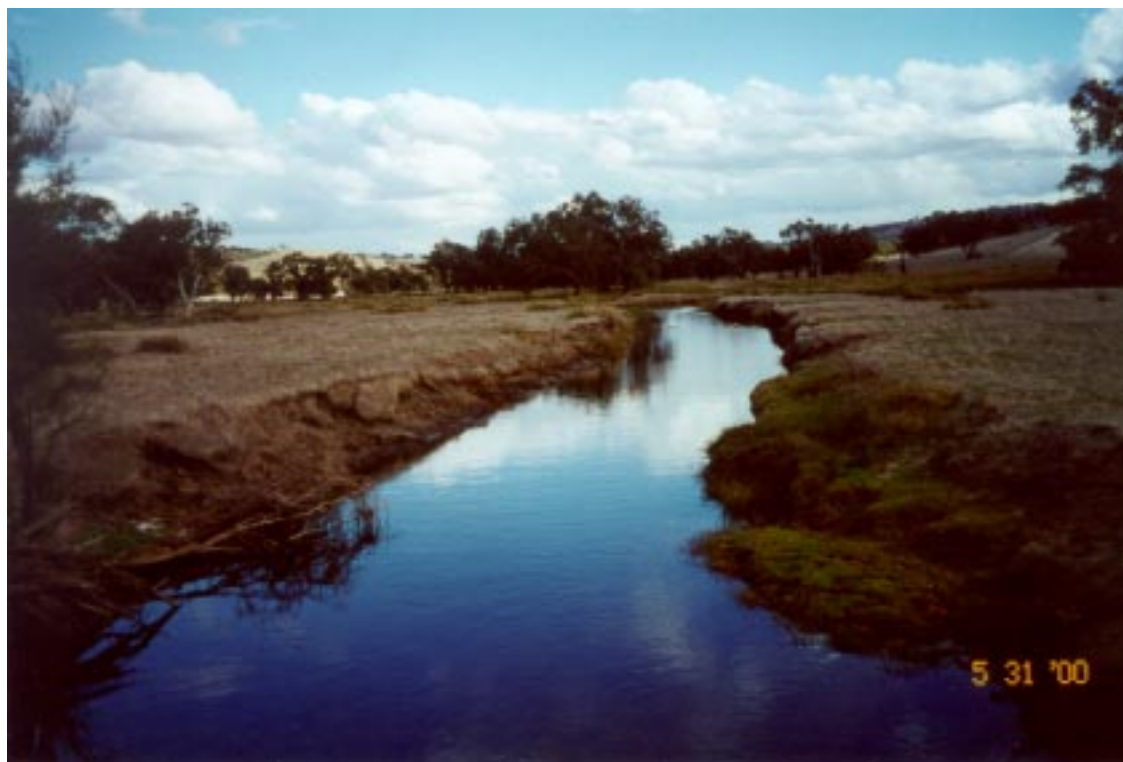
Map 7 shows the poorest foreshore conditions recorded along the waterway. The poorest foreshore condition recorded was a rating of D2, located upstream of Bindoon-Dewars Pool Road. This is defined as a freely eroding ditch where riparian vegetation has disappeared, and erosion is significant along with undercutting and subsidence. There are large sand slugs along the waterway (Pen and Scott, 1995). The majority of sites were given a poorest rating of C3 (eroded) and D1 (ditch – eroding) for foreshore condition.

*Plate 3. A typical D-grade foreshore*

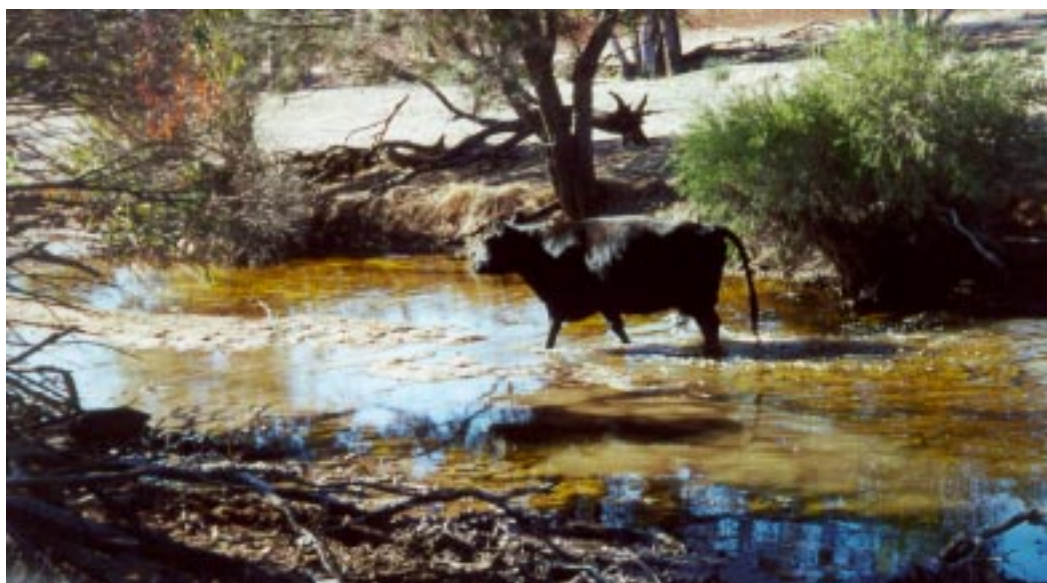
*Plate 6. Cattle crossing the waterway cause channel and bank erosion*
