FORESHORE AND CHANNEL ASSESSMENT OF TALBOT BROOK

Cover Photograph: Channel and foreshore condition along Talbot Brook (Patricia Janssen, 2001).

WATER AND RIVERS COMMISSION
REPORT NO. WRM 29
2002

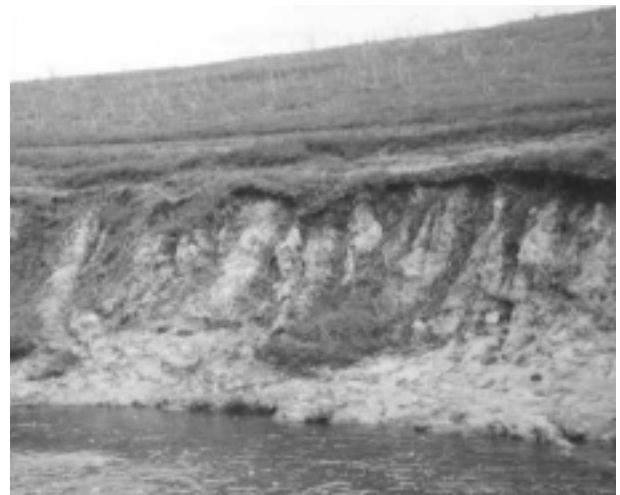
The most significant components were erosion and sedimentation. The overall stability of the channel might be defined as poor (see Table 2) with nearly 75% of survey sections being highly eroded and unstable with large deposits of coarse sand sediment. Sediment deposits were identifiable along many areas of the channel, while there were also some areas along the riverbed that have been eroded down to the underlying clays.

Bank erosion along Talbot Brook

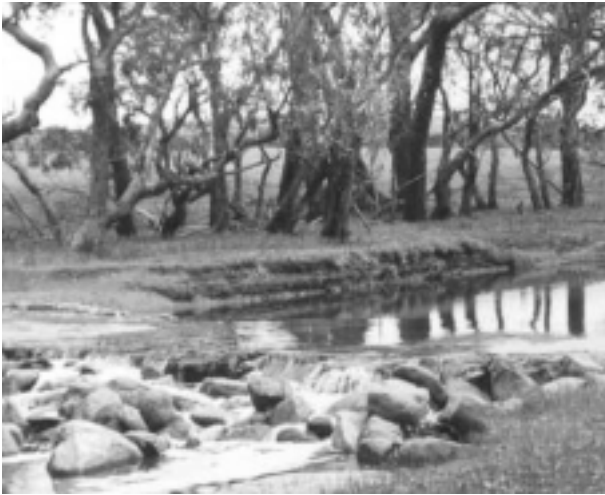
A man-made riffle provides a crossing point for stock and vehicles, acts as a sediment trap and aerates the water

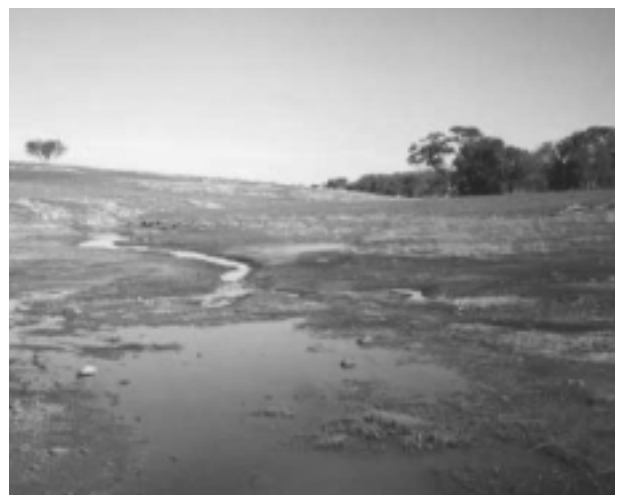
A D-grade section of Talbot Brook

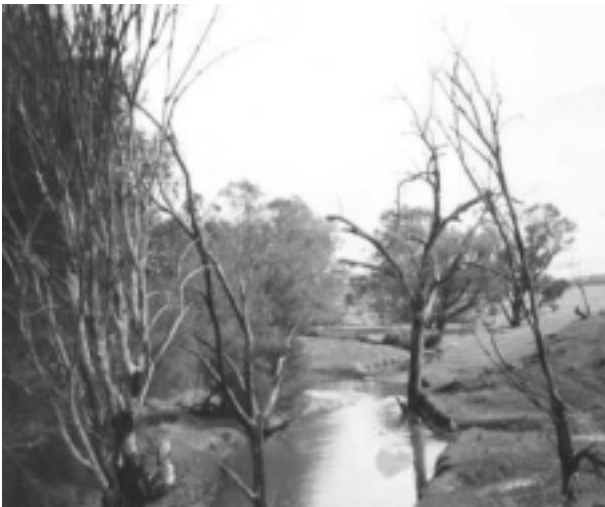
Many factors such as increasing salinity levels, waterlogging, disease and heat stress are responsible for causing the death of foreshore vegetation

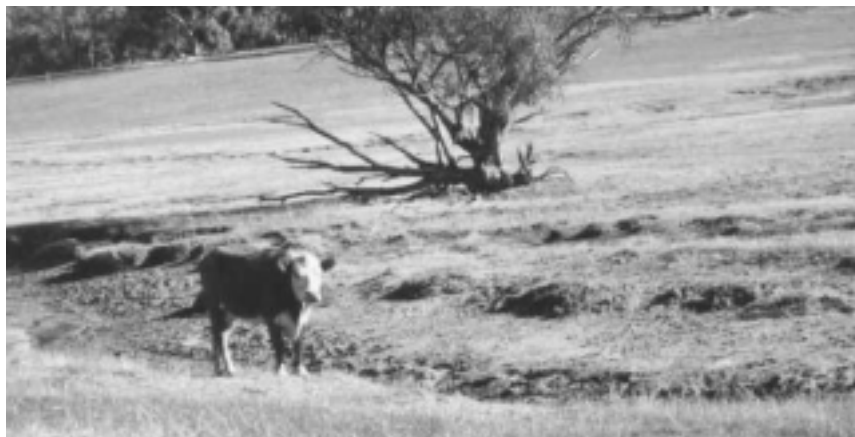
Stock trample and eat native vegetation and cause erosion of the bed and banks

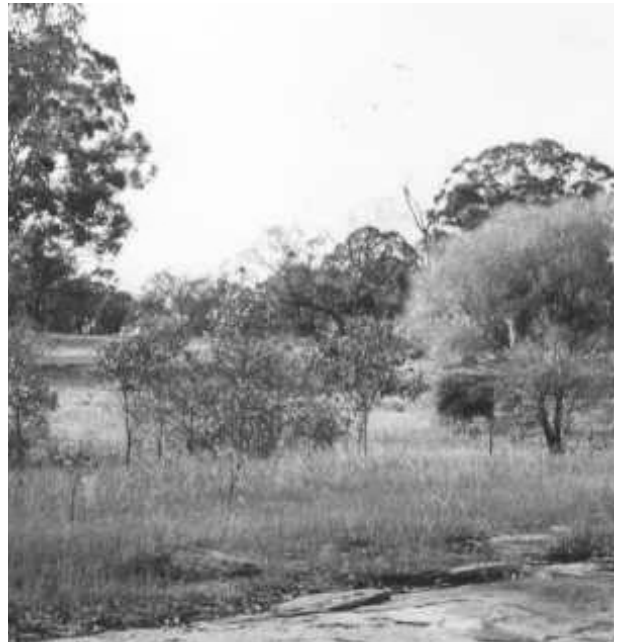
Revegetation of the riparian zone is a common management practice

If revegetation of riparian areas takes place, it is important that stock do not have access to these areas of fringing vegetation. A fence around the revegetated area (or the riparian zone) is the most effective tool to prevent livestock grazing and trampling newly revegetated areas.

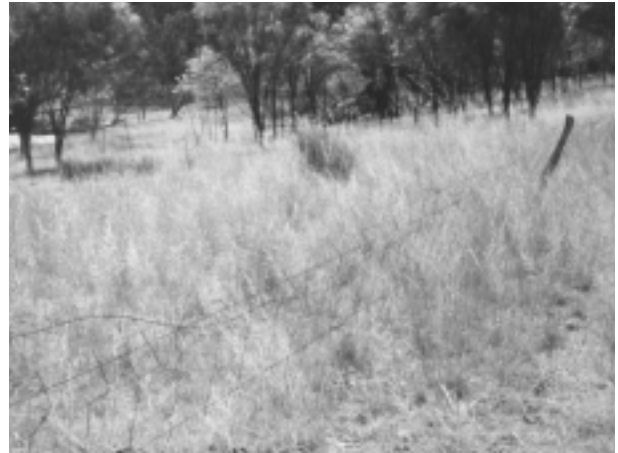
Fence condition: POOR

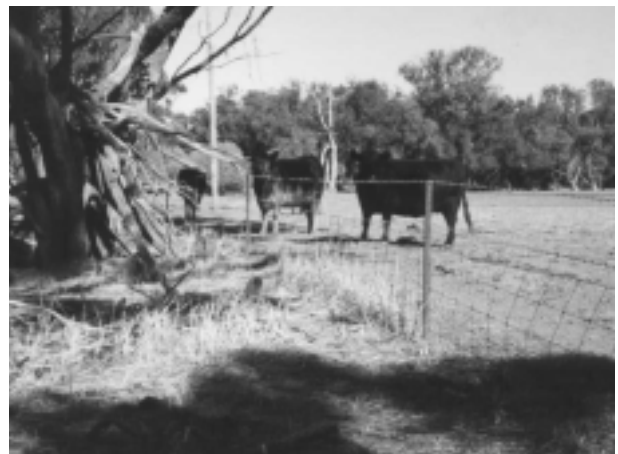
Fence condition: MODERATE
