FORESHORE AND CHANNEL ASSESSMENT OF MORTLOCK RIVER EAST

DEPARTMENT OF ENVIRONMENT WATER RESOURCE MANAGEMENT SERIES REPORT NO WRM 41 MARCH 2005

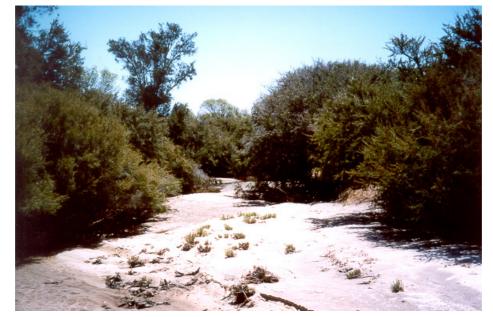
Healthy foreshore vegetation (Melaleuca thyoides, Casuarina obesa) growing along banks

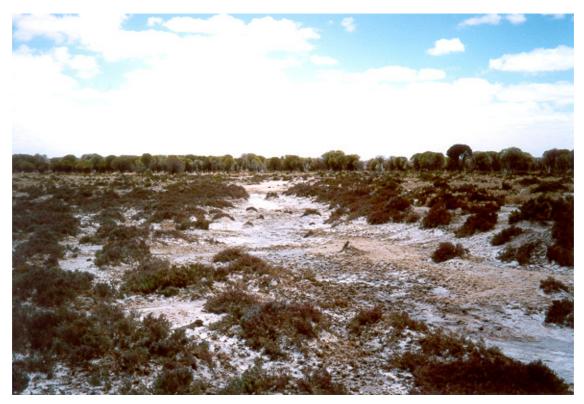
Numerous stock tracks within river channel

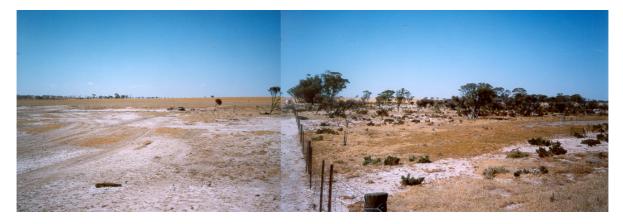
Unfenced (left side of photo) and fenced (right side of photo) river sections

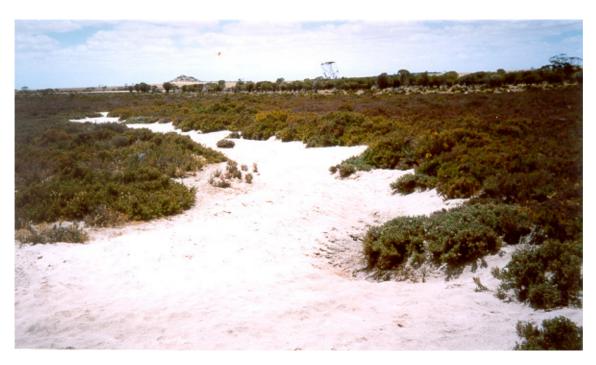
A C-grade section along the Mortlock River East in the Ancient Drainage zone

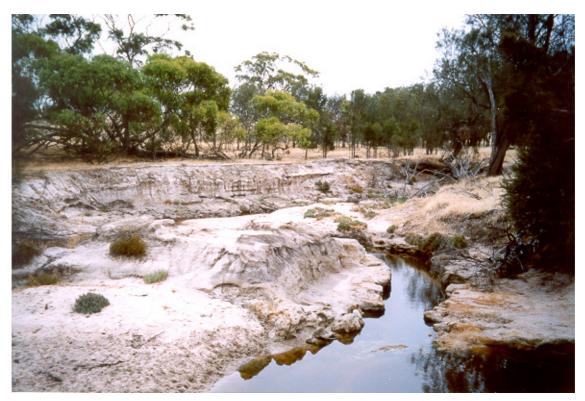
A D-grade foreshore along the Mortlock River East in the Rejuvenated Drainage zone

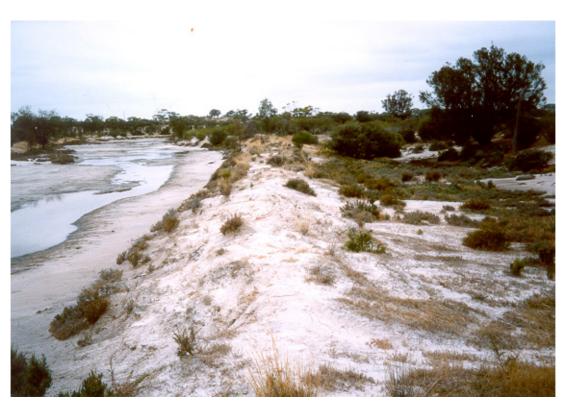
Levee banks were the most common form of earthworks within the riparian zone

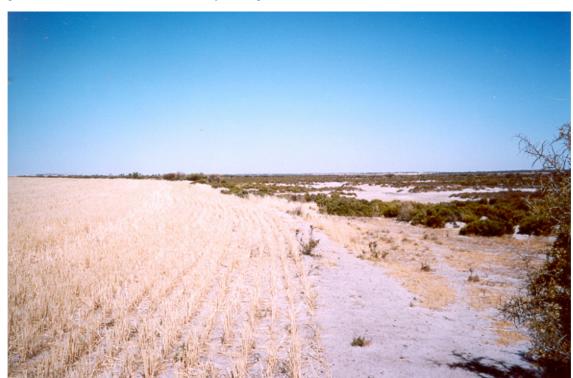
Throughout the survey it was also common to find cropping along the edge of the riparian zone. Cropping areas can contribute large amounts of sediments and nutrients into the river from cleared paddocks. There is increased runoff due to the lack of vegetation. In cropping and grazing areas, there has been a change in the water cycle. Where water previously infiltrated into the soil, it now flows overland, transporting soil as it moves.

Cropping to the edge of the riparian zone

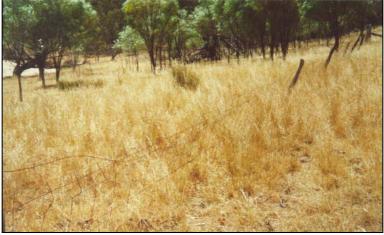
Fence condition: POOR

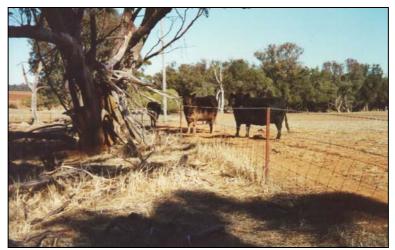
Fence condition: MODERATE

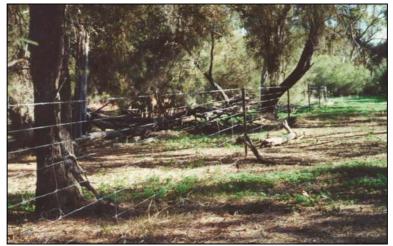
Fence condition: GOOD
