Foreshore and channel assessment of Jimperding Brook

Water resource management series

Report No. WRM 48
February 2008

Prepared by Viv Read & Associates for Department of Water
and the Avon Waterways Committee

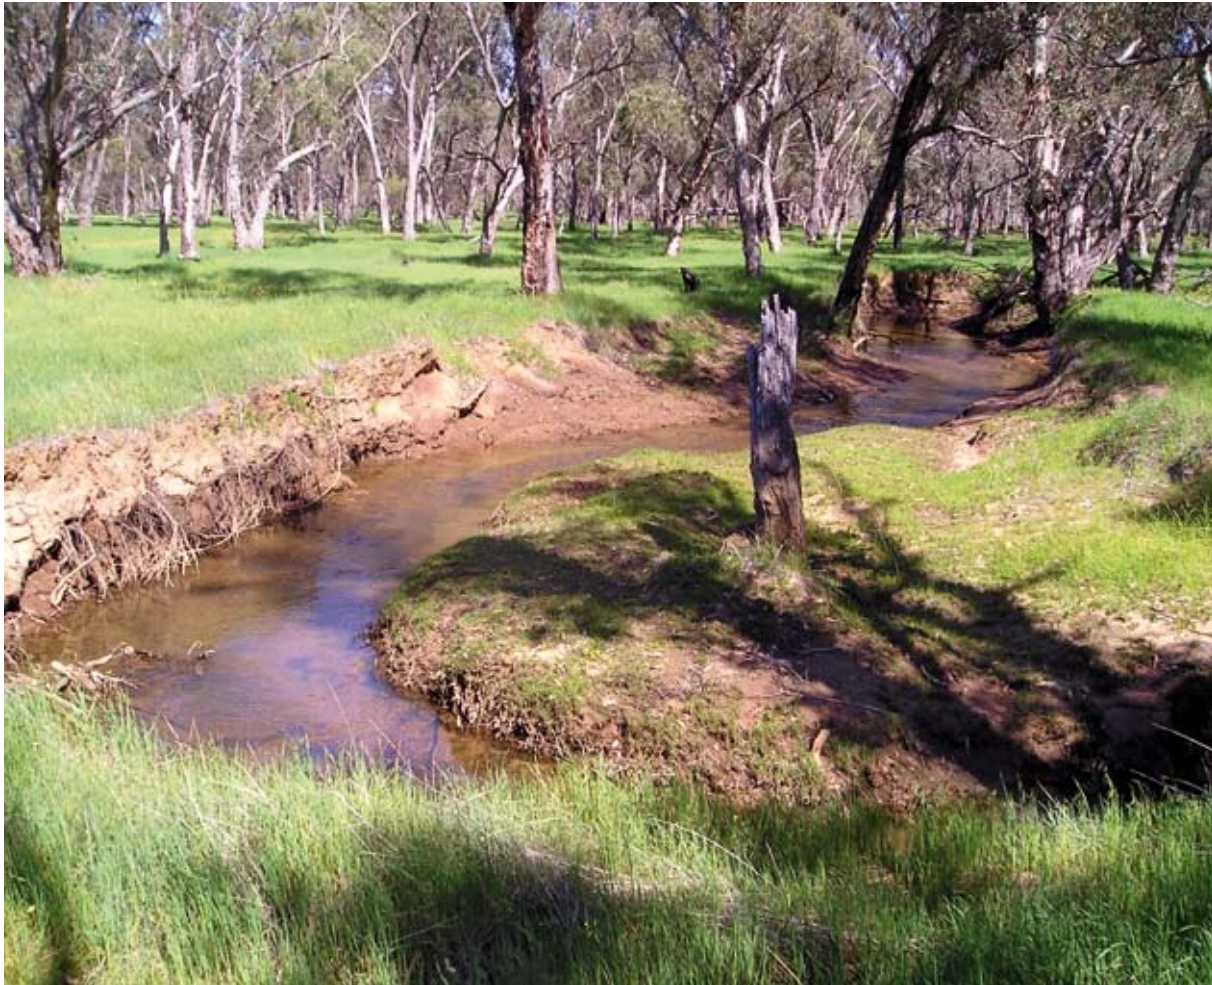
Photo 2 Stream meander with active bank erosion

As the stream meander pattern became more sinuous, the level of erosion increased. This was quite extensive for section JB012 (photo 2). There was one acute meander with active bank erosion estimated to be three metres deep in section JB019 (photo 5). This was immediately downstream from the confluence of a major tributary (TR006) so bank erosion would have occurred during high flow events when the combined stream flow was turbulent.

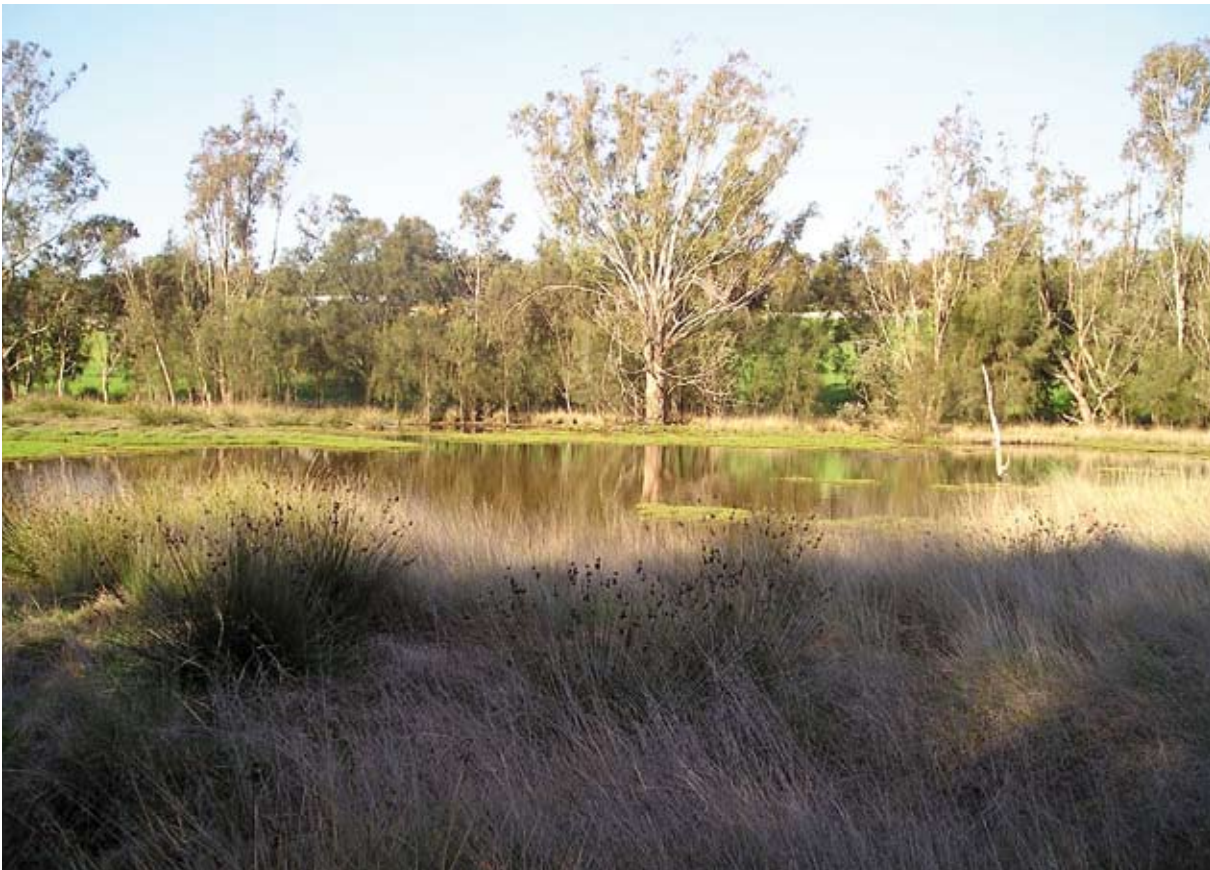
Only one survey section (JB003) had a significant wetland (Photo 3). This was a small area where surface water ponded on the LHS.

Photo 3 Perched wetland adjacent to Jimperding Brook in section JB003

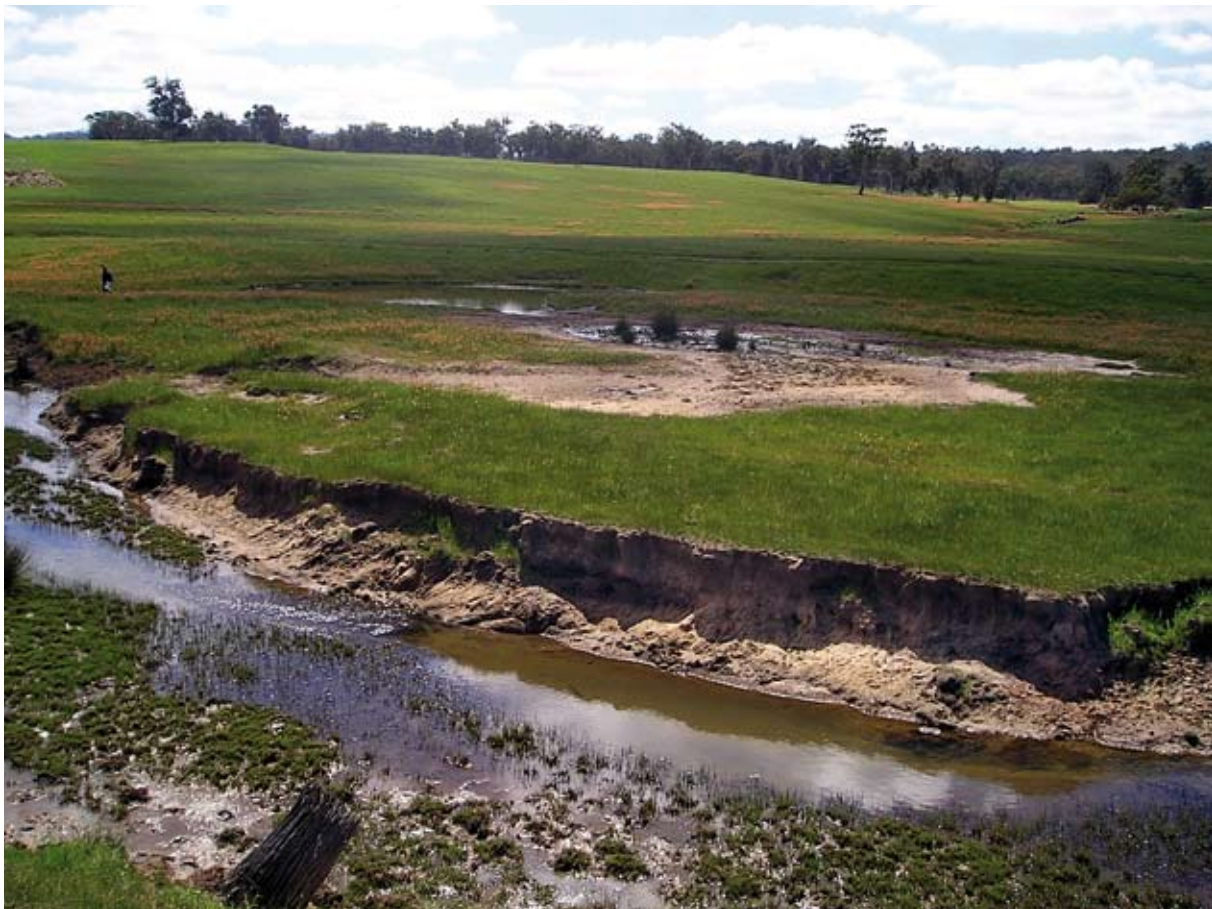
Undercutting was extensive where there was limited fringing vegetation. This was the major cause of erosion in section JB010 (photo 4). Where fringing vegetation was in near natural condition, there was little or no channel erosion (e.g. section JB024).

Photo 4 Bank erosion where there is no fringing vegetation

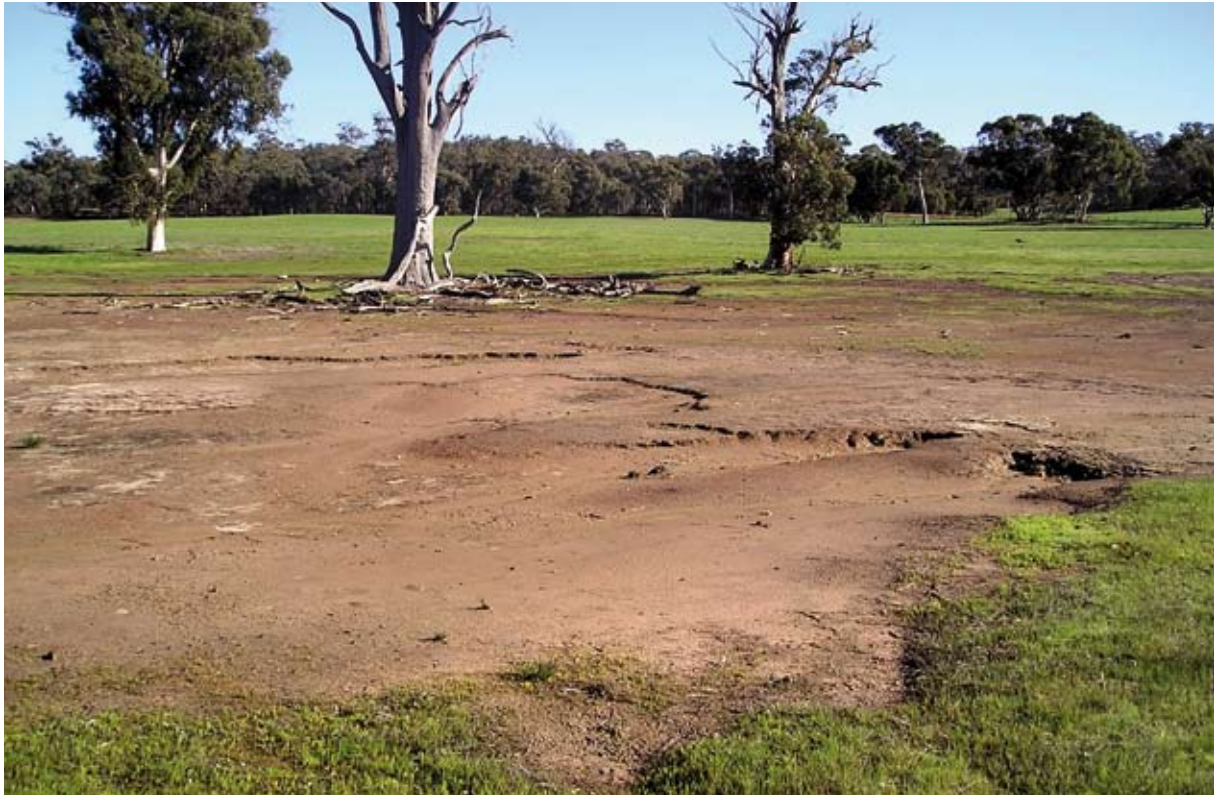
Photo 8 Sheet erosion adjacent to Jimperding Brook in section JB006

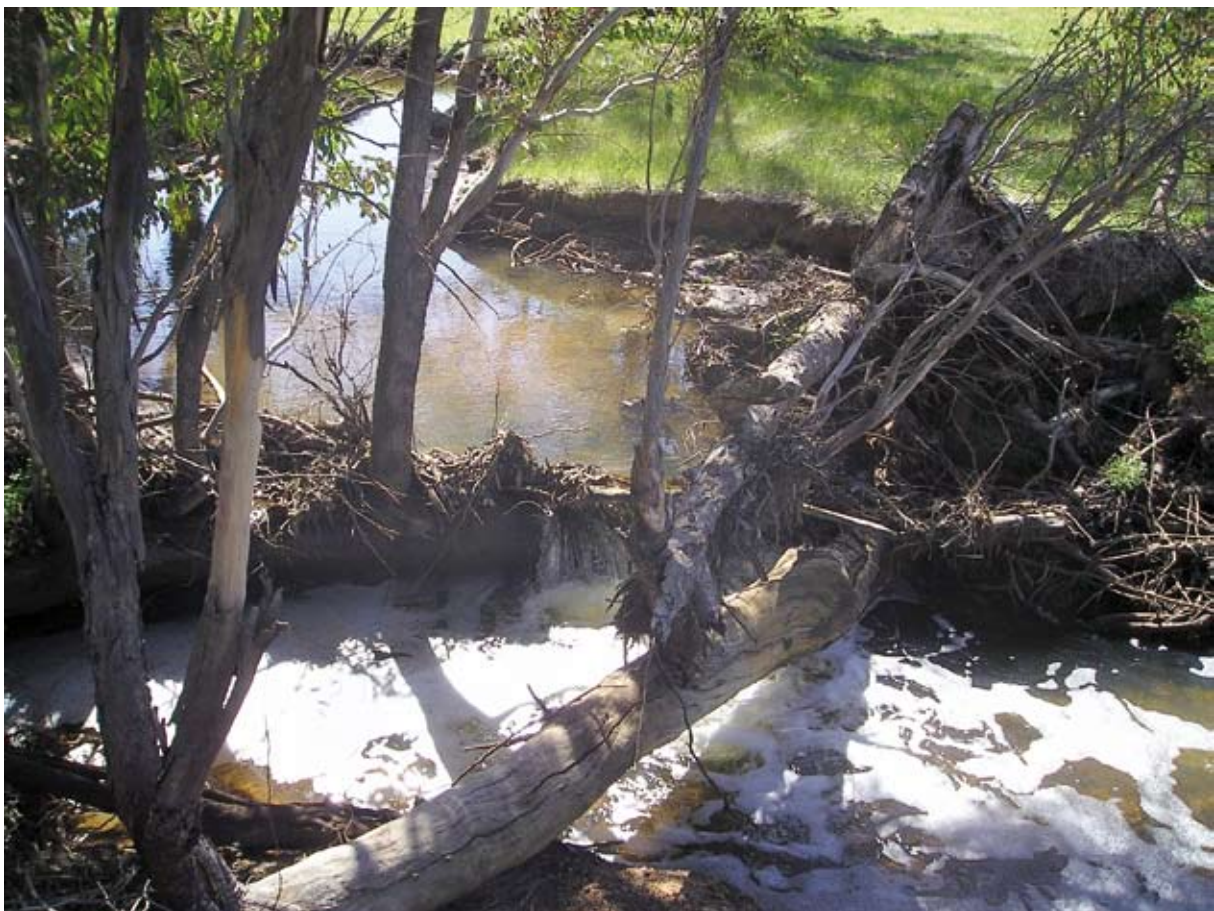
Photo 9 Log jam controlling gully erosion in section JB013

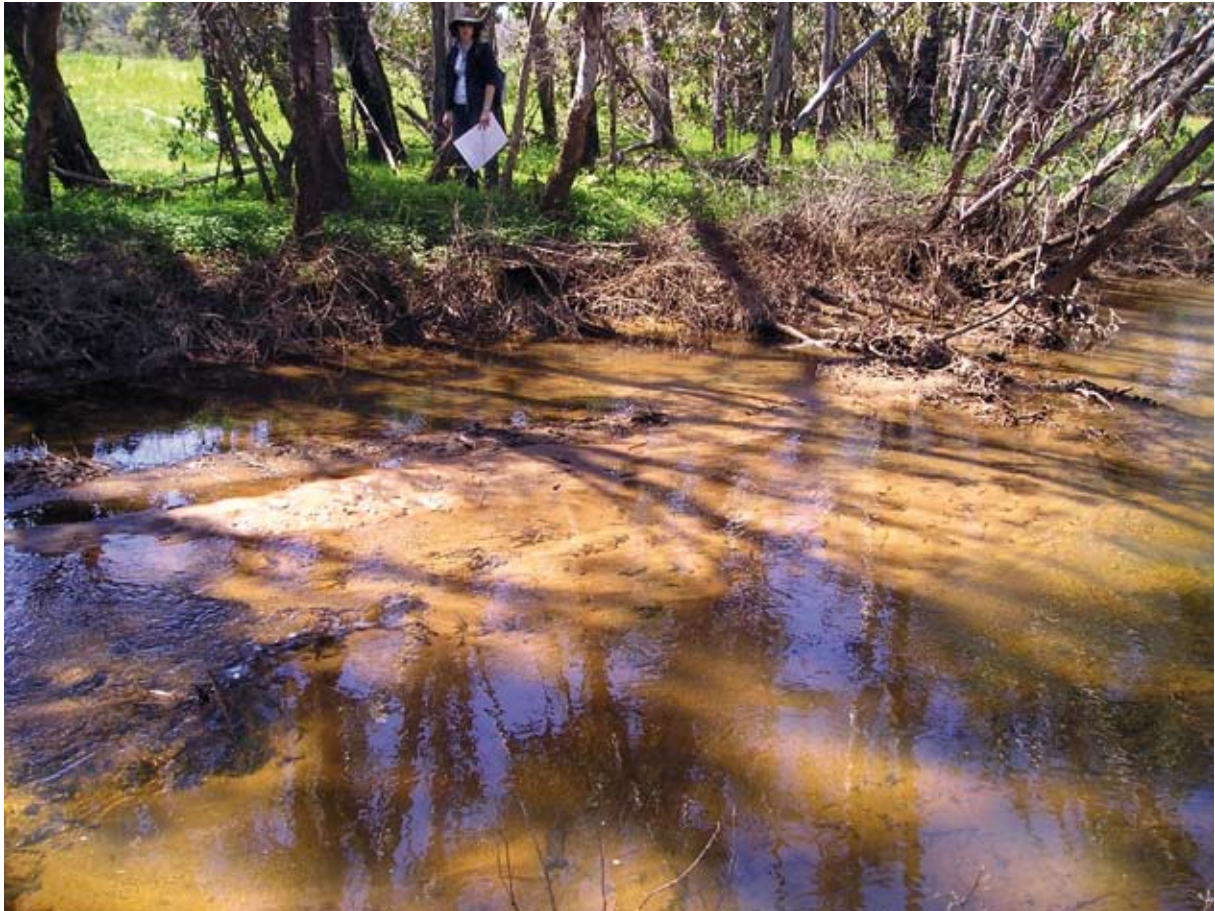
The processes of sediment transport were important. Coarse sediments were recorded only in sections JB021 (photo 10), JB025 and at the confluence with the Avon River (JB026). Most sediment was of a medium-to-fine texture. It was likely that most sediment was easily transported downstream and that the sediments observed were mostly temporary depositions. The highly mobile character of sediments provided explanation for there being so little sediment deposition compared with the high level of channel erosion that has occurred.

Photo 10 Coarse sand sediment deposit in section JB021

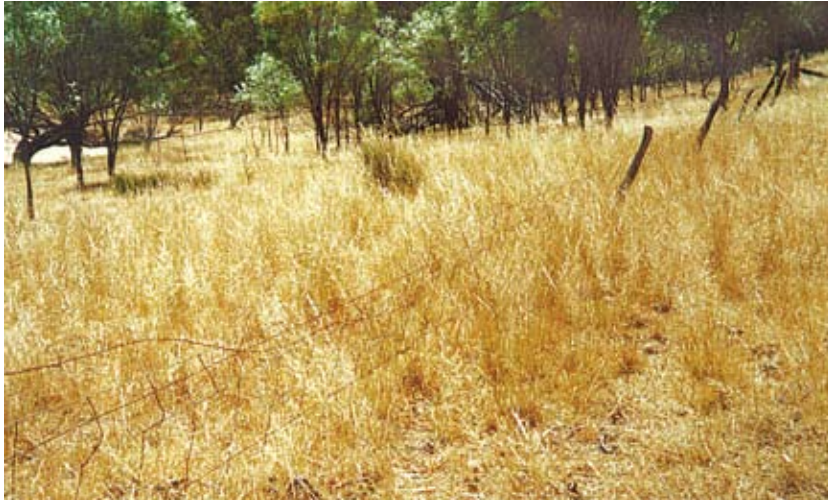
Fence condition: POOR

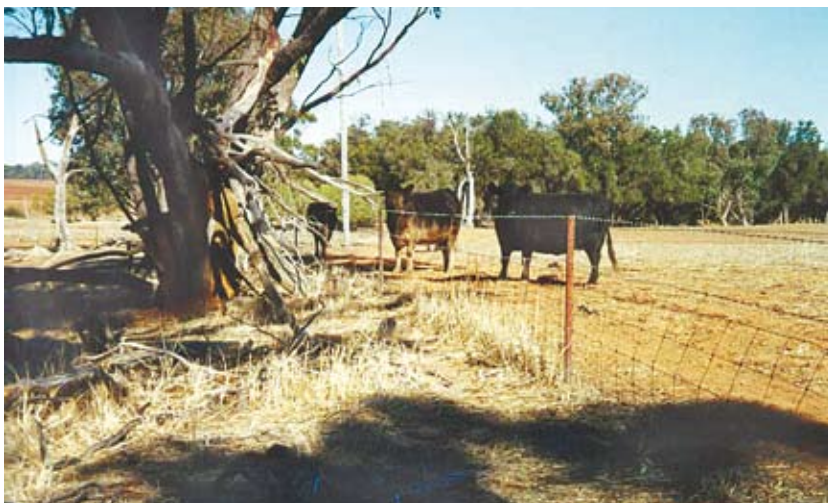
Fence condition: MODERATE

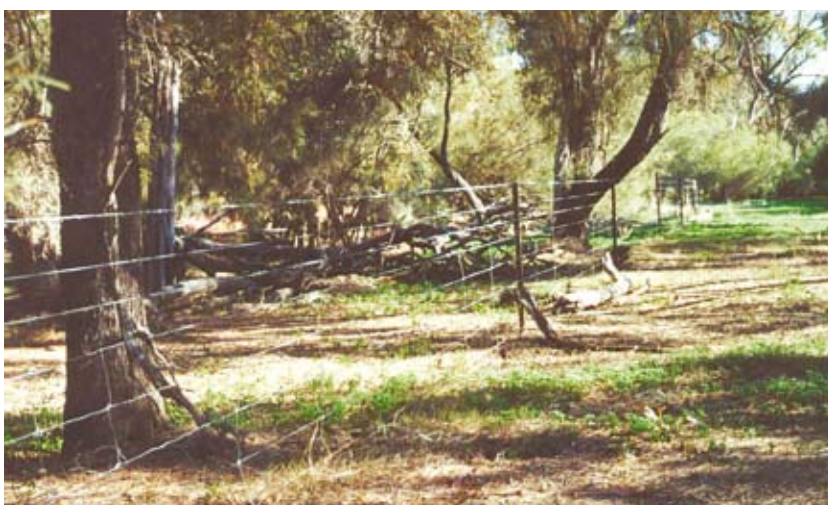
Fence condition: GOOD
