## Foreshore and channel assessment of Christopher Brook

Report No. WRM 52  
November 2008

Prepared by  
BlueSands Environmental for  
Department of Water

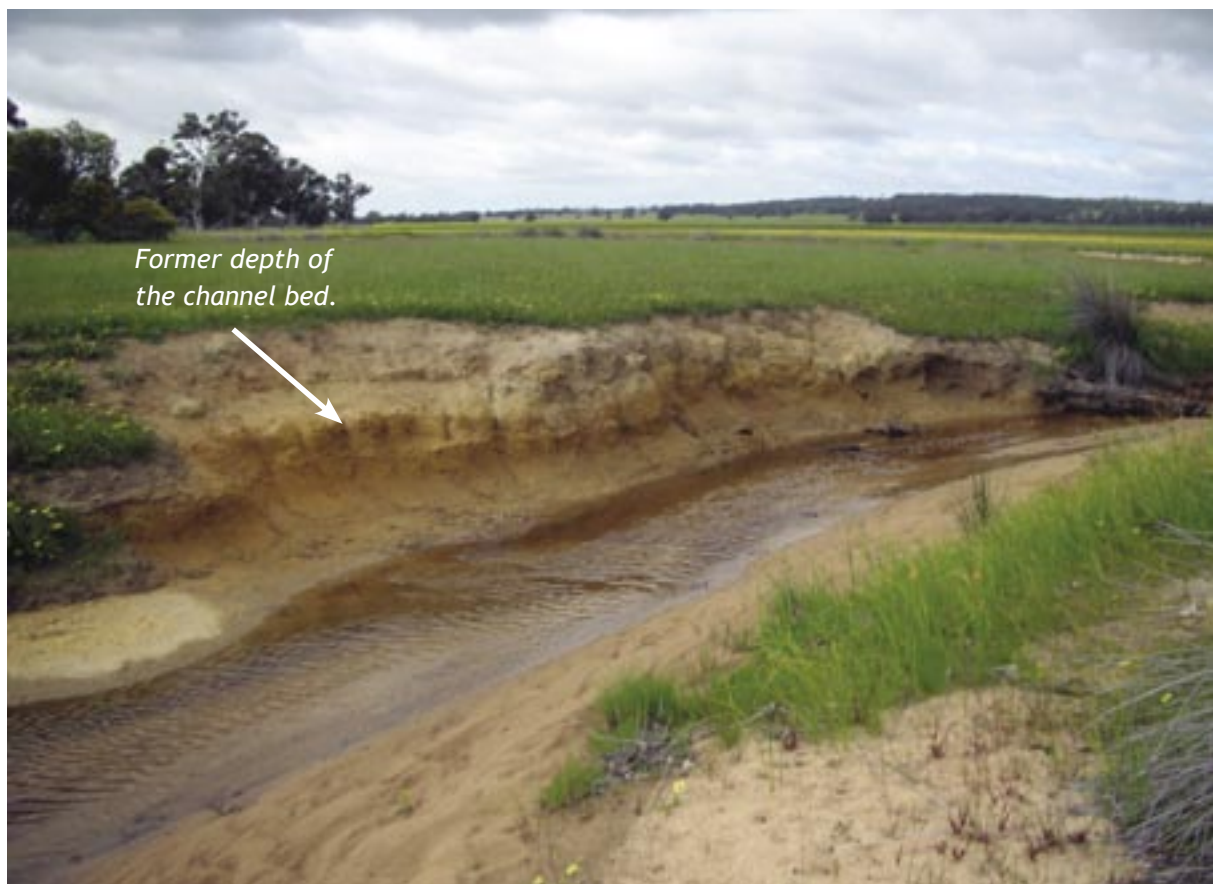
**Photo 1** Bank undercutting on a meander bend of Christopher Brook. The arrow indicates the former depth of the channel bed. Also note the sediment deposit on the inside bend.

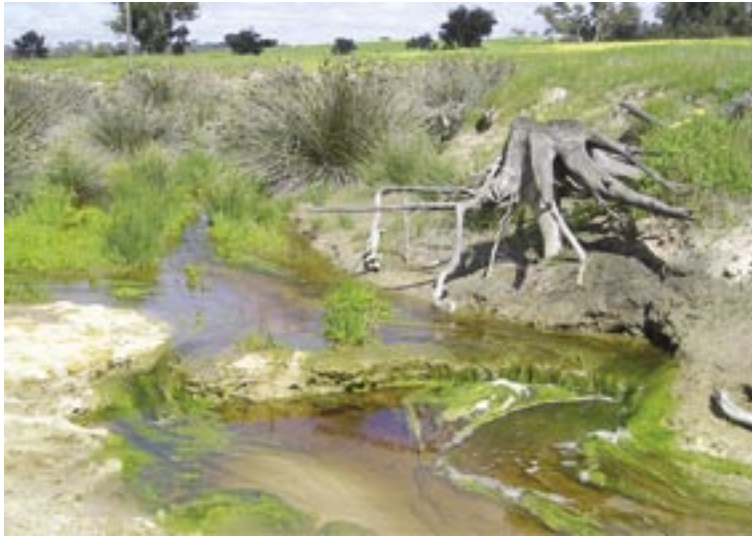
**Photo 2** An exposed dead tree root along an unfenced tributary of Christopher Brook.

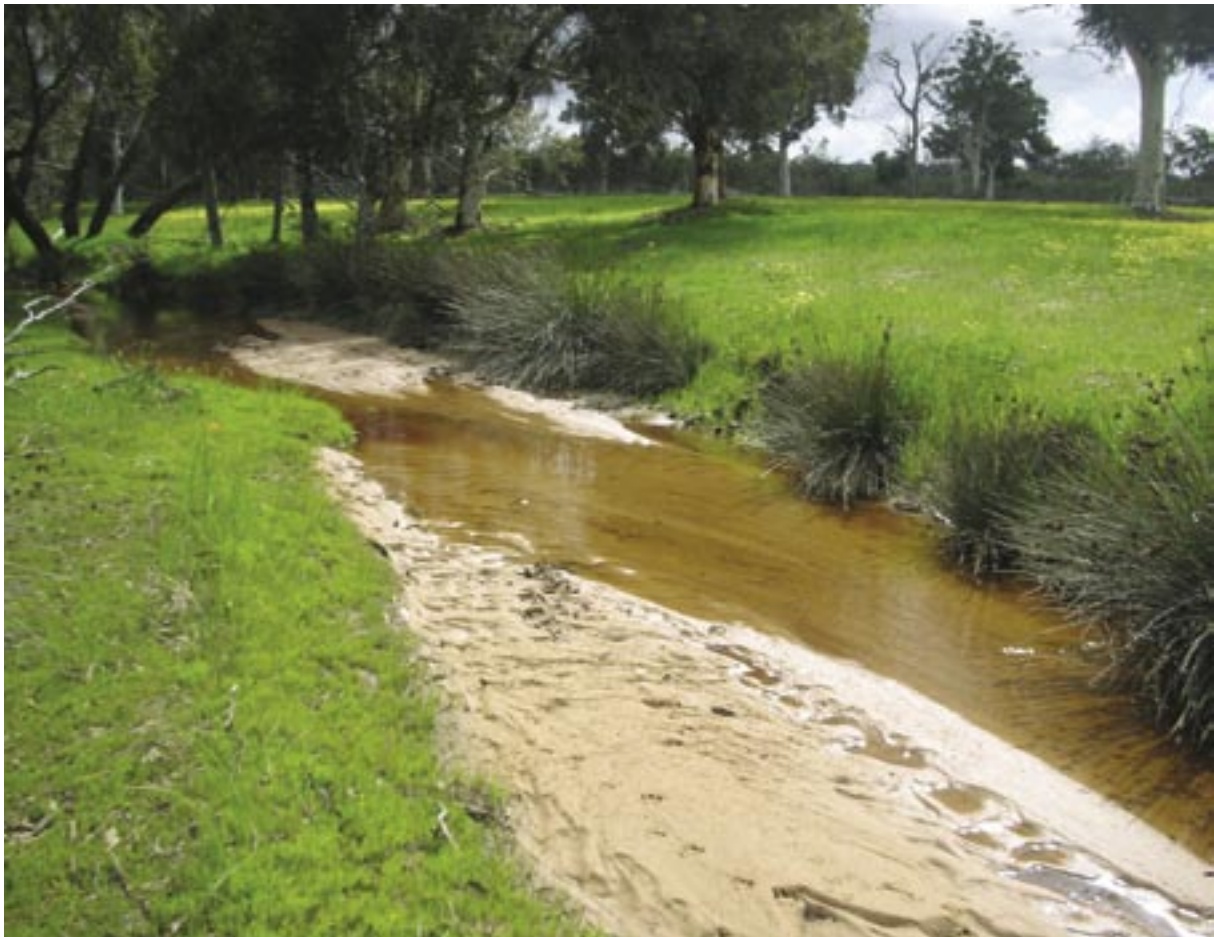
**Photo 3** Sediment deposit in Christopher Brook

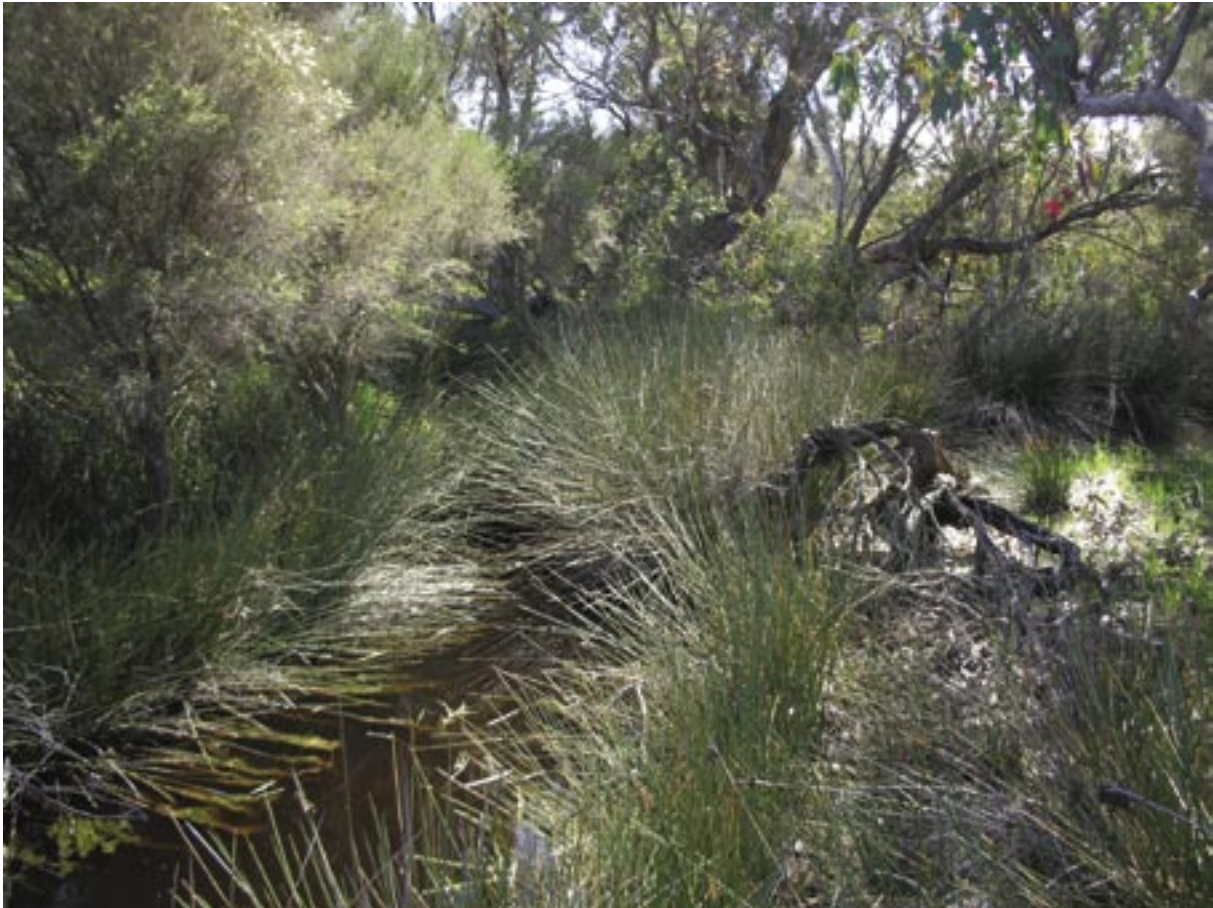
*Photo 4 Well vegetated, stable banks along a tributary of Christopher Brook*

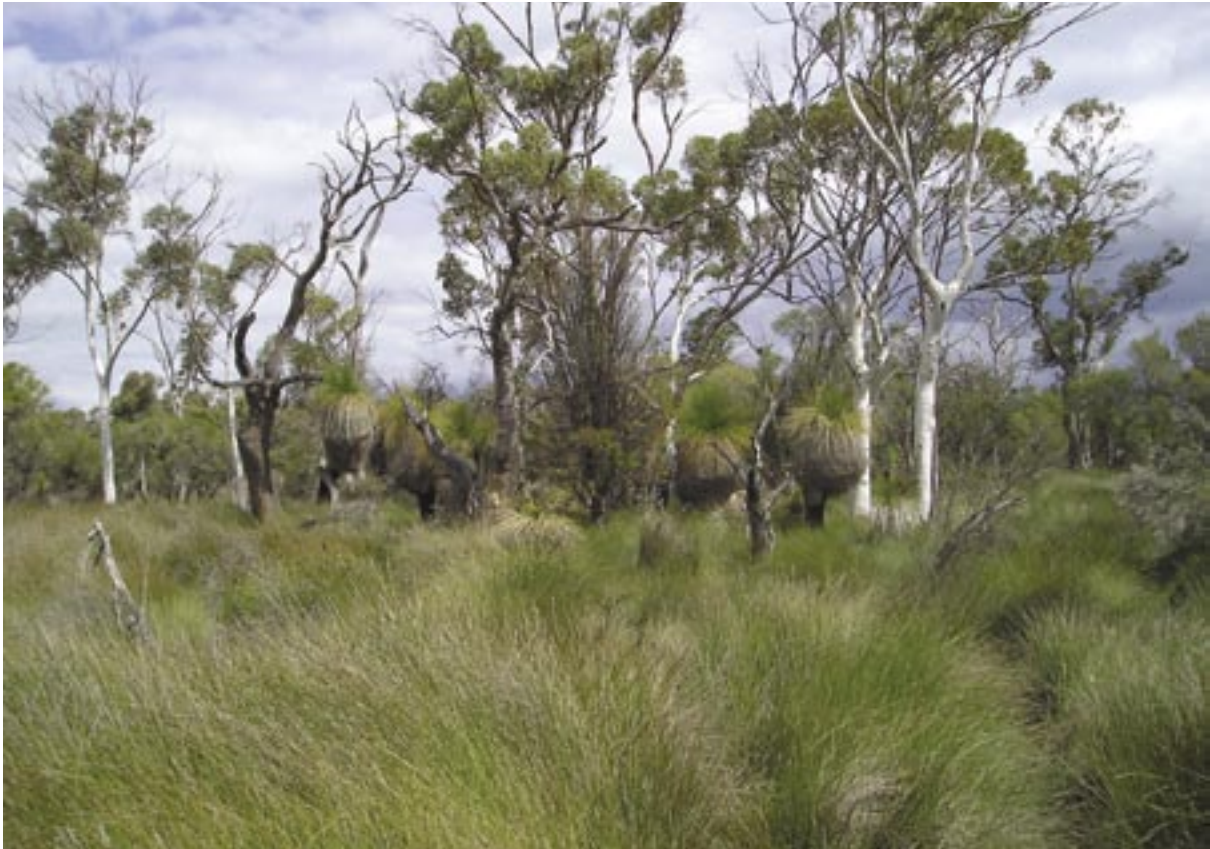
*Photo 5 An A-grade reach on a tributary of Christopher Brook*

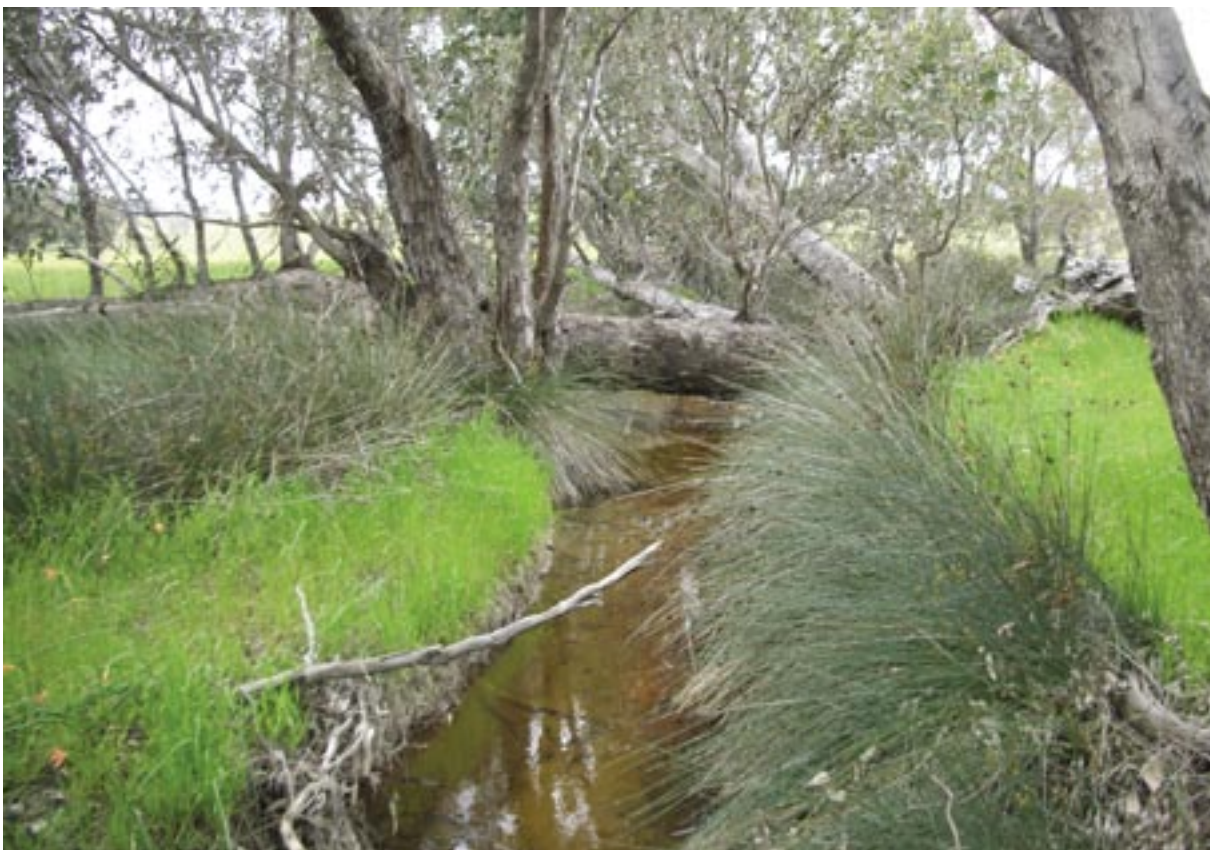
*Photo 6 A B-grade reach of Christopher Brook*

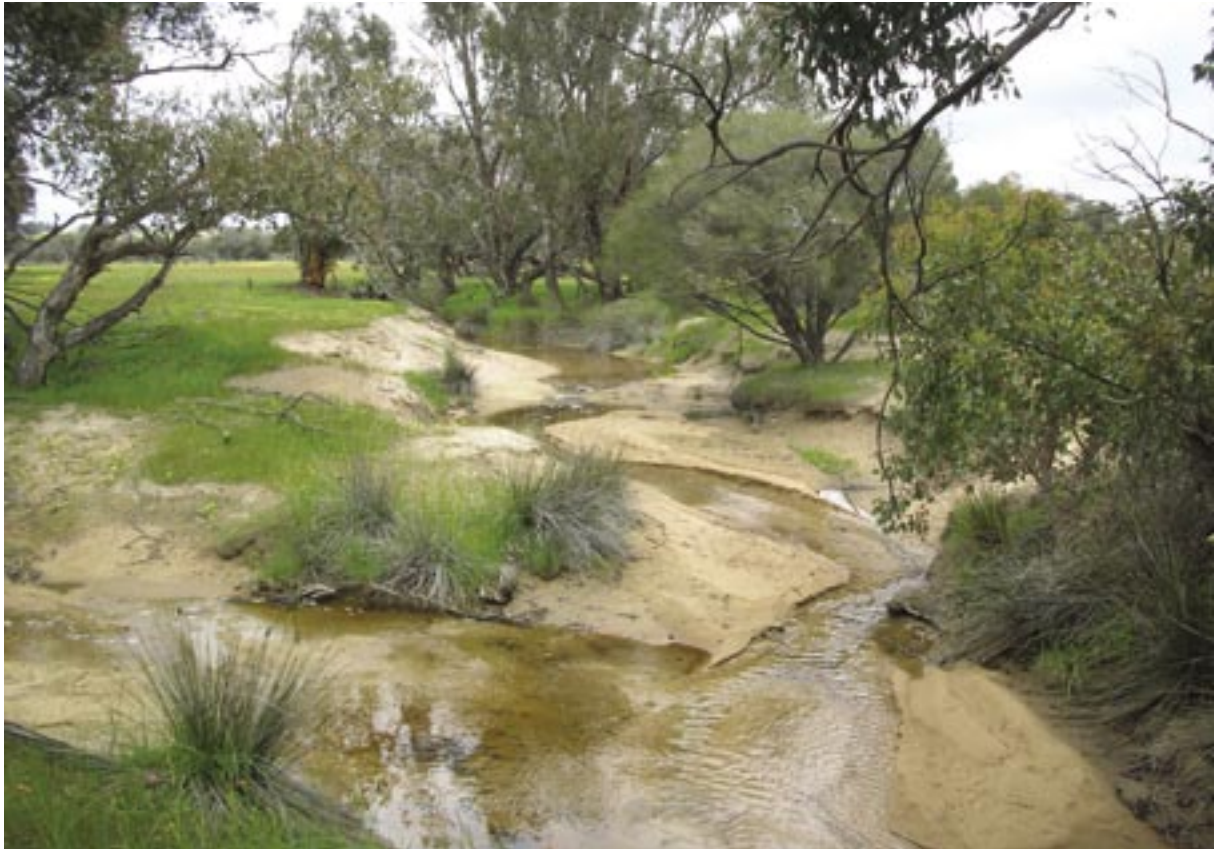
**Photo 7** A C-grade reach of Christopher Brook

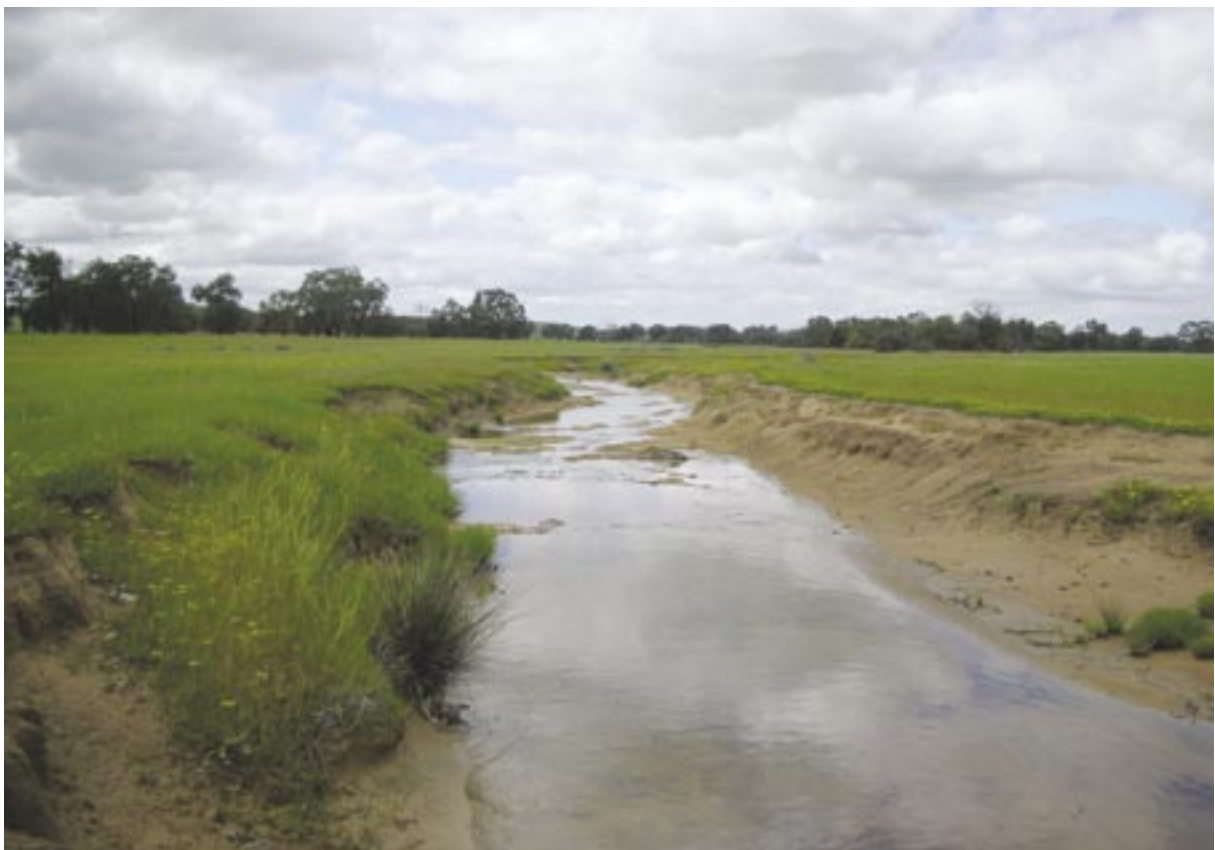
**Photo 8** A D-grade reach of Christopher Brook

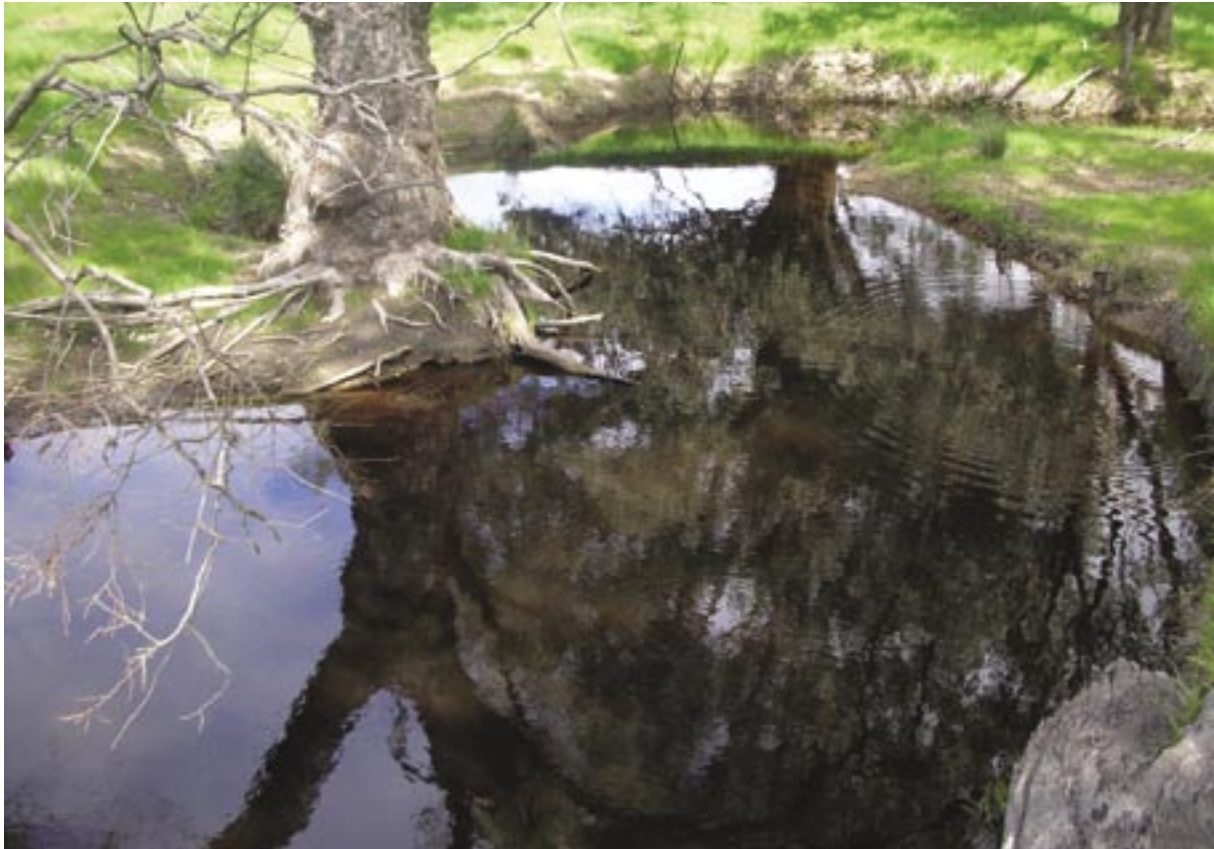
*Photo 9 A deep pool on a meander bend in the downstream reaches of Christopher Brook*

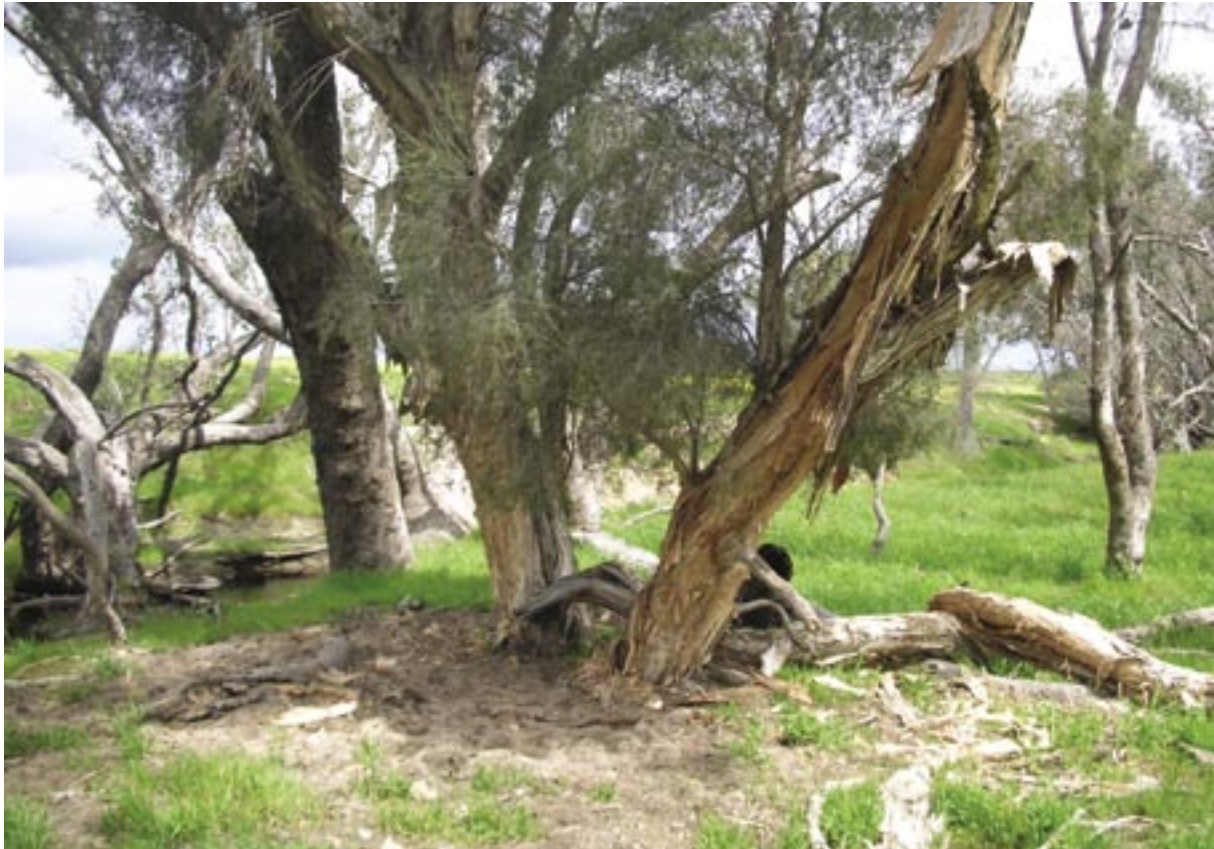
**Photo 10** Effects of stock access on native vegetation. Cattle have stripped the bark from this swamp paperbark (*Melaleuca raphiophylla*).

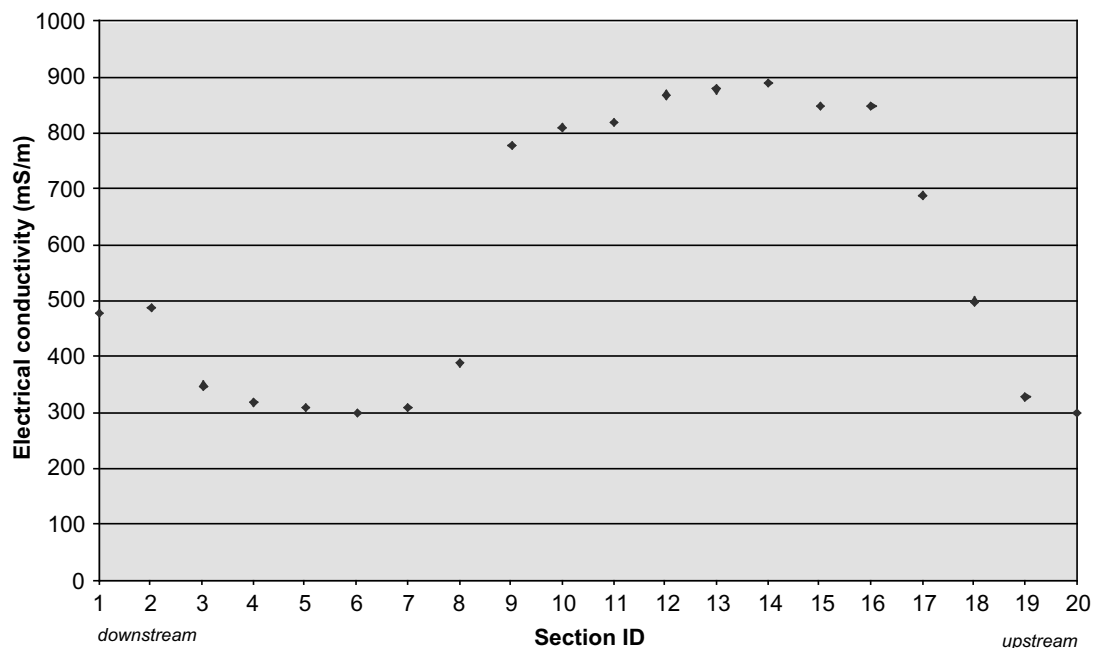
**Figure 2** Salinity levels recorded in the main channel Christopher Brook, September 2007

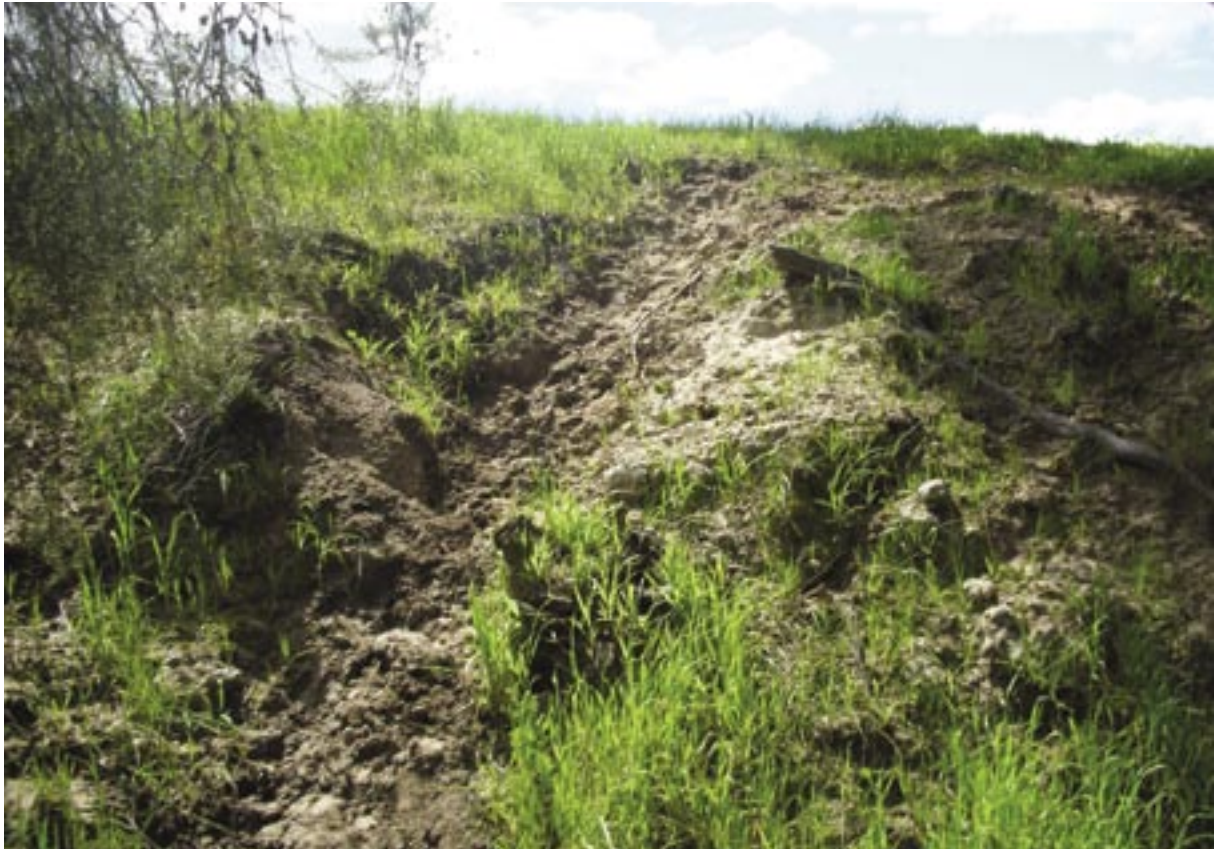
**Photo 11** *Stock access down this steep embankment is exposing the soil to erosion. Left unmanaged, this bank will eventually erode into the channel.*

The most effective means of slowing and preventing further erosion and sedimentation of Christopher Brook is to restrict stock access by fencing. This will enable the bed and banks to recover from disturbance and allow natural regeneration

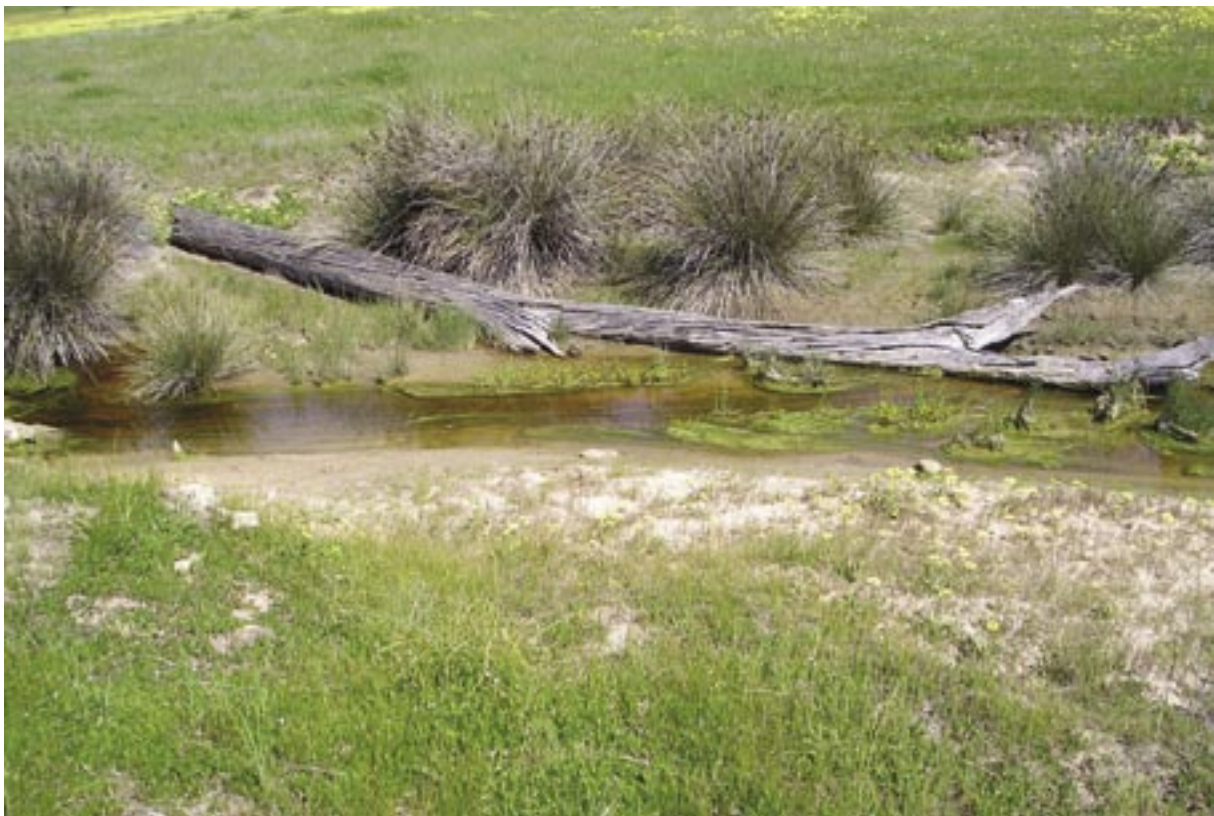
**Photo 12** Bank stabilisation using large woody debris along a tributary of Christopher Brook. This tributary receives minor flows but the log would be more secure if the butt was buried into the bank.
