Foreshore and channel assessment of Monjerducking Gully

Report no. WRM 53
March 2009

Prepared by
BlueSands Environmental
for Department of Water

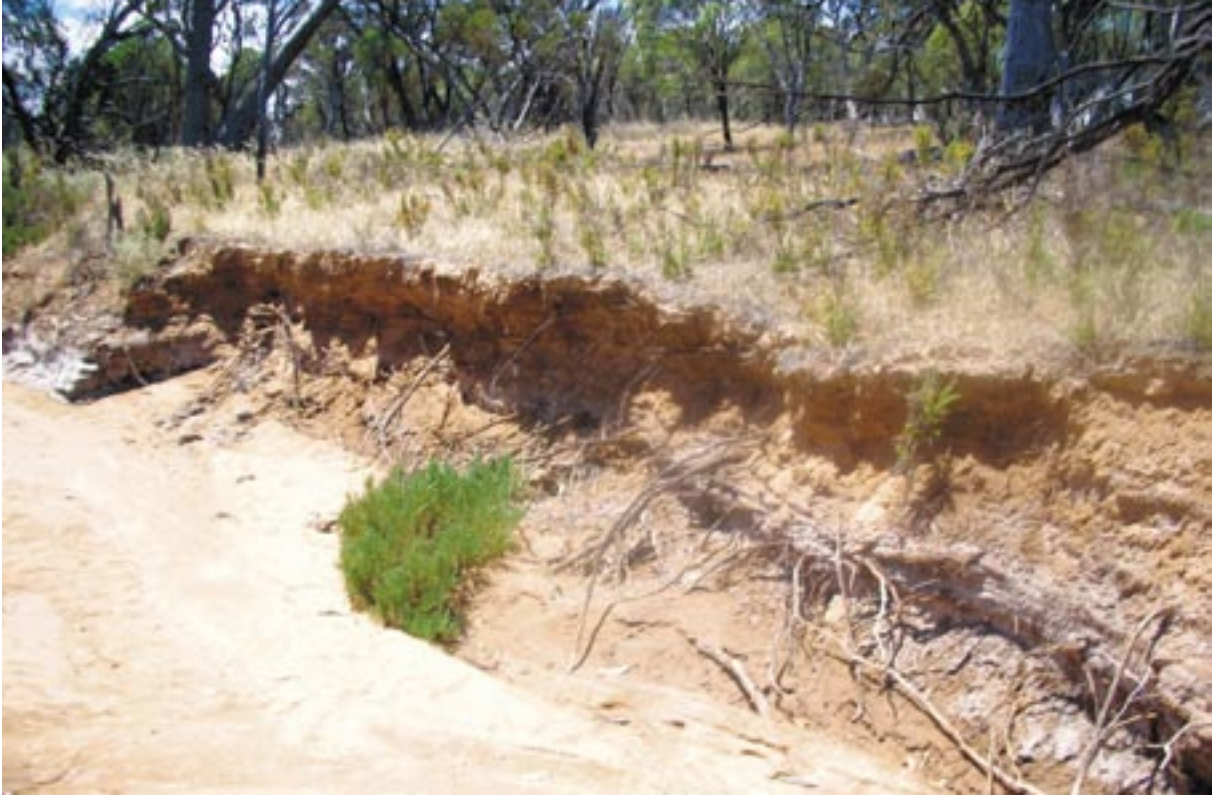
These processes are explained on following pages and some are illustrated by photos 1 and 2. Photo 1 shows a section of Monjerducking Gully where undercutting is occurring as a result of the channel incising (becoming deeper). Photo 2 shows the process of sedimentation, where weeds have colonised the unstable sand bar which has formed within the channel. In contrast, photo 3 shows a well-vegetated, stable channel on a downstream section of the gully.

Photo 1 Bank undercutting on Monjerducking Gully

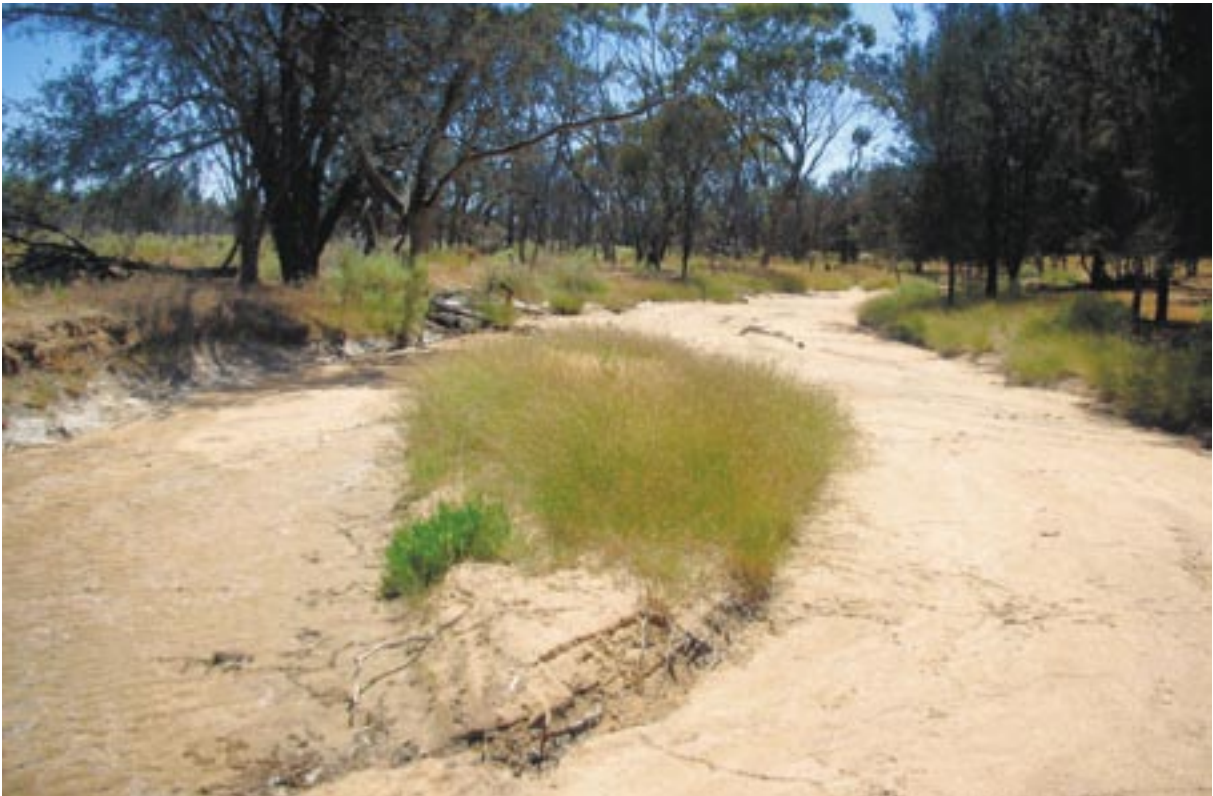
Photo 2 Sediment bar colonised by weeds in the braided channel of Monjerducking Gully

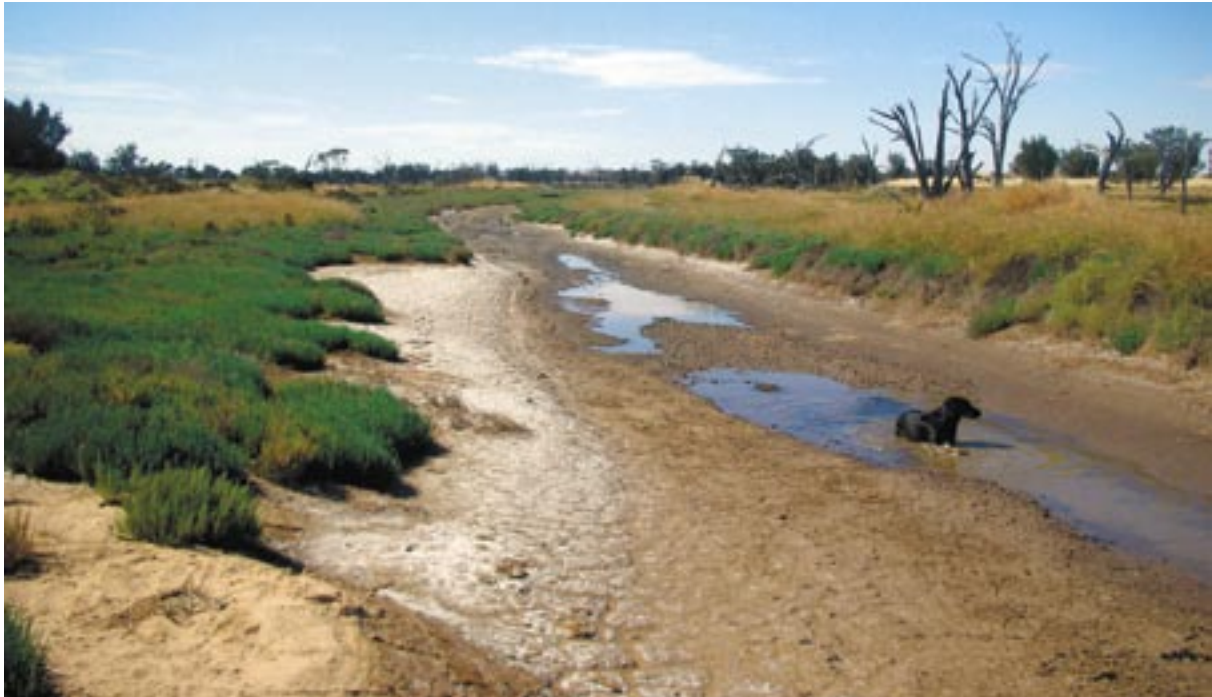
Photo 3 Stable banks well vegetated with samphire (Halosarcia sp.) on a downstream section of Monjerducking Gully

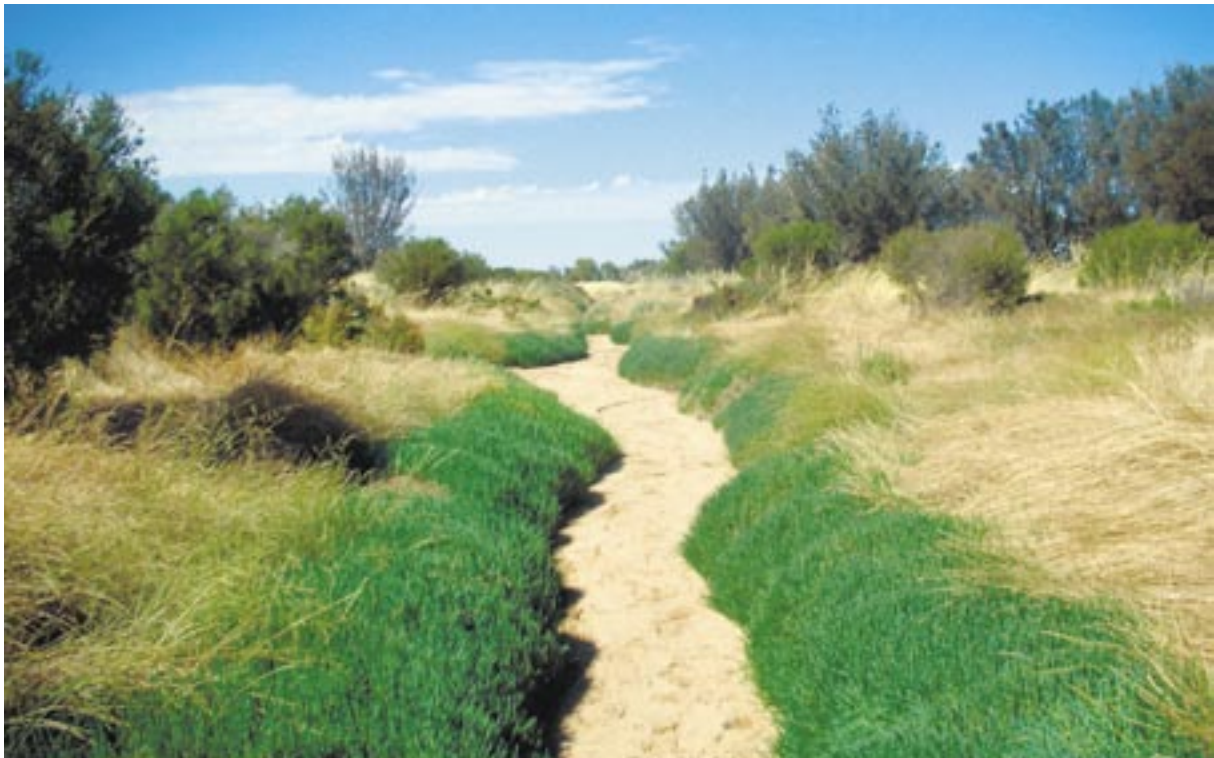
Photo 5 A B-grade reach of Monjerducking Gully (note the high occurrence of native species, including samphire (Halosarcia spp.) but also the dominance of weeds in the understorey)

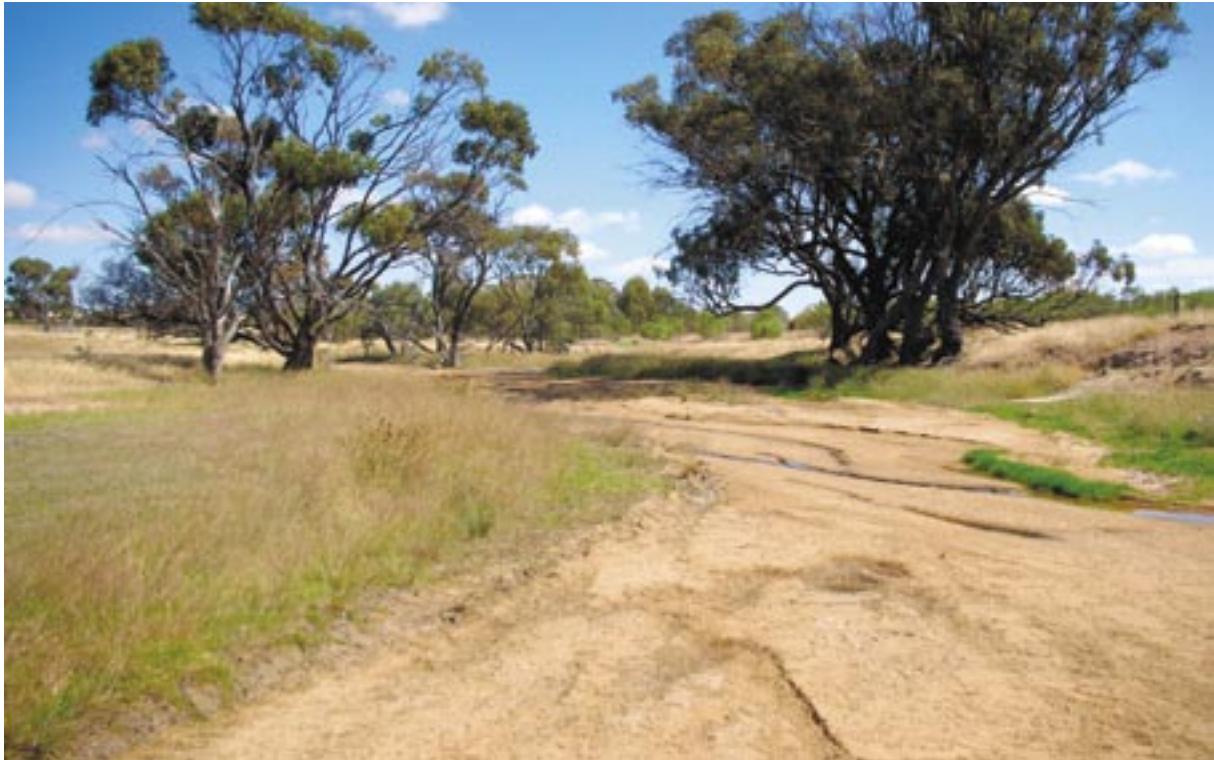
Photo 6 A C-grade reach of Monjerducking Gully (weeds dominate the understorey and the exposed banks are susceptible to erosion)

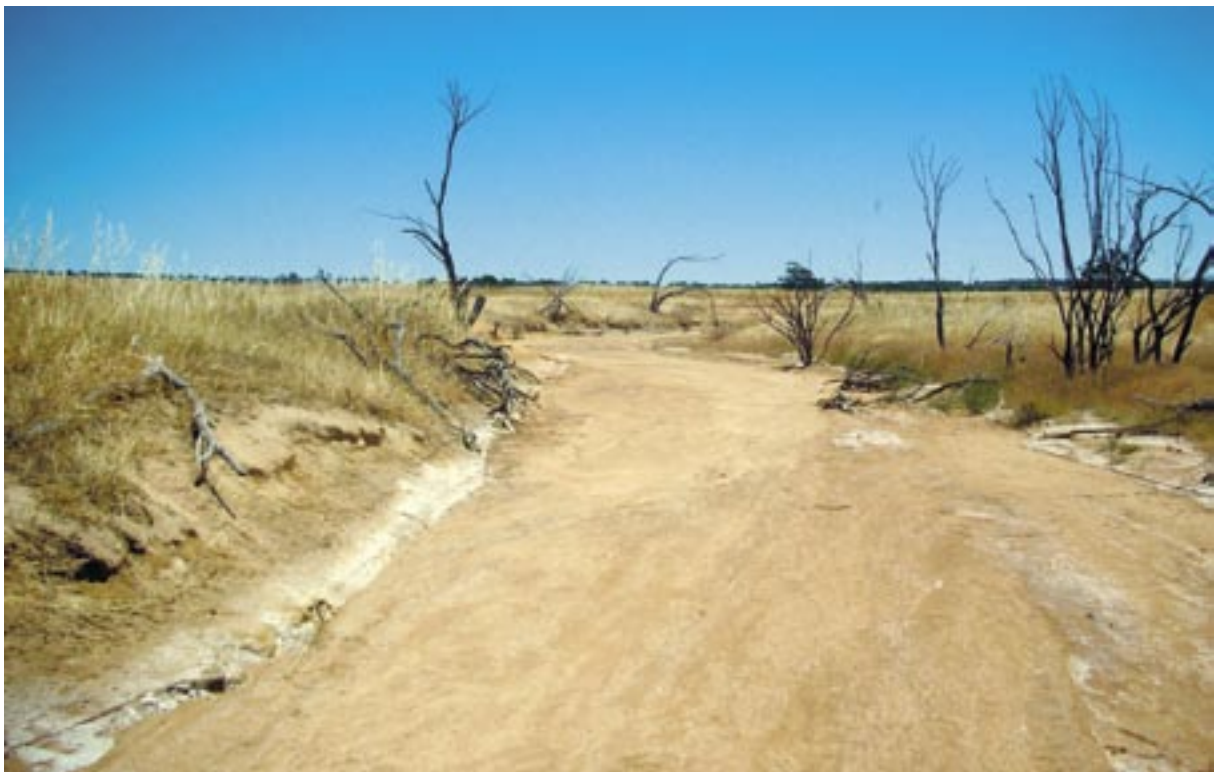
Photo 7 A D-grade reach of Monjerducking Gully (very little vegetation remains and the banks are heavily eroded)

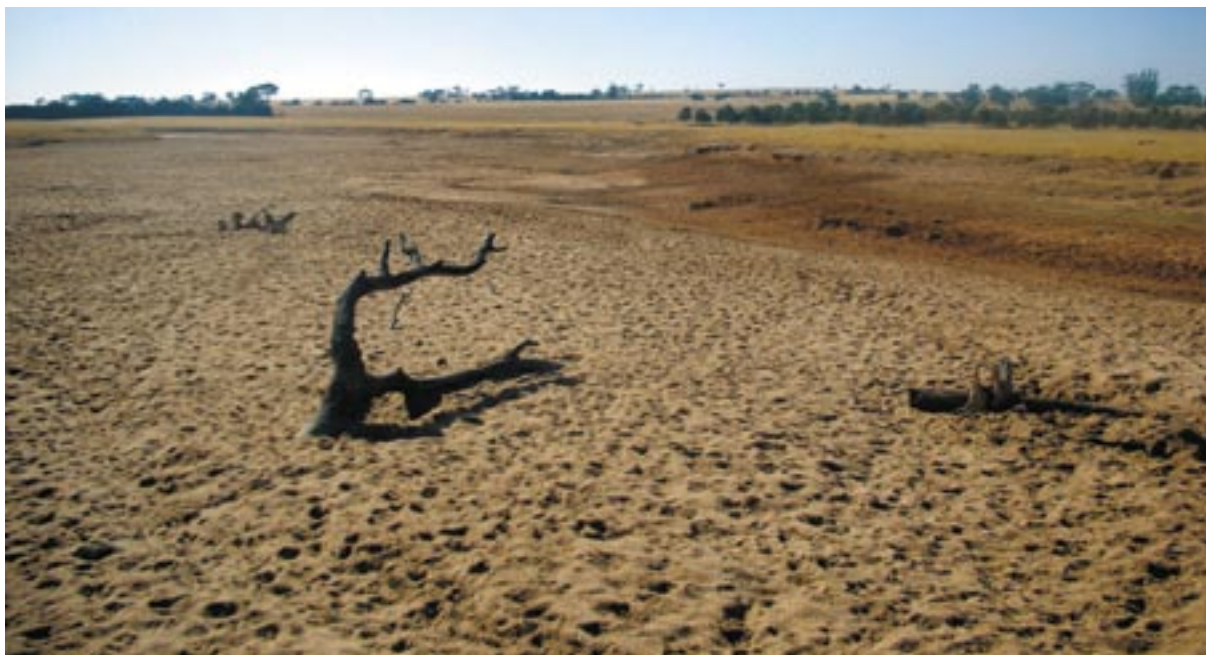
Photo 8 The absence of fringing vegetation has resulted in severe lateral erosion in the middle reaches of Monjerducking Gully. Unrestricted stock access is also evident in this photograph.

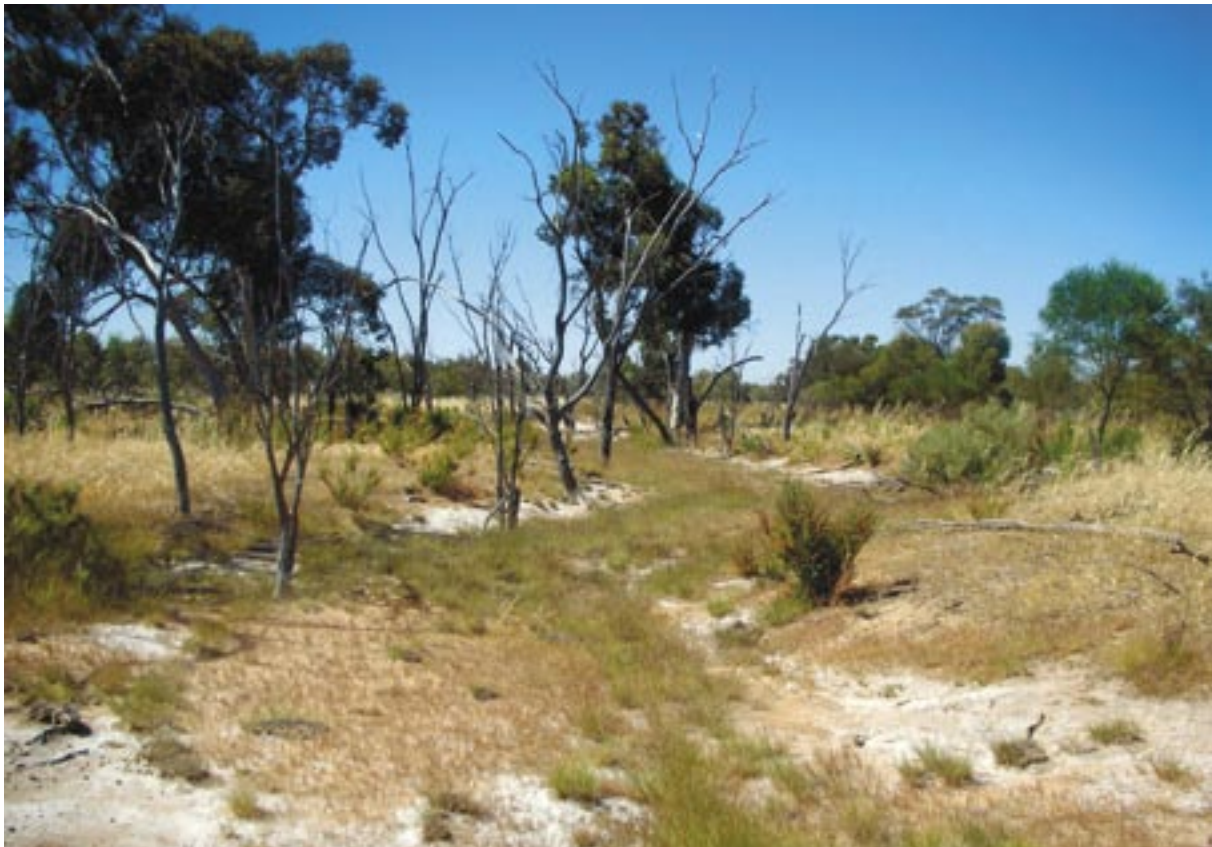
Anabranches occur in 24 per cent of sections, although they are more common in the middle reaches (Photo 9). Many of these anabranches are still connected to the main channel, although they would only receive water during high flow events.

Photo 9 An anabranch in the middle reach of Monjerducking Gully

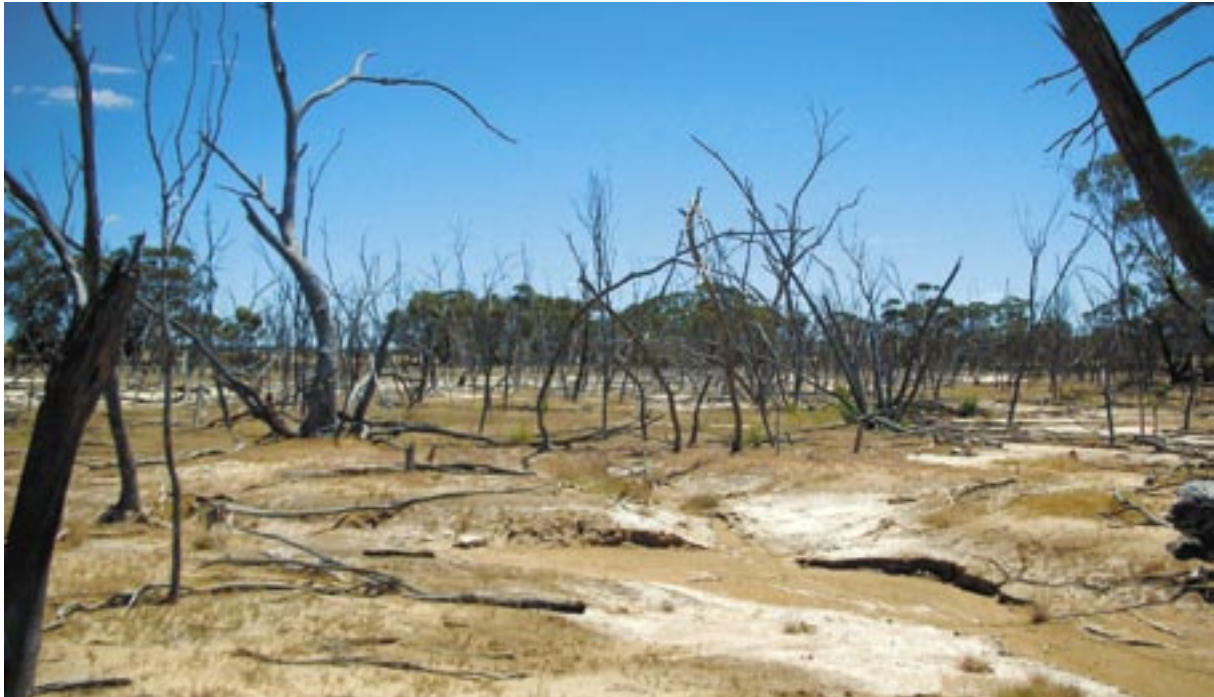
Photo 10 Dead trees were common in the salt lakes that are located in the Monjerducking Gully floodplain

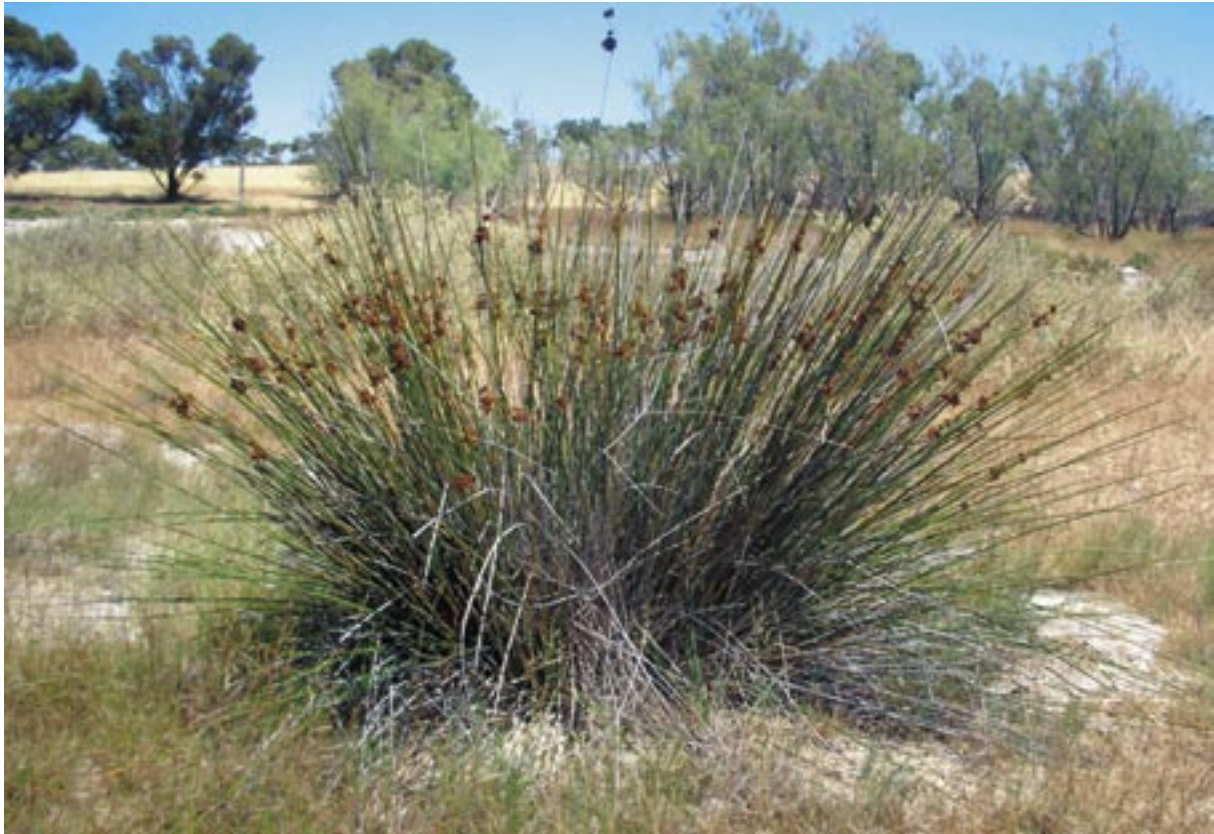
Photo 11 Sharp rush (Juncus acutus) in the floodway of Monjerducking Gully

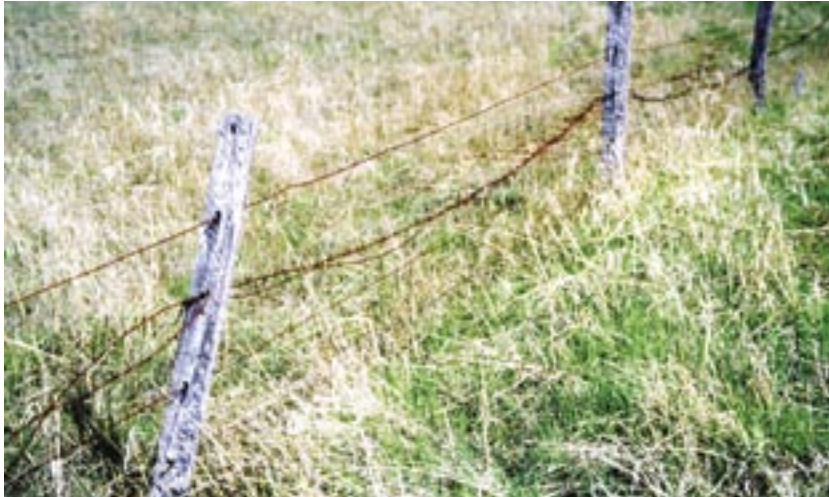
Fence in poor condition

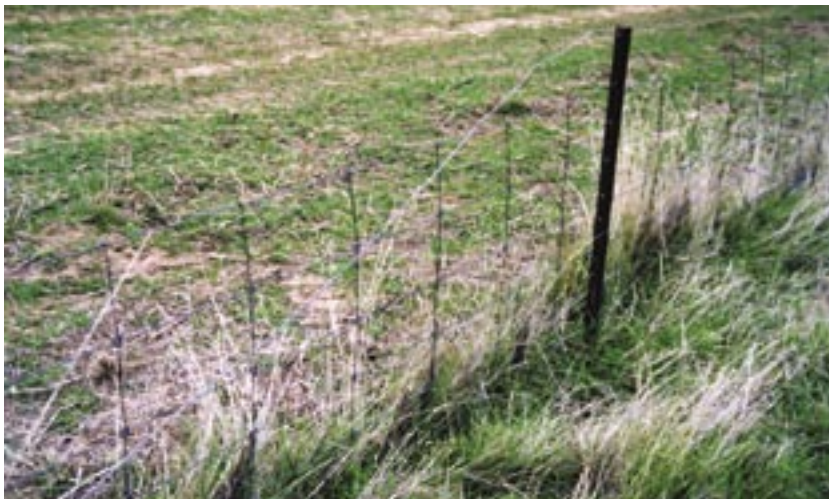
Fence in moderate condition
