River Recovery Plan for the Dale River

Incorporating foreshore and channel assessment

REPORT NO. RRP 10
APRIL 2006

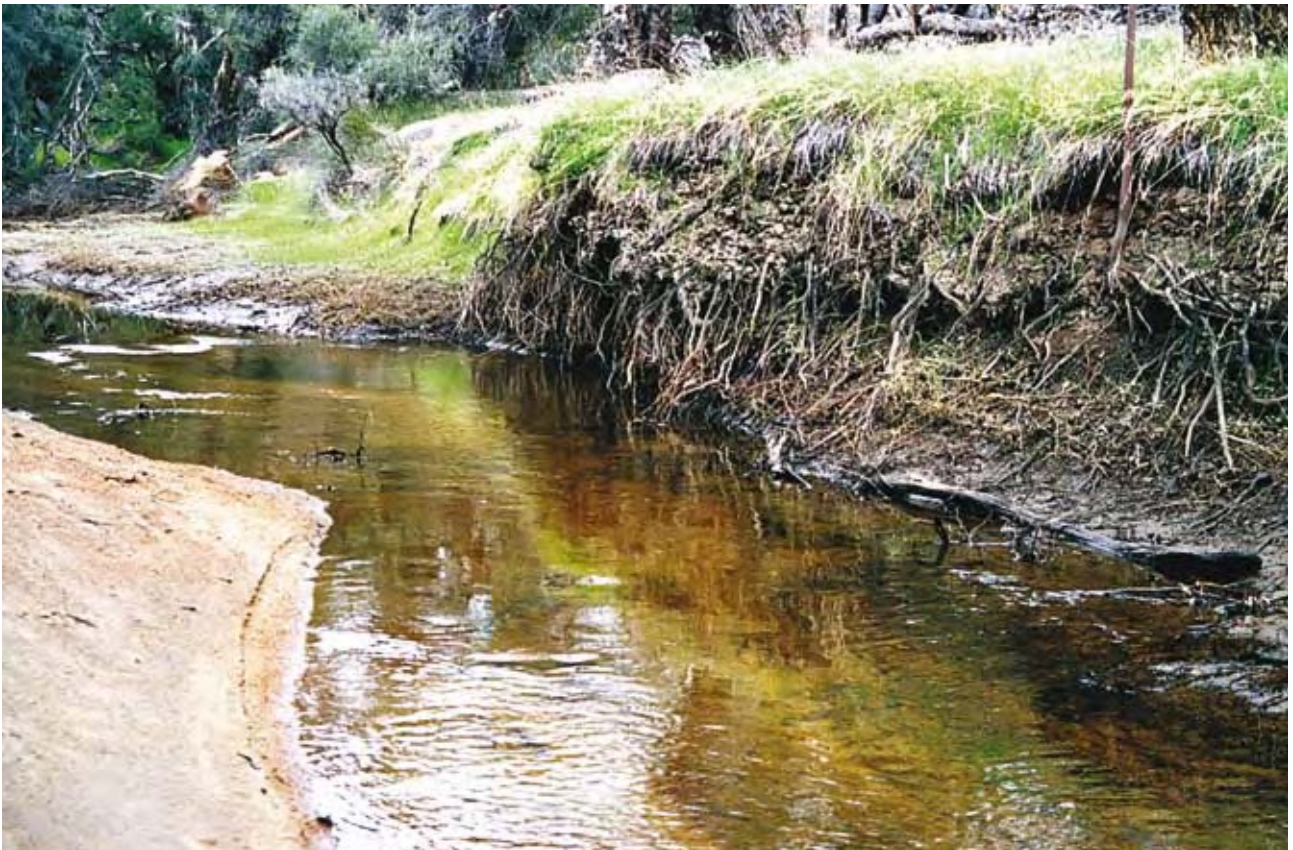
Image 2. Undercutting of the bank, exposing plant roots

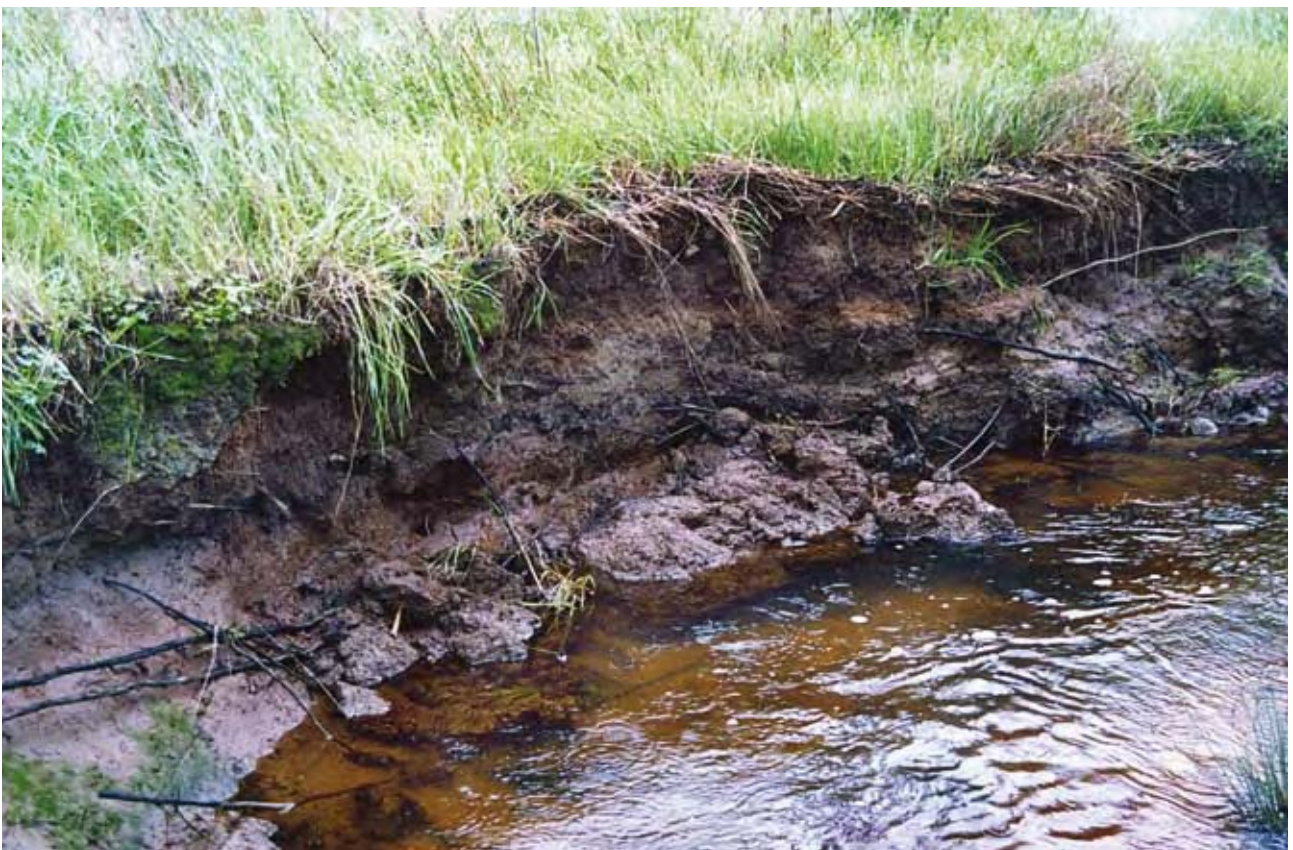
Image 3. Slumping, where an undercut bank has collapsed under its own weight

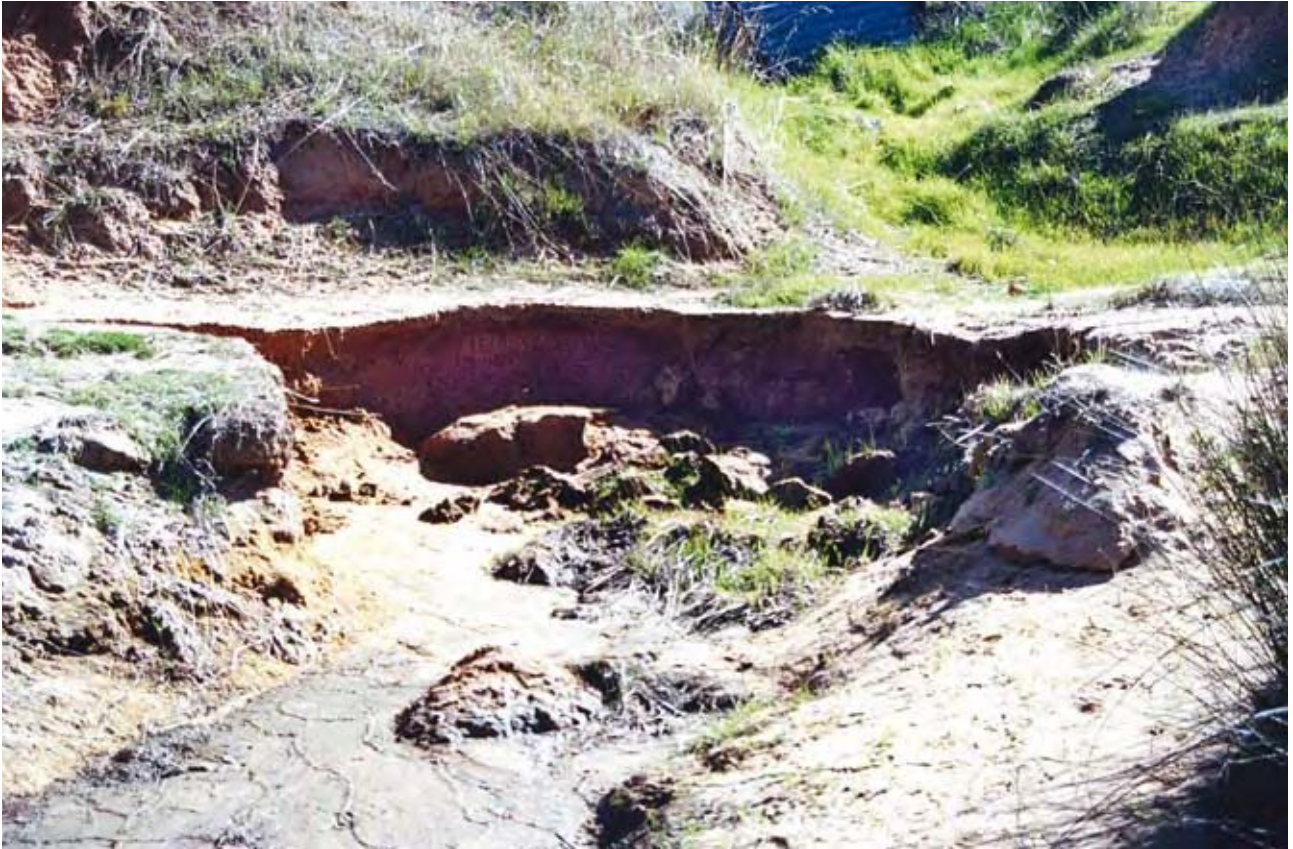
Image 4. A gully, formed by headcutting along a small tributary

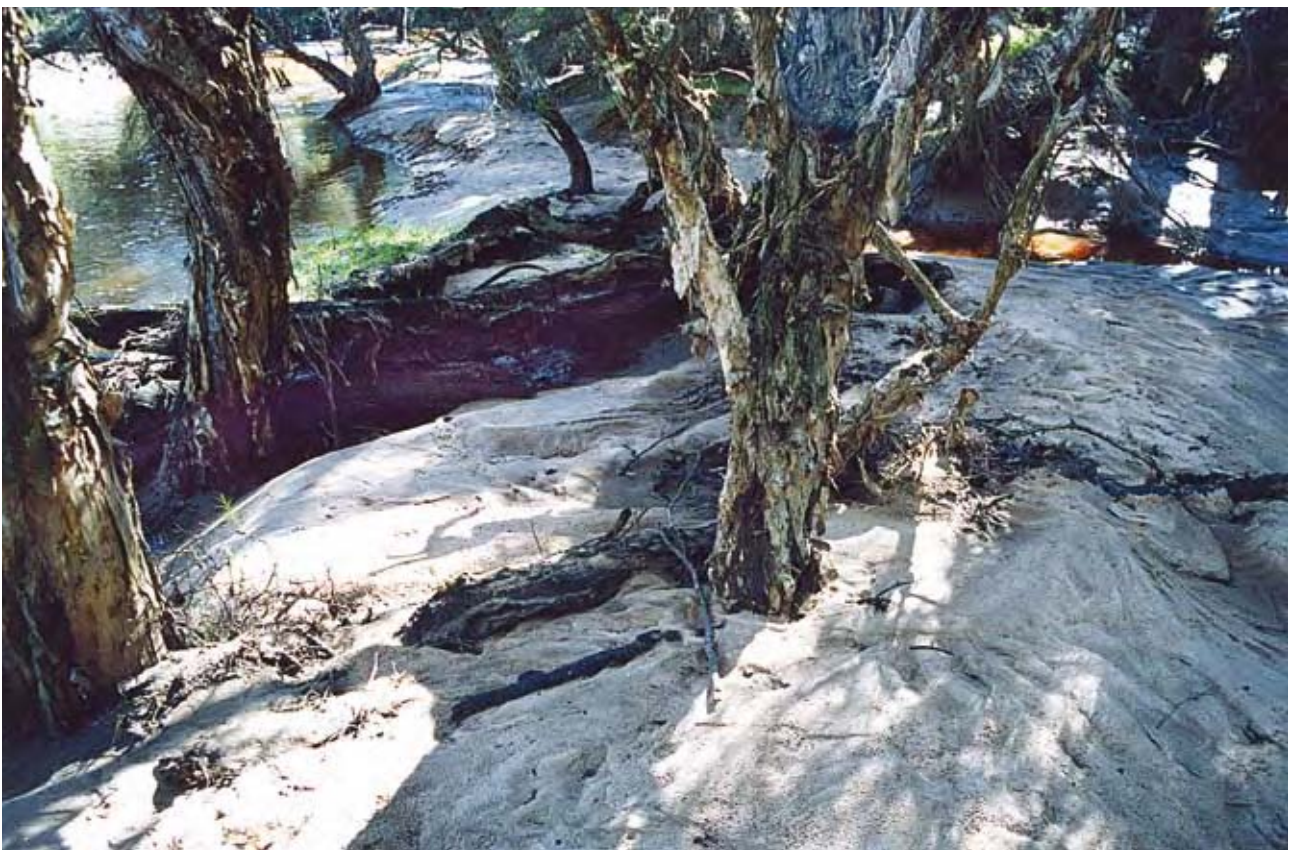
Image 5. Severe sedimentation in the main channel of the Dale River

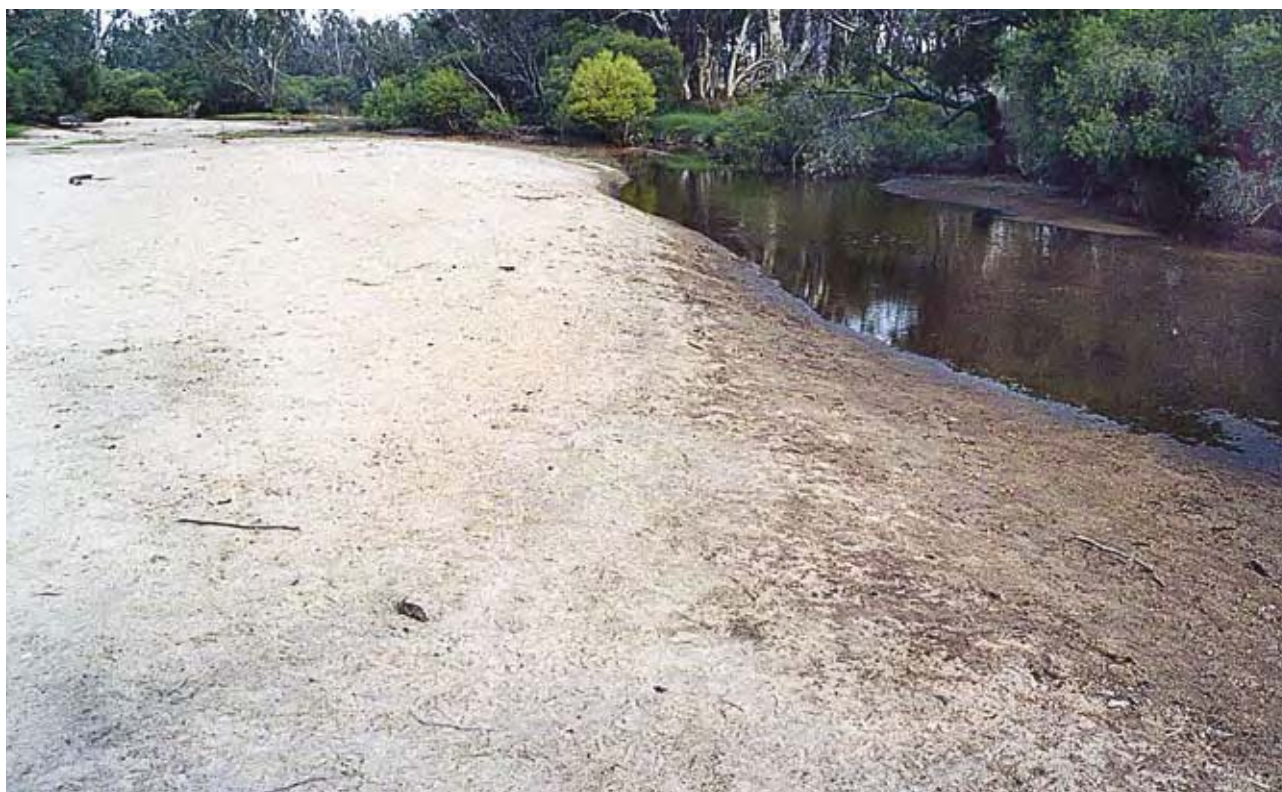
Sediment slugs are present in 73% of sections. While sediment can prevent channel incision, it can also contribute to lateral erosion, where flow is deflected into banks, and smother aquatic habitat. Large sediment slugs are steadily filling in many of the river pools along the

Image 6. Sediment slug smothering Reserve Pool

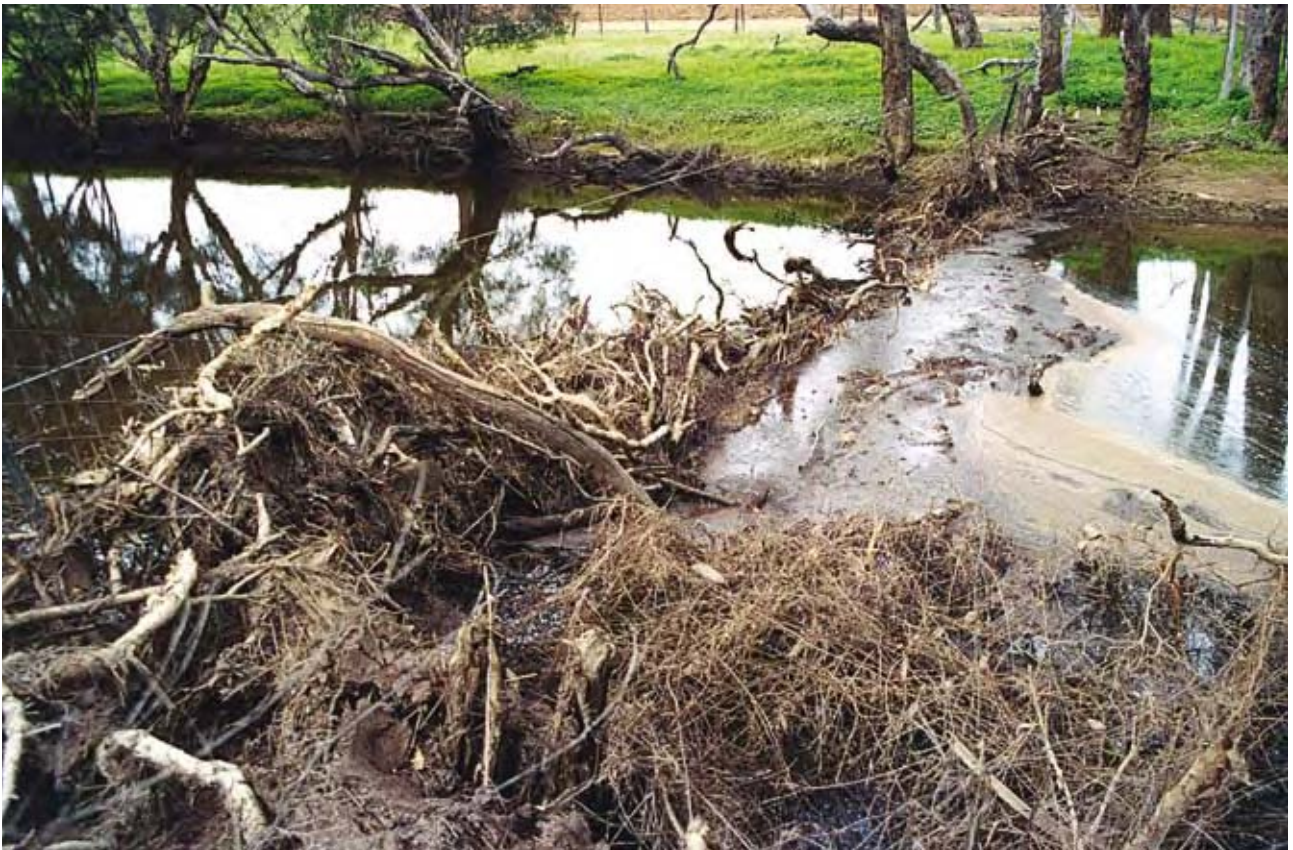
Image 8. Debris caught in a cross-channel fence

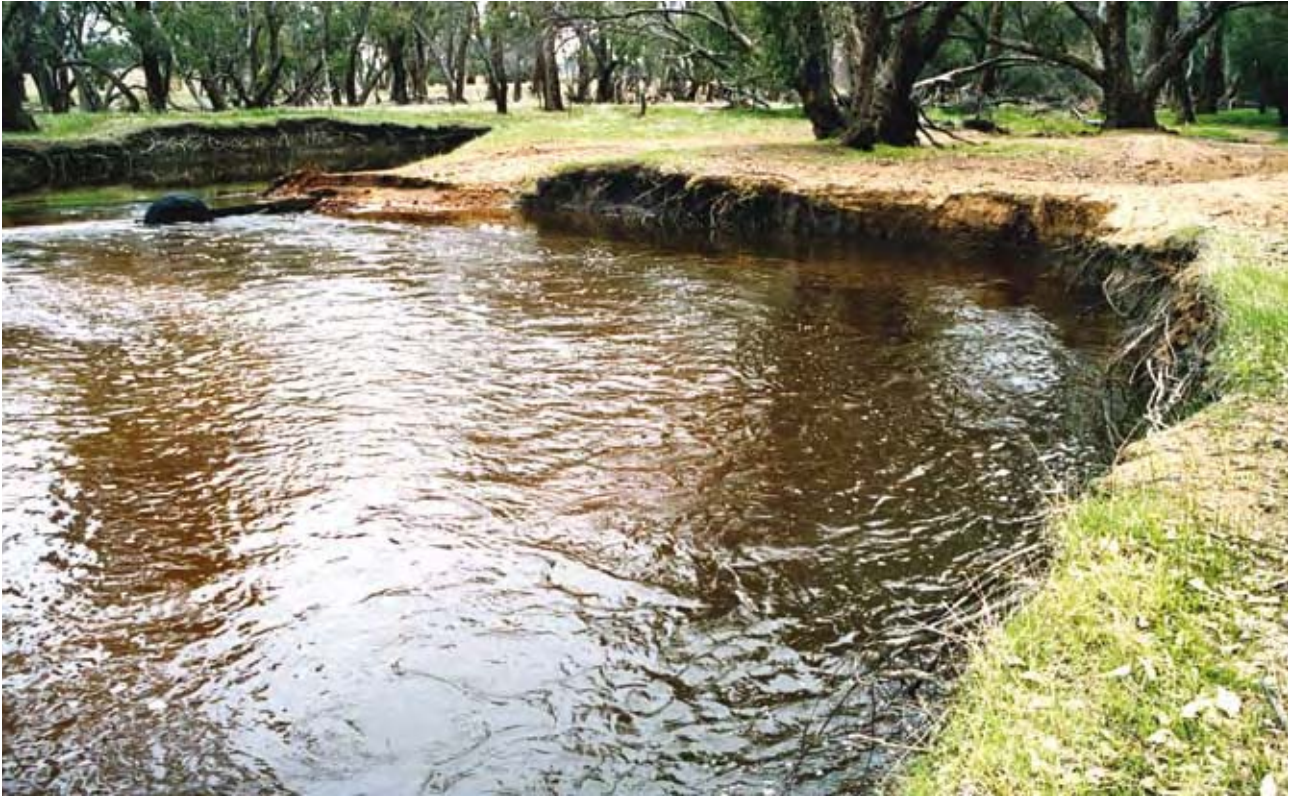
Image 10. Incorrect placement of this crossing has caused it to be washed out and the banks to erode

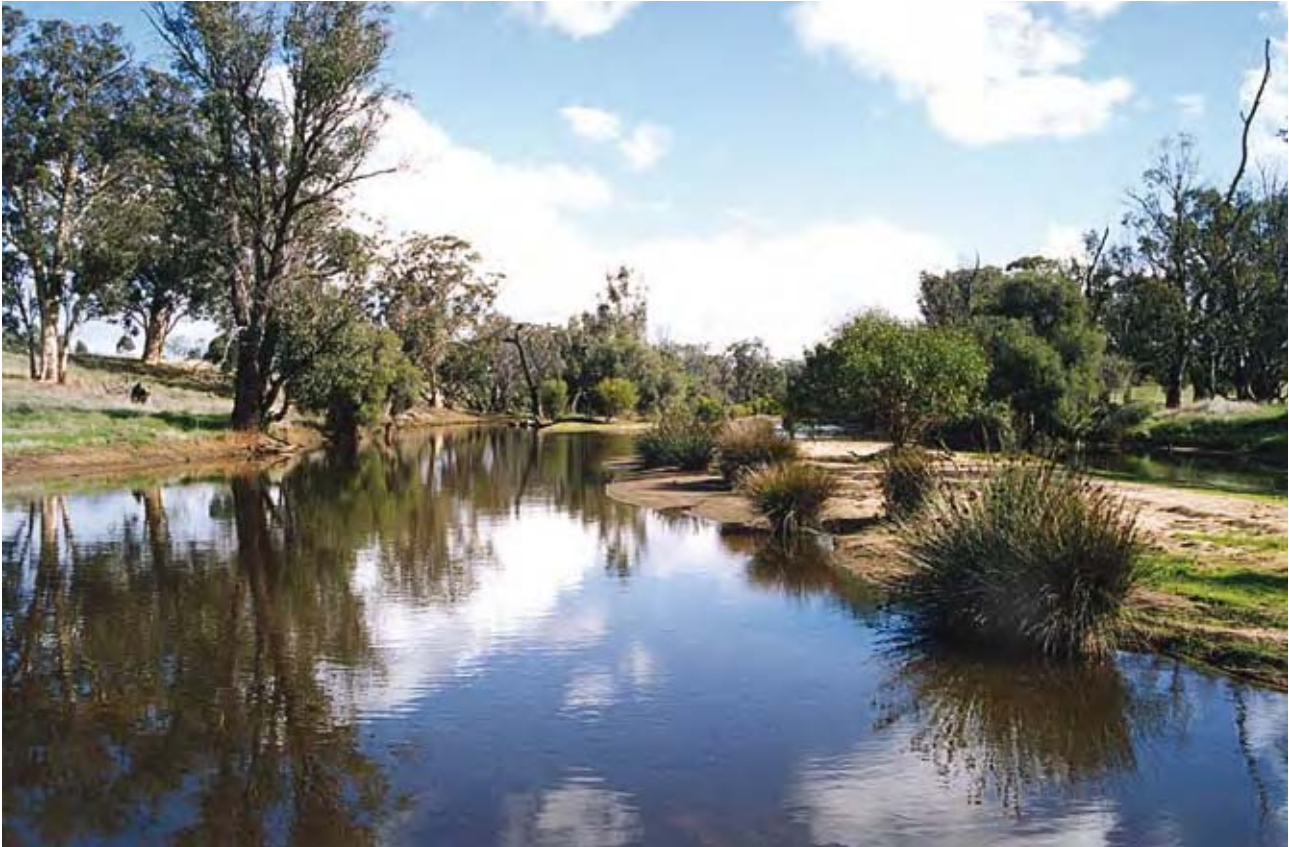
Image 11. Sediment choking Mandiakin Pool

In conjunction with mobilising or stabilising existing sediment slugs, the sediment source also needs to be managed by stabilising banks to prevent further erosion. Where the sediment source is bank erosion, river banks need to be stabilised using techniques such as revegetation, rebuilding pool-riffle sequences and replacing large woody debris. Where soil erosion in nearby paddocks is a significant sediment source, surface water needs to be managed to prevent erosion.

Planting native vegetation increases bank stability and additionally provides habitat and improves water quality by filtering sediment and nutrients. A list of suitable species for riparian revegetation in the Dale catchment is provided in Appendix 10. Severely eroded banks may need stabilising prior to replanting to prevent plants from being washed away.

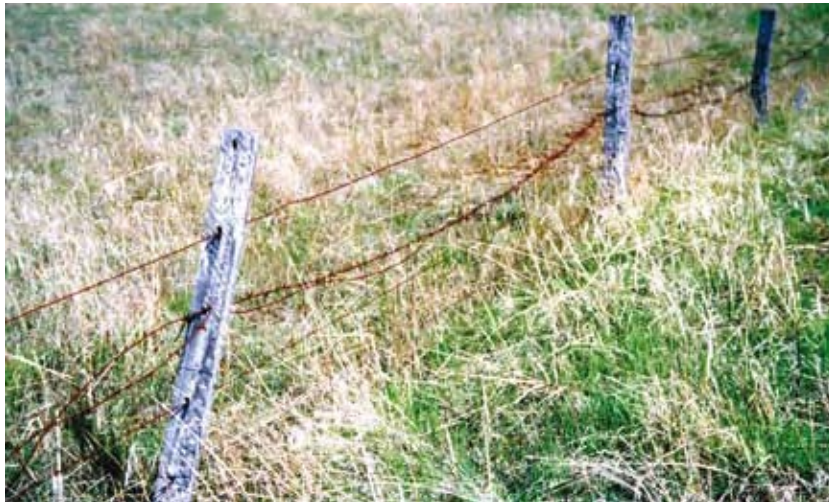
Fence condition:
POOR.

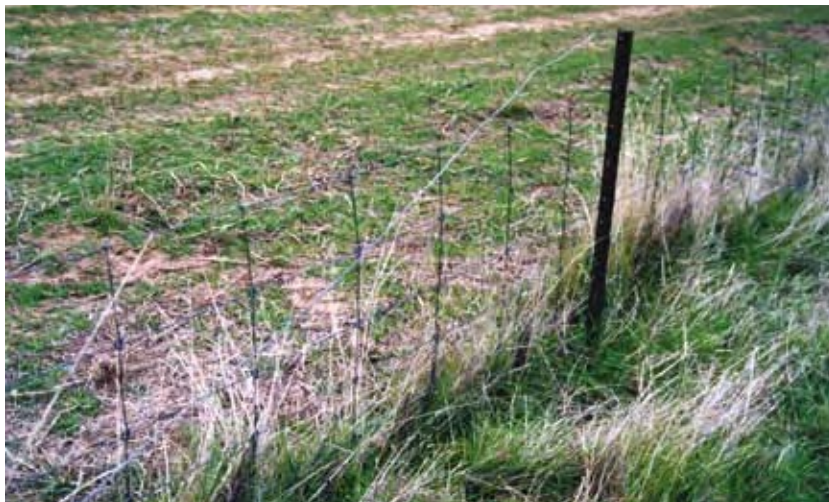
Fence condition:
MODERATE.
