Lower Avon river recovery plan: Incorporating foreshore and channel assessment

River recovery plan series

Report No. RRP 13
June 2008

Prepared by Viv Read & Associates for
Department of Water and the Avon Waterways Committee.

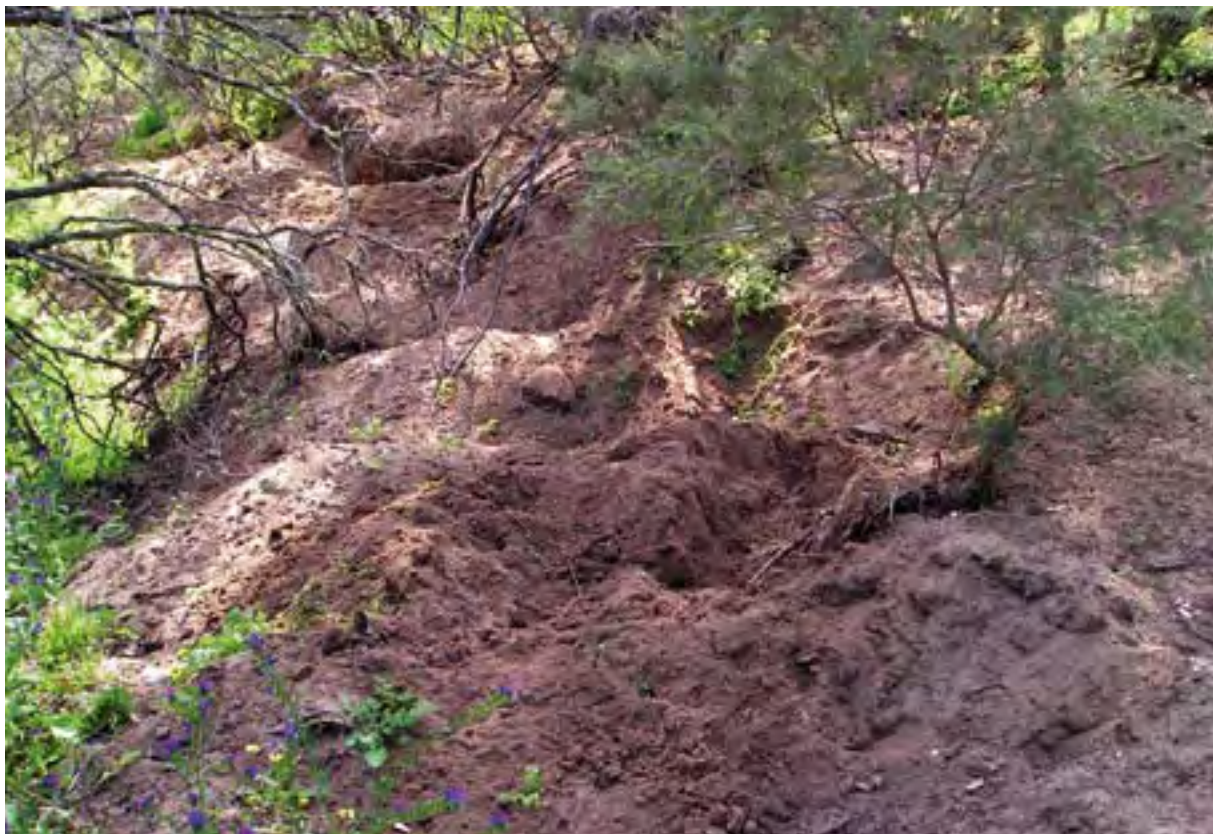
Wild pigs have been introduced to the landscapes of the Lower Avon river section. Small groups of wild pigs forage in the moist floodways and banks of the river, causing very substantial disturbance to the sedimentary soils of the river environment. The pigs range along the length of the river so disturbance is extensive on both sides. From observations made during the river survey, it was clear that soil disturbance occurs frequently, with recent disturbance a common occurrence.

Photo 7 Disturbance by wild pigs in section LA05

Figure 4.7 shows that four river sections have severe soil disturbance and a further 13 sections have significant disturbance. Over 50% of the Lower Avon river section has significant or severe soil disturbance caused by pigs. Minimal disturbance occurs only in the four downstream survey sections (LA28–31).

With significant soil disturbance for prolonged periods in floodways, levees and banks of the river, the potential for erosion and sediment transport during high flow events is high. Increasing river levels by just 50 cm from winter base flow would cause erosion. These medium to fine grained sediments are considered to be relatively high in nutrients compared with coarse sand sediments, as coarse sediments have a lower surface area and therefore lower potential for nutrient adsorption. Therefore, these sediments may contribute to nutrient enrichment in upper reaches of the Swan River where streamflow velocity is reduced and sediments are deposited.

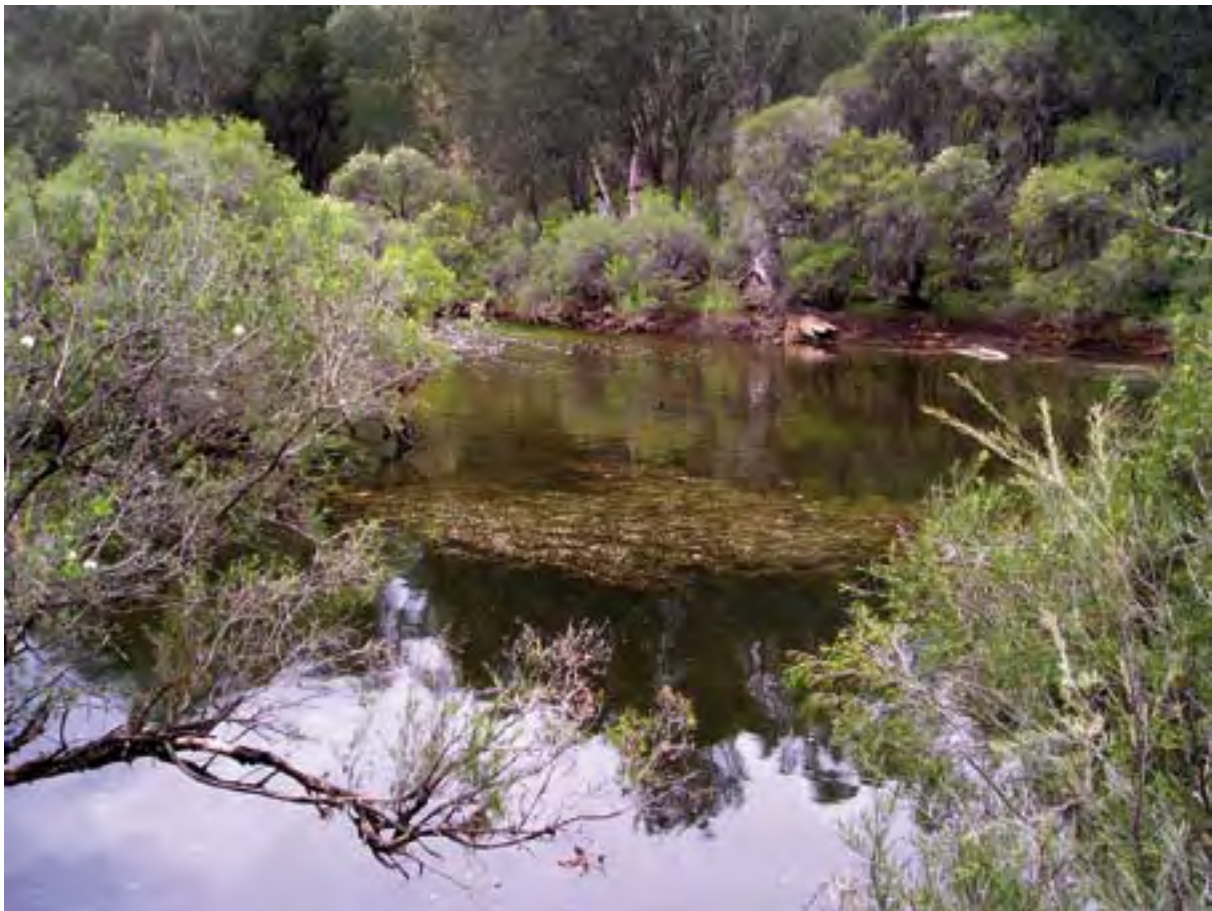
Boongarup Pool (Section 31) is a long river pool where the river gradient is decreasing. This pool is considered to be at moderate risk of sedimentation (Department of Water, 2008).

Photo 8 Ruppia species growing in Boongarup Pool, indicating shallow pool depth

3. Although there are many rapids or riffle structures, there is a greater proportion of river pools and reaches. Most river pools are of high value and in stable condition. Moondyne Pool and Boongarup Pool need to be assessed for potential sediment infill.

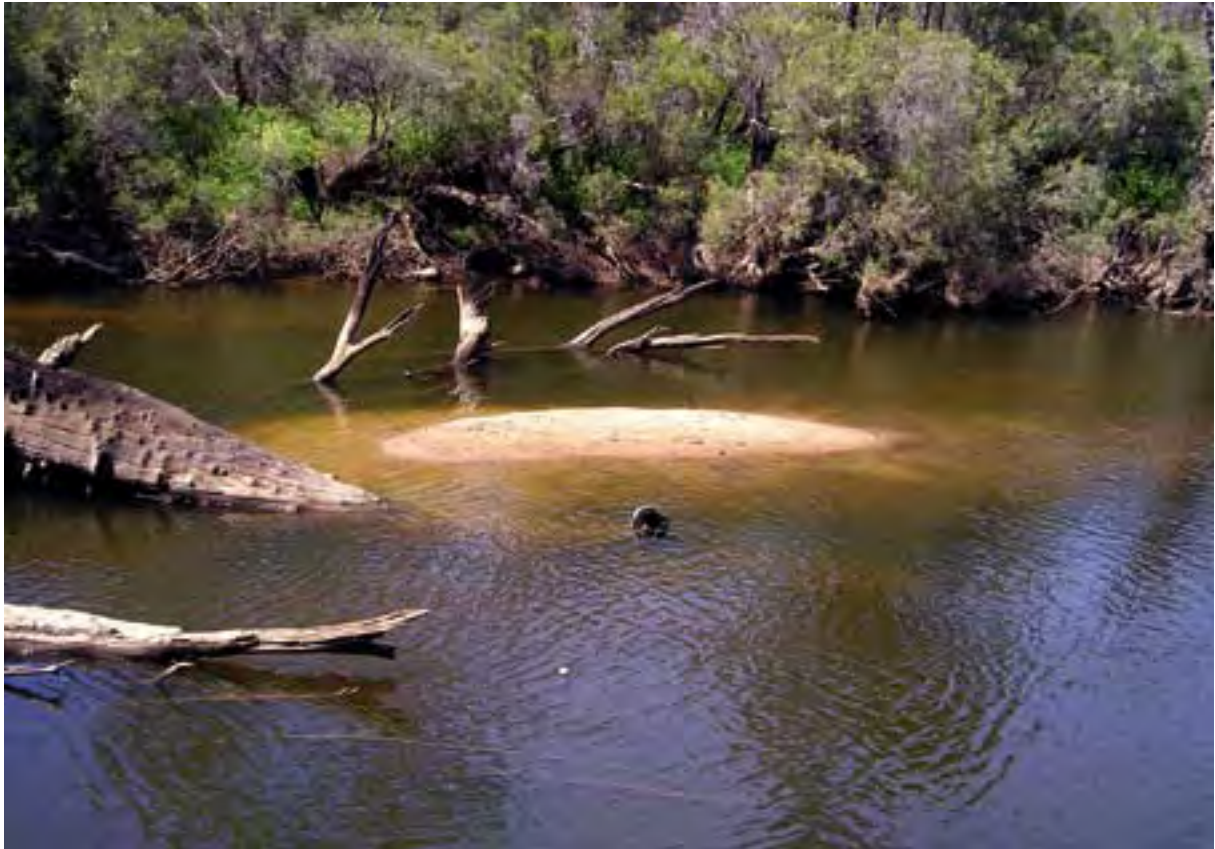
Photo 9 Sediment deposition in a river pool in section LA06

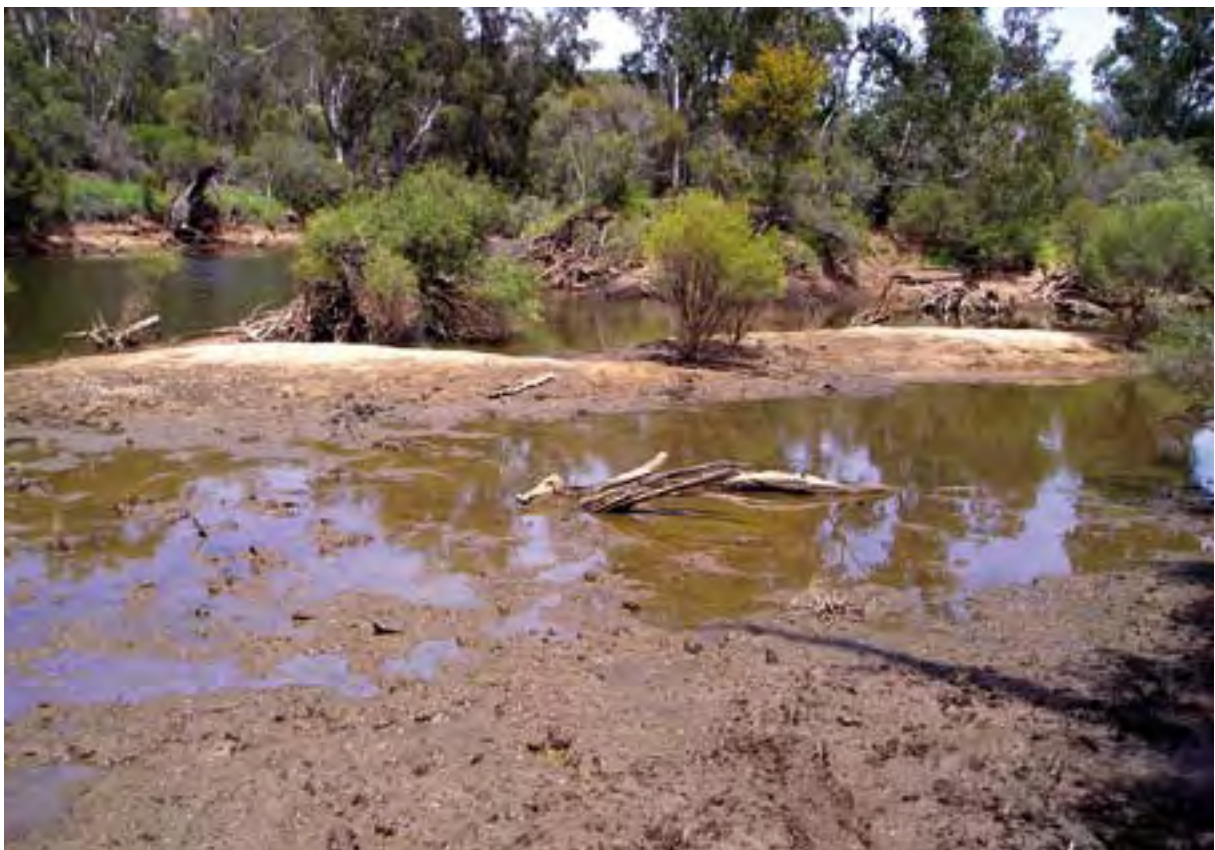
Photo 10 Pig disturbance in a deposit of fine sediments

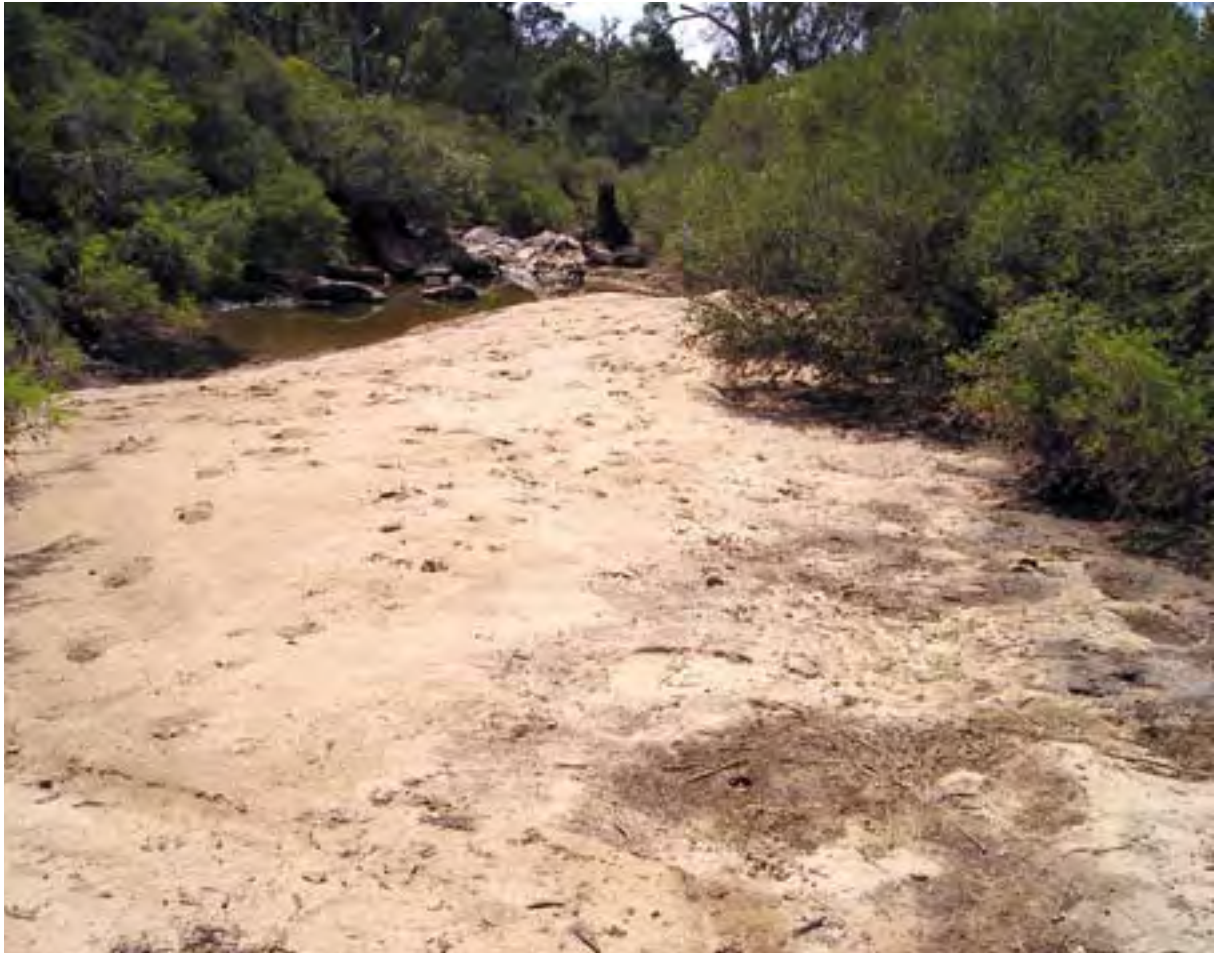
Coarse sand sediment was recorded for river sections during the survey. This occurred as small beaches on river banks, sand slugs within the channel or as a trailing deposition downstream from large rocks or small islands. Figure 4.8 provides a relative index of the occurrence of sediment deposition for the Lower Avon river section. Most survey sections had little or no sediment deposition recorded. Compared with sedimentation of the Avon River upstream from the Darling Scarp, the level of sedimentation is generally very low. The coarse sediments that were observed were most commonly as a small unconsolidated sand slug. This suggests temporary deposition.

Photo 11 Coarse sand deposition

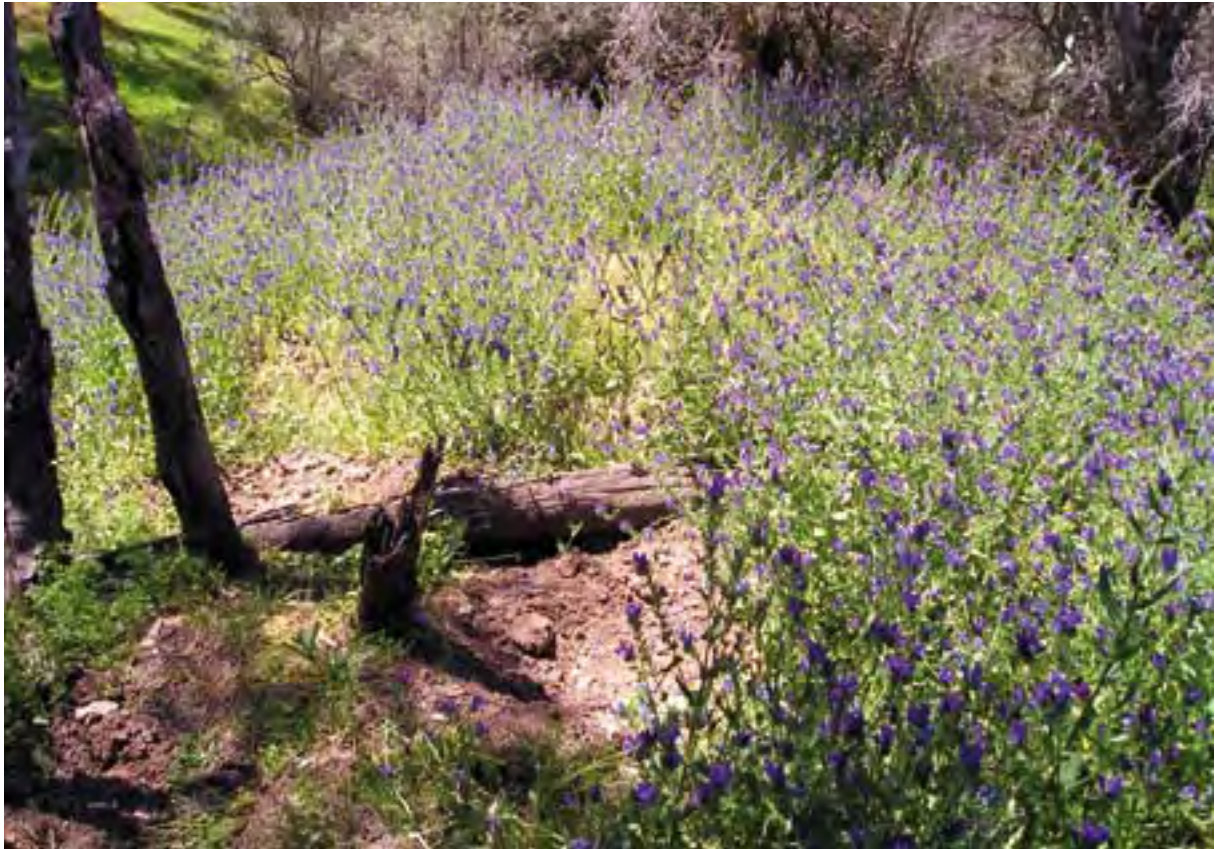
Photo 14 Patterson's curse (Echium plantegenium) in the Avon River floodway

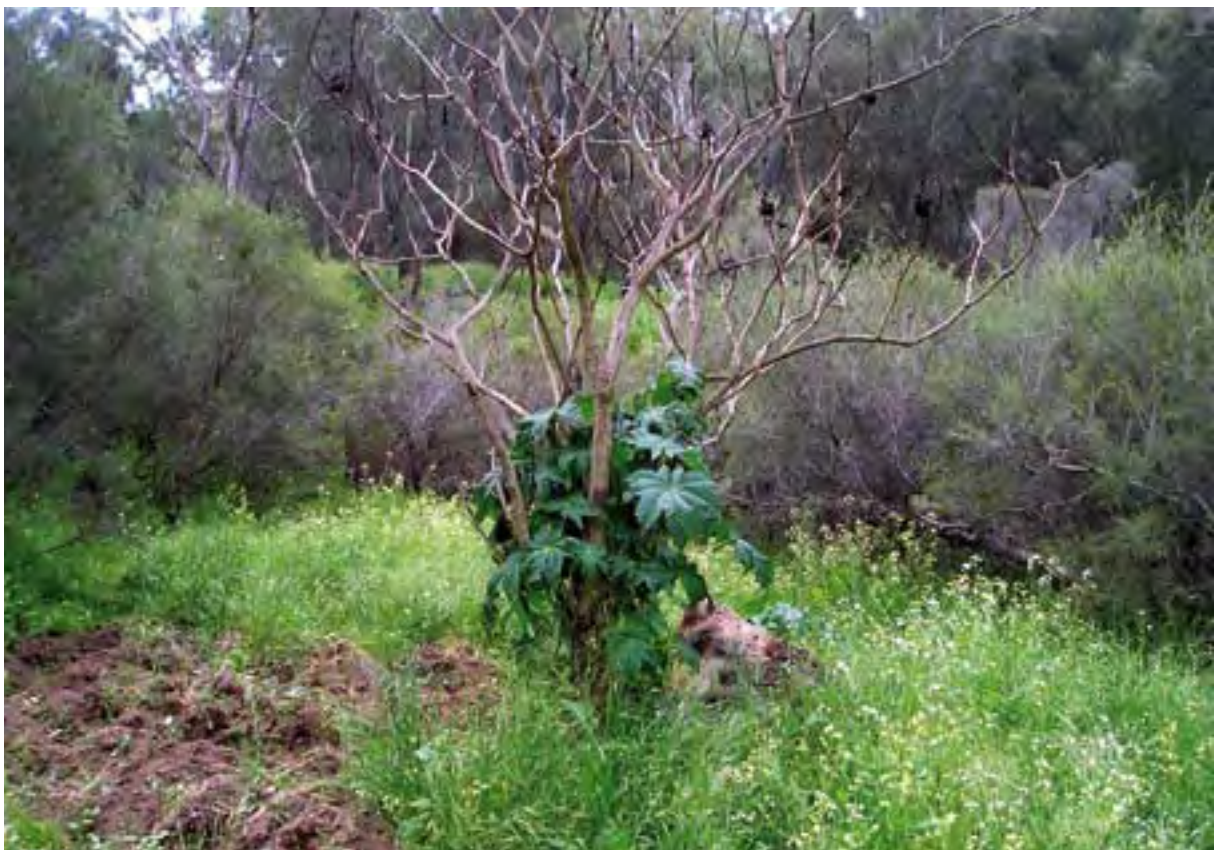
The weeds of greater concern in the riparian zone include castor oil plant (*Ricinus communis*), occurring in 19 survey sections, watsonia (*Watsonia bulbillifera*), occurring in 18 survey sections and cape tulip (*Homeria* spp.) and soursob (*Oxalis pes-caprae*) occurring in 17 survey sections. Blackberry nightshade (*Solanum nigrum*) occurs in 11 survey sections. This weed species and castor oil plant occur most commonly in association with soil disturbance caused by pigs. These weeds are currently established in the riverine environment and generally suppress regeneration of native species. Other weeds occur that are unlikely to further devalue the riparian zone. A total of 17 species of weeds were recorded during the survey. Appendix 11 shows the occurrence of these weeds for each survey section.

The distribution of weeds is significant for management. Castor oil plant (*Ricinus communis*) occurs in all sections downstream from LA14 but at only one section

Photo 15 Castor oil plant (Ricinus communis) regenerating

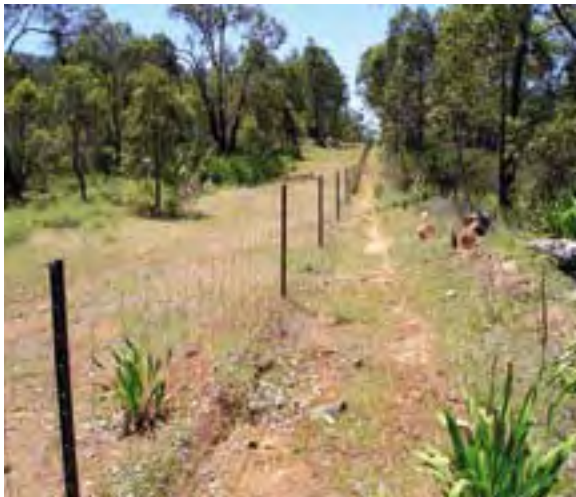
Photo 26 River fencing in good condition in section LA24

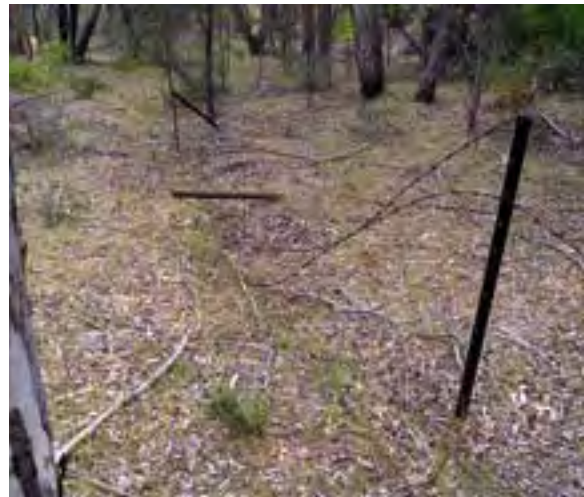
Photo 27 Fencing in poor condition adjacent to the rail corridor

A fence was constructed on the river-side of the rail infrastructure corridor at the time of rail construction to identify the boundary. This fence is now in very poor condition and serves no function, however there is no requirement for river fencing to exclude domestic animals from the river environment on the southern side of the river.
