Yallingup Brook Action Plan

1999

Prepared for Geographe Catchment Council - GeoCatch
and the Yallingup LCDC

by
Sasha Taylor
Community Environmental Management
and
Ken Tinley
Bushclan Enterprises

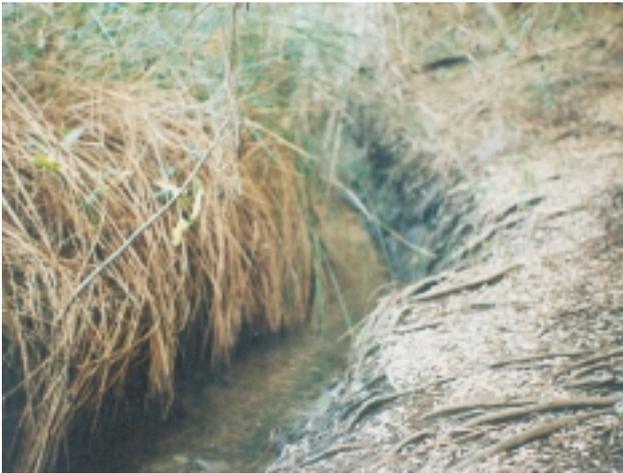
*Excellent bank cover by sedge on north bank.
Loss of vegetation cover, erosion south bank.*

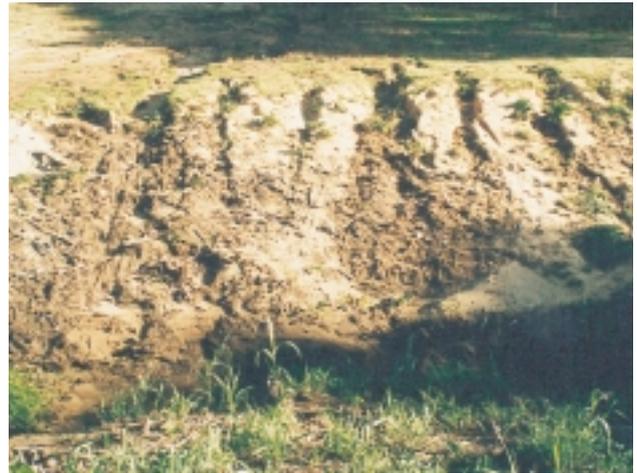
Loss of vegetation, gully and sheet erosion.

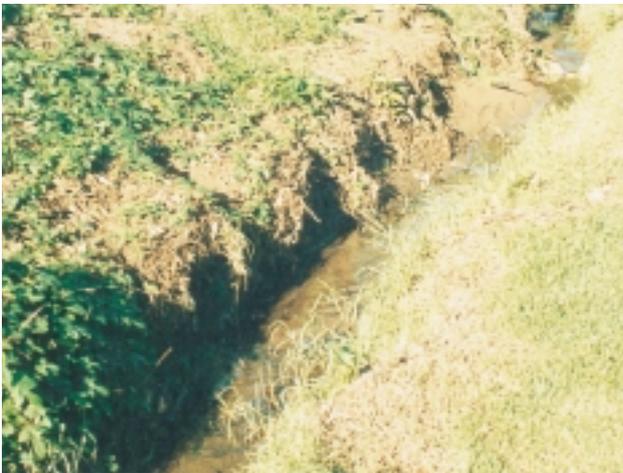
*Vegetation replaced by morning glory and kikuyu.
Undercutting, bank collapse and sediment deposition.*

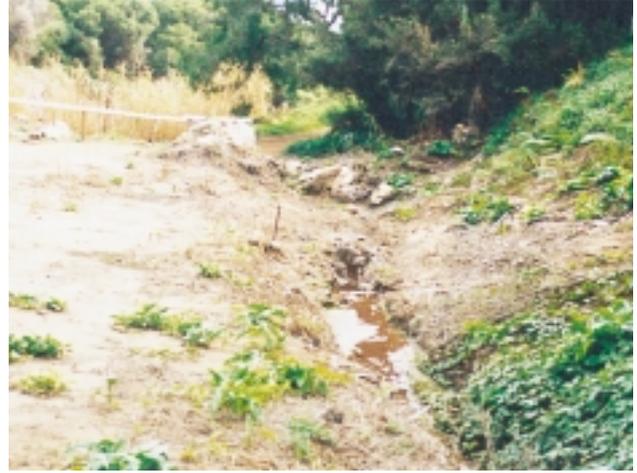
*Wide stream valley. Sheet erosion and infestation of
arum lily and morning glory.*

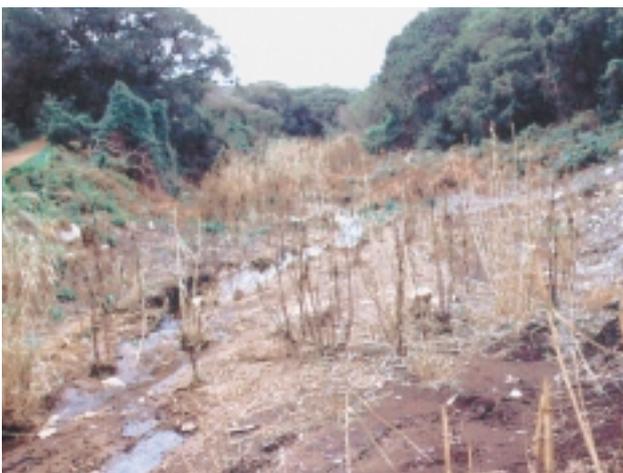
Remains of giant reed infestation after successful treatment.

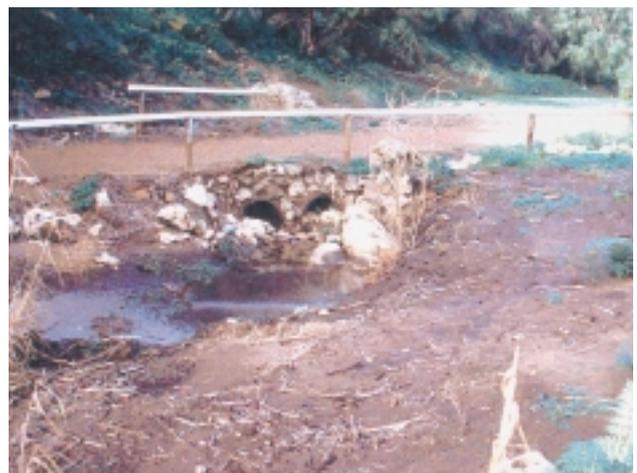
*Crossover at end of ghost trail. Exposed stream bank after
weed removal.*

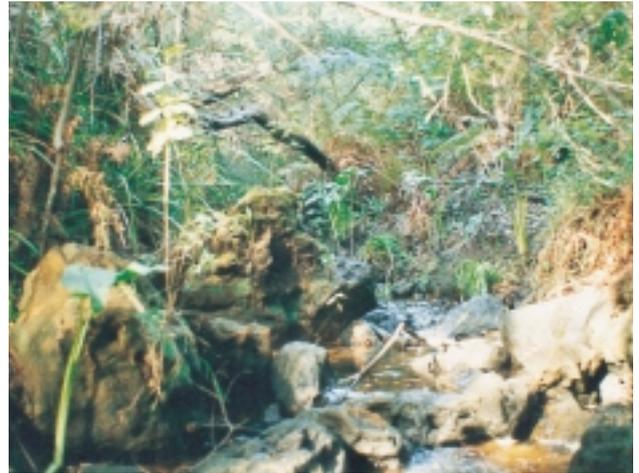
Good vegetation cover; localised weed infestations. Exposed basement rock creating riffles and pools.

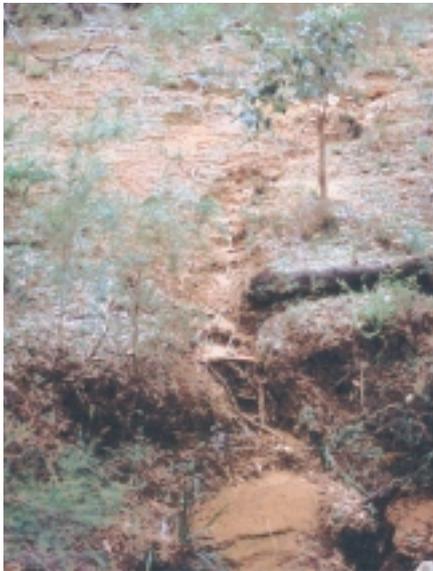
Loss of vegetation cover; gully and sheet erosion along powerline track.

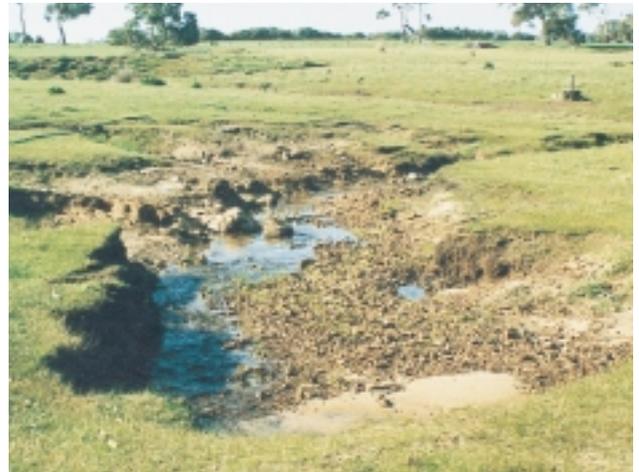
Gully and sheet erosion through pasture. Areas of exposed rocky streambed can be useful for stock crossings.
