# Capel River Action Plan

1999

Prepared for Geographe Catchment Council - GeoCatch  
and the Capel Land Conservation District Committee

by  
Kirrily White and Sarah Comer  
in association with  
Evangelisti & Associates

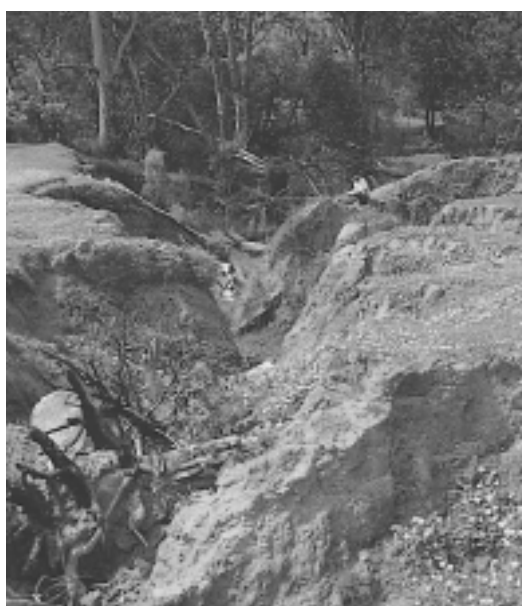
Plate 12: Severe gully erosion on the Capel River.

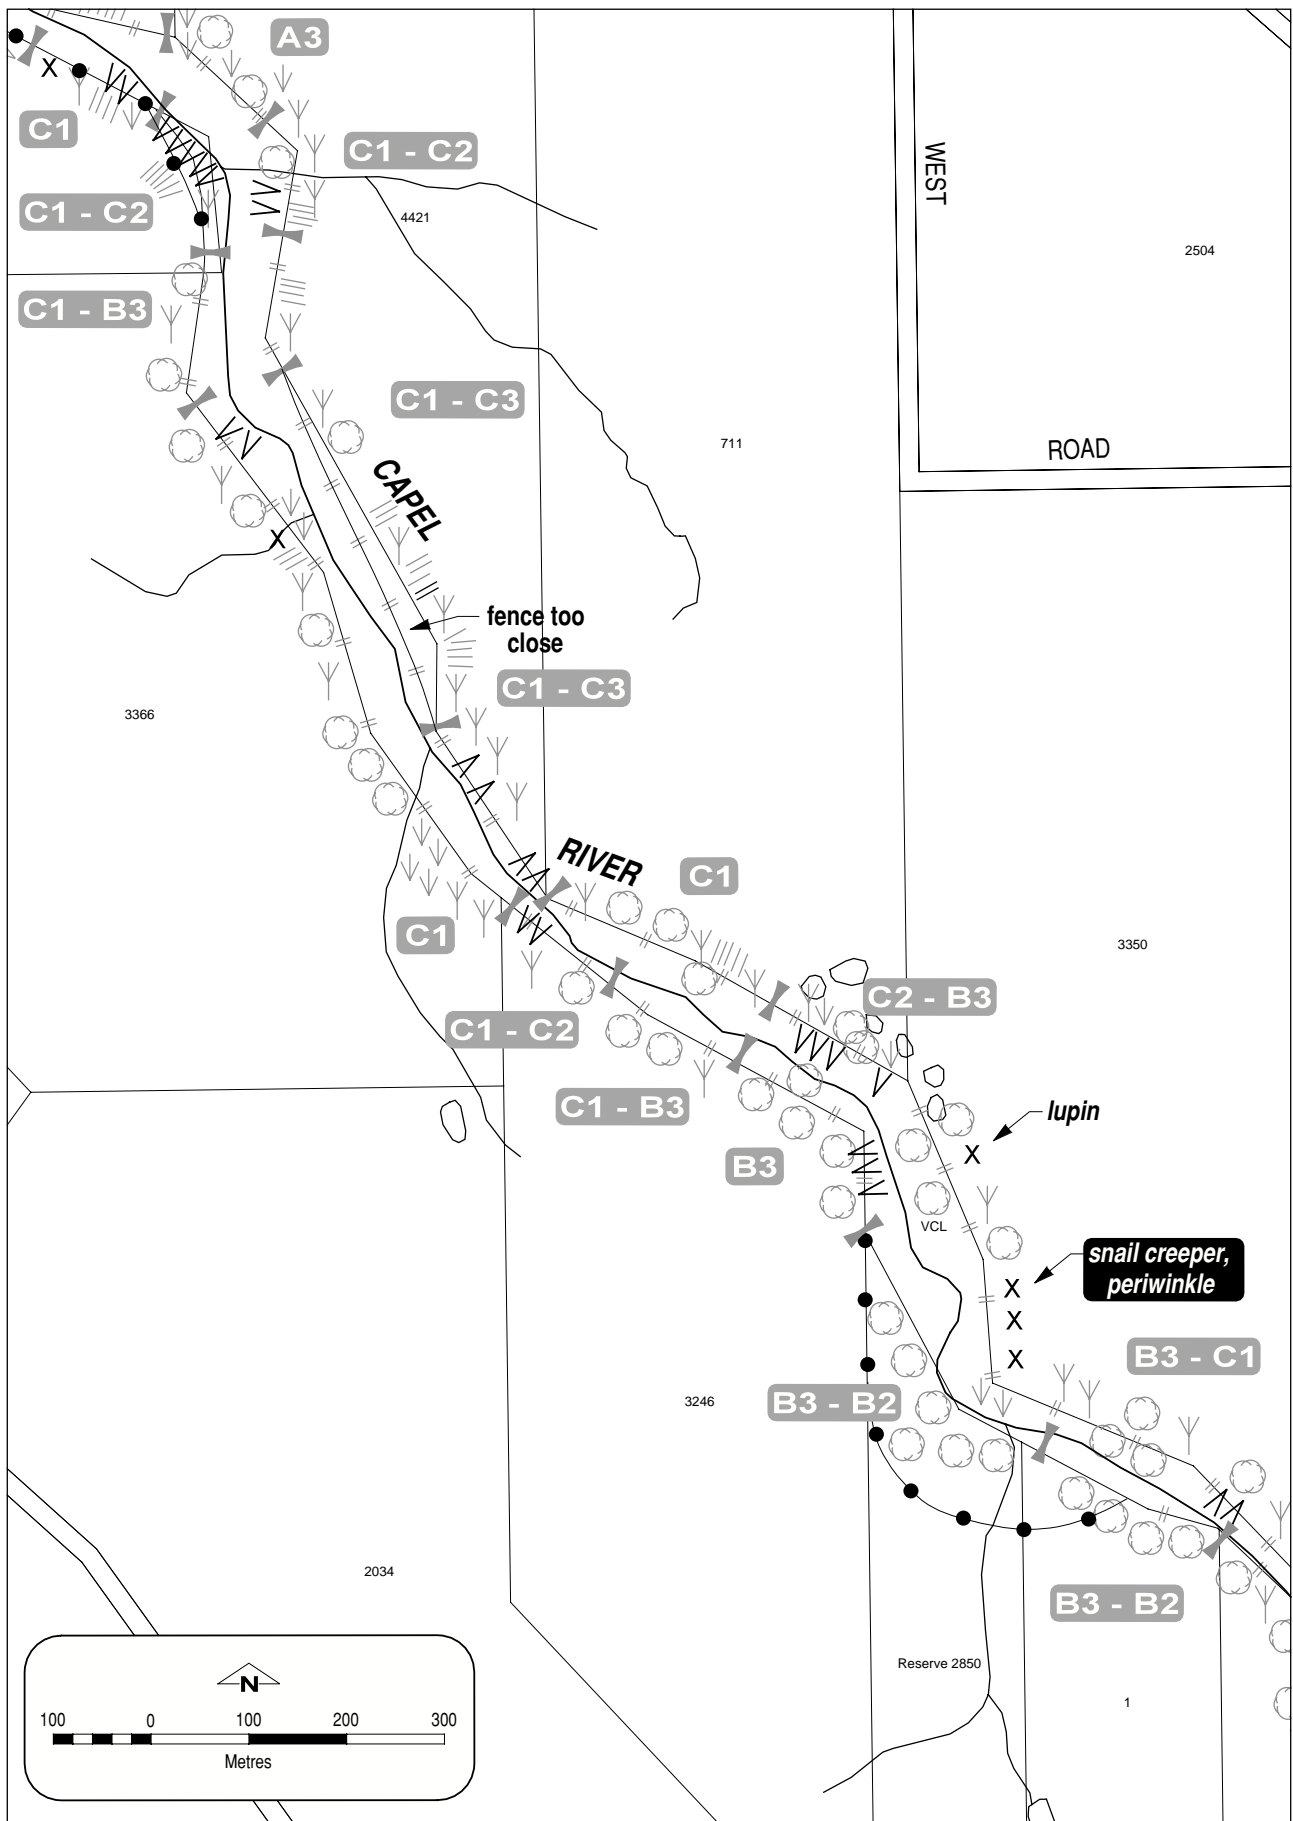
Capel River Map 9

Weed invasion	Periwinkle, snowdrops and snail creeper.	Refer to Specific weed management advice Chapter 8.1.2 points 4, 14 and 13 (pages 23 & 25).
Other management comments	Good source of seed for revegetation around soaks on reserve 2850.	Complete detailed vegetation survey of vegetation surrounding the soak on reserve 2850.

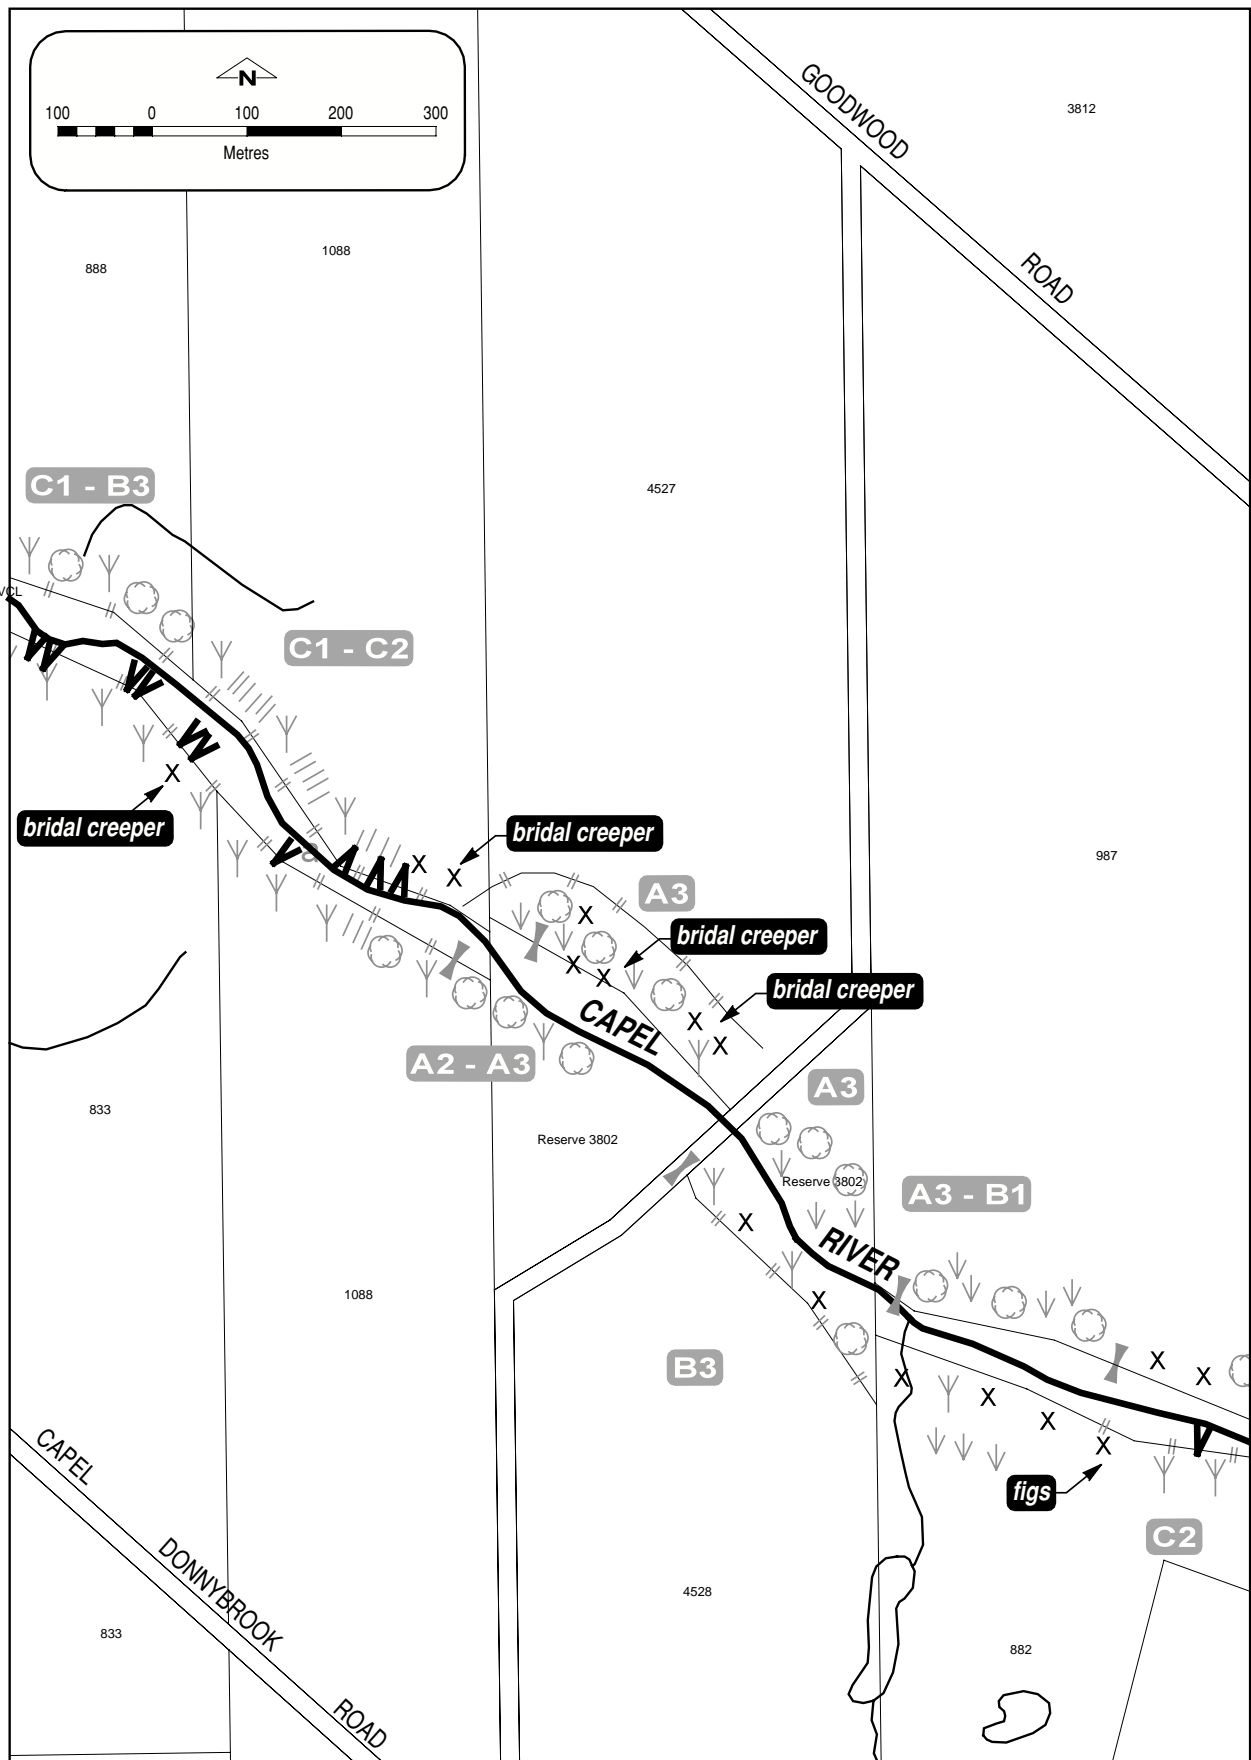
Capel River Map 12

Weed invasion	Some arum lily and bridal creeper, occasional Pittosporum and patches of figs found in this section.	Refer to Specific weed management advice Chapter 8.1.2 points 2, 5, 10 and 15 (pages 23 - 25).
Other management comments	Stock access point needs maintenance to limit area of access on foreshore. Reserve 3802 contains good quality remnant vegetation.	Complete a detailed vegetation survey of reserve 3802.
