Tributary Foreshore Assessment: Bennett Brook

Conservation and Ecosystem Management Division

March 2019

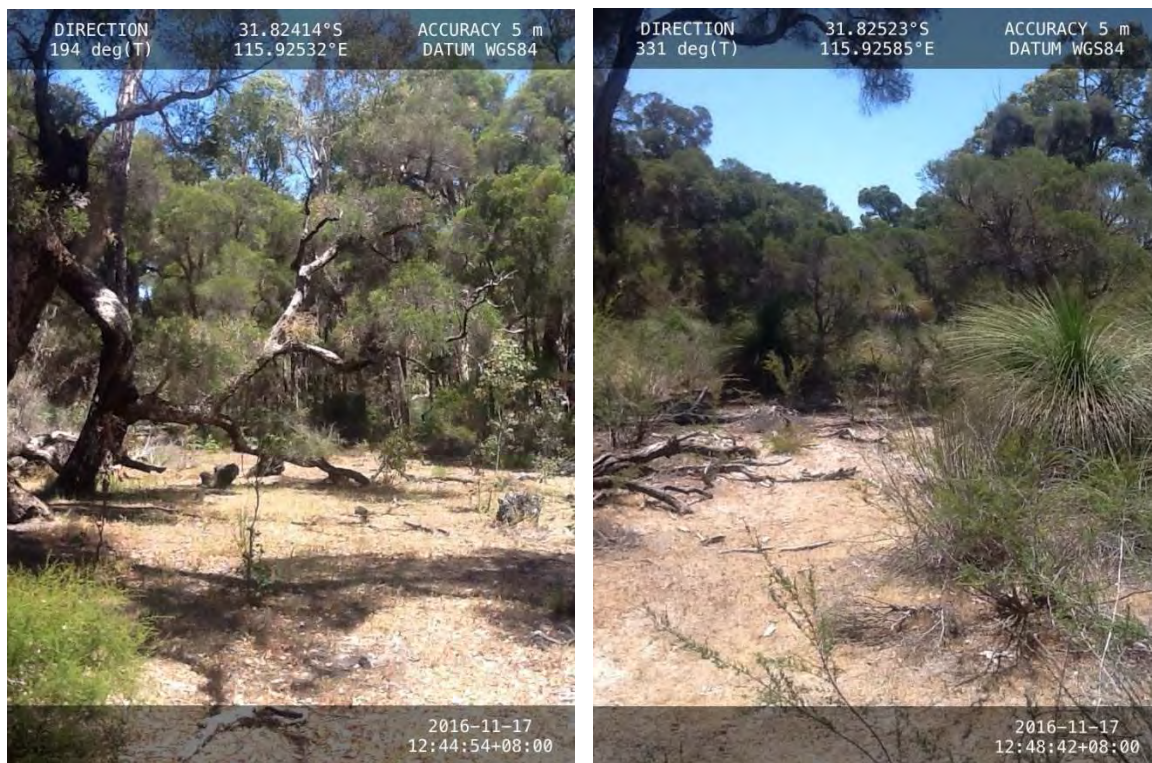
The headwaters of Bennett Brook are shallow and gently sloping (*Figure 18-19*). The channel is difficult to distinguish as the landscape is flat and riparian vegetation is dispersed among dryland plants.

Figure 18 (left) and Figure 19 (right): Shallow, undefined banks near the headwaters.

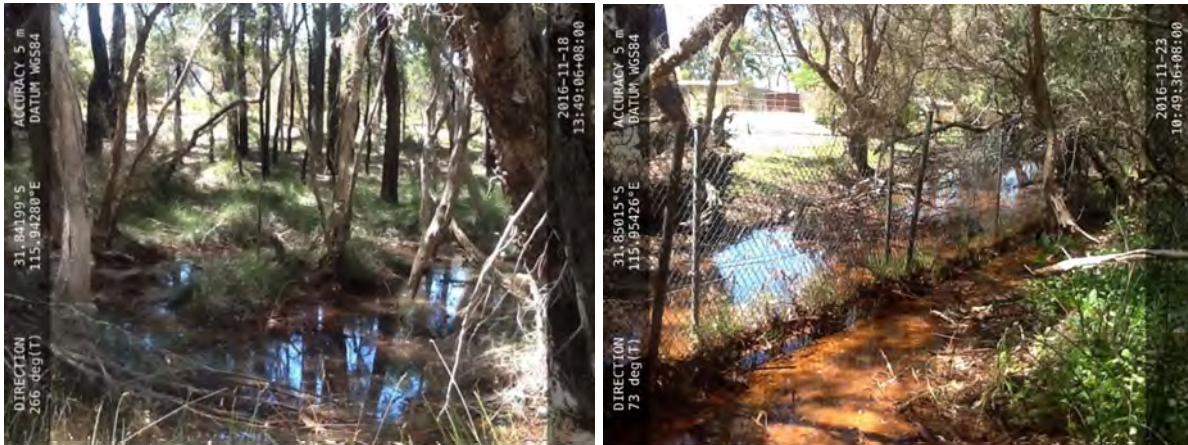
Bank stability is good for most of the North section (*Figure 24*). In only three segments erosion or sedimentation were noted. At the headwaters localised sedimentation was associated with a culvert on the Beechboro Road North crossing. A sand-based dam is located in the brook near the northern-most rail crossing (*Figure 22*). Near another rail crossing about 700m north of Mussel Pool, the rail embankment appears to have impeded water flow and the surface water was stagnant (*Figure 20*).

Figure 20 (left): Slow-flowing to stagnant water north of Mussel Pool.

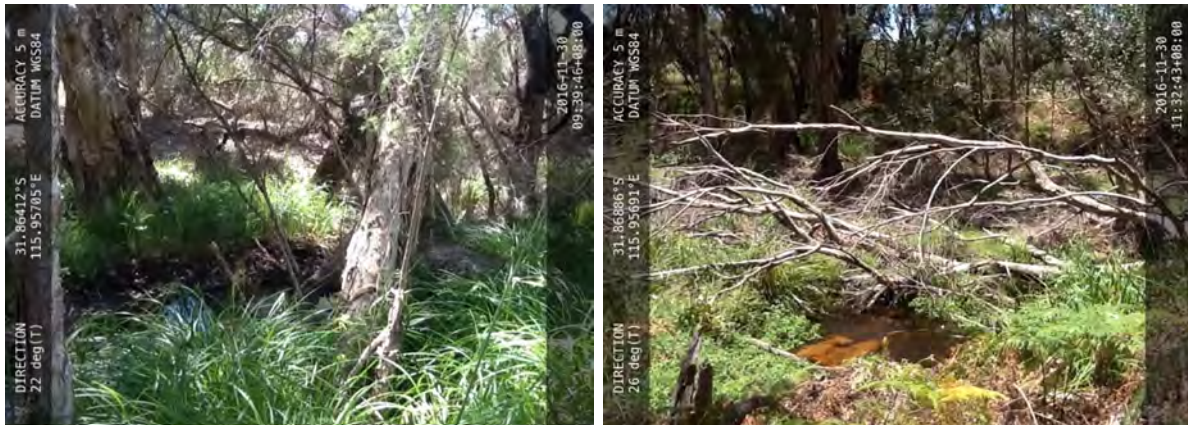
Figure 29 (left): Typical bank structure in the Central section.
 Figure 30 (right): Small areas of localised sedimentation only were found.

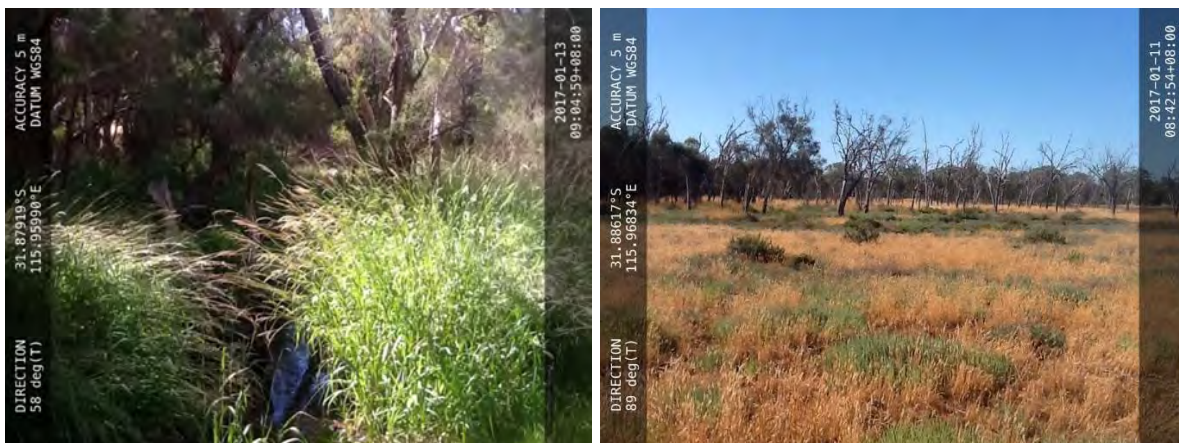
Figure 38 (left): Drainage channels on the western side of Grogan Swamp.

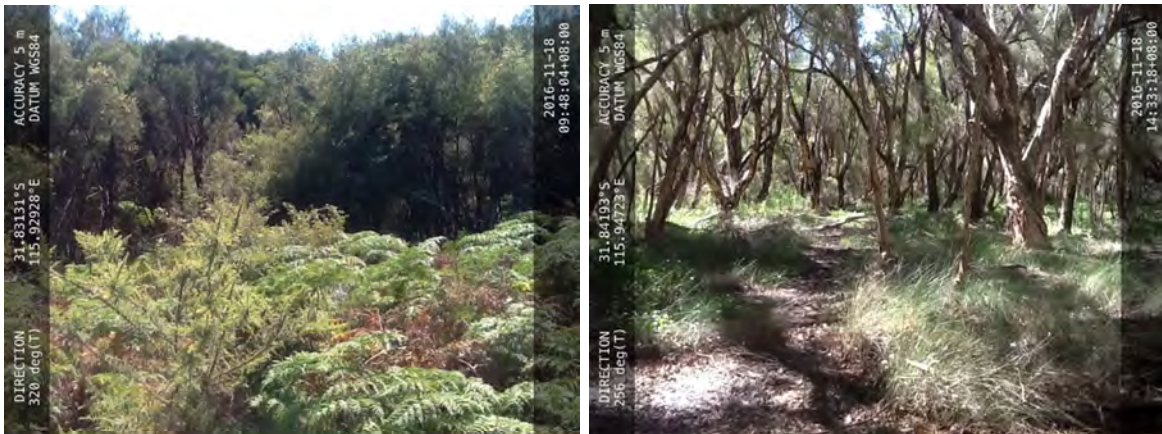
Figure 55 (left): Bracken fern is dominant in areas of the upper bank.

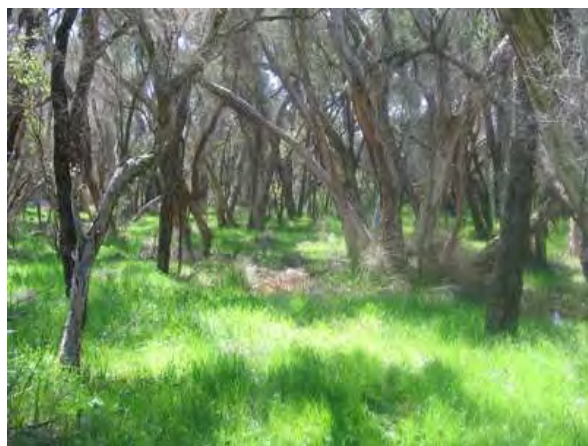
Figure 60 (right): Understorey south of Mussel Pool dominated by weeds in 2007.

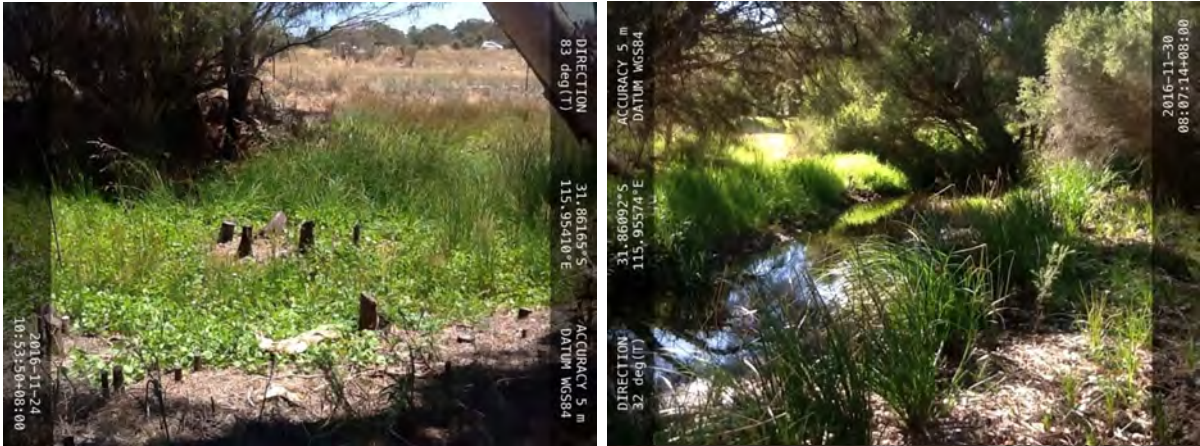
Figure 62 (left): Some mature *Acacia saligna* were removed from Bandicoot Creek to prevent the spread of *Acacia gall rust*.

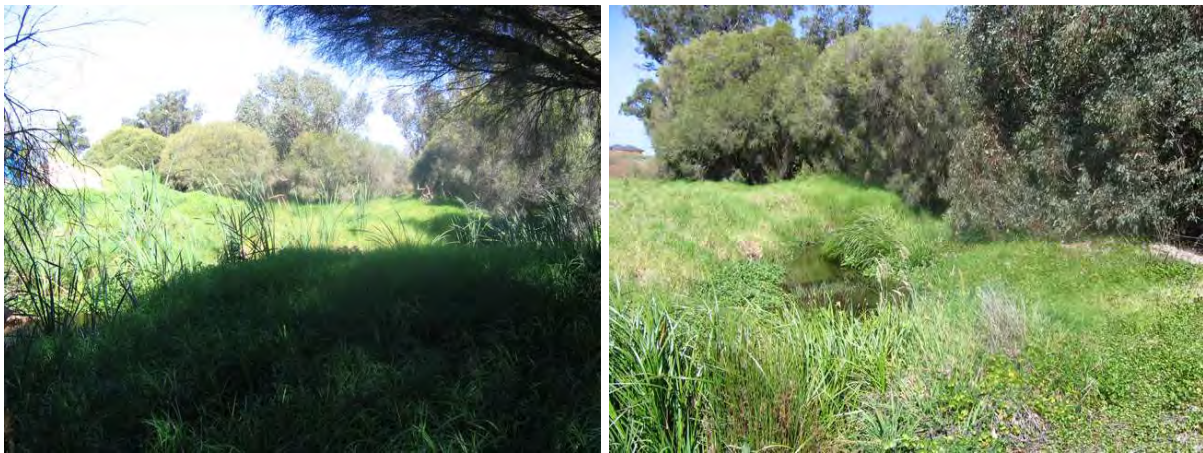
Figure 64 (left) and Figure 65 (right): Kikuyu dominated understorey near the Bandicoot Creek confluence in 2007.

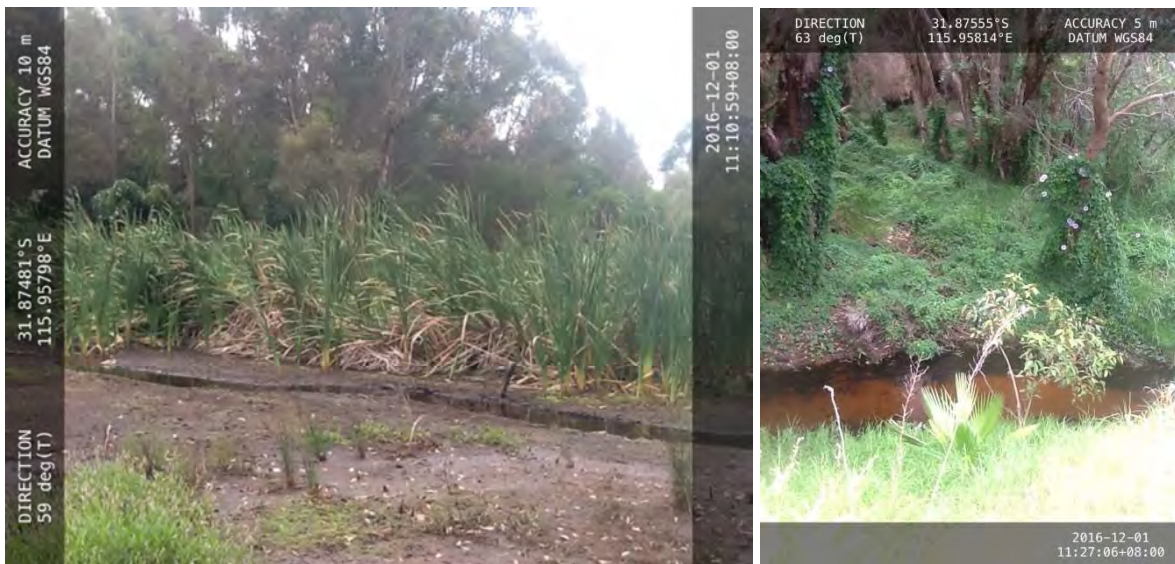
Figure 68 (left): *Typha* population north of Benara Road that Friends of Bennett Brook have removed in stages.

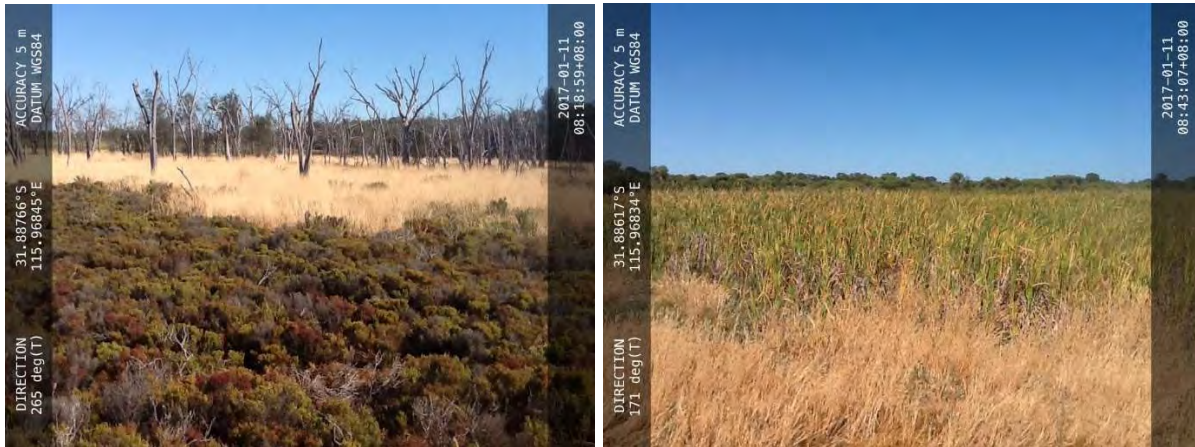
Figure 81 (left): Samphire flats with dead swamp sheoak in the background.
 Figure 82 (right): Typha population on the eastern side of Grogan Swamp.

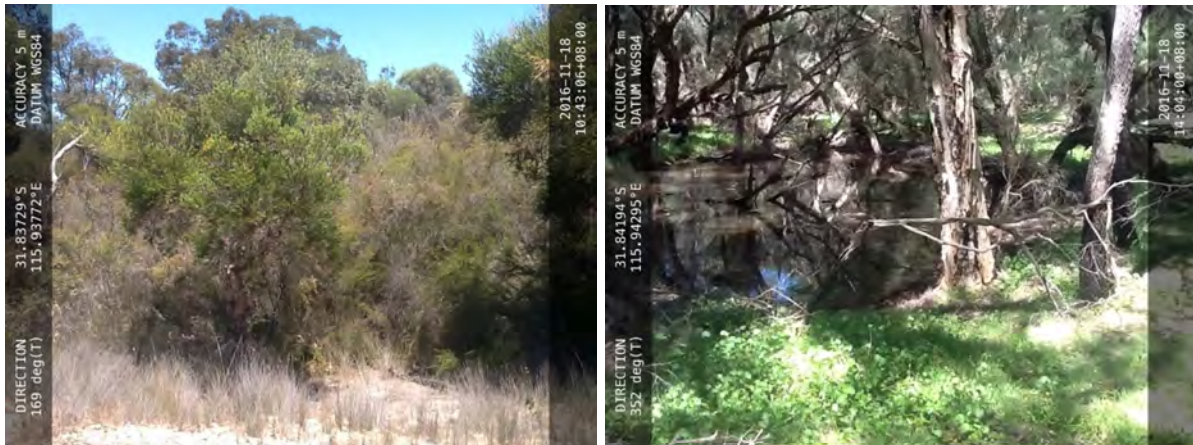
Figure 89 (left): Scattered annual grasses on the upper bank.

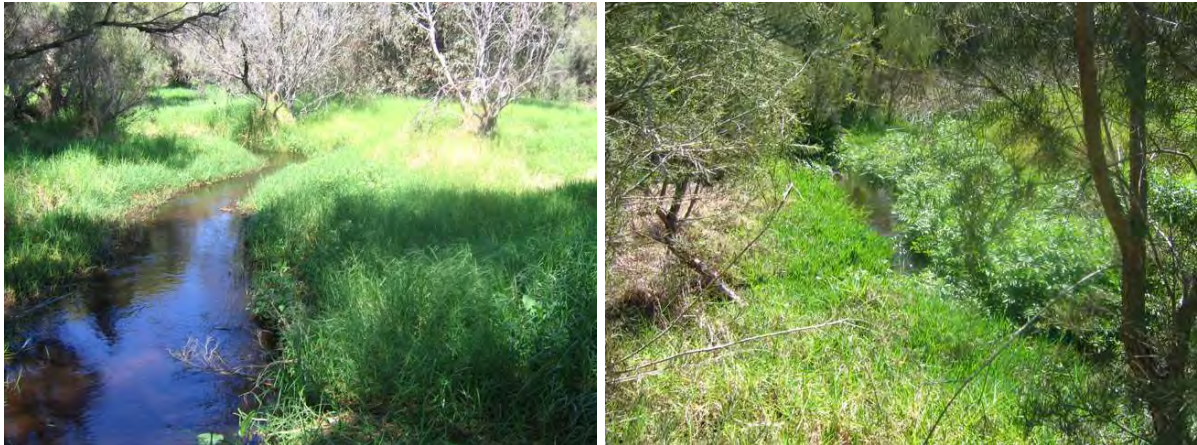
Figure 98 (left) and Figure 99 (right): Weed dominated understorey north of Reid Highway in 2007.

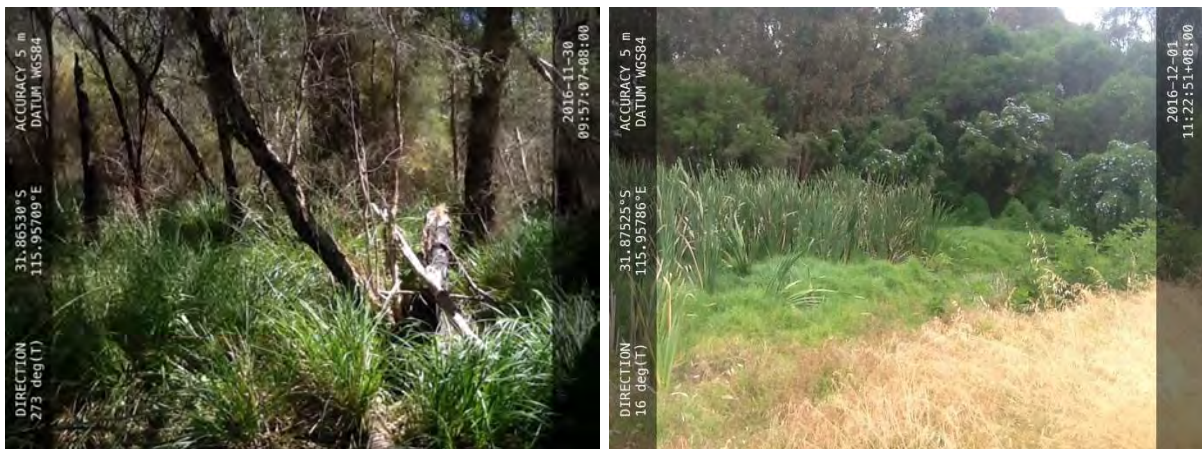
Figure 100 (left): In many areas between Bandicoot Creek and Simla Park the native sedge *Carex fascicularis* has outcompeted what had been a weedy understorey.
 Figure 101 (right): Dense kikuyu and morning glory infestation north of Benara Road.

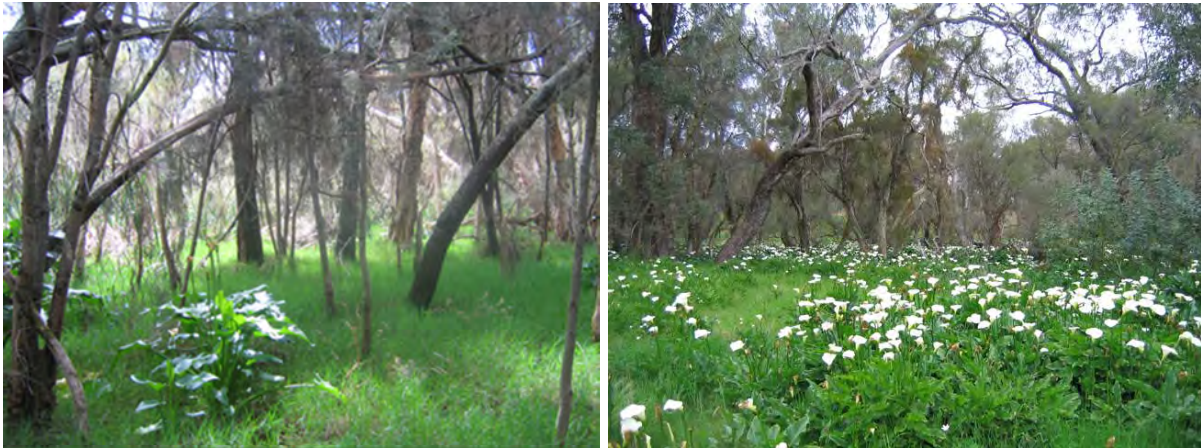
Figure 107 (left): Grass dominated understory on eastern side of Grogan Swamp, 2007.
