Tributary Foreshore Assessment Report: Helena River (Mandoon)

Version: 1.2

Last Updated: 31 January 2018

Custodian: Rivers and Estuaries Division

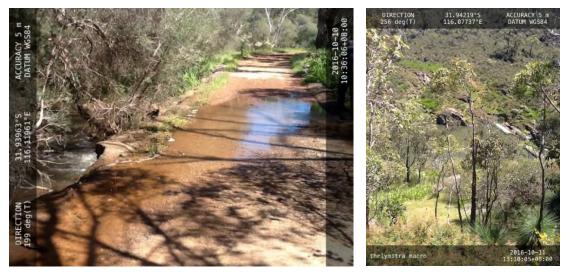
Figure 10: Localised flooding occurs above this small ford. Figure 11: Steep banks above the Pumpback Dam.

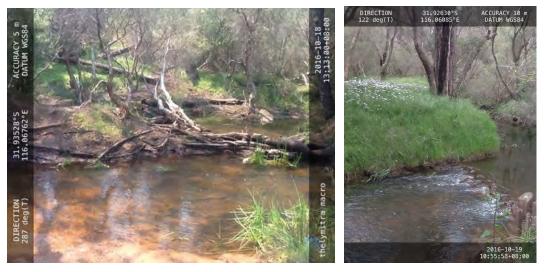
Figure 13: 1-2m medium sloped bank in Helena Valley. Figure 14: 1-2m steep sloped bank in Helena Valley.

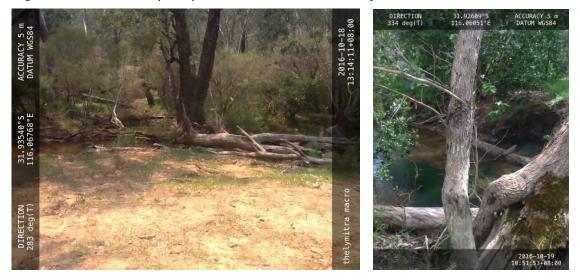
Siemon (2001) found localised occurrences of erosion and slumping in the 600m assessed upstream of Scott Street, especially on the outside of river bends. Bank stability was considered poor. We could not access all 600m assessed by WRC on foot, but viewed the river from a point 1.5km upstream of the Scott Street bridge and at the bridge where bank stability is now considered average.

Figure 15: Exposed riverbank near Craignish Gauging Station. Figure 16: Erosion on a riverbend on private property in Helena Valley.

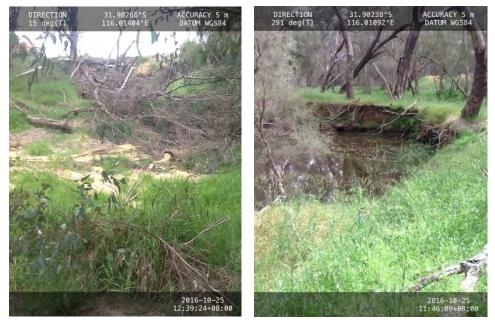
Bank stability is poor in a drain from a small wetland near an industrial property in Midland, where there is erosion and sedimentation downslope from the industrial site. A significant amount of sand has also mobilised down an embankment from another industrial property in Midland, causing both erosion and sedimentation on the floodplain.

Figure 17: Sedimentation downslope from an industrial property in Midland. Figure 18: Incised bank on grazed floodplain in Midland.

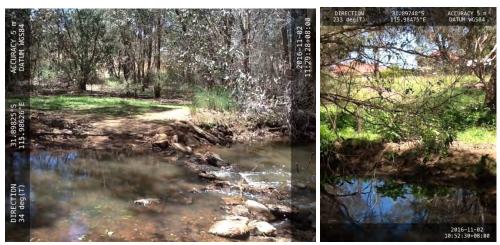
Figure 19: 0.5-1m medium slope bank in South Guildford. Figure 20: 0.5-1m steep slope bank in Woodbridge.

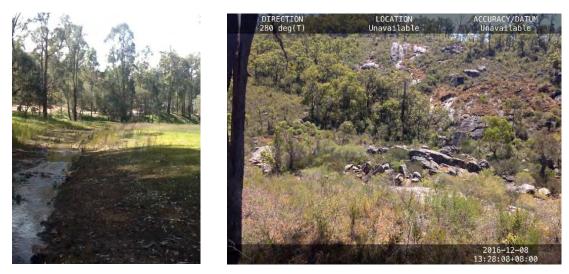
Figure 27: Poor condition vegetation immediately downstream of Mundaring Weir. Figure 28: Granite dominated area with good condition vegetation.

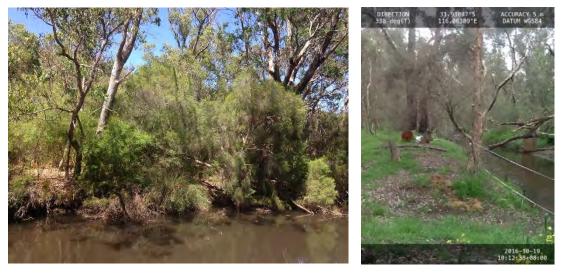
Figure 29: Remnant riparian vegetation in Beelu National Park. Figure 30: Understorey dominated by weedy grasses and herbs, Helena Valley.

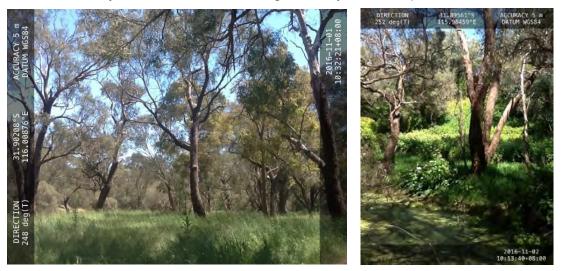
Figure 31: Connected upperstorey of Eucalyptus rudis *in the floodplain in Midland. Figure 32: Understorey of arum lily and nasturtium in Guildford.*

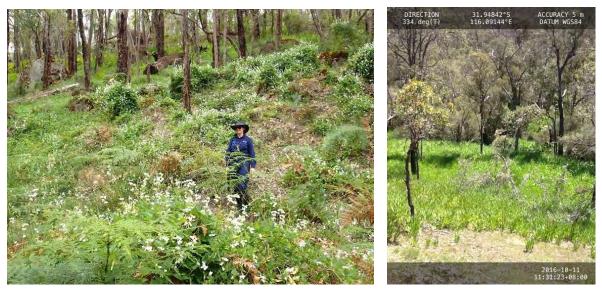
Figure 36: Dolichos pea infestation about 1km downstream of Mundaring Weir. Figure 37: Dense watsonia infestation above the Pumpbank Dam.

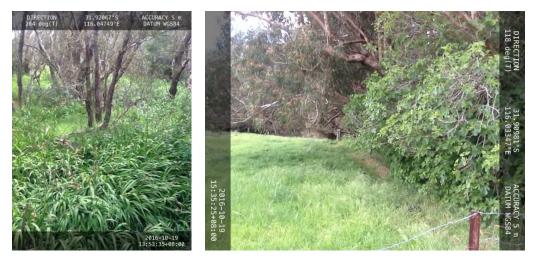
Figure 38: Dense watsonia infestation immediately downstream of Scott Street.

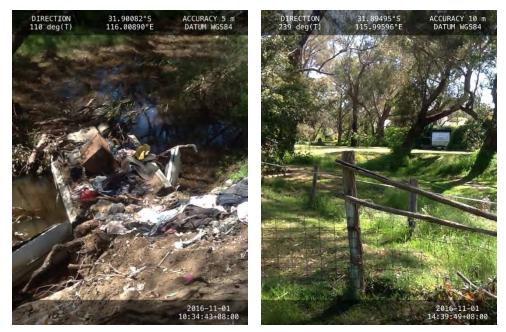
Domestic rubbish was also found near Perth Polo Ground in Guildford and reported to the Pollution Watch Hotline and the City of Swan.

Figure 49: Dumped domestic rubbish in Midland. Figure 50: Private gardens encroaching onto the watercourse.

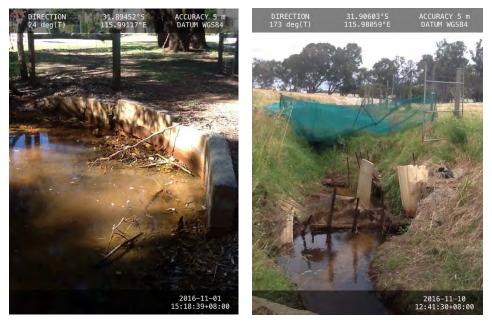
Damaged fencing is located in a drain near Rosehill Waters estate, posing a hazard to birds, and may also impact aquatic fauna if it ends up in the Helena River.

Figure 51: Stagnant water in northern alignment of the Helena River in Woodbridge. Figure 52: Damaged fencing in drain from Rosehill Estate.

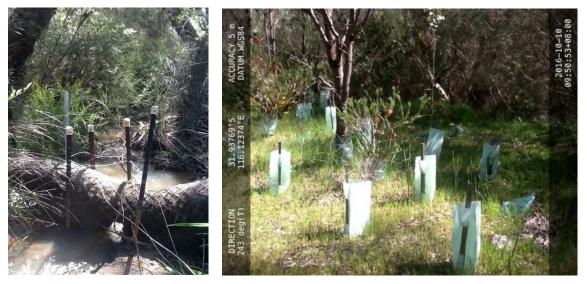
Figure 53: Coir logging in a pool downstream of Mundaring Weir Road. Figure 54: Small revegetation site requiring maintenance.

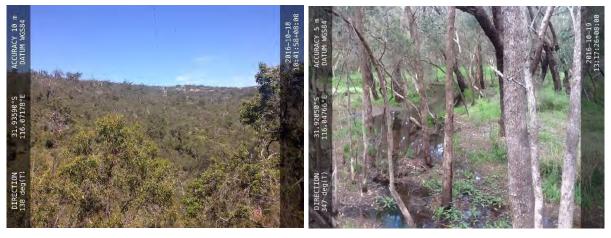
Figure 55: Watsonia has been controlled in the valley below the Pumpback Dam. Figure 56: Weed control and revegetation immediately upstream of Scott Street.

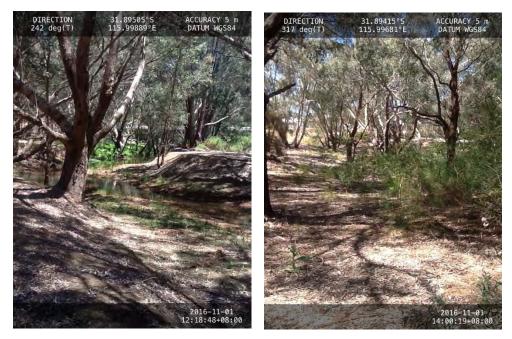
Figure 57: Revegetation site adjacent to the Men of the Trees property in Hazelmere. Figure 58: Revegetation site near Amherst Road in Woodbridge.

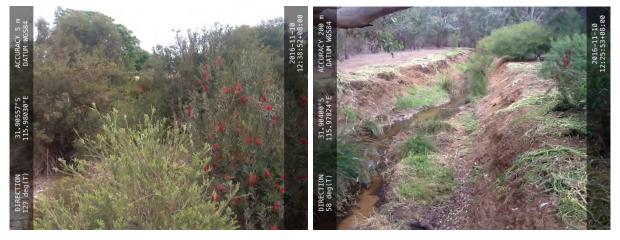
Figure 59: Revegetation site in South Guildford.

Figure 60: Recent weed control was evident in the lower part of the drain from Rosehill Estate.
