SURVEY OF STREAM FORESHORES IN THE  
SCOTSDALE BROOK CATCHMENT  
DENMARK, W A

WATER RESOURCE MANAGEMENT SERIES

WATER AND RIVERS COMMISSION REPORT WRT 19  
1998

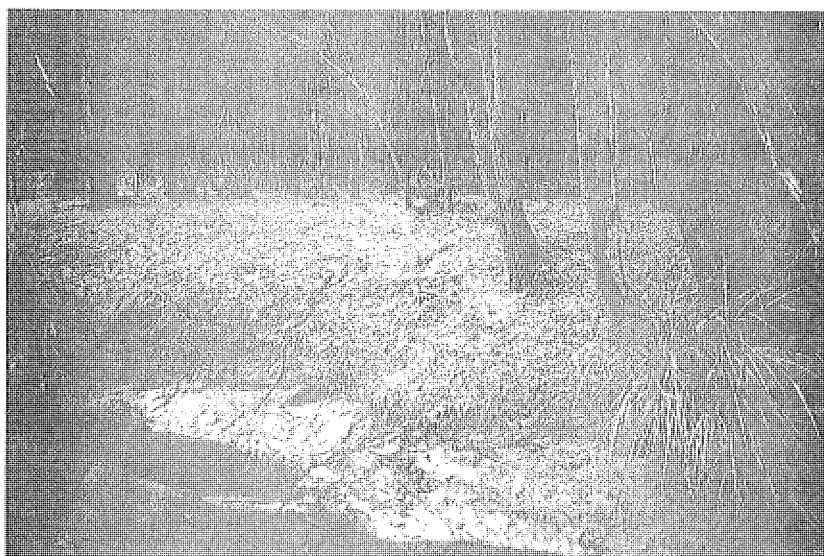
*Scotsdale Brook foreshore, showing scarcity of understorey under Peppermint (*Agonis flexuosa*) trees, and erosion along the banks.*

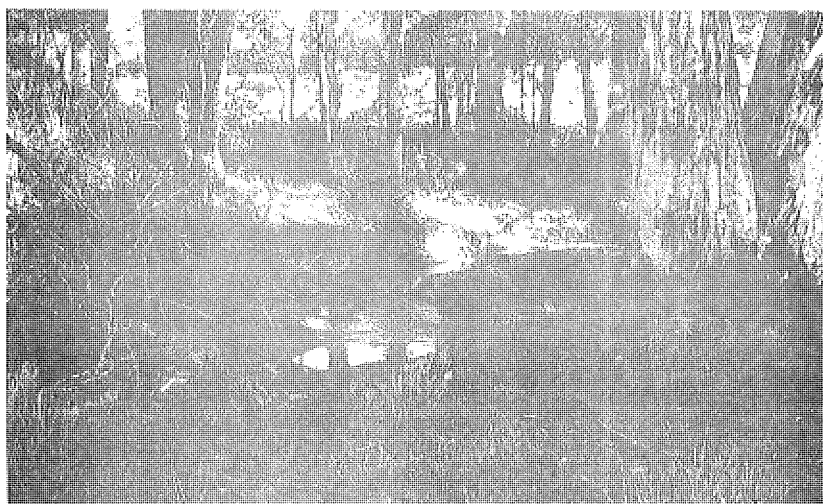
*Southern tributary of Scotsdale Brook, adjacent to karri forest remnant. B3 Grade foreshore at this point.*

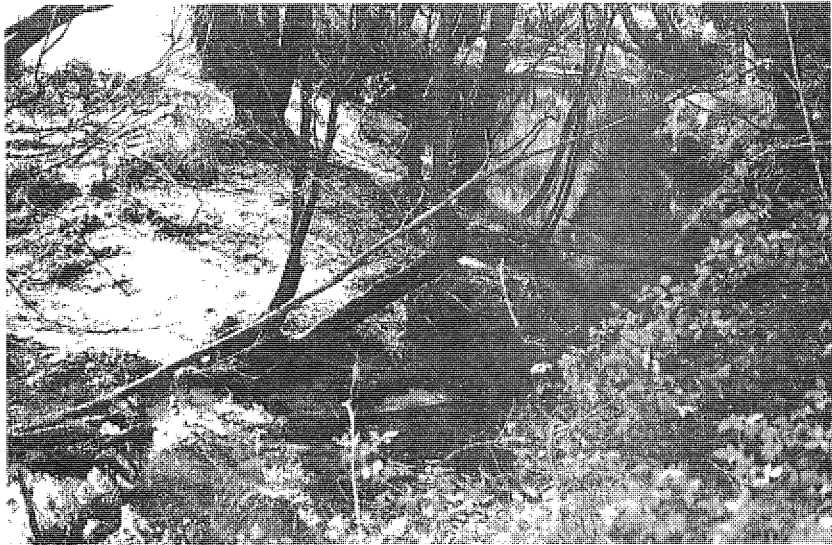
*Erosion and collapse of  
banks and trees into the  
Scotsdale Brook.*

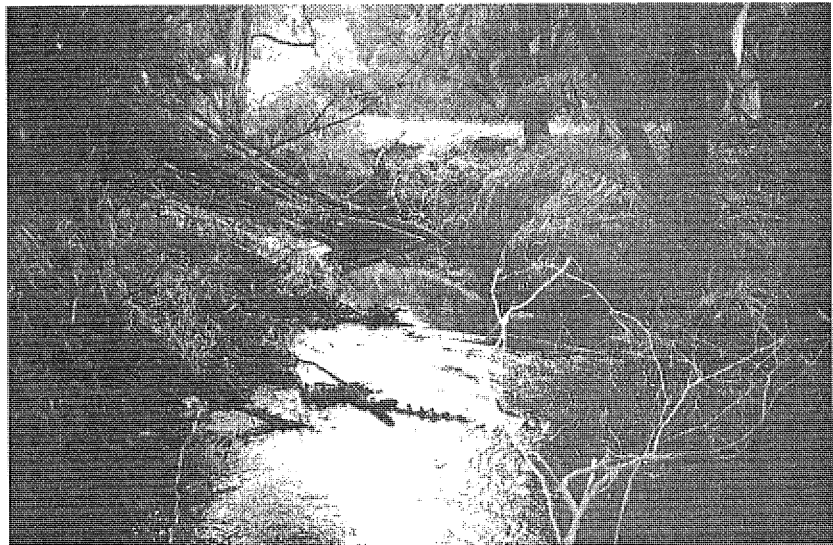
*Erosion and woody  
snags along the  
Scotsdale Brook. It is  
recommended that such  
logs not be removed, as  
they provide aquatic  
habitat.*

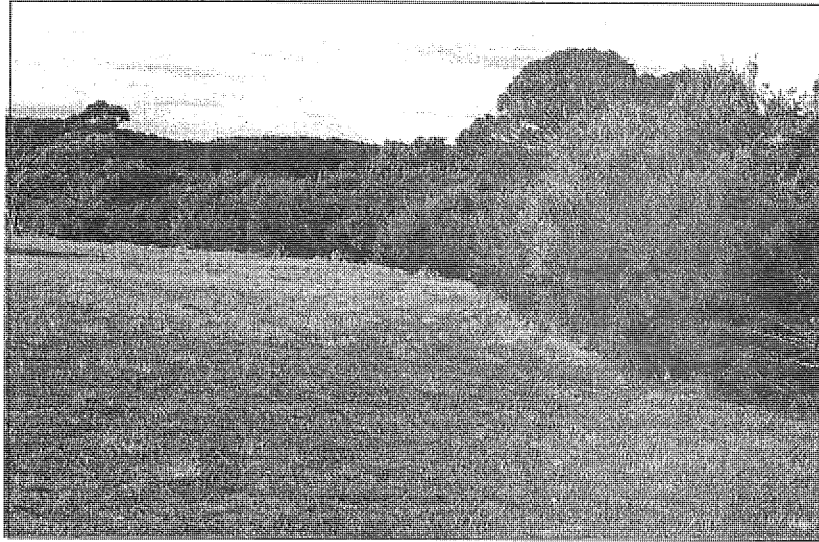
*Drain (D1 grade) through farm paddock, with Arum lily, a weed species, growing nearby.*

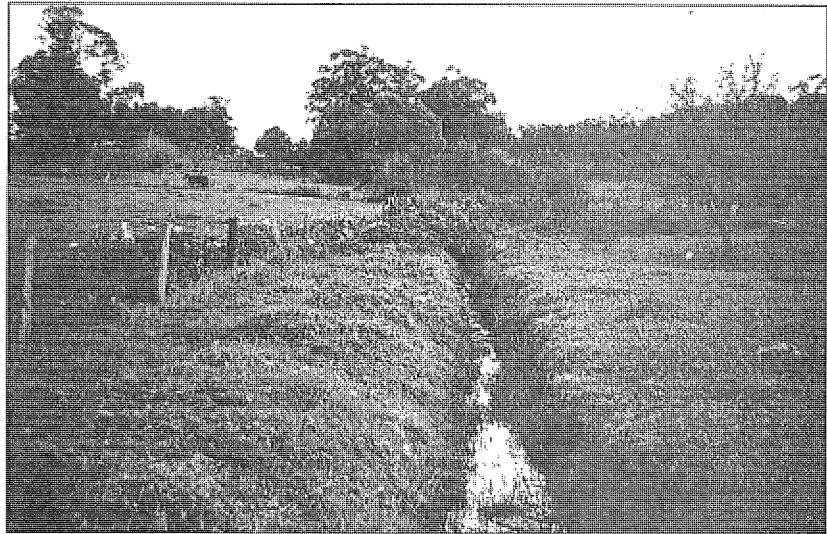
*Blackberry growing beside a waterway in the catchment. This is a major weed species and requires a carefully planned catchment approach for its control.*

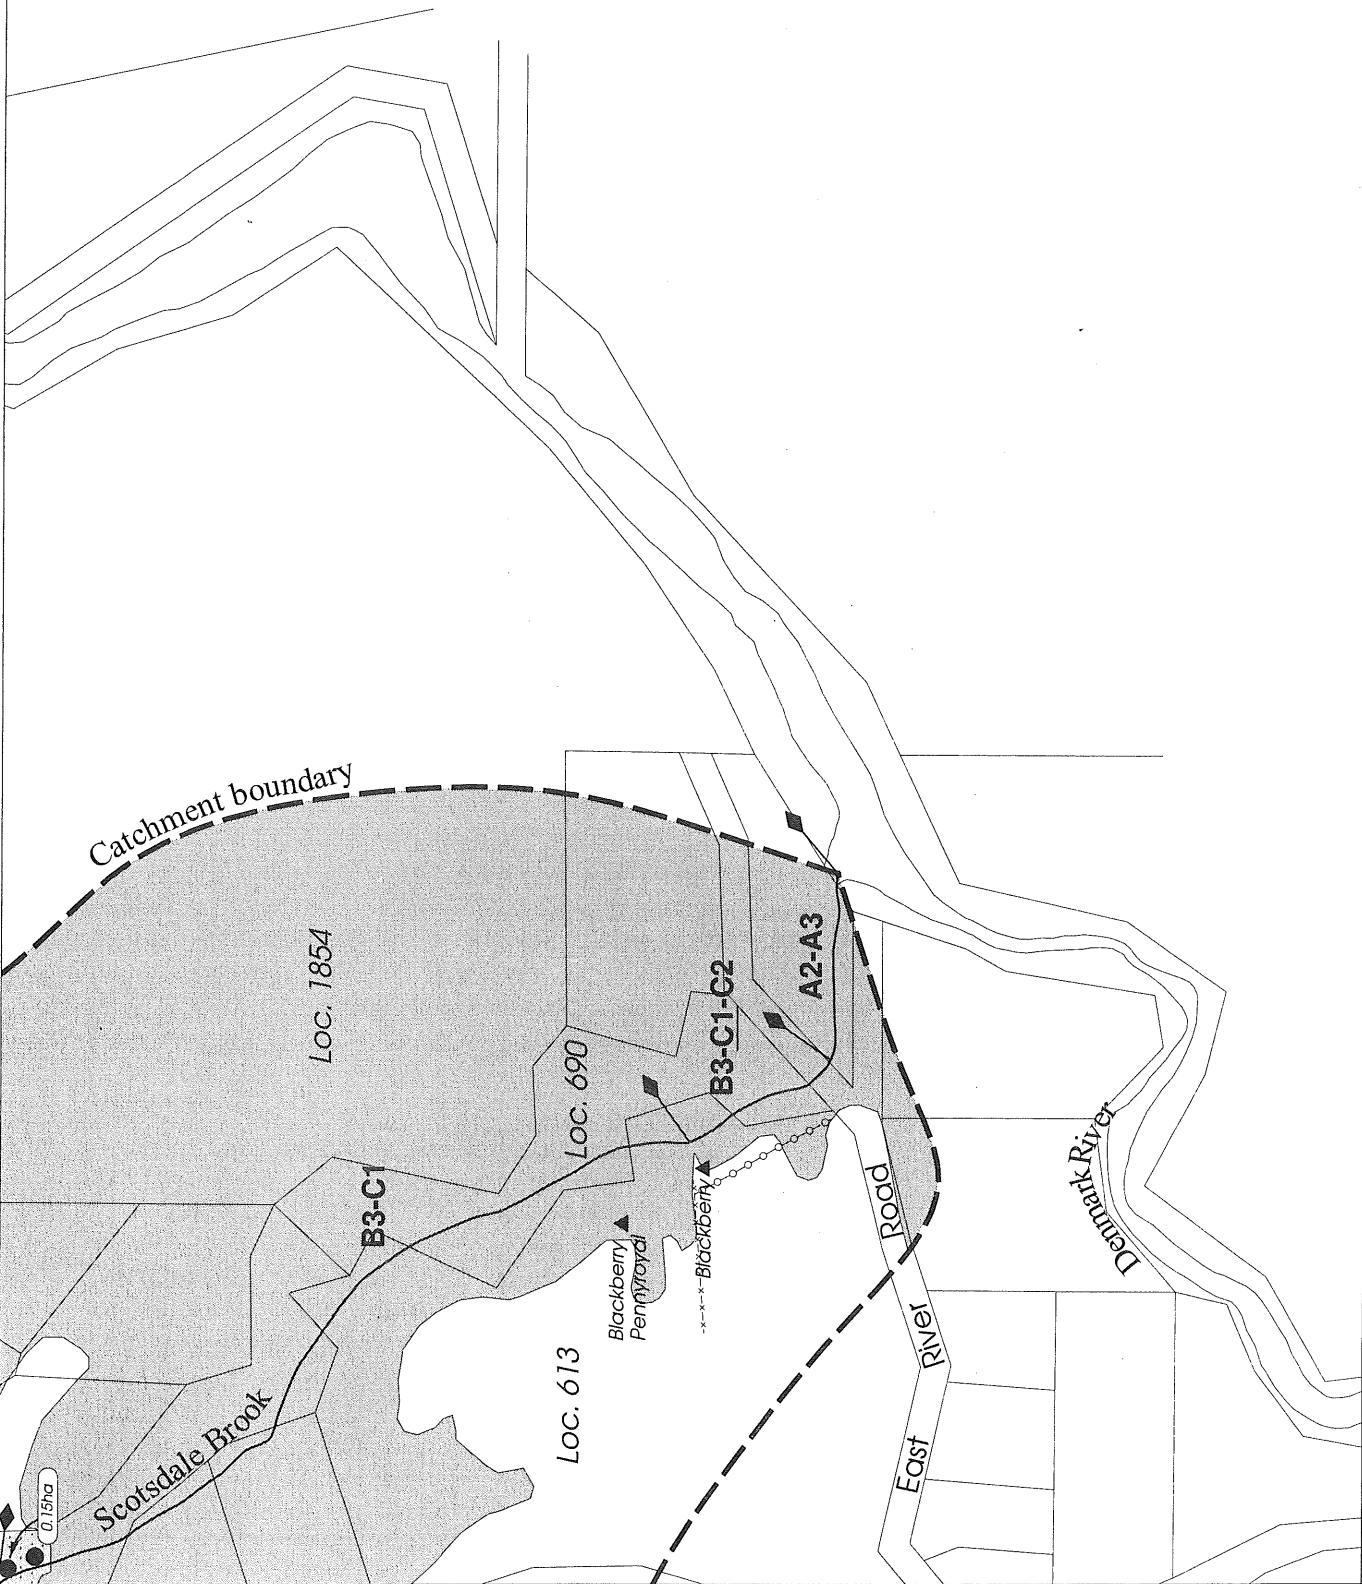
M6

| | Scotsdale Brook | Tributaries/Tributary |
|---|---|---|
| Other Management Related Information for this map | Occasional severe undercutting with slumping. The problem lies with greatly increased water volumes during flood events caused by vegetation removal in the catchment. | N/A |

| | Scotsdale Brook | Tributaries/Tributary |
|---|---|---|
| Advice on Rehabilitation of these sites | Recommendation:<br>Control Blackberry and garden escapes | Recommendation:<br>N/A |

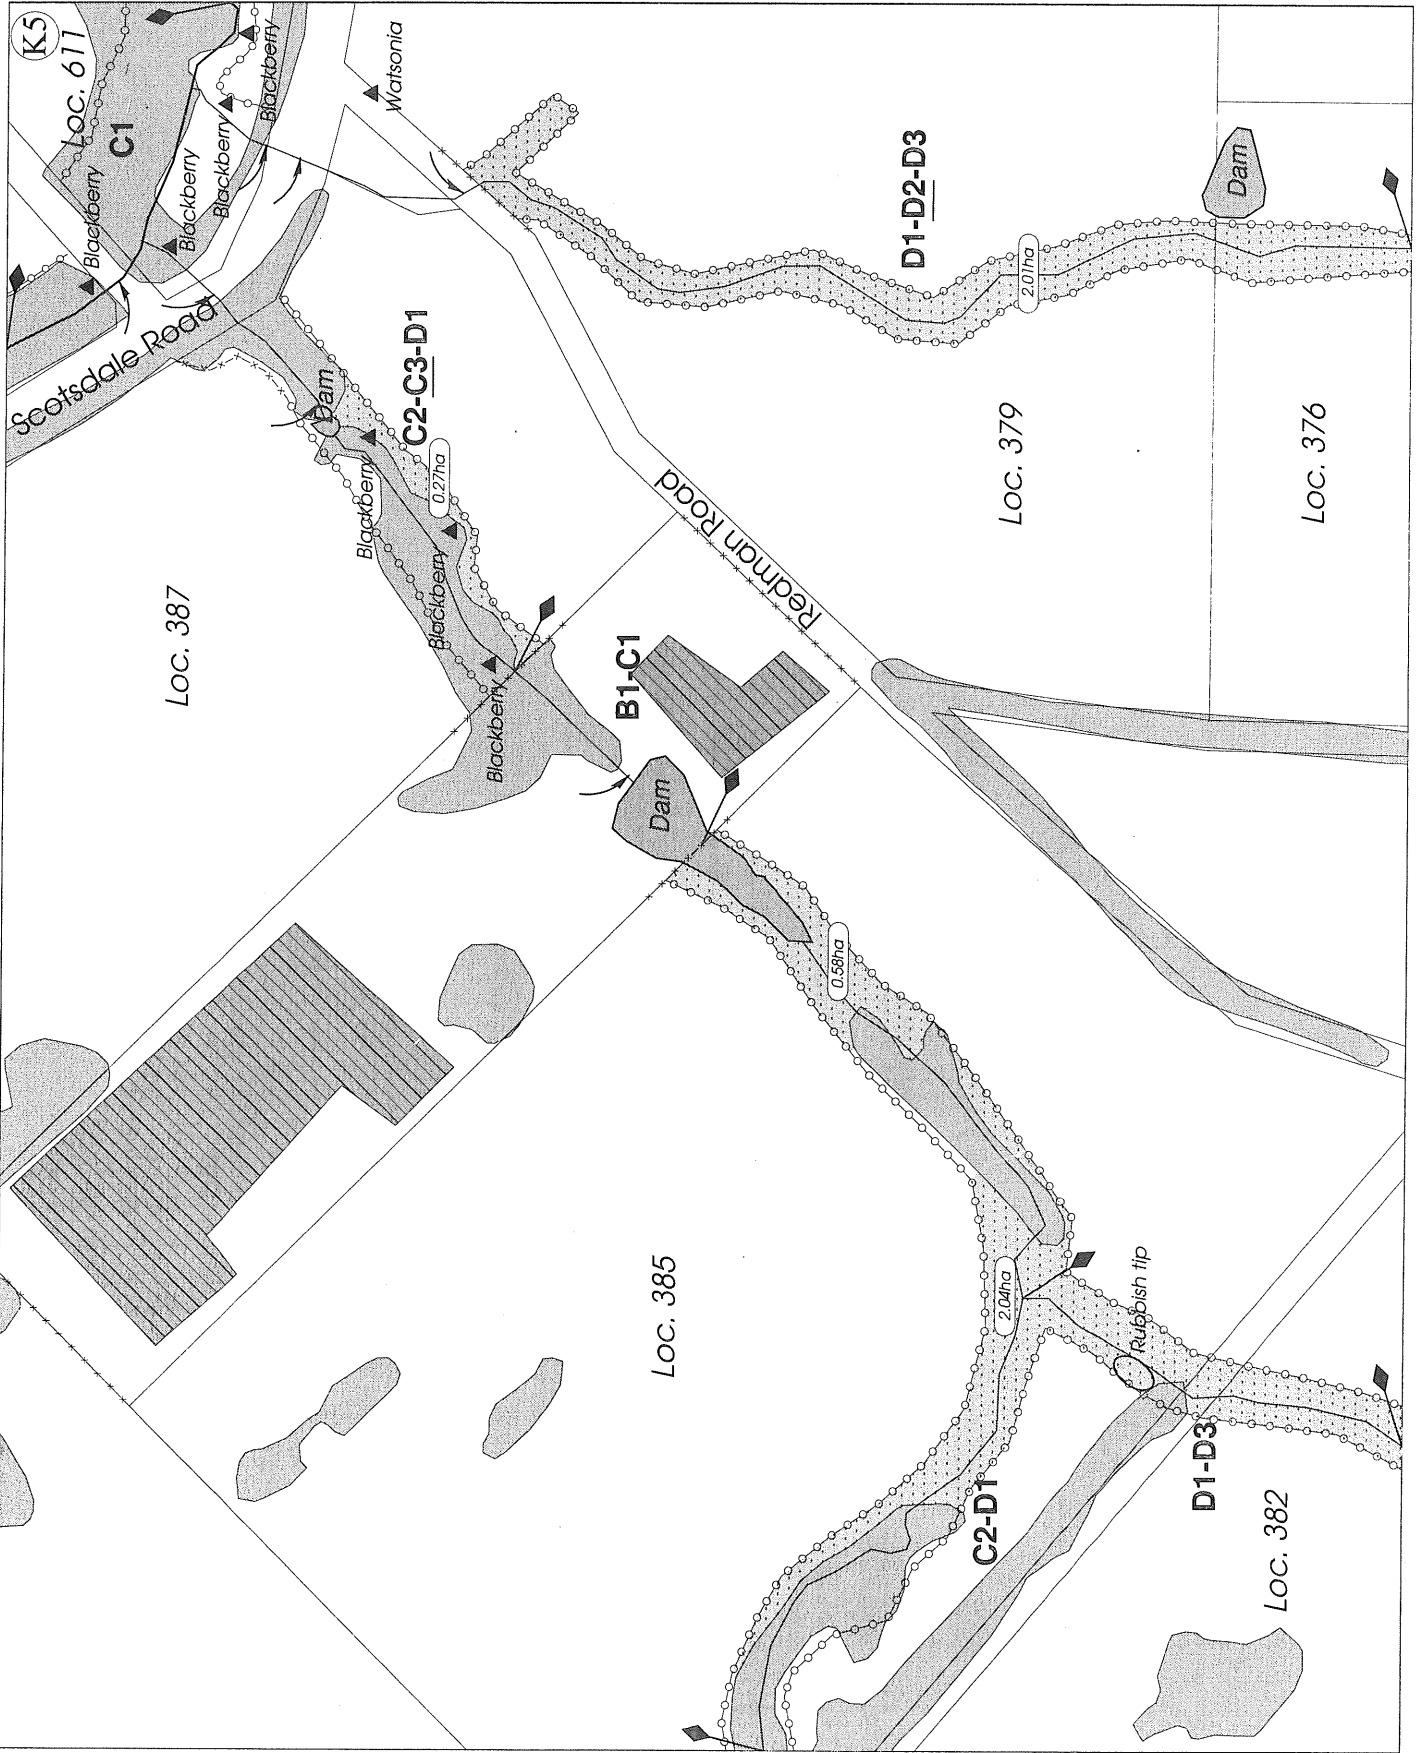
| | Scotsdale Brook | Tributaries/Tributary |
|---|---|---|
| Other Management Related Information for this map | Occasional severe undercutting with slumping. The problem lies with greatly increased water volumes during flood events caused by vegetation removal in the catchment. | Where no fencing is recommended in the absence of an existing fence, the recommendation is conditional upon present management of the land continuing. |

| | Scotsdale Brook | Tributaries/Tributary |
|---|---|---|
| Advice on Rehabilitation of these sites | Recommendation:<br>Carefully treat Blackberry and monitor results | Recommendation:<br>Carefully treat Blackberry and monitor results |

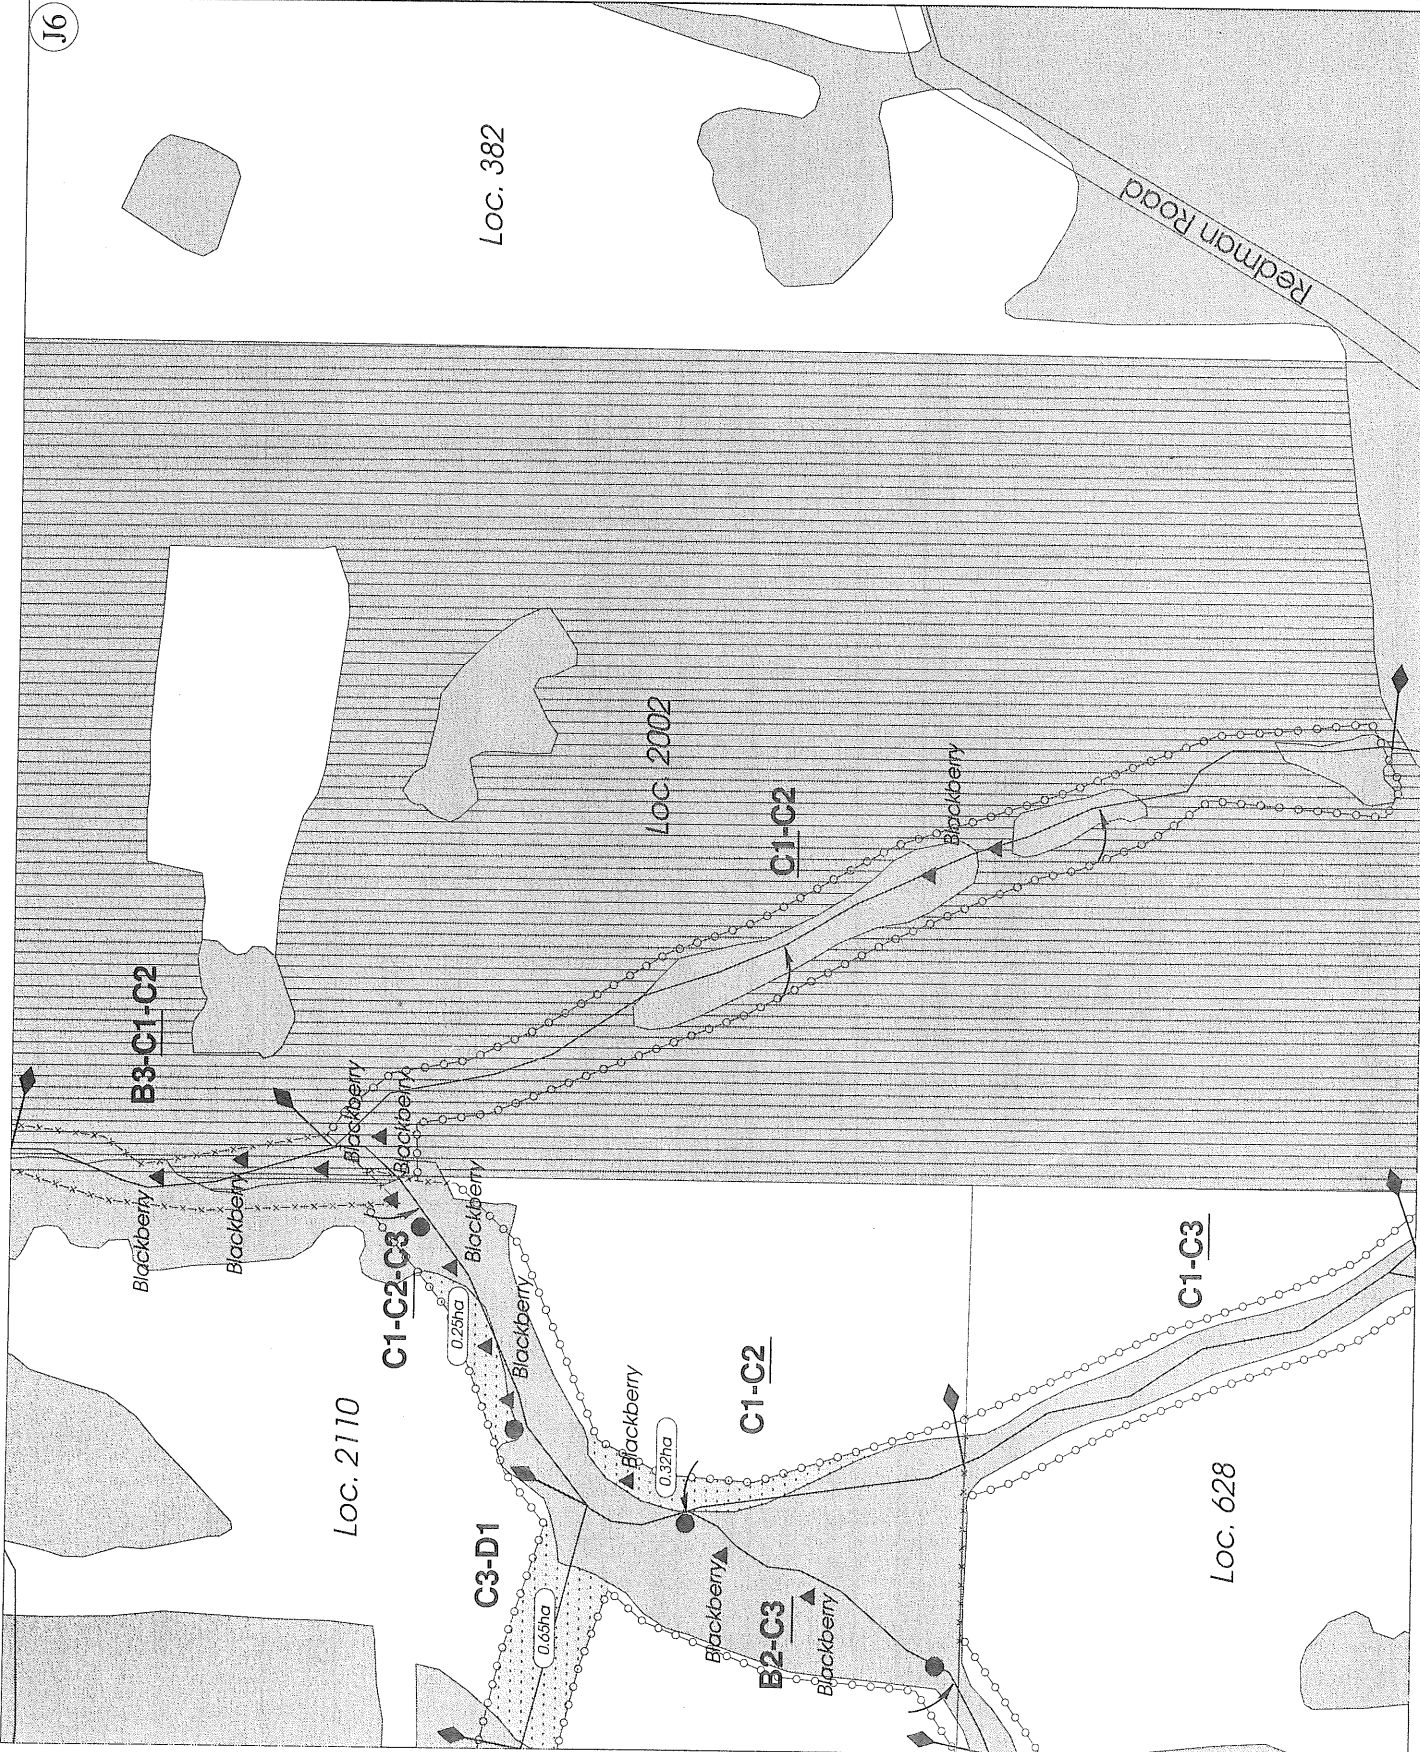
J6

| | Scotsdale Brook | Tributaries/Tributary |
|---|---|---|
| Other Management Related Information for this map | N/A | Fencing along watercourse in new plantation is needed before grazing begins under plantation trees. |

| | Scotsdale Brook | Tributaries/Tributary |
|---|---|---|
| Advice on Rehabilitation of these sites | Recommendation:<br>N/A | Recommendation:<br>Carefully treat Blackberry and monitor results |

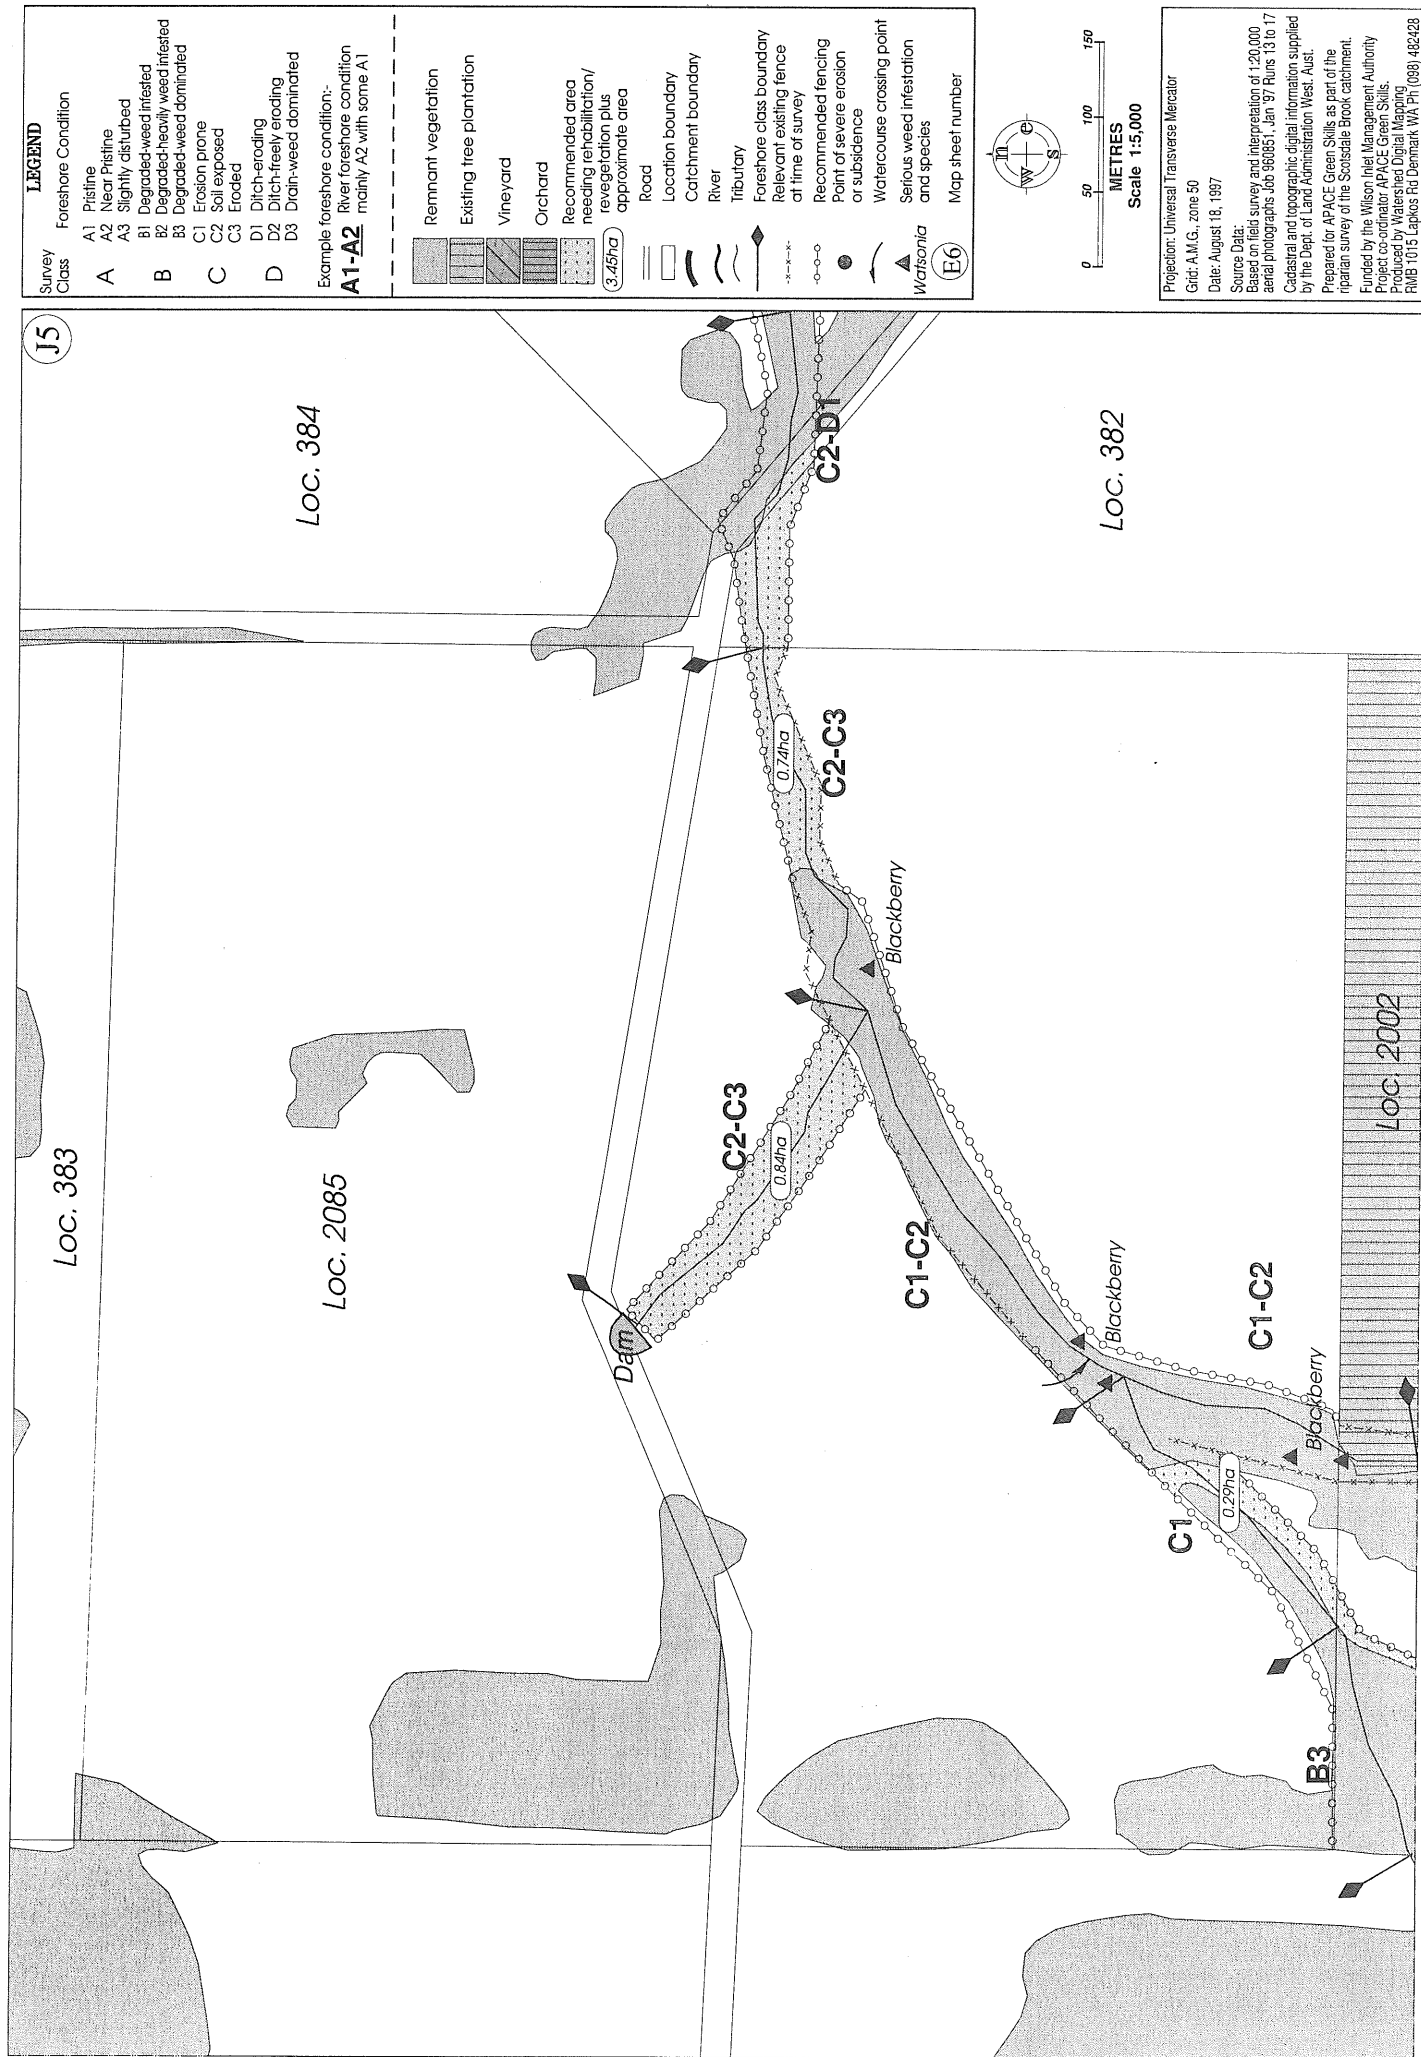
# SCOTSDALE BROOK SURVEY- Map J5 (See Map 1.2 pg.4 for general location)

| | Scotsdale Brook | Tributaries/Tributary |
|---|---|---|
| Other Management Related Information for this map | Occasional severe undercutting with slumping. Most of the problem lies with greatly increased water volumes during flood events caused by vegetation removal in the catchment. | Weed infestations on southern tributary are so severe and wayward so disturbed that mechanical removal of weeds is probably the best option initially. |

| | Scotsdale Brook | Tributaries/Tributary |
|---|---|---|
| Advice on Rehabilitation of these sites | Recommendation:<br>Treat weed infestations and monitor results | Recommendation:<br>Treat weed infestations |

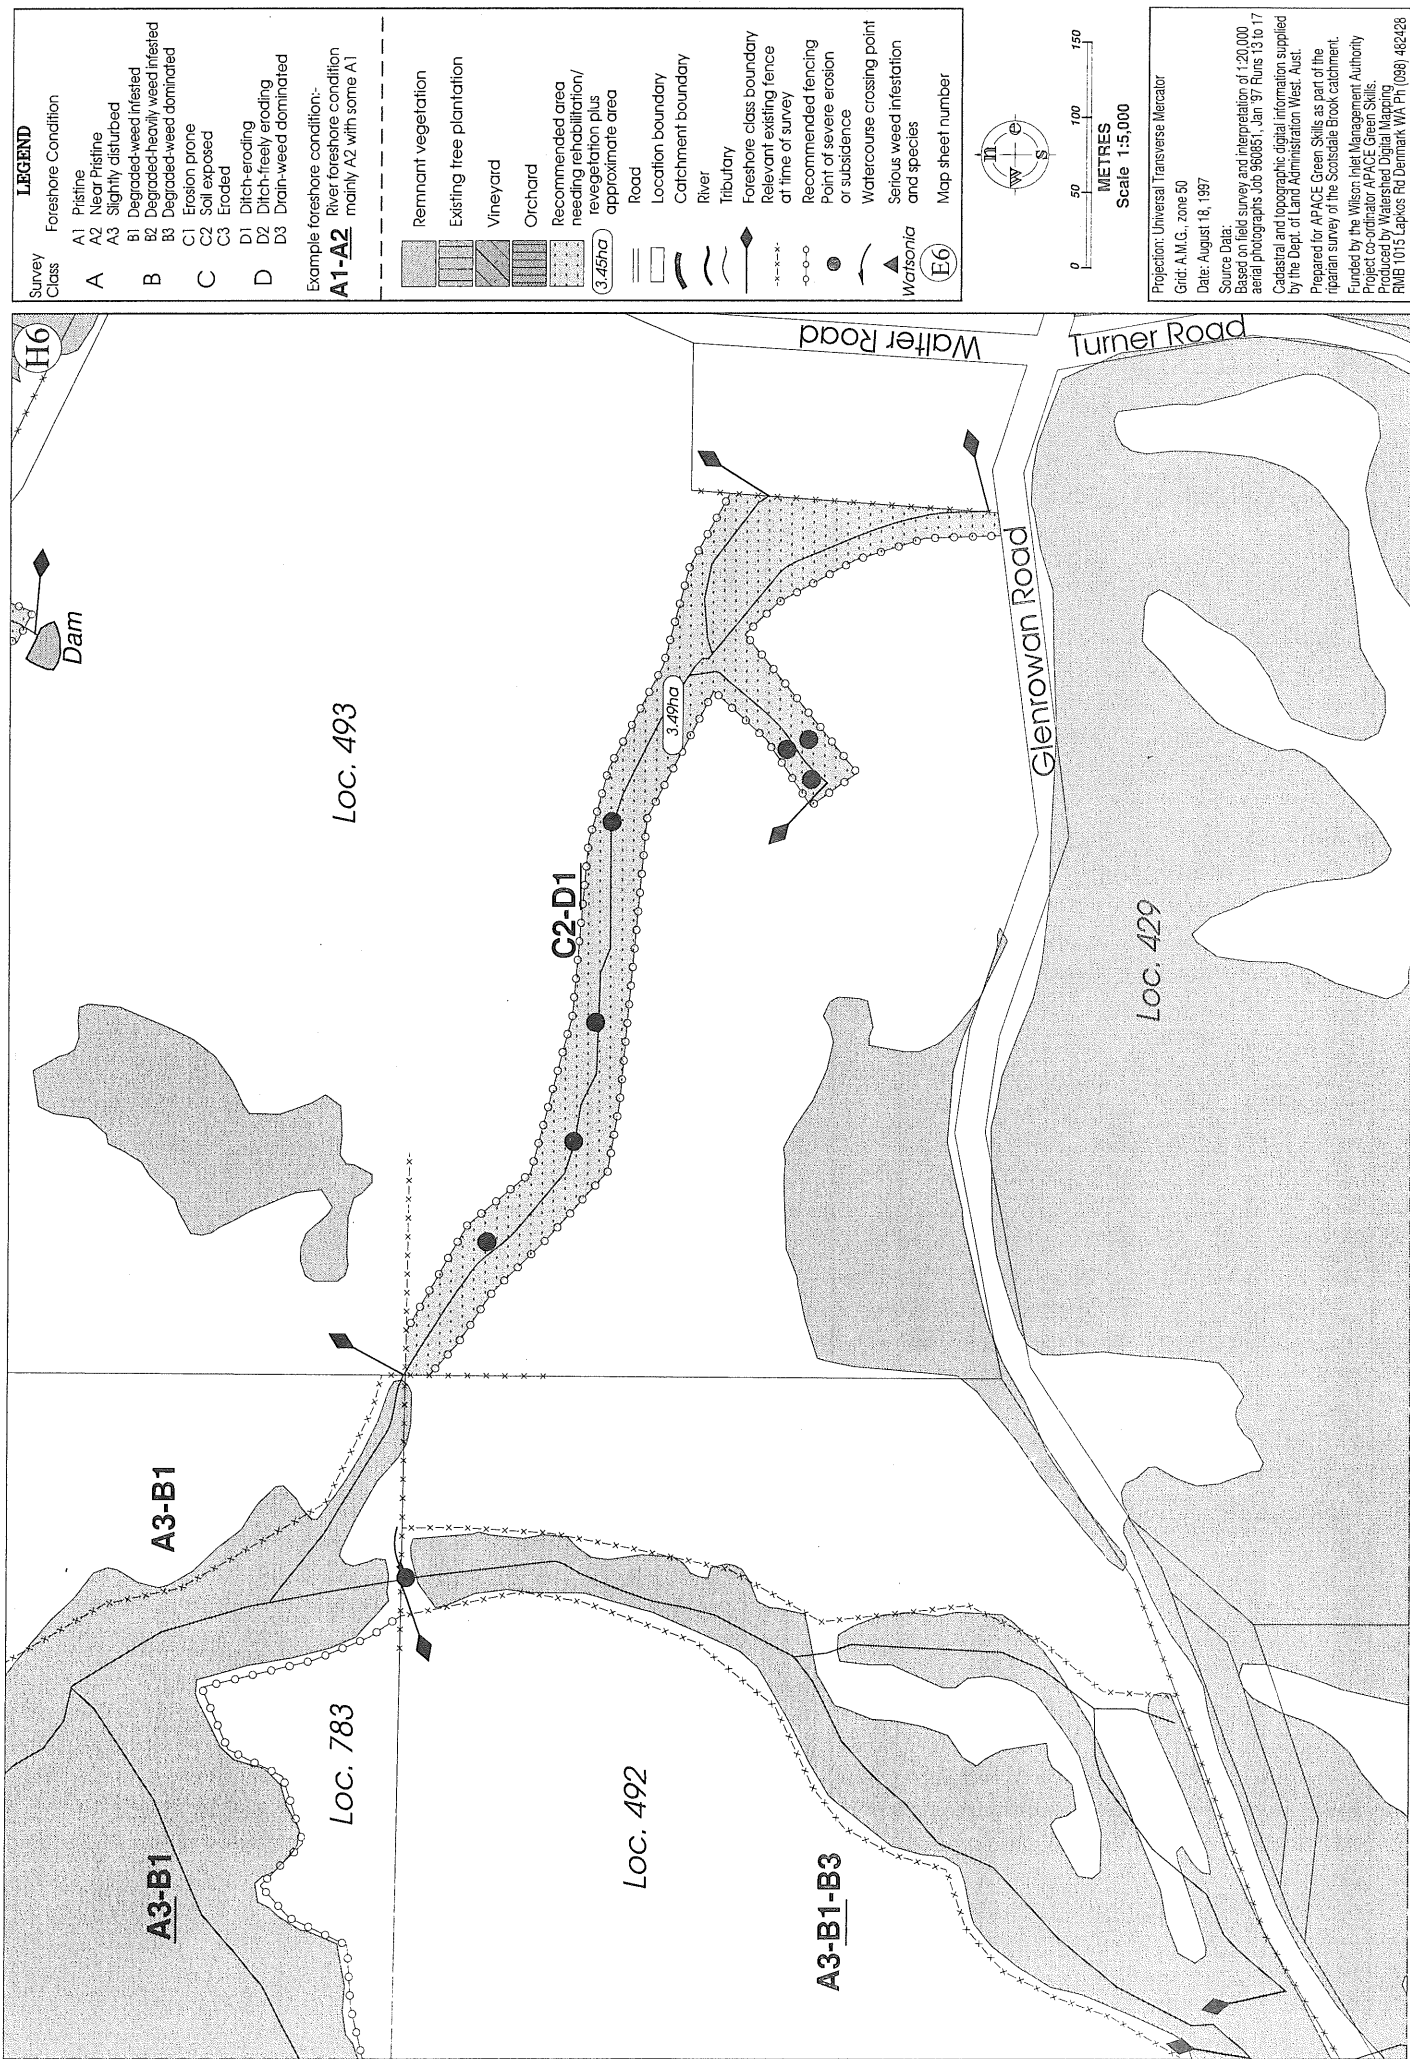
SCOTSDALE BROOK SURVEY- Map H6 (See Map 1.2 pg.4 for general location)

| | Scotsdale Brook | Tributaries/Tributary |
|---|---|---|
| Other Management Related Information for this map | N/A | The stream in need of revegetation has been severely degraded by the high volumes of run off coming from the now disused gravel pits to the south of Glenrowan Road. Successful rehabilitation of these pits is urgently required. |

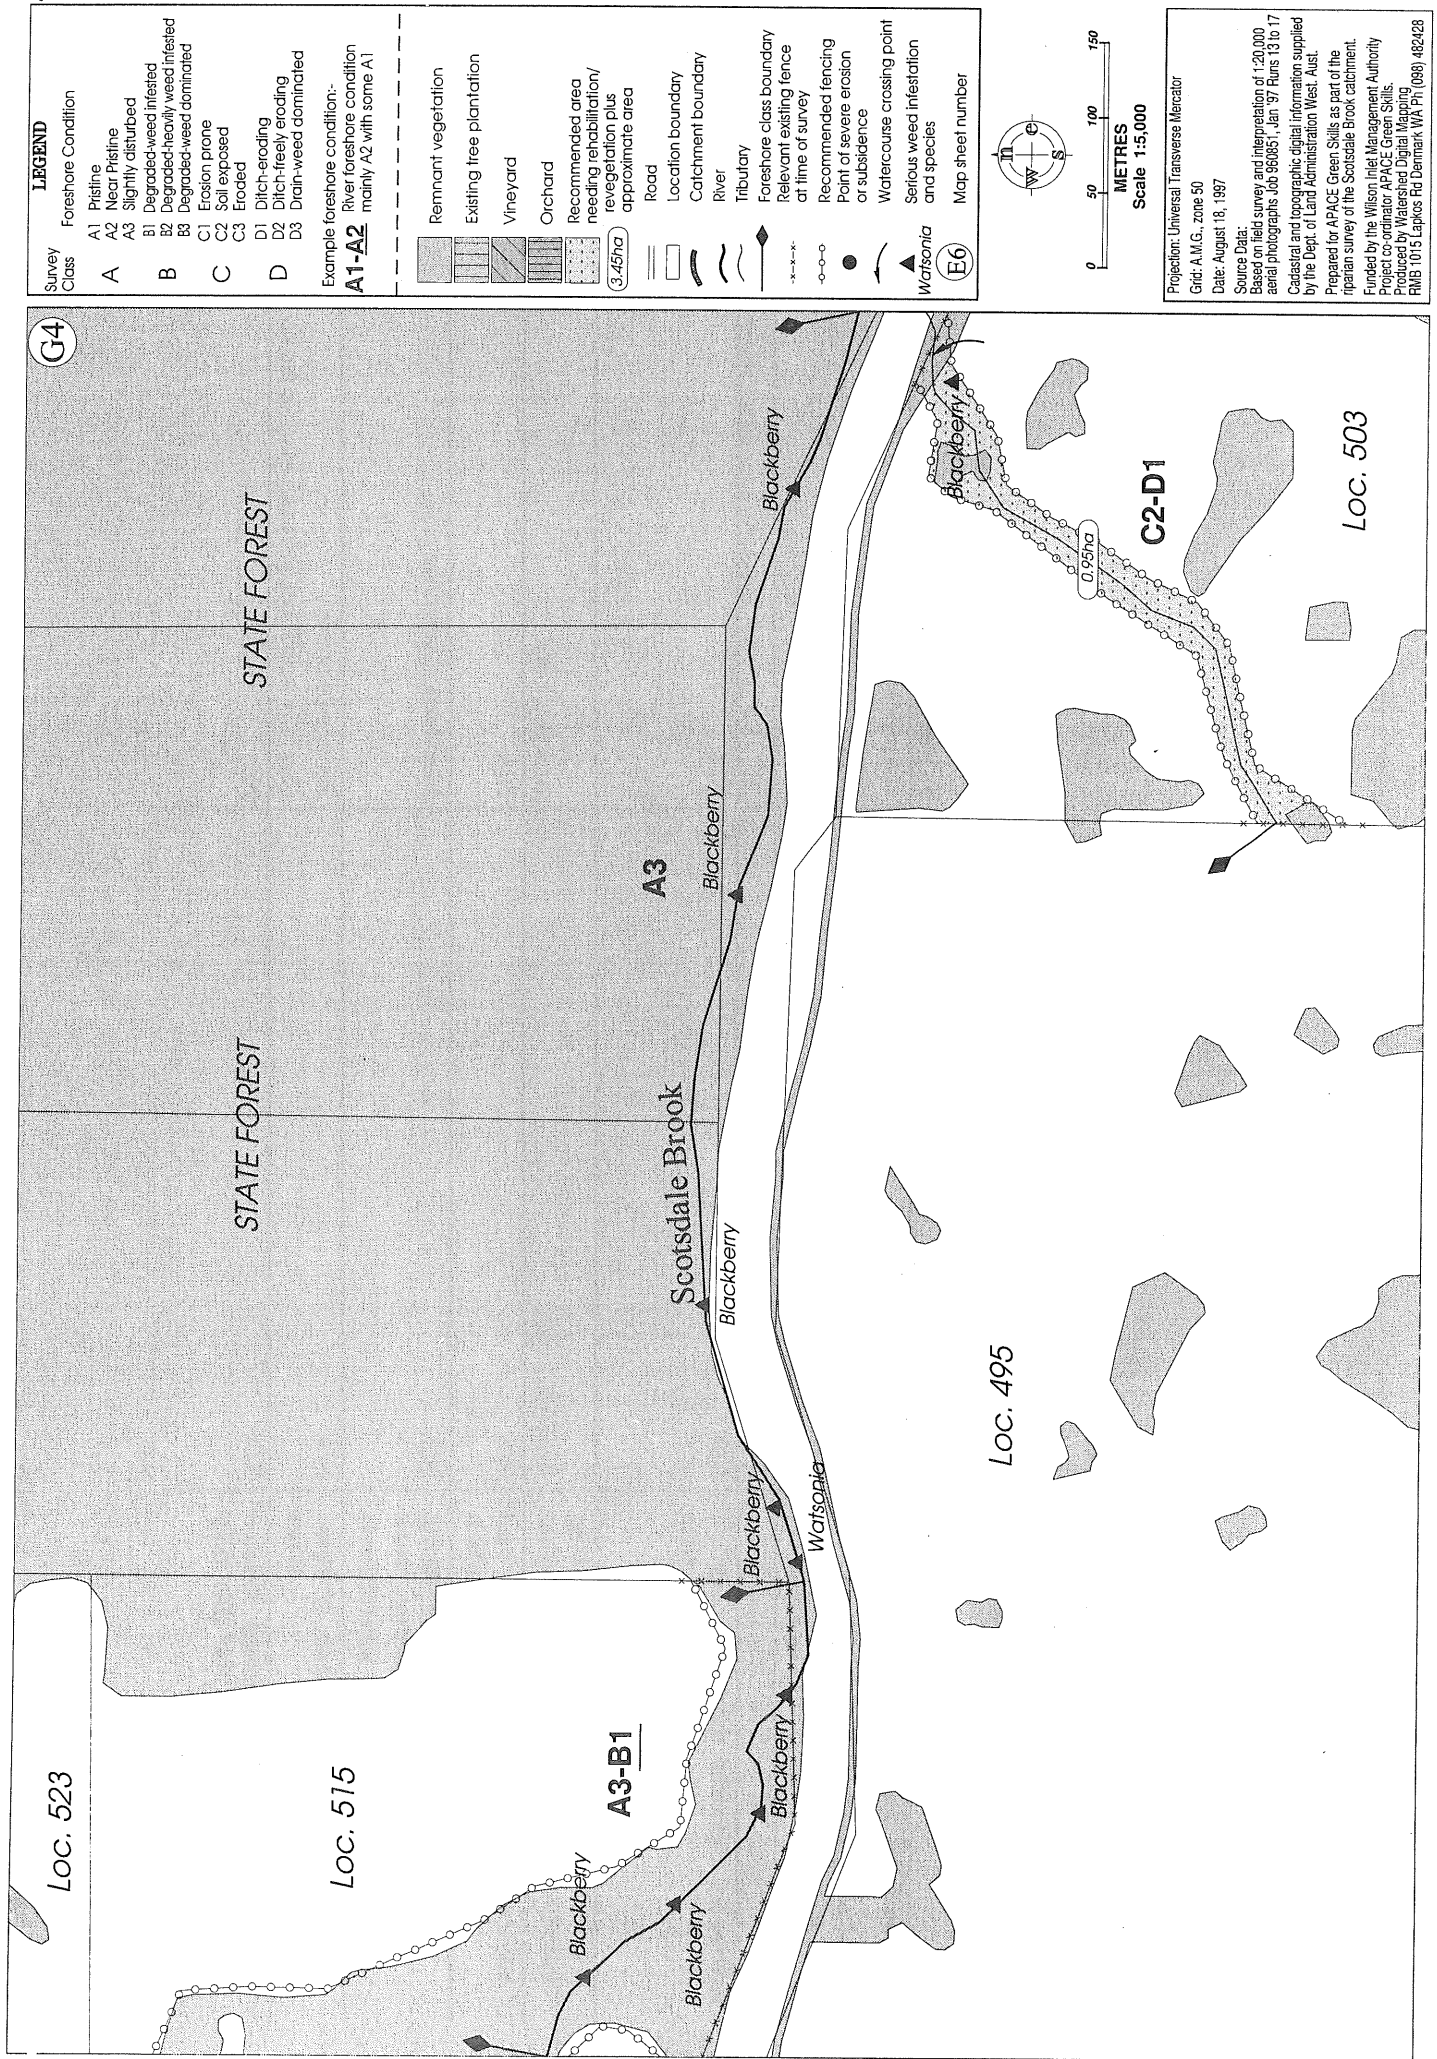
SCOTSDALE BROOK SURVEY- Map G4 (See Map 1.2 pg.4 for general location)

| | Scotsdale Brook | Tributaries/Tributary |
|---|---|---|
| Other Management Related Information for this map | Steep slopes on northern banks require fencing to be placed well away from Brook. i.e. 25 metres minimum. | Nil |

| | Scotsdale Brook | Tributaries/Tributary |
|---|---|---|
| Advice on Rehabilitation of these sites | Recommendation:<br>Control Blackberry and garden escapes | Recommendation:<br>Control Blackberry |

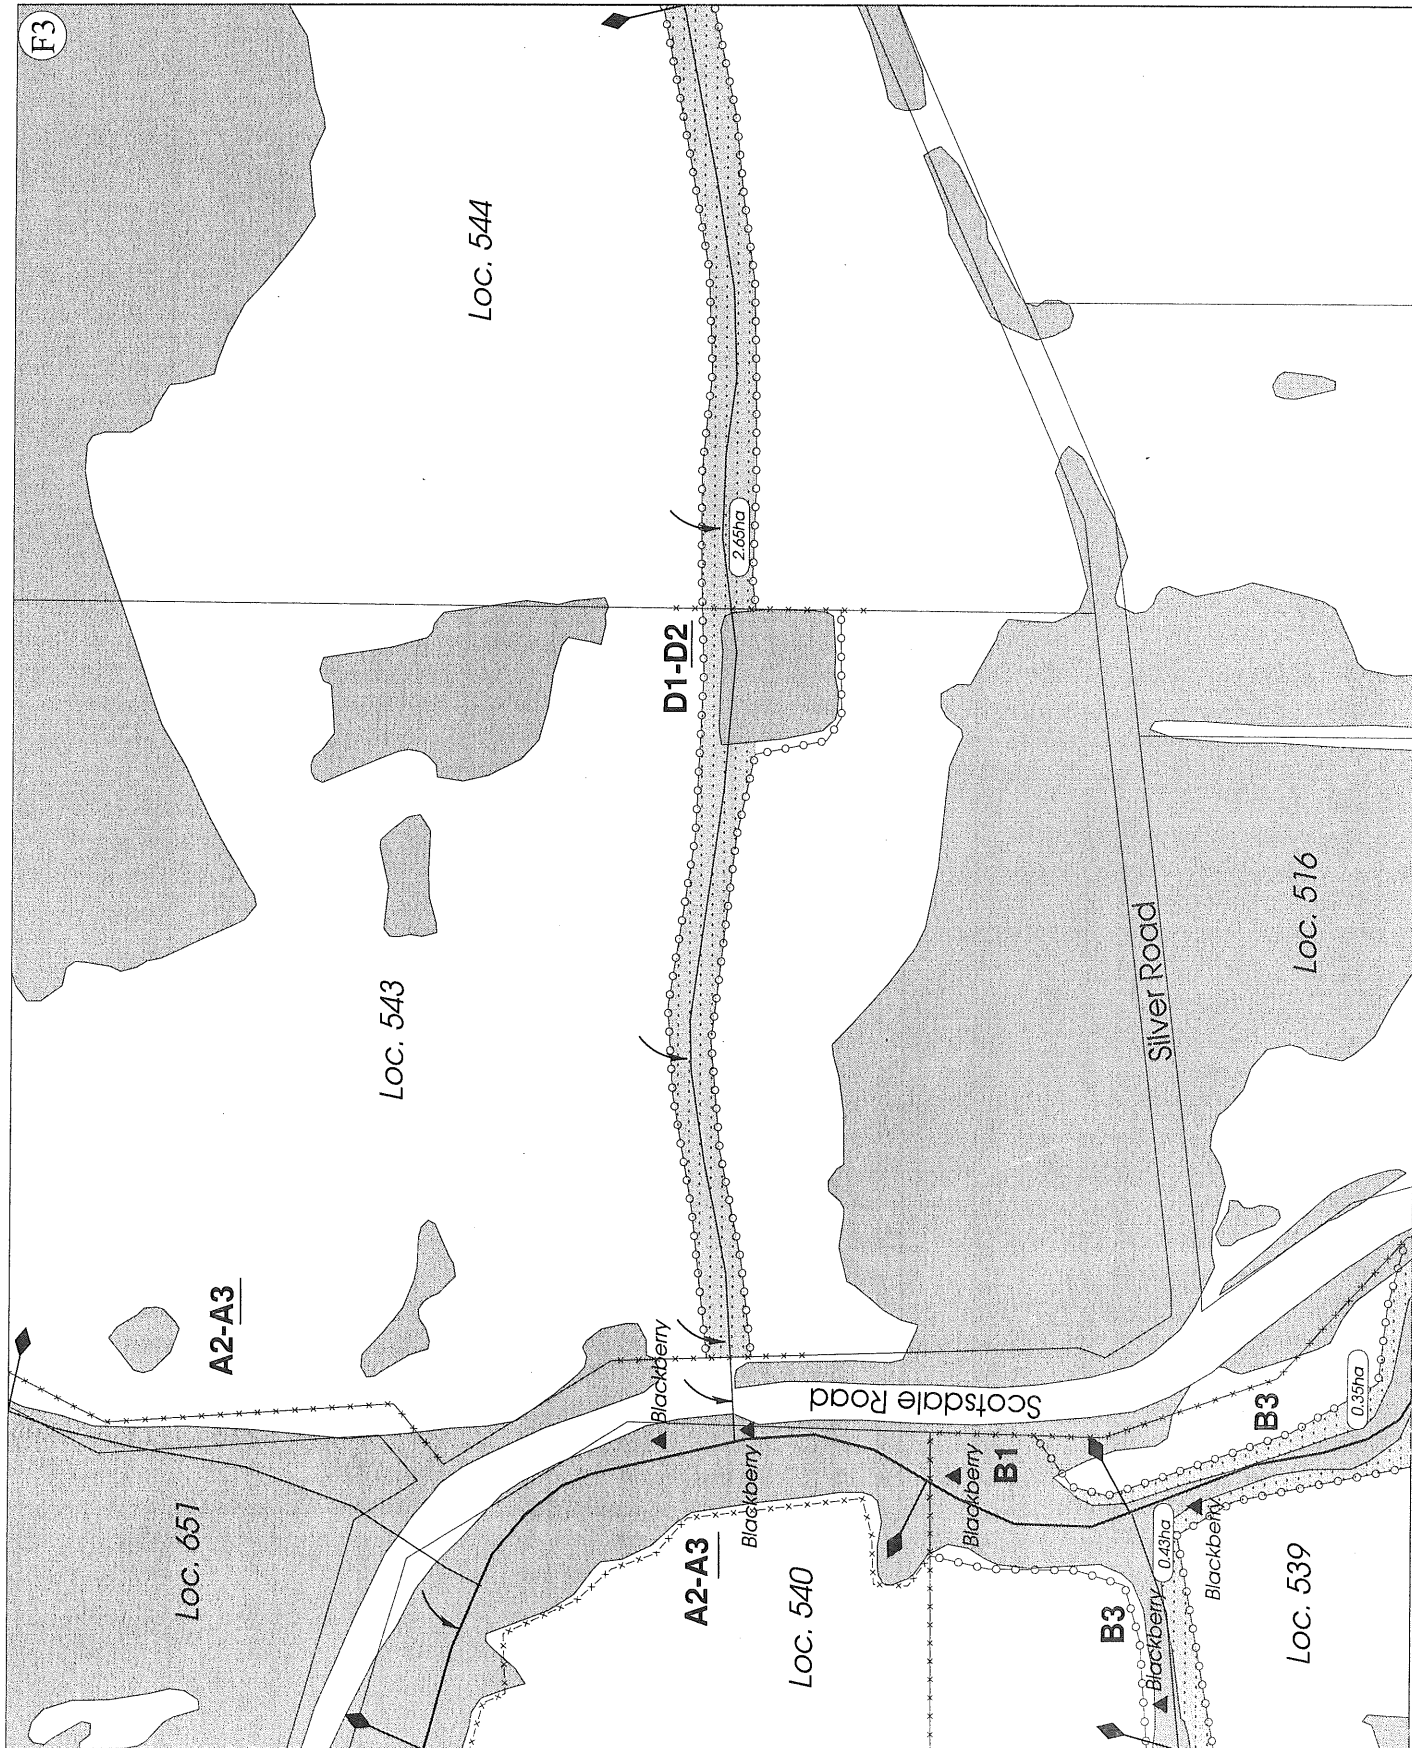
| | Scotsdale Brook | Tributaries/Tributary |
|---|---|---|
| Other Management Related Information for this map | Nil | Newly bulldozed track on road reserve between to Loc. 543 and 651, unnecessarily encroaches on stream riparian zone. Should relocate track to already cleared firebreak adjacent to boundary fence of Loc. 543. |

| | Scotsdale Brook | Tributaries/Tributary |
|---|---|---|
| Advice on Rehabilitation of these sites | Recommendation:<br>Carefully treat Blackberry and monitor results | Recommendation:<br>N/A |
