SURVEY OF STREAM FORESHORES IN THE  
SCOTSDALE BROOK CATCHMENT  
DENMARK, W A

WATER RESOURCE MANAGEMENT SERIES

WATER AND RIVERS COMMISSION REPORT WRT 19  
1998

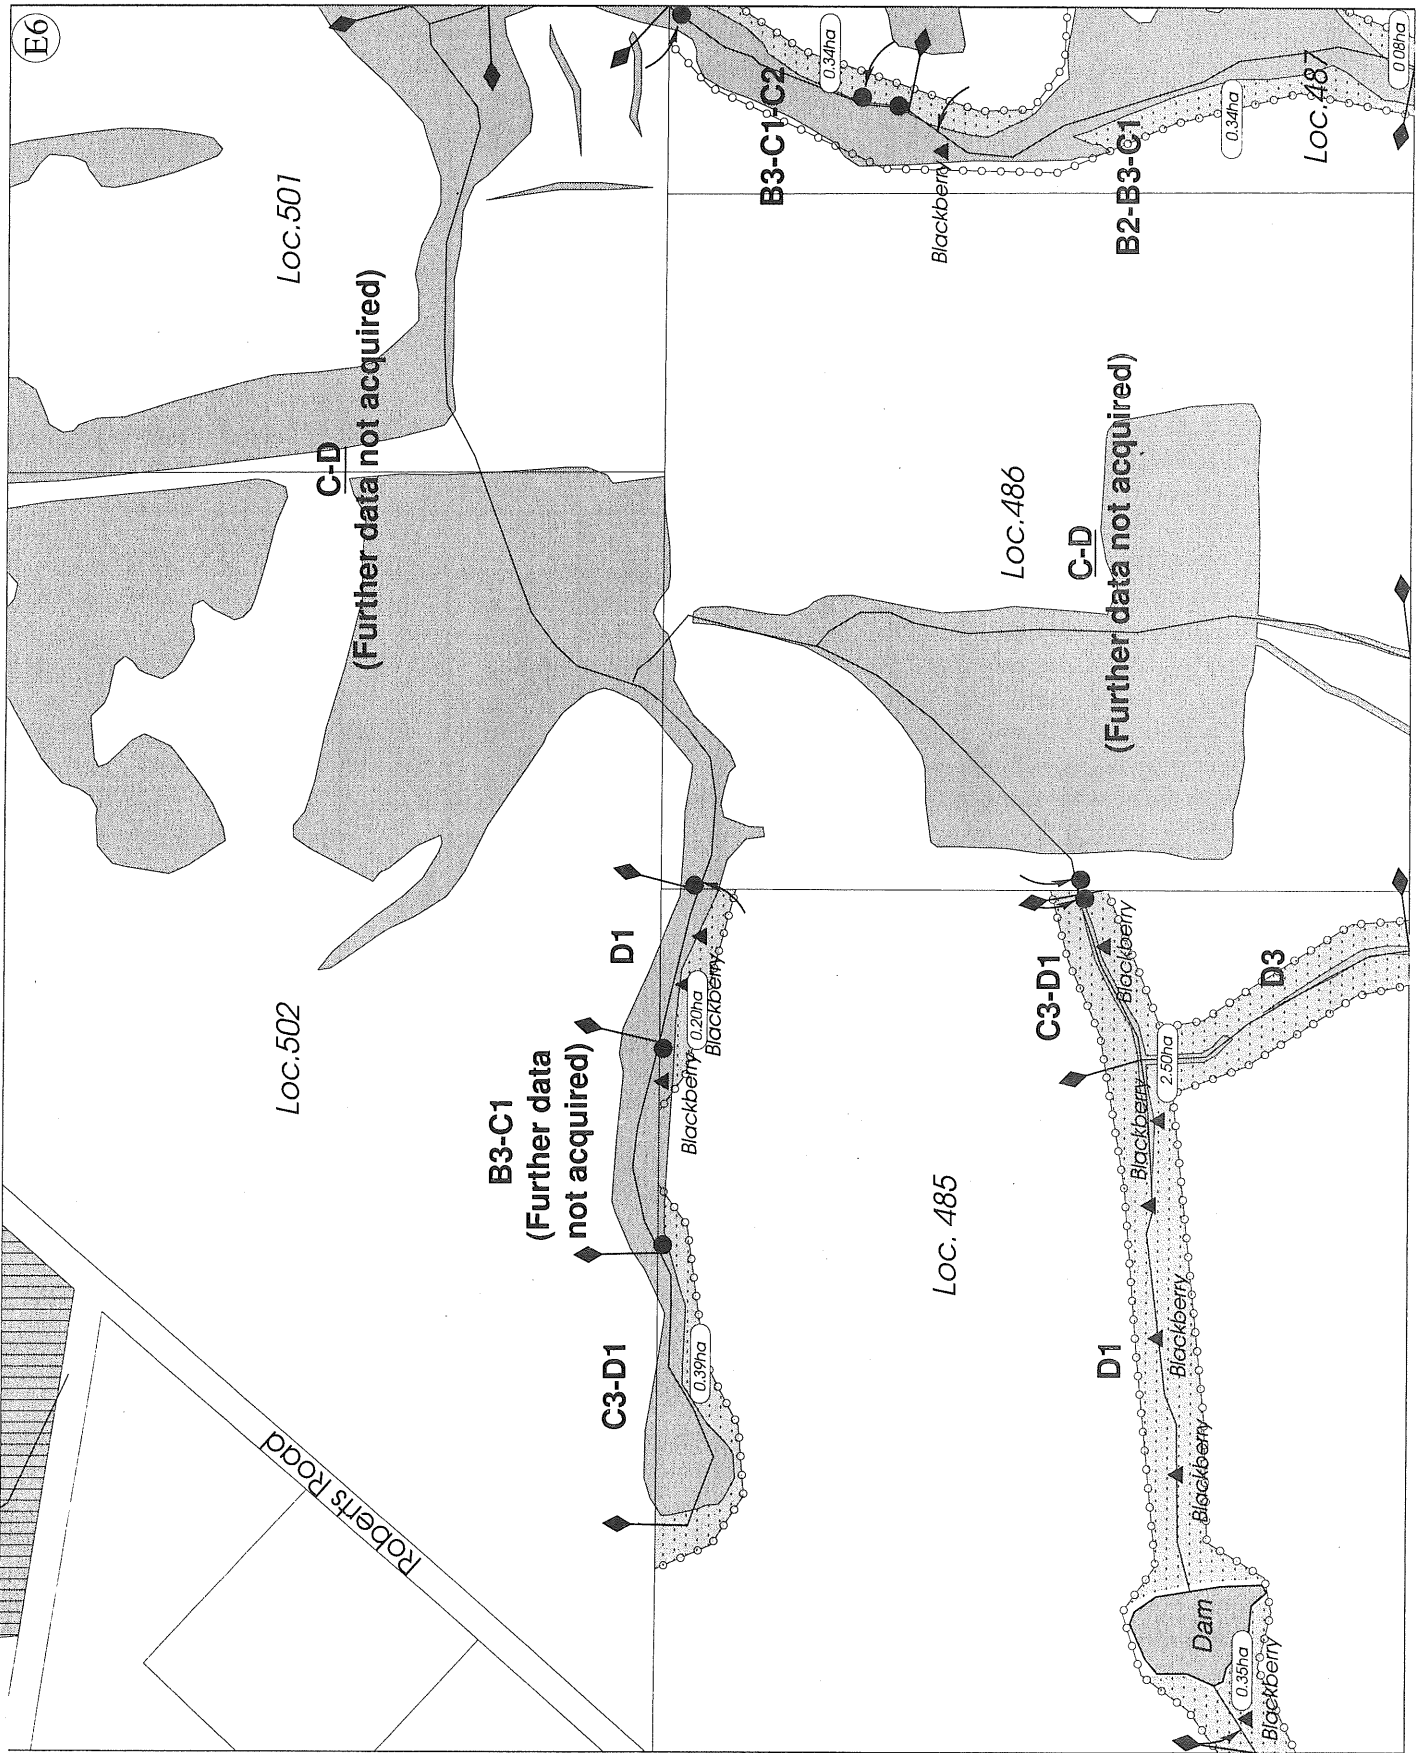
| | Scotsdale Brook | Tributaries/Tributary |
|---|---|---|
| Other Management Related Information for this map | N/A | If no alternative water supply for stock is available, then constructed watering points on streams that minimise bank erosion are desirable. |

| | Scotsdale Brook | Tributaries/Tributary |
|---|---|---|
| Advice on Rehabilitation of these sites | N/A | Recommendation: Stock crossing points need to be constructed and stock excluded from them when not in use. Carefully treat Blackberry and monitor results |

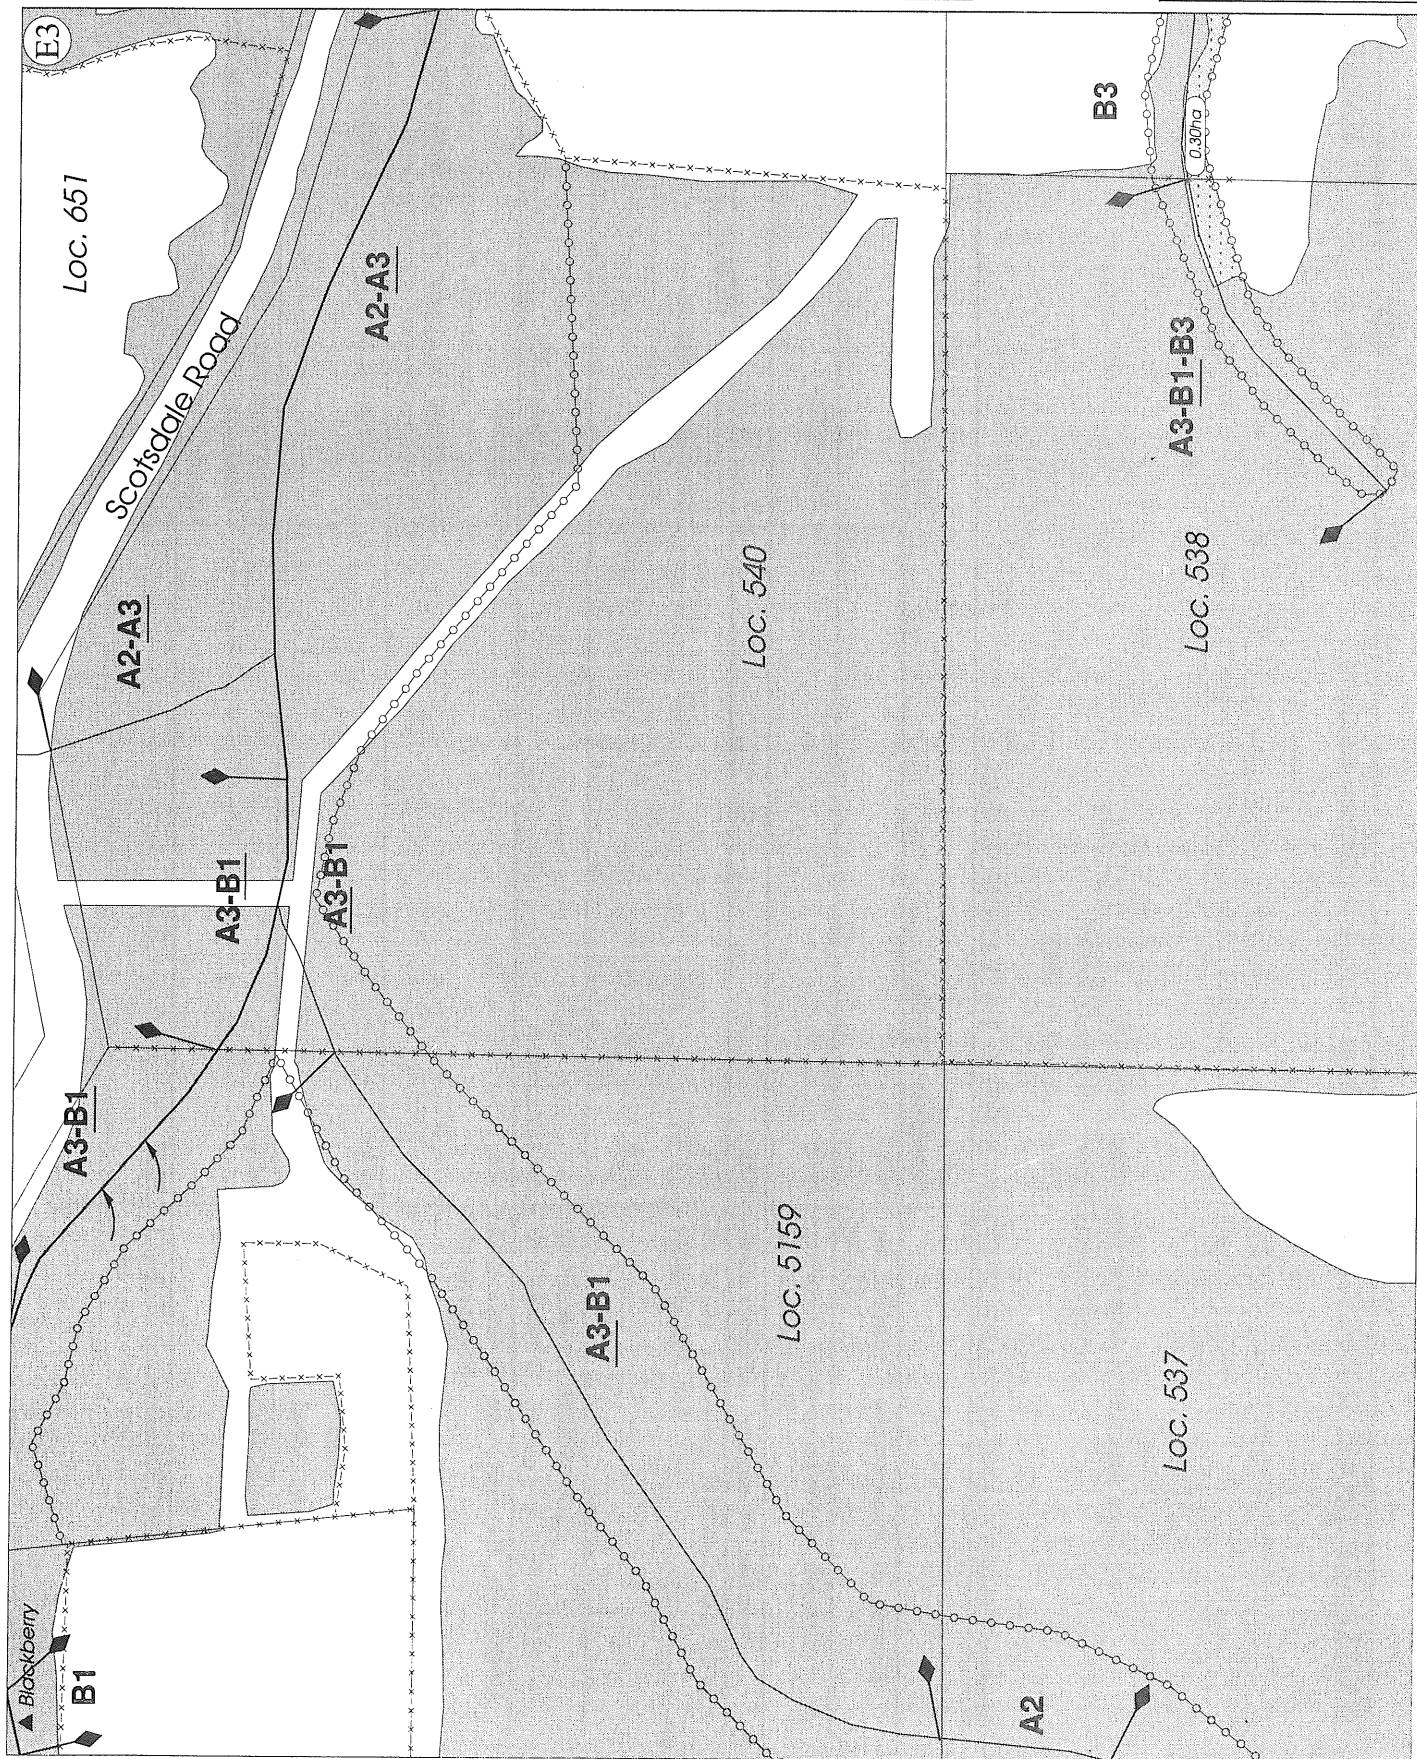
| | Scotsdale Brook | Tributaries/Tributary |
|---|---|---|
| Other Management Related Information for this map | Nil | Streams on loc. 659 need urgent rehabilitation and revegetation. |
