**Wungong Catchment Trial**

Tree deaths in native forests and rehabilitated minesites in the Wungong Catchment

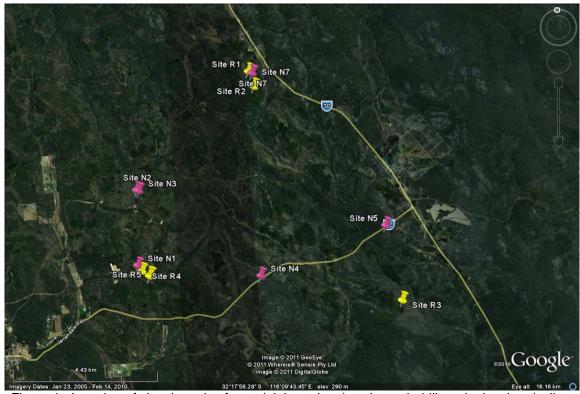
Figure 1. Location of sites in native forest (pink markers) and on rehabilitated minesites (yellow markers) visited in May and June 2011.

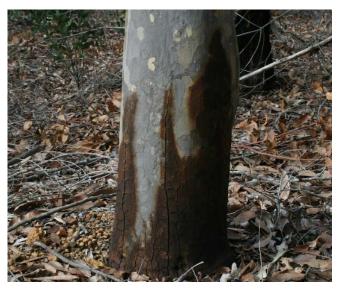
Figure 11. Basal canker at the on spotted gum (Site R5).

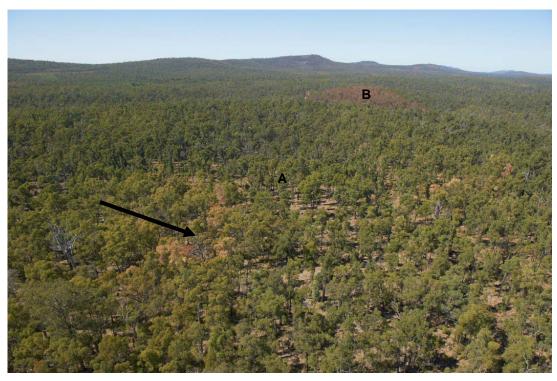
Figure 18. Aerial view of Site N5 (arrow), Demonstration plot 1, unthinned jarrah stand showing some dying crowns. A: adjacent thinned stand; B: wildfire damage in the background.
