An Evaluation of the Footpaths in the Stirling **Range National** Park (SRNP)

Pamela Mende

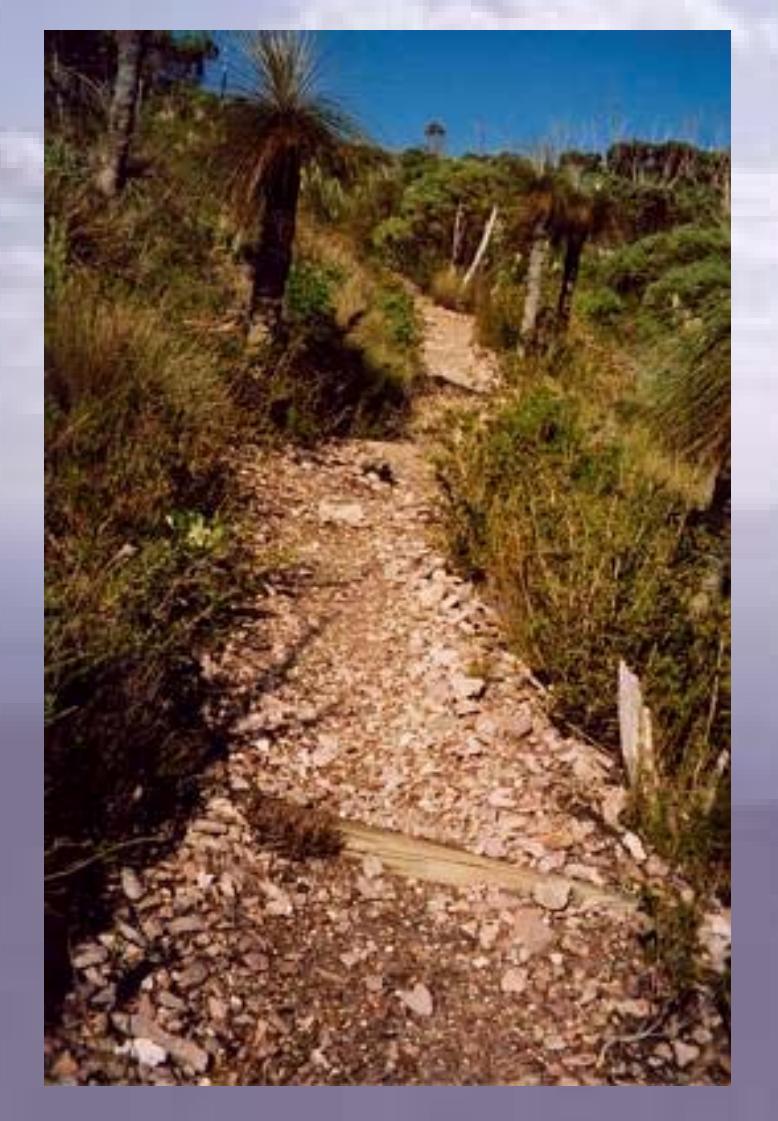
Mt Trio has 0.7% erosion, 4 extra paths

Continue with regular upkeep of maintenance features

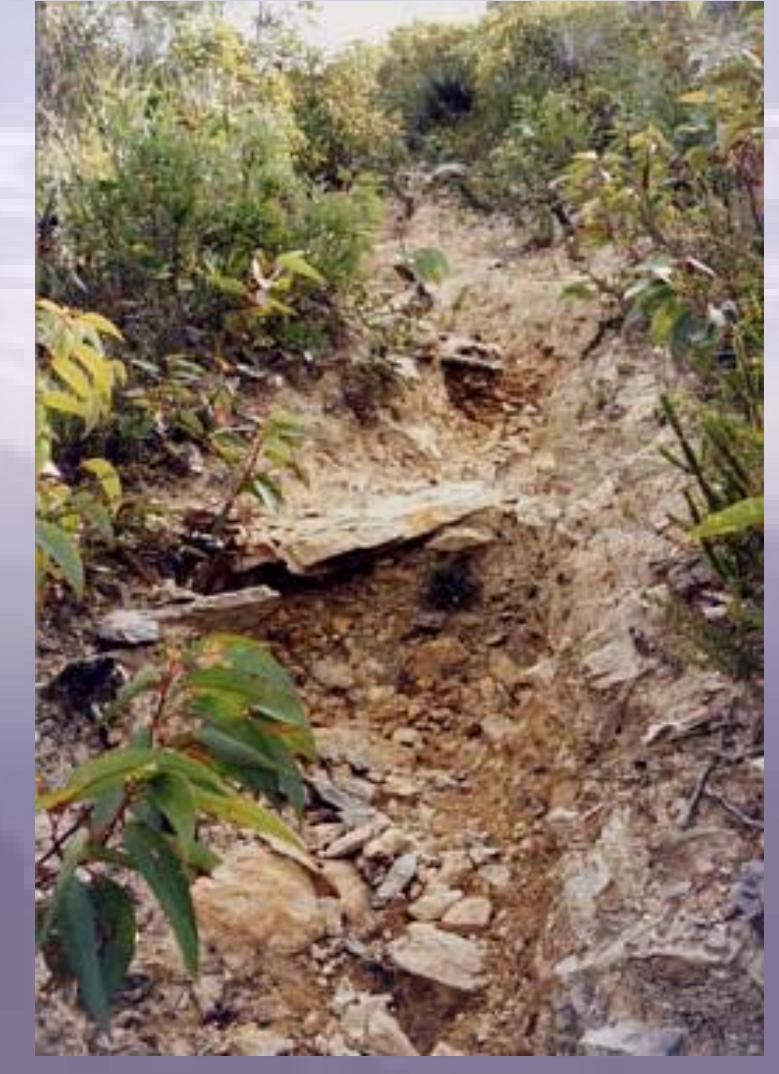
Talyuberlup has 78.1% erosion, 11 extra paths

- Heavy engineering to stabilize path
- Signposting
- Regular upkeep of maintenance features
