# **Restoring the Health of the Little River:**

**Riparian Survey and  
Management Recommendations  
for Repairing the Little River  
Catchment near Denmark, WA.**

by Apace Green Skills

December 1996

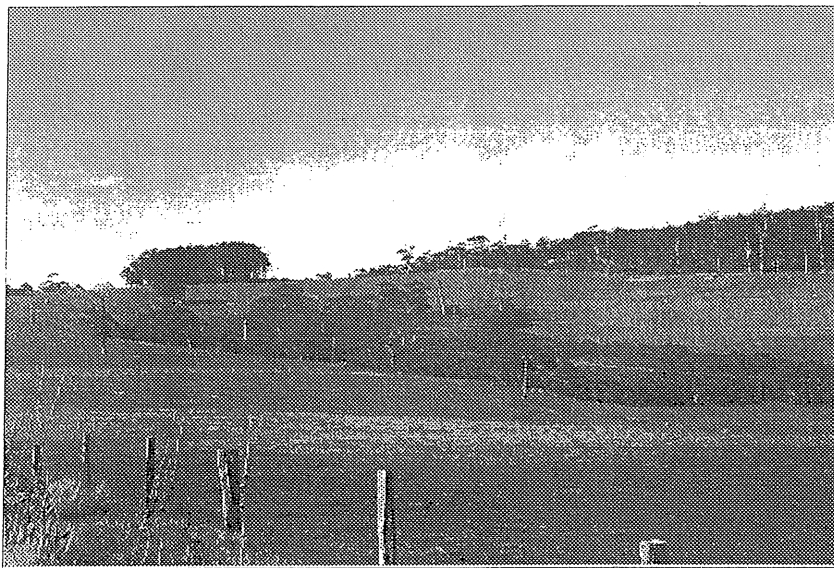
*View over tributary of Little River, looking north east from Sunrise Road towards Mt Shadforth. It is recommended that remnant vegetation along this tributary be permanently fenced from stock.*

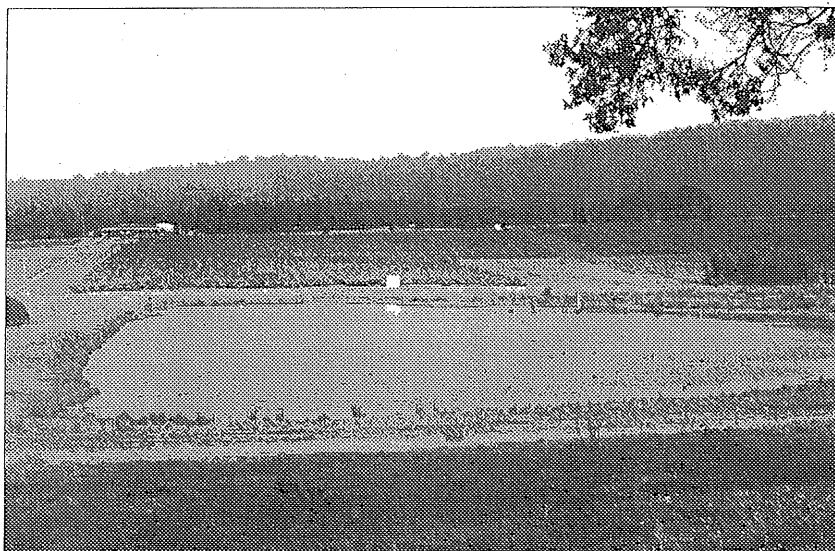
*Major dam on Little River. This photograph was taken from South Coast Highway looking south. Construction of islands, and revegetation of some of the dam's fringe with native vegetation, would greatly enhance its value for bird habitat. The dam's spillway channel needs repair to allow for native fish migration.*

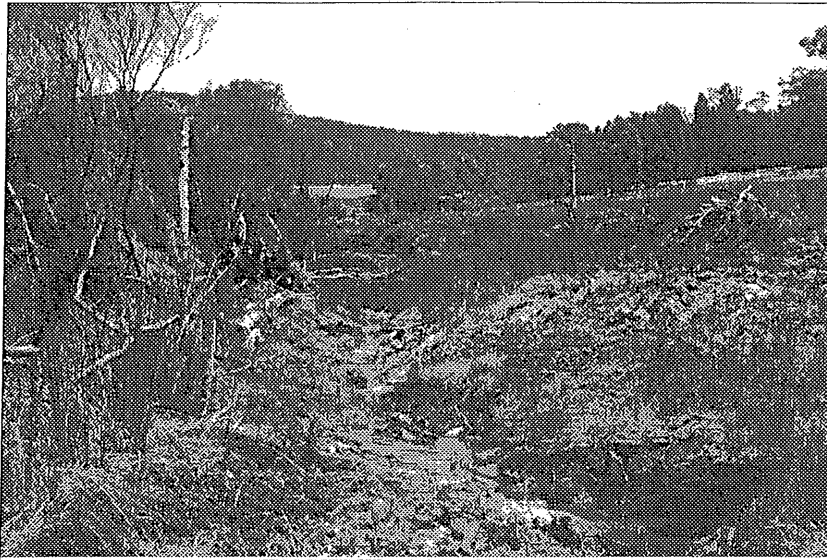
*Recently bulldozed watercourse in the Little River catchment, adjacent to South Coast Highway. This action has lead to significant erosion and sediment loss. Protection of this watercourse from stock and natural regeneration of revegetation would be essential to rehabilitate this site.*

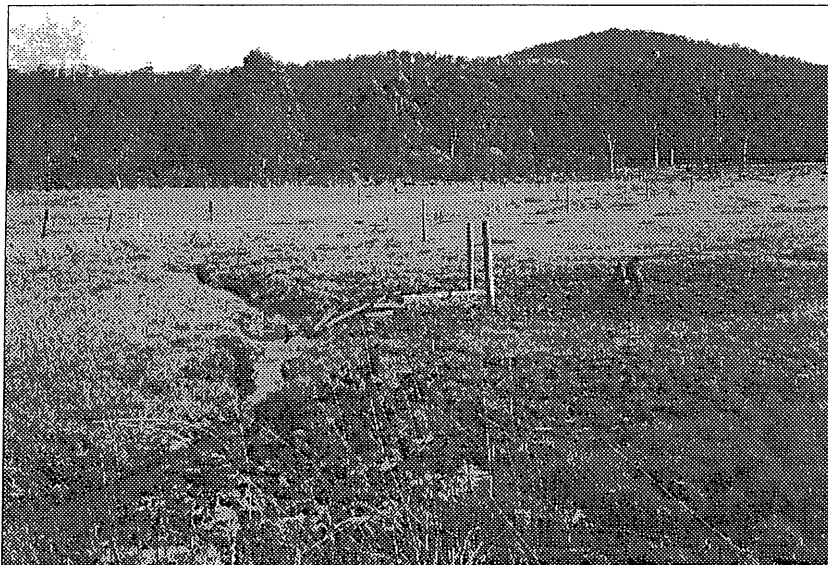
*Fencing in progress on a small tributary of the Little River, close to Ocean Beach Road. In this case, the fence ought be sited further away from the watercourse, in order to allow for several rows of trees and shrubs to be established in the riparian buffer zone.*

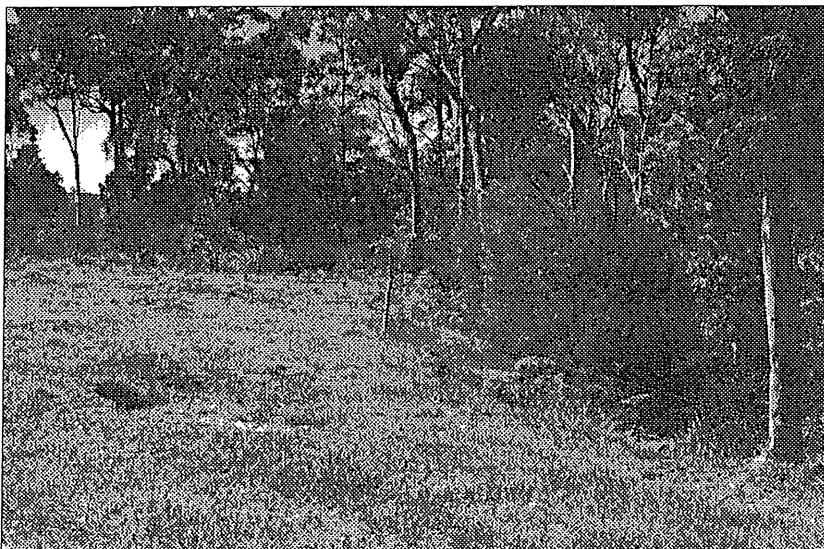
*Little River fenced off with single wire electric fencing. While this does prevent cattle from damaging the riverbanks, the fence needs to be relocated, to allow for several rows of native trees and shrubs to be planted and ensure a properly buffered riparian zone.*

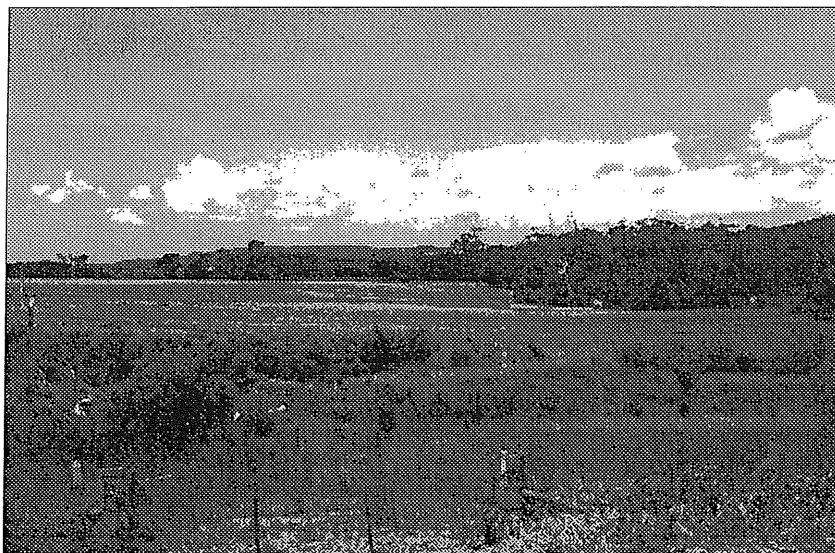
*View over the Little River valley. Little River has been fenced off along the portion visible in this photograph. However, revegetation between the fence and remnant fringing vegetation has been with Tasmanian Blue Gums. It would have been much more preferable for Karri (*Eucalyptus diversicolor*) and other local species to have been planted, in order to enhance the corridor and habitat values of the Little River riparian zone.*

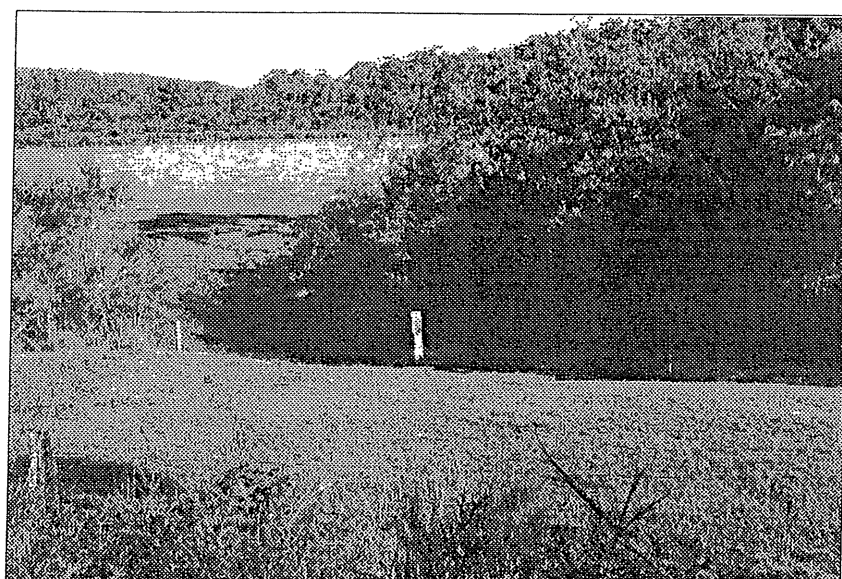
*A cattle crossover point on Little River, near Lights Road. Such points can be sources of erosion if not well stabilised with gravel and, where necessary, with rock.*

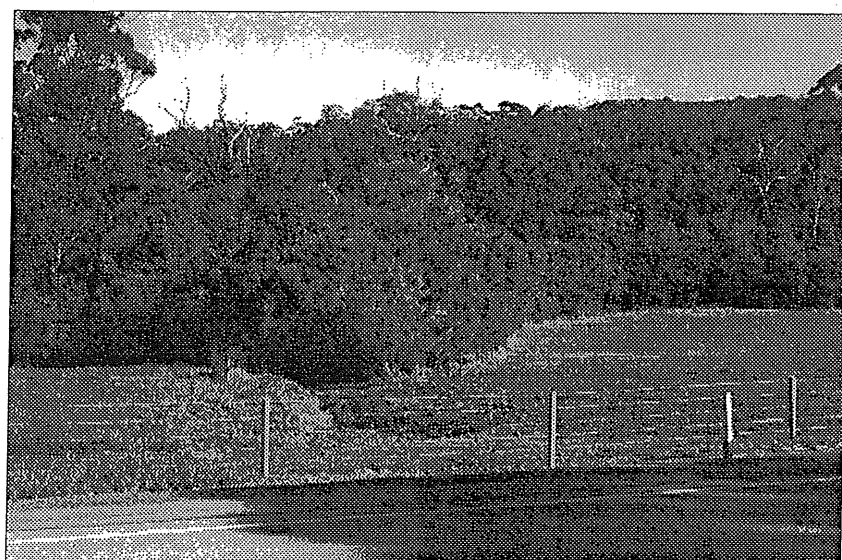
*A drain from a culvert off South Coast Highway, in the vicinity of the Lights Road overtaking lane. Such drains need to be stabilised with native revegetation and, where necessary, with riffle and pool zones.*
