# PHOTOGRAPHS

FIRE RESEARCH

W.P. 562/61

- CAREY BLOCK -

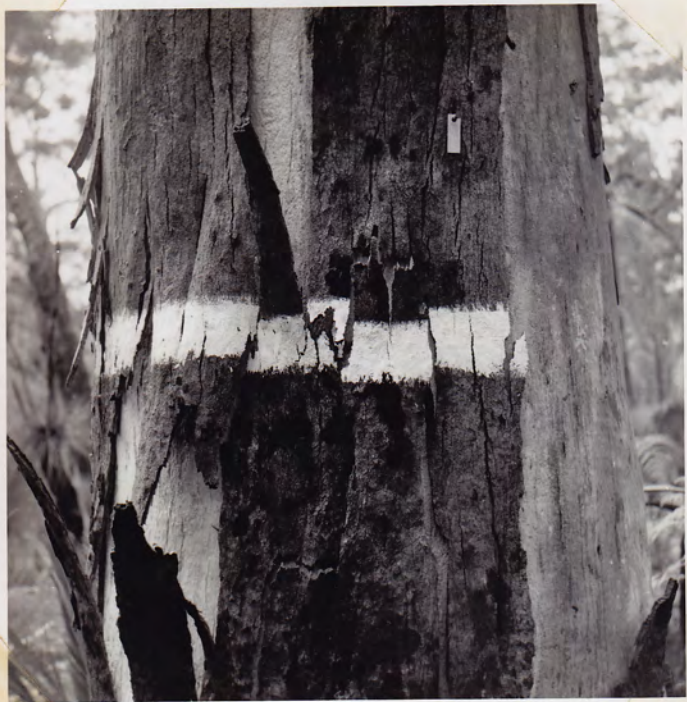
1. Tree N°401 Plot 10: CAREY BLOCK.  
 Date: 17/4/62.  
 Date of Burning: 18/2/61  
 Defoliating bark.

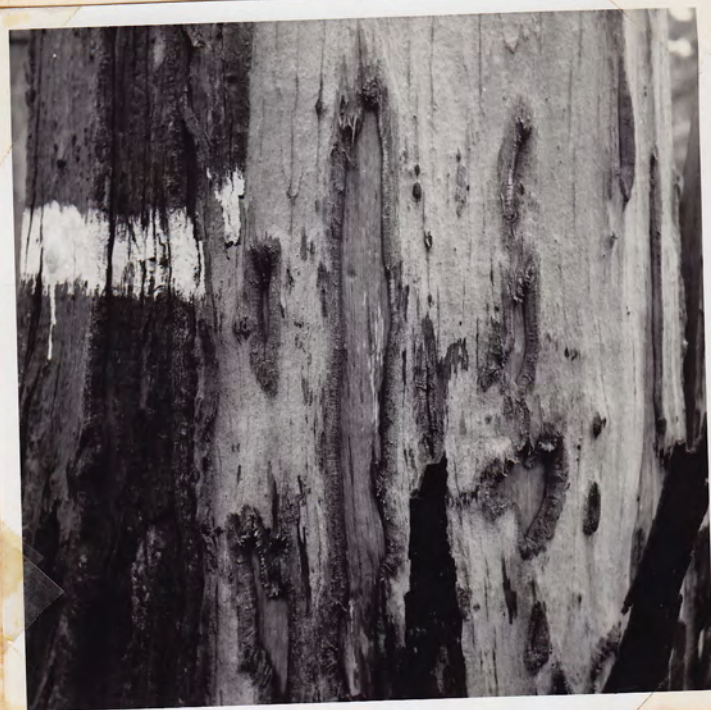
2. Tree N°404 Plot 10  
 CAREY BLOCK  
 Severe cambial lesions at  
 4'3" →

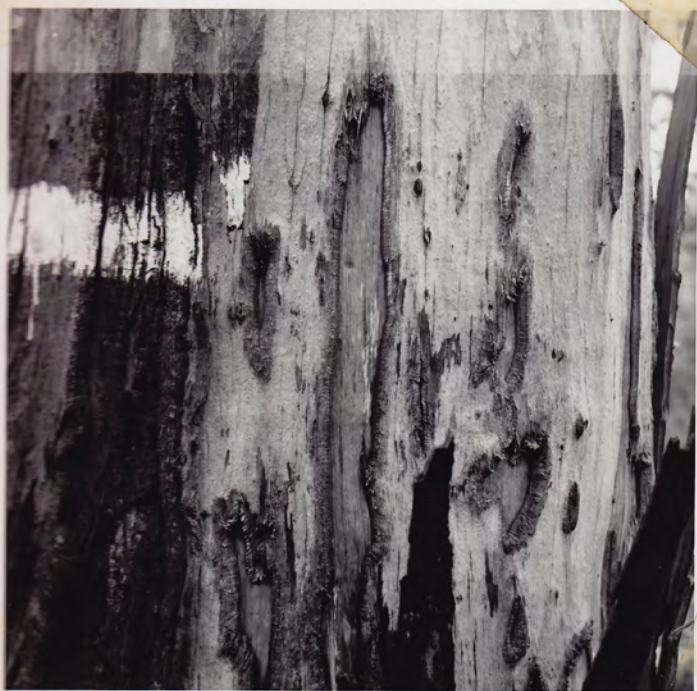
- ← 3. As for N°2

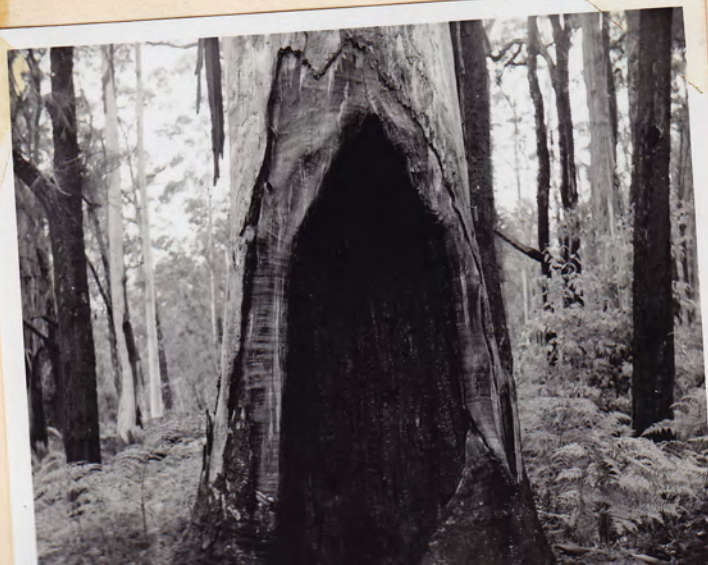
4. Tree N°406 Plot 10  
 Hollow butt and  
 associated dry side. →

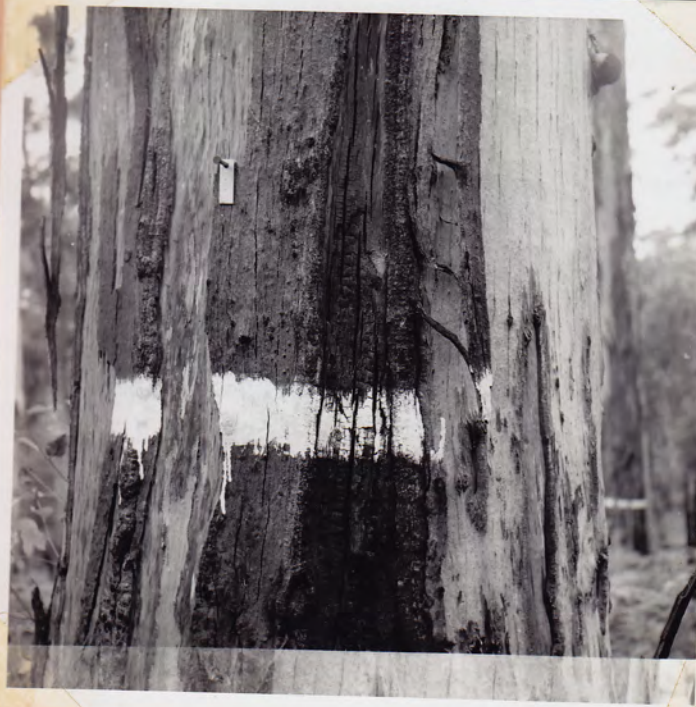
5. Tree N°404 Plot 10  
Cambial lesions at 4'3" and old  
cambial damage.

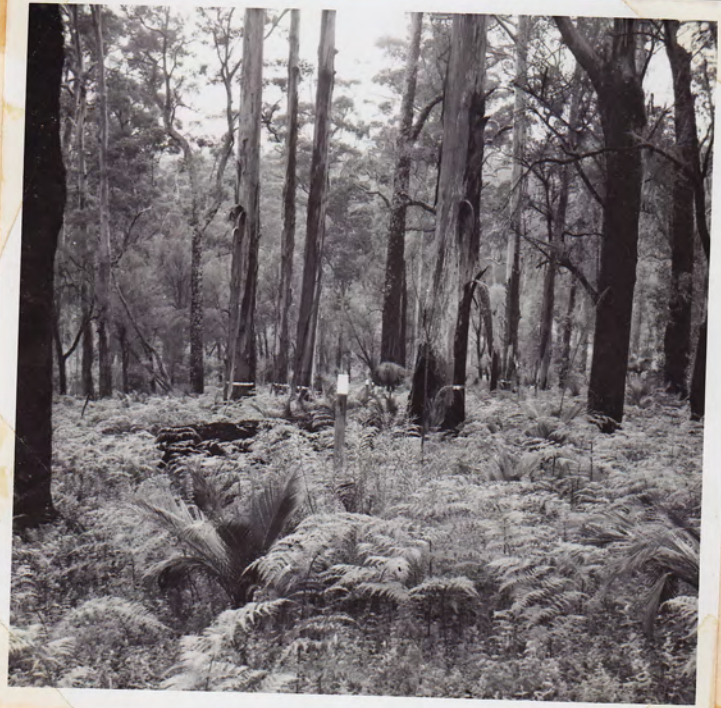
6. Plot 10: General view of  
undergrowth recovery  
looking N.E. →

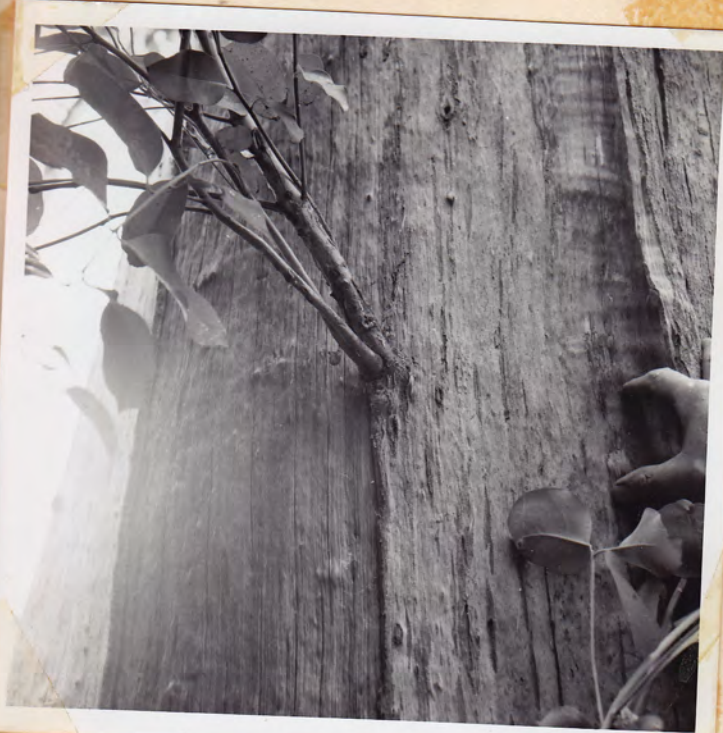
← 7. Tree N°408? Plot 10.  
Epicormic shoot developing  
adjacent to cambial lesion

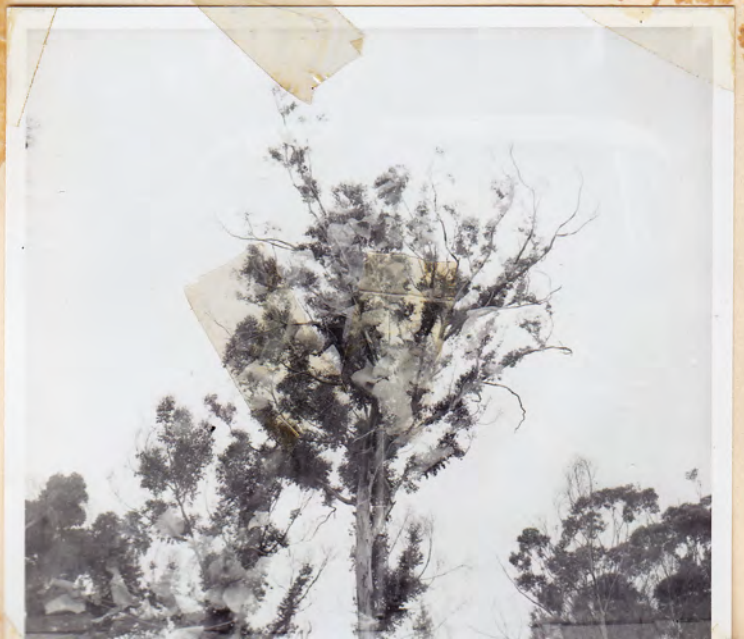
8. Tree N°480 Plot 6  
Recovery of defoliated crown →

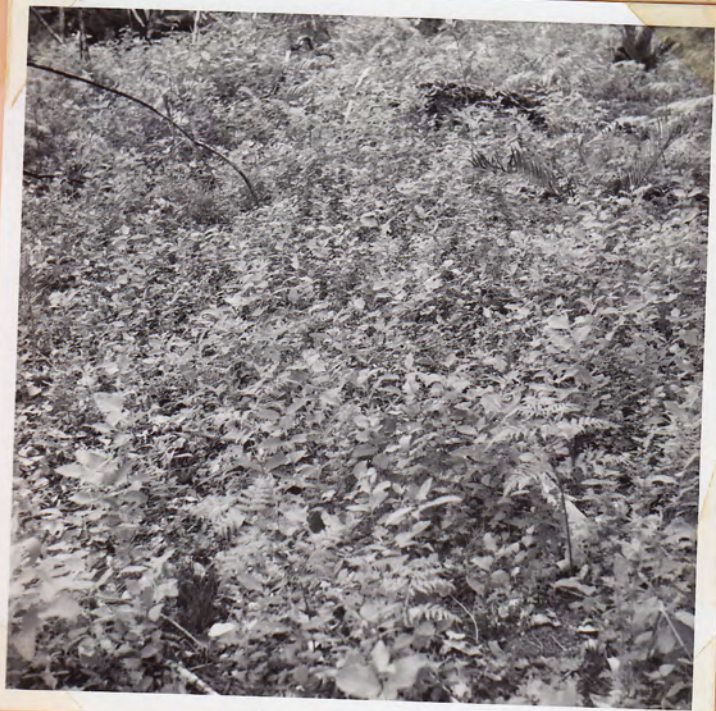
9. Plot 8 - Prolific Karri regeneration adjacent to Casuarina trees - not ashbed but has had heavy dressing of ash.

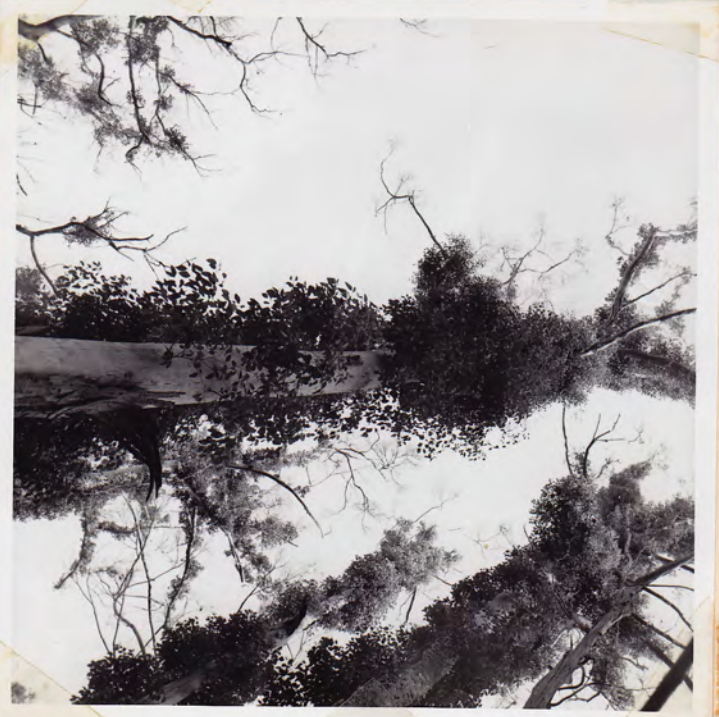
10. Tree N°478 Plot 8  
Epicormic development on →  
bole of tree.

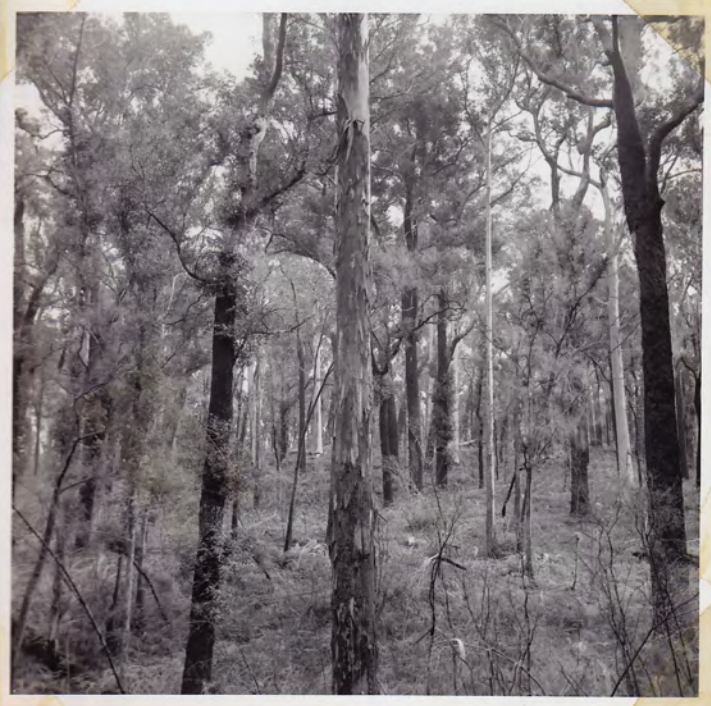
12. Plot 2 - Fire killed undergrowth with retention of full canopy of overstory →

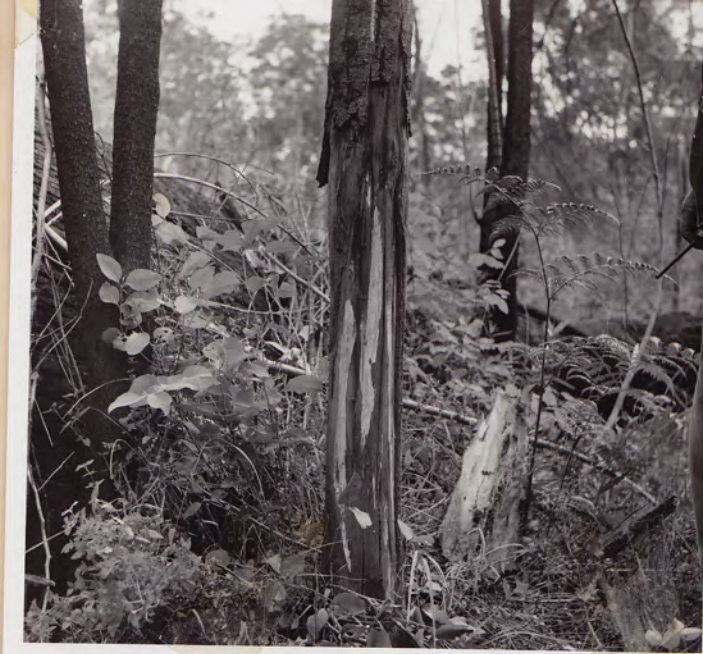
1. Tree N°381 - extensive lesion  
ground level to 3' in young  
karri regrowth.

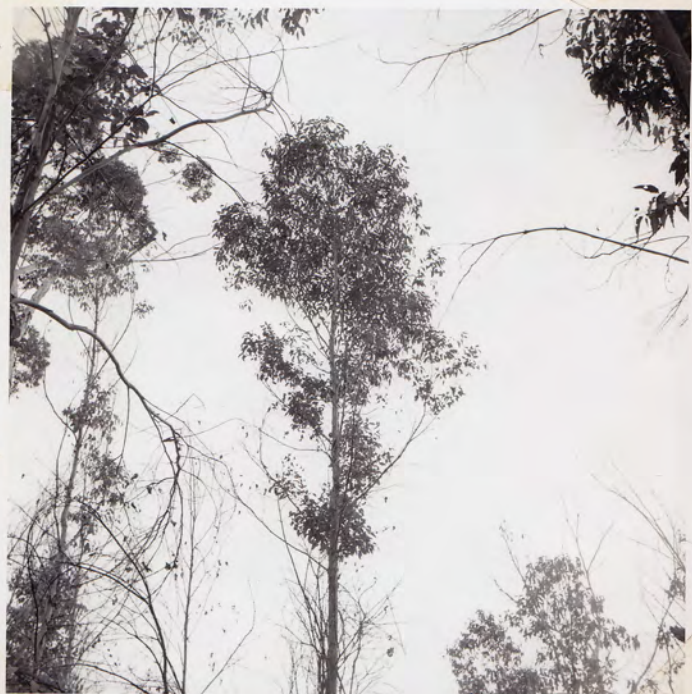
2. Tree N°381 - showing  
crown of tree with defect  
as in photo 1.

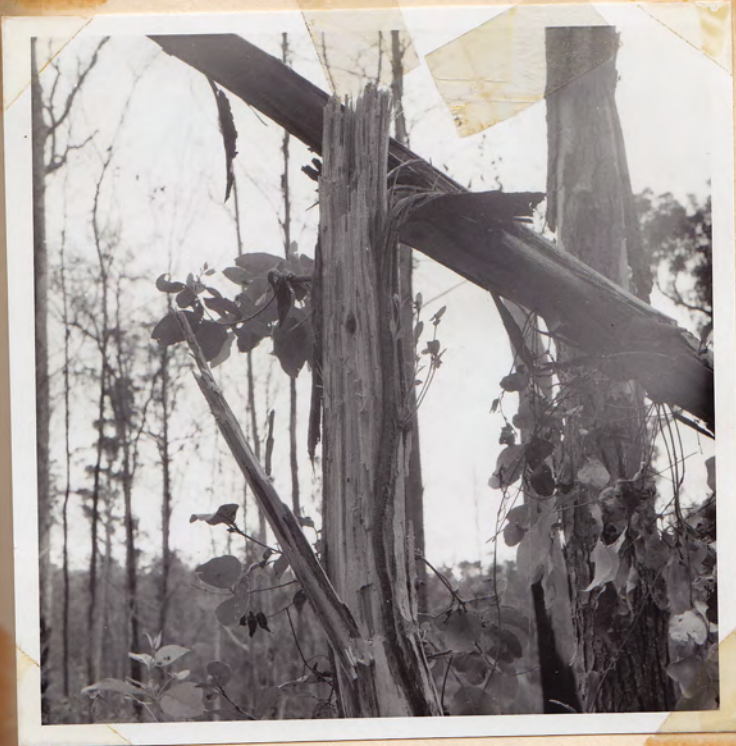
6. Plot E - fire damaged  
young Karri subsequently  
infested with borers - broken  
off.

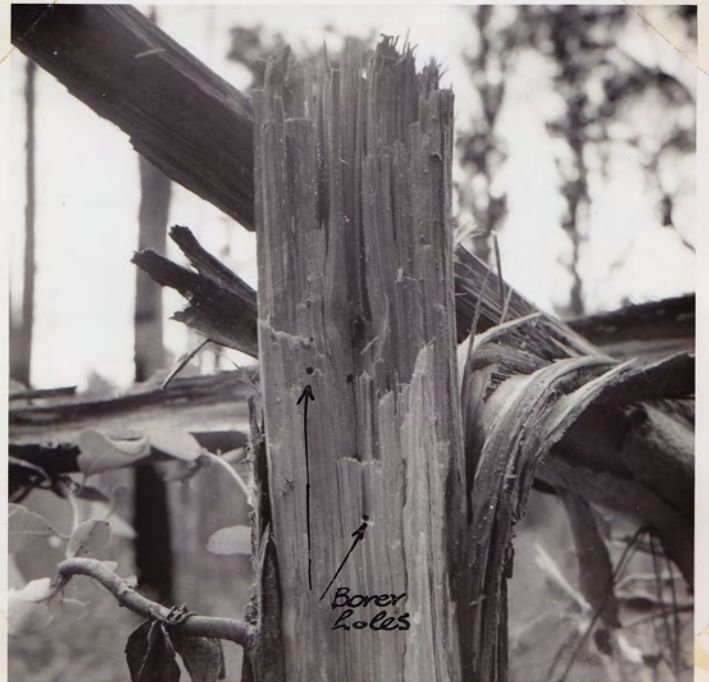
7. Plot E - close up of broken zone  
in photo 6 showing  
secondary infestation  
with borers
