**THE CONDITION OF THE
KALGAN RIVER
FORESHORES 1992/93**

**Albany Waterways
Management Authority,
Oyster Harbour Catchment
Group and the Department of
Agriculture of WA**

**Waterways Commission
Report No 52
November 1994**

Dr Luke Pen

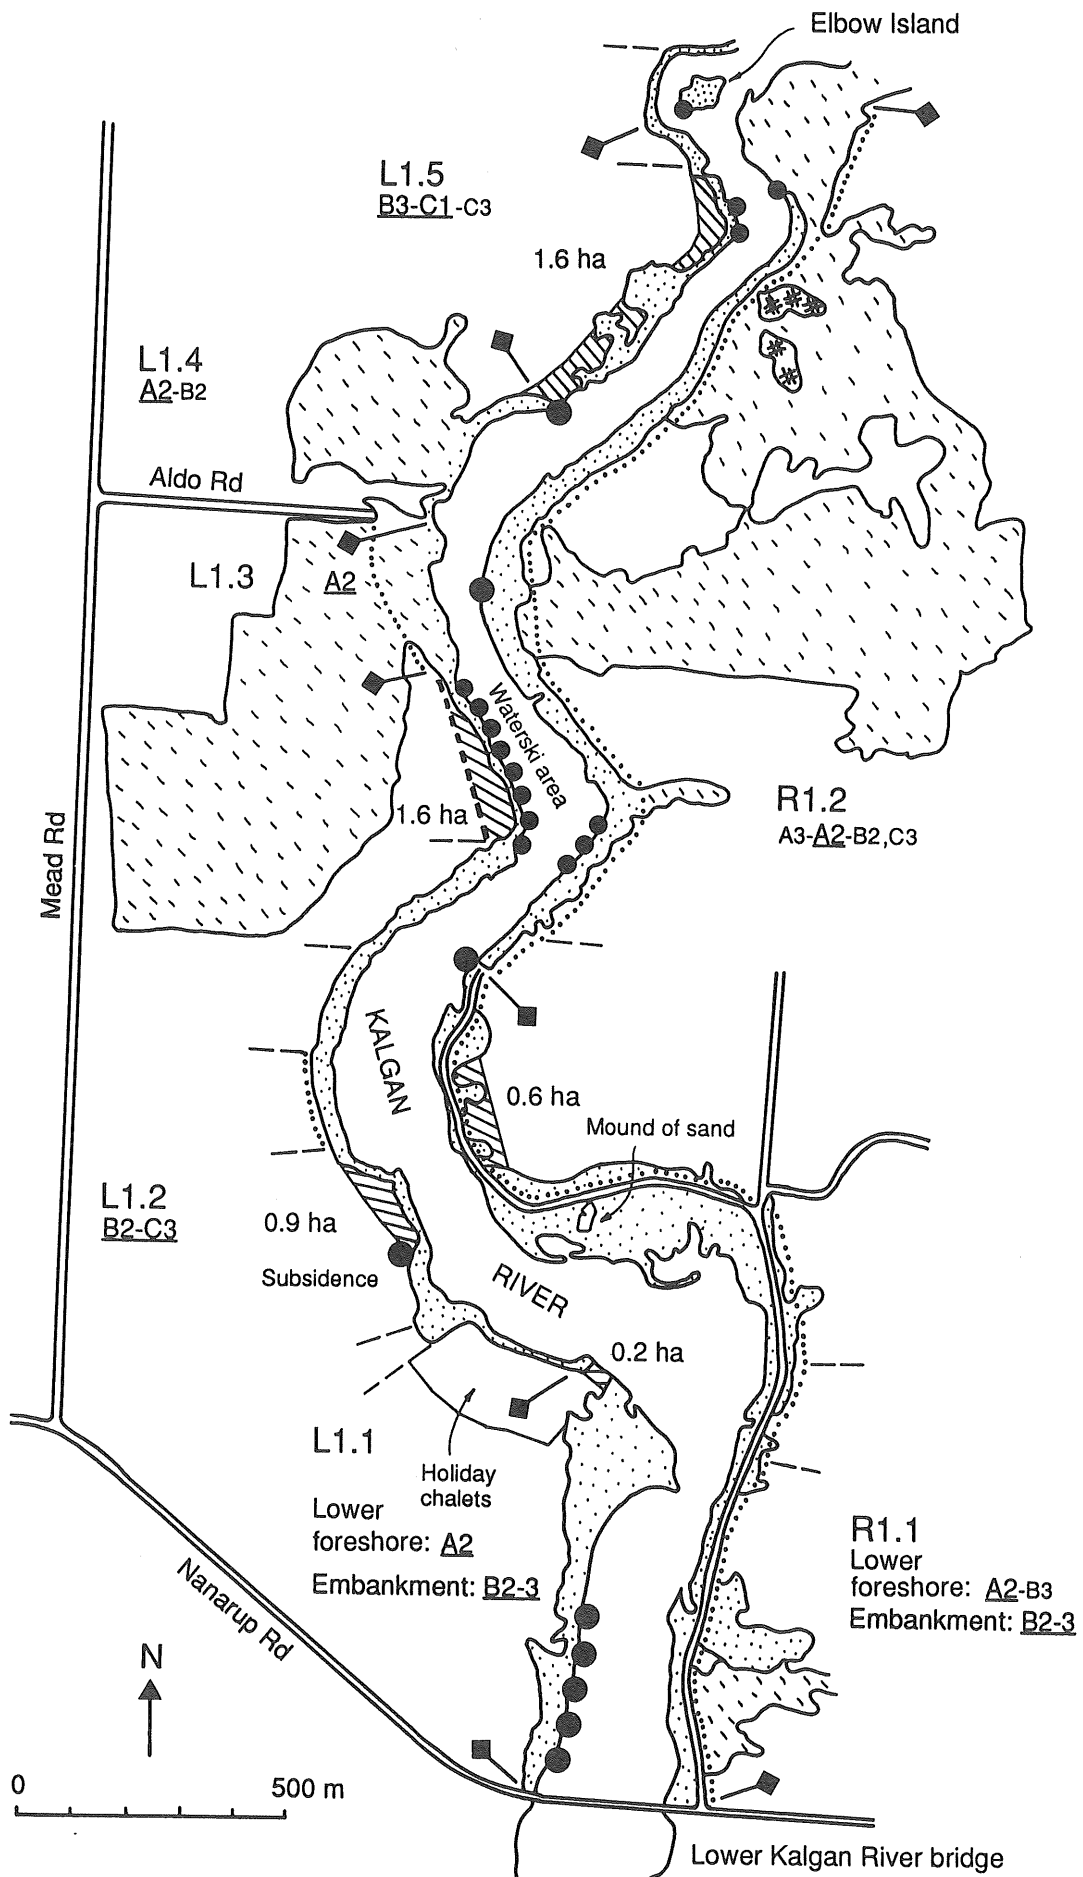
Map 1

On the left side of the river the condition of the steep embankment was mostly between B and C grade, with only 8% of the riparian zone fenced off from livestock, mostly cattle (Table 5.1, Maps 1 and 2). In fact, 67% of the left bank was C grade, representing the most extensively degraded embankment anywhere in the study area. There were some broad areas (4.3ha in total) of high embankment which had been substantially cleared and which required stabilisation with tree planting. Serious foreshore erosion was extensive in two main areas, near the waterski club and the Lower Kalgan bridge (Map 1), the latter probably being natural. Otherwise, there were a few points of severe erosion and subsidence, mostly near Elbow Island (Maps 1 and 2).

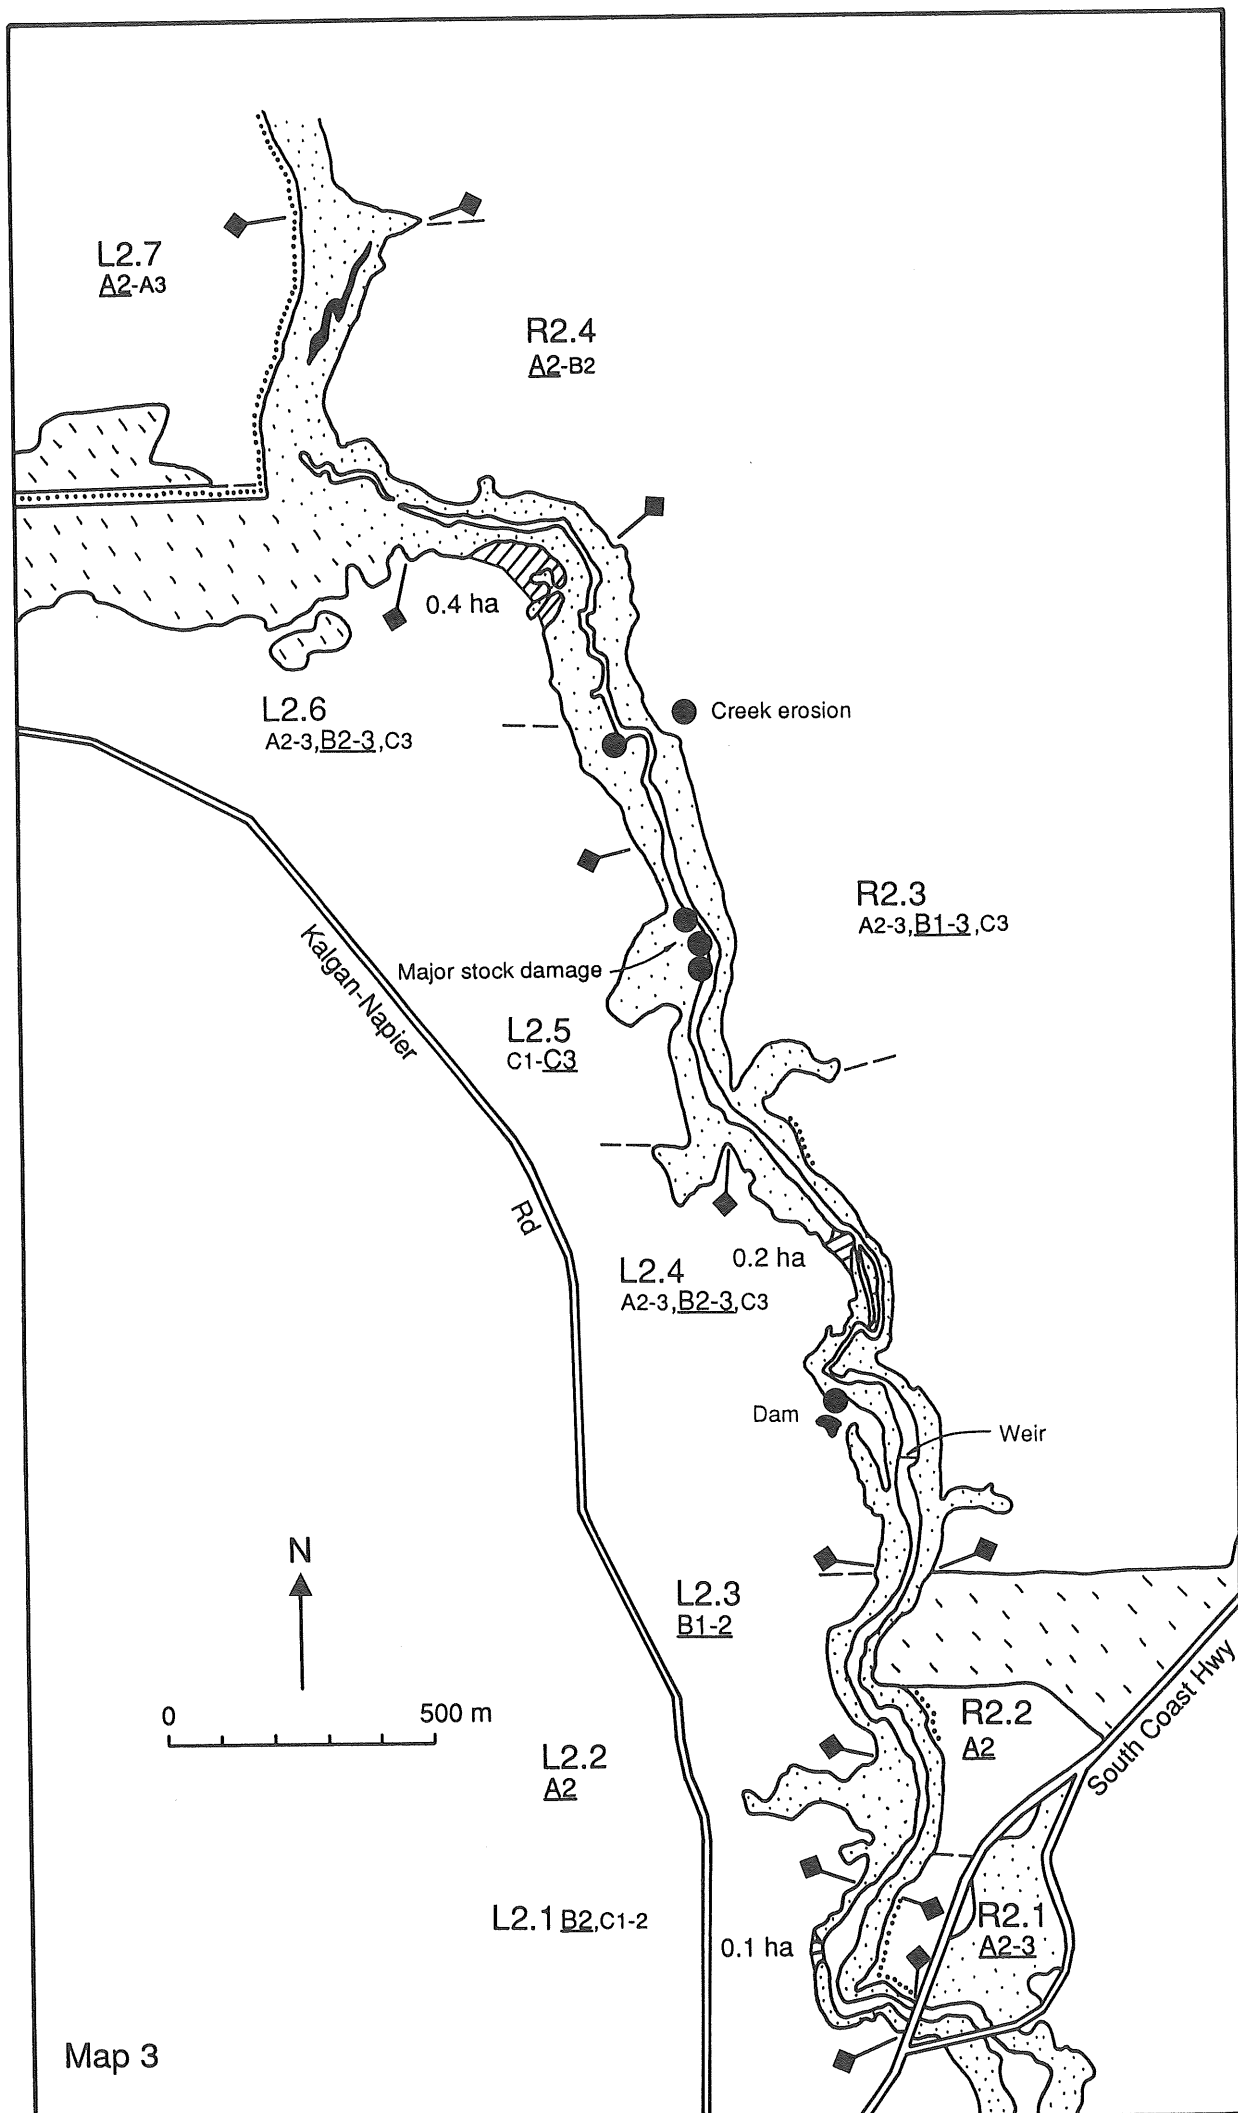
Map 3

The most serious point erosion to be found anywhere along the river was in this section, especially on the left bank (Maps 3, 4 and 5). Here, cattle grazing and trampling had exposed the soil over large areas, leading to serious sheet erosion or undercutting by floodwaters. In some places huge bites had been taken out of the river valley embankment, either by direct water erosion or by bank failure following undercutting of the root zone. Repair of these areas will be an expensive and time consuming process, but other areas of the embankment which had been cleared but which did not yet exhibit erosion, could be stabilised relatively easily with trees: 2.7ha on the left bank and 8.9ha on the right bank.

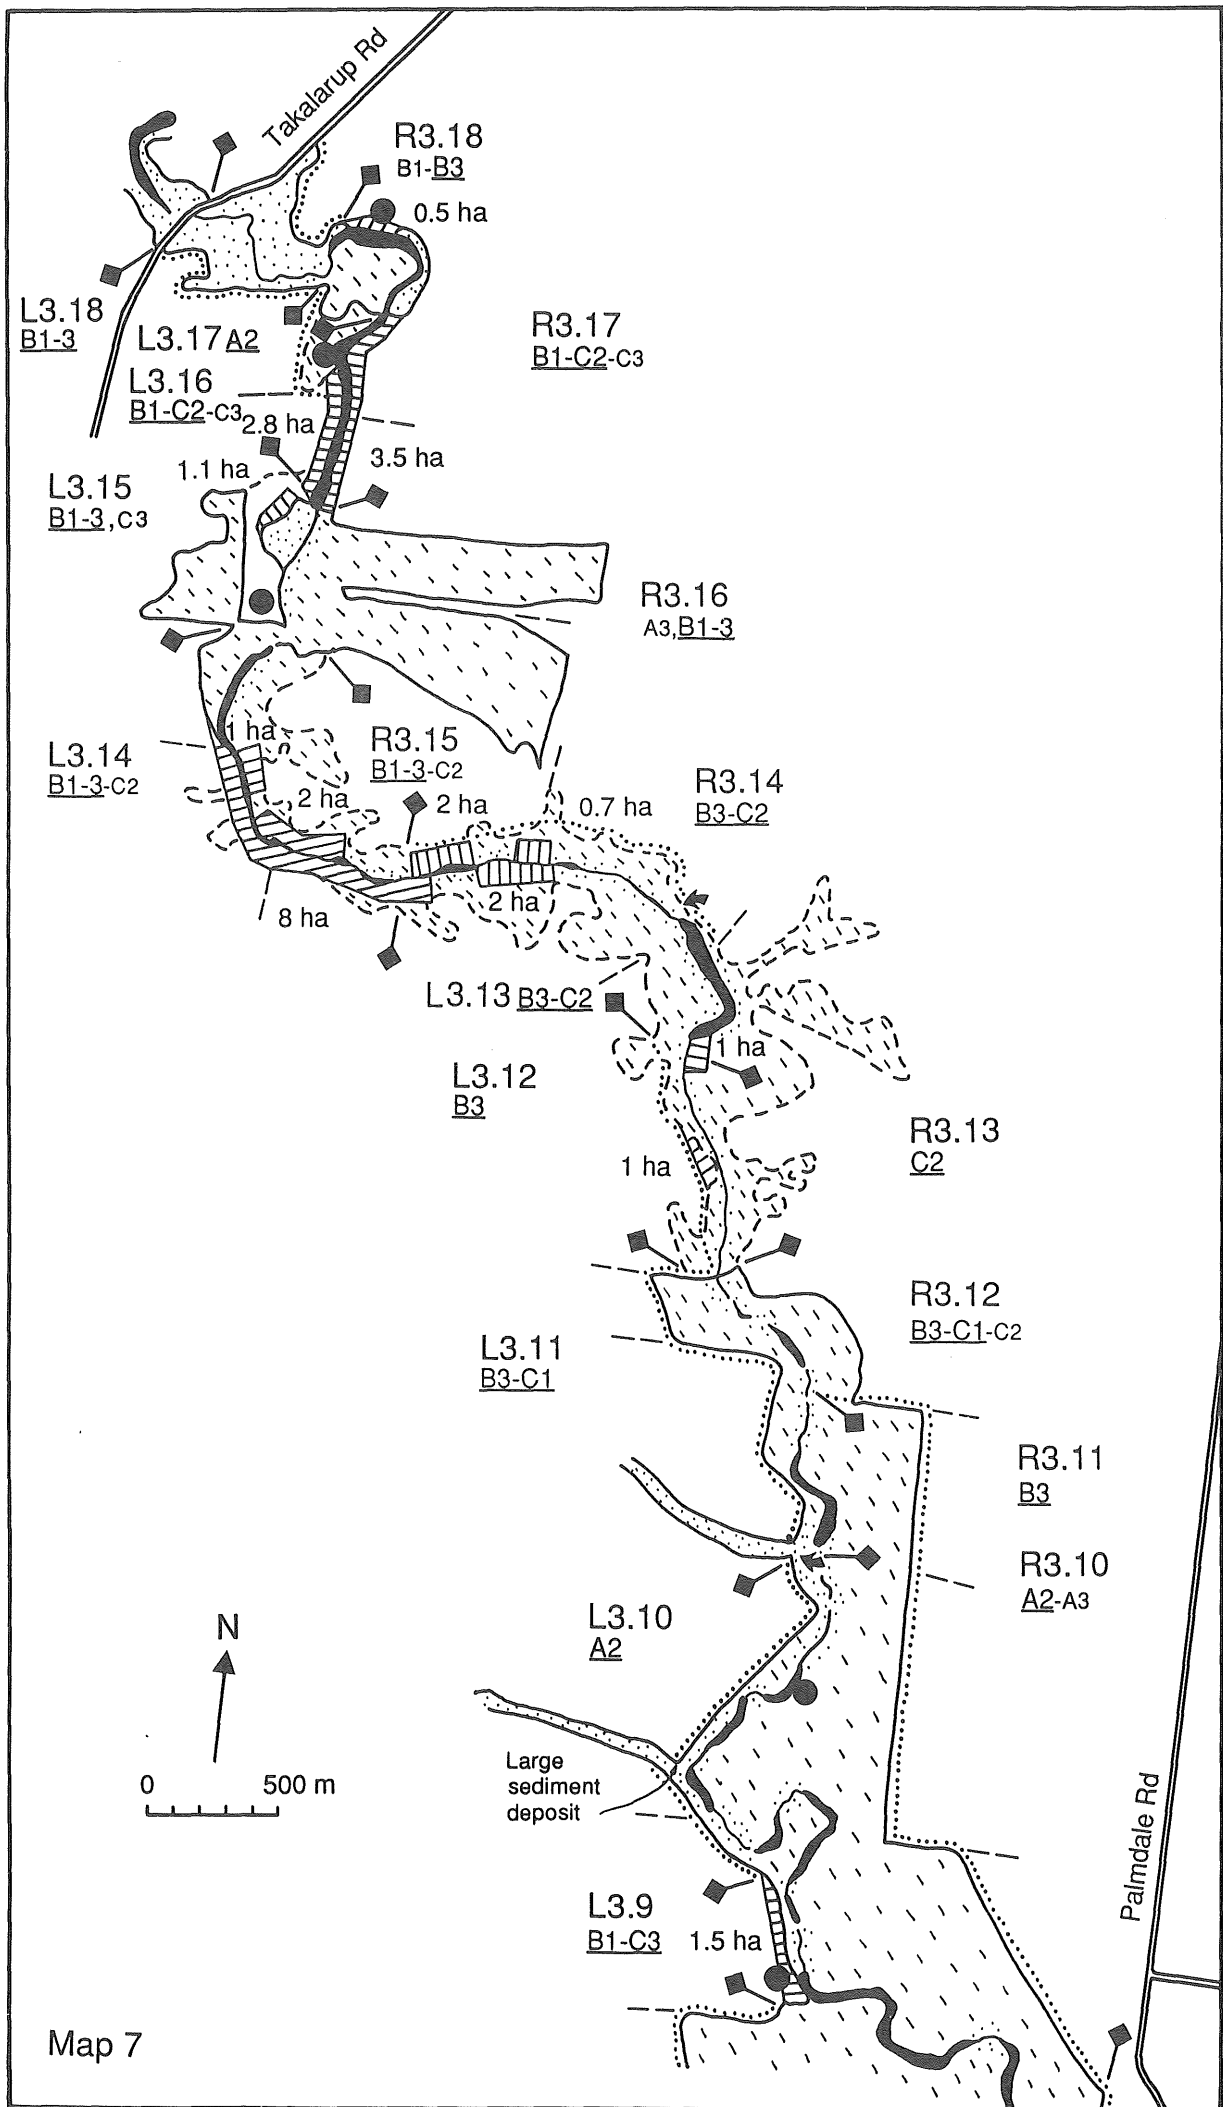
Map 7

Nearly all of the B and C grade foreshores of Section 3 were found in the upper 7km (Map 7), where relatively little of the river valley had been fenced off. Livestock grazing and probably frequent fires have rendered much of this area devoid of native understorey species and even tree cover in some places. The result is that whereas the lower 20km exhibit only a few points of severe erosion (Maps 6 and 7), most of which appeared to be semi-natural (see 6.5), the upper 7km were marked by either extensive soil exposure, sheet erosion and points of severe erosion, or a high potential for erosion, owing to the absence of perennial vegetation. Thus, over 16ha on the left bank and nearly 13ha on the right bank required vegetation rehabilitation to stabilise the embankments (Table 5.1, Maps 6 and 7).

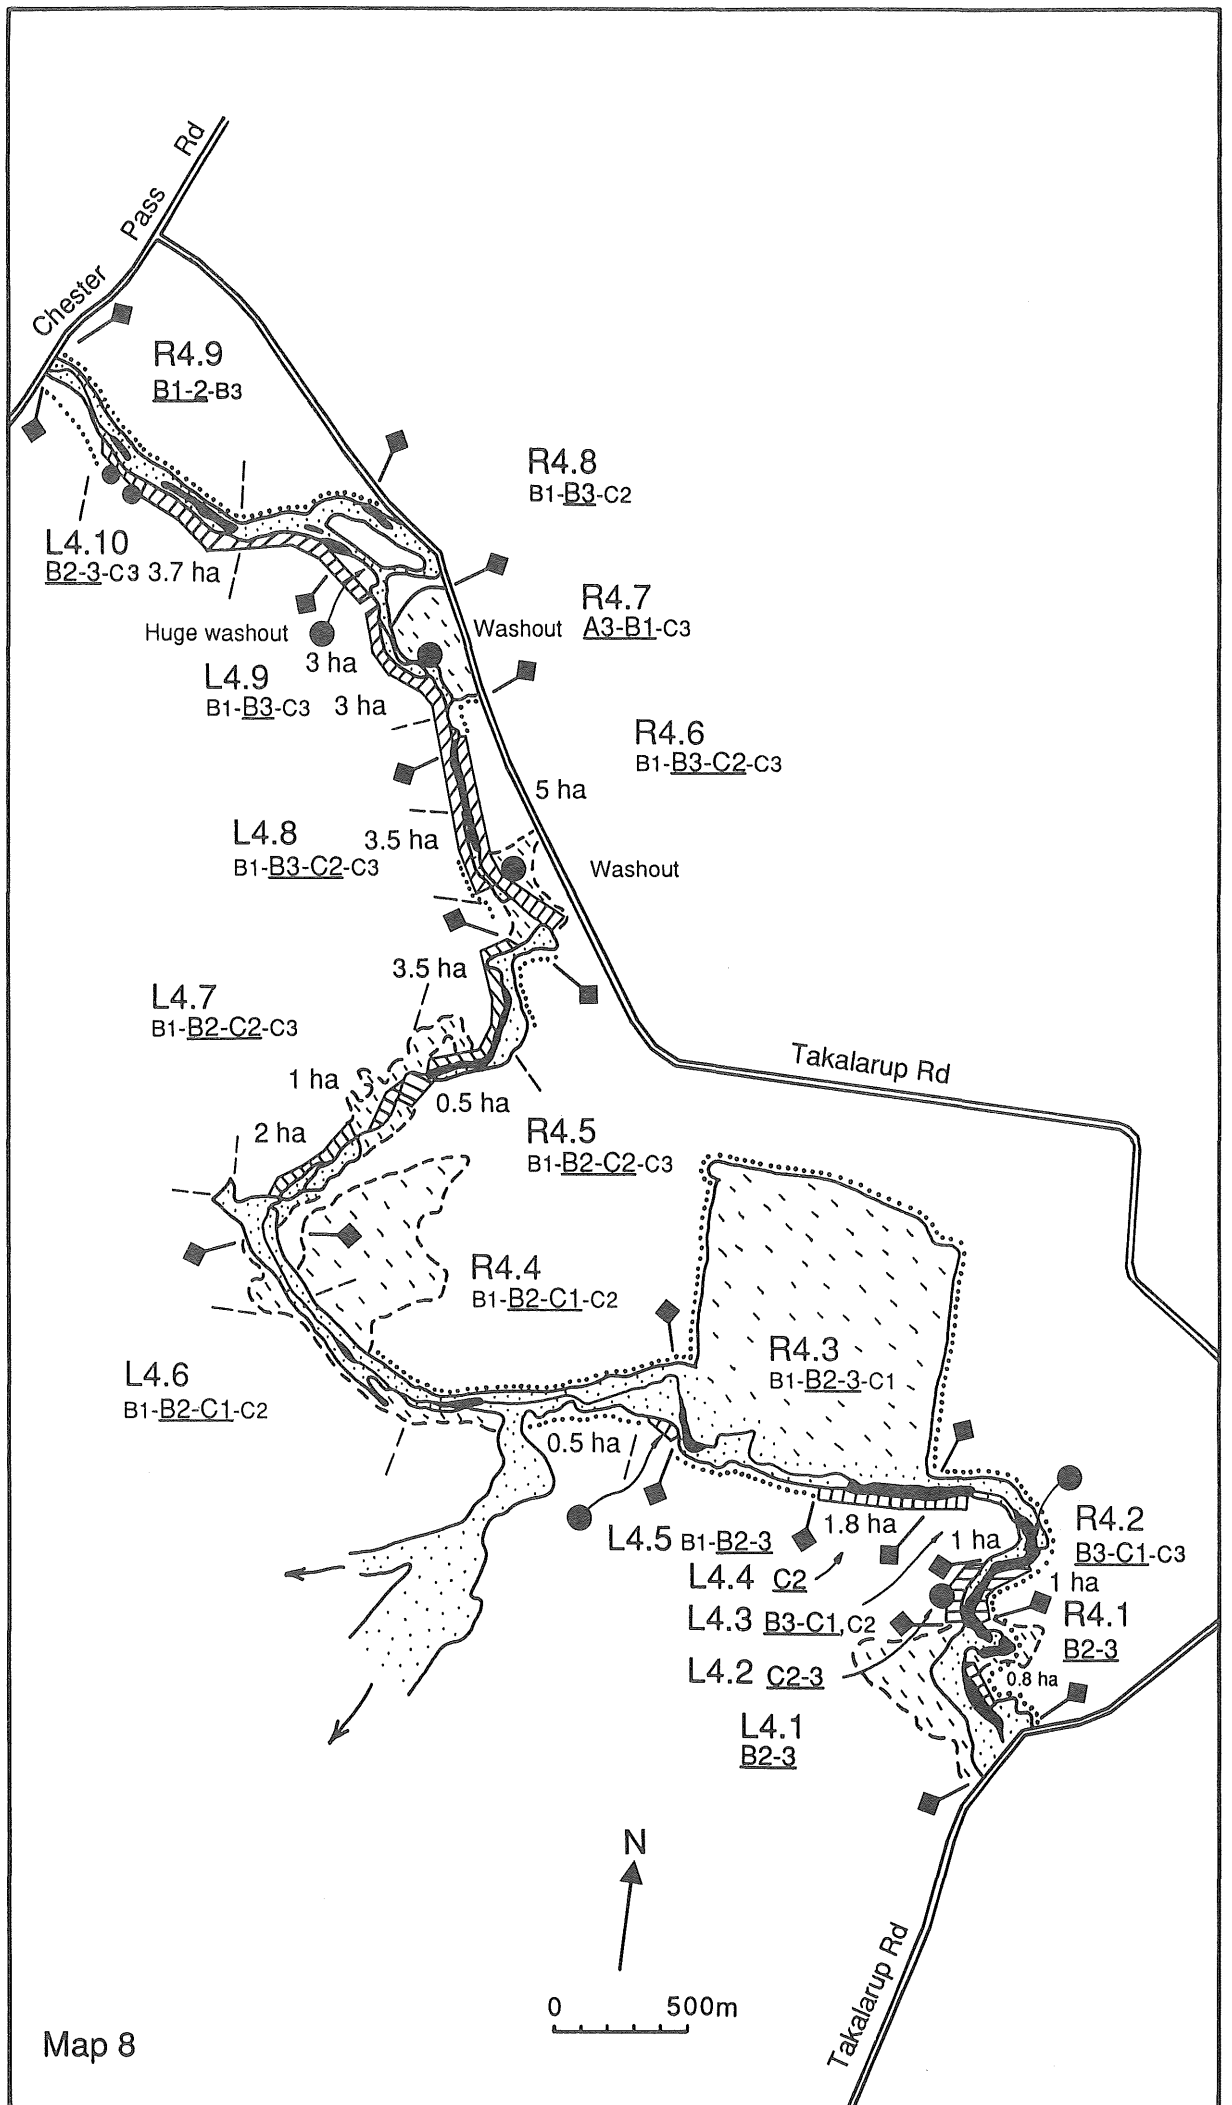
Map 8

About two thirds of the foreshores of this section were classified B grade, with the rest classified C grade (Table 5.1). No substantial A grade foreshore was found, even with 76% of the right bank fenced off. This suggests that very little of Section 4 has been fenced off continuously since the advent of agriculture and that grazing pressure and frequent fires have facilitated major weed invasions. Only 21% of the left bank was fenced off and there were large riparian areas with little or no perennial plant cover, necessitating about 30ha of vegetation rehabilitation to stabilise erosion prone sections of the river valley (Table 5.1 and Map 8).
