Revegetation

Case studies from
south-west Western
Australia

August 1999
Report No. RR 5

REVEGETATION

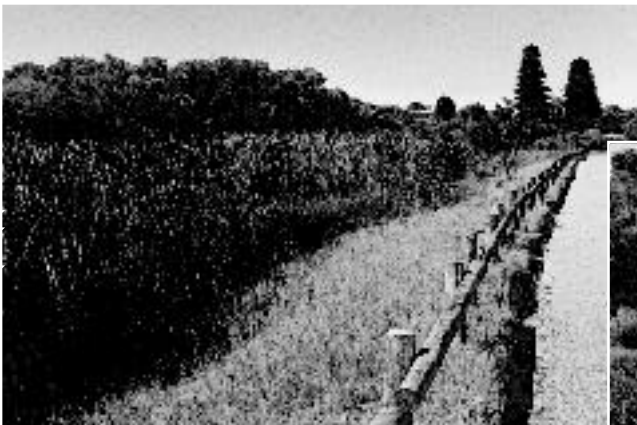
In assessing the weed control, priority has been given to control of bulrush, as the massive extent of the infestation is preventing the return of the indigenous populations of rushes and sedges. The fire hazard caused by this plant has resulted in almost annual fires, and a large reduction in the swamp paperbark community. The following summary outlines the methods and timing of weed control at the reserve, and gives an indication of the success of the treatments:

Baigup Reserve — bulrush prior to weeding.

The initial attempts at control of bulrush by Bayswater Greenwork were largely unsuccessful. They consisted of repeated slashing of the plants as they regrew, in an attempt to weaken the rhizomes. Burnout of the group occurred long before the bulrush showed signs of diminishing. The LEAP group slashed larger areas of Bulrush, and then sprayed the regrowth with Roundup Biactive. This method showed a definite reduction in the amount of bulrush, however after the project finished the area was again invaded, and within eighteen months it was back to its original condition.

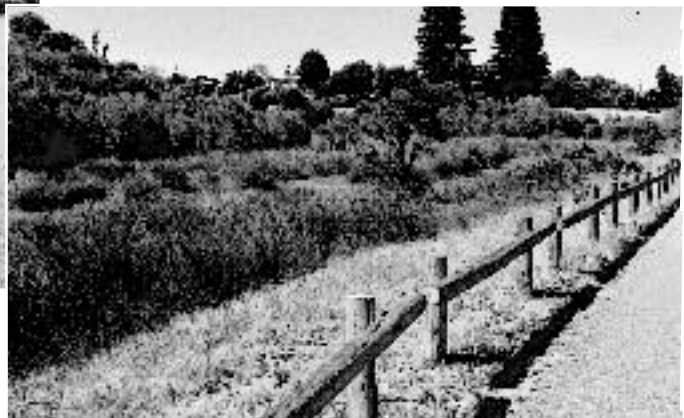
Two years after weeding.

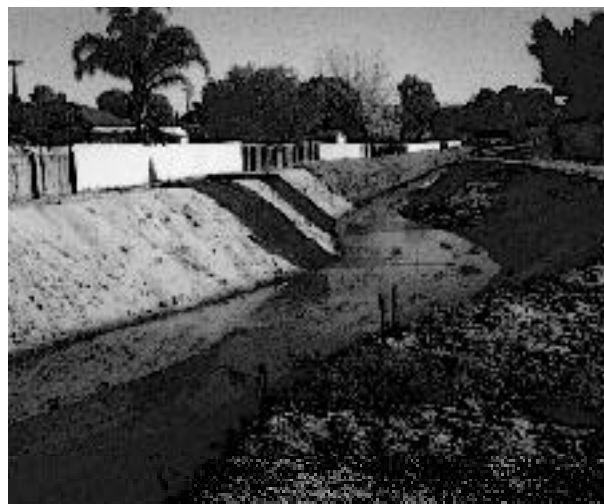
It was necessary to carry out extensive grading of the drain banks before the project began. One side of the drain backed onto fences with a narrow 3m strip along the top of the bank. It was not possible to alter the slope on this side, and it remains at 40° - 50°. To ensure public safety on the slope facing the park, the slope was contoured to 20°. A meander was also created in the drain to give it a more natural appearance and to mimic the water's natural course of flow. No weed control was necessary to prepare the site for planting, as the banks were bare following the earthworks.

Paterson St Drain after earthworks to create meanders and lessen the slope of the bank. (Photo supplied by Rosemary Glass, BICM).

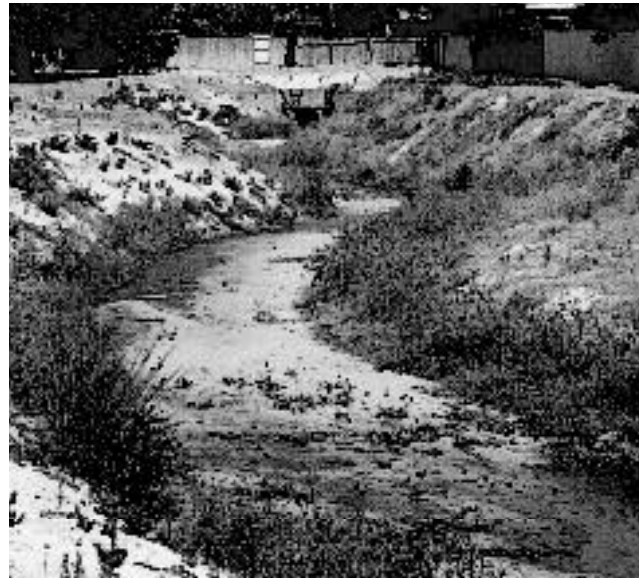
After planting, couch grass became a problem, as well as annual grasses. The couch will be sprayed with Fusillade or Glyphosate, and Greencorp trainees will remove the annual weeds. Greencorp is an environmental training program for young unemployed people.

Eight months after planting (June/July 98). Couch is still a problem but the rushes are taking well and the meanders are clearly evident. (Photo supplied by Jodie Oates, WRC).

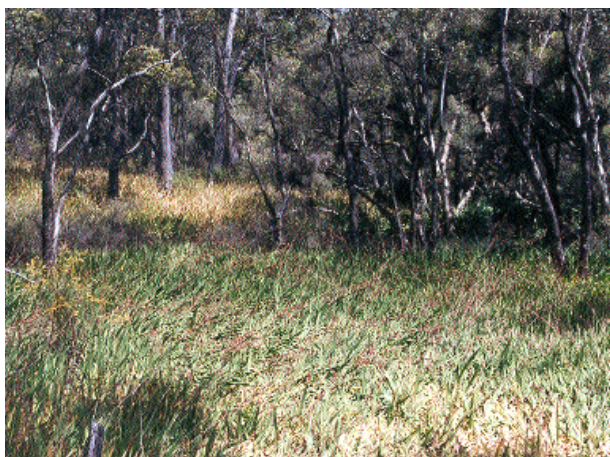
Prior to Watsonia weeding.

At both Falls Park and Brookside Park, Watsonia formed a continuous carpet, and formed a monoculture in the understorey. The members of the group sprayed the infestations with a 1% solution of Roundup Biactive between August and November each year, starting with the drier areas, and following the receding water down towards the streambed. Initial spraying was done with a boom spray, and generally killed 80-85% of the Watsonia in the first year. The next year touch-up spraying was carried out with a 5L handsprayer, and the following year a final spray was done to eradicate any new seedlings. At this point, the area was burnt in autumn to stimulate growth of native seed within the soil bank, and planting of native seedlings was commenced the following winter. Any Watsonia plants reappearing were then easily dealt with by wiping them with herbicide.

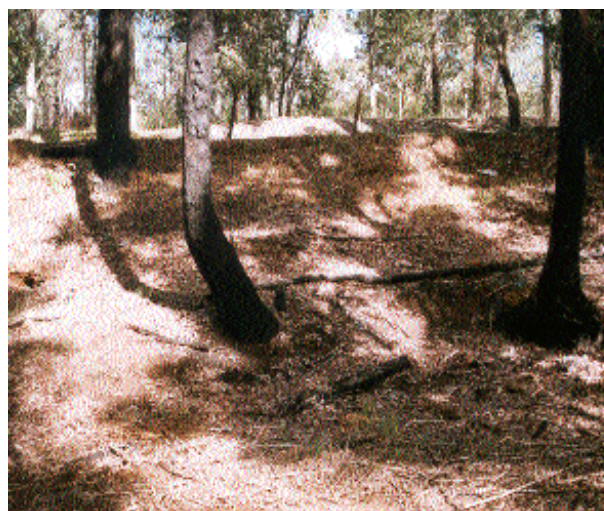
After weeding.

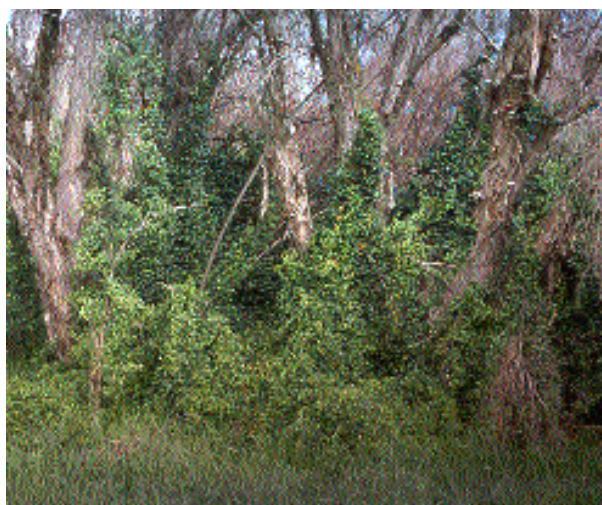
Weed control has been the initial focus of the group, as they do not wish to revegetate until they have the bulk of the weeds under control. The Bridal Creeper has been cut and removed, and the regrowth sprayed with Roundup. The Arum Lily has also been slashed, and sprayed with Roundup, however the group have not found this to be very successful, and will be seeking other methods to control this species.

Bridal creeper behind Toodyay town site (April 98)

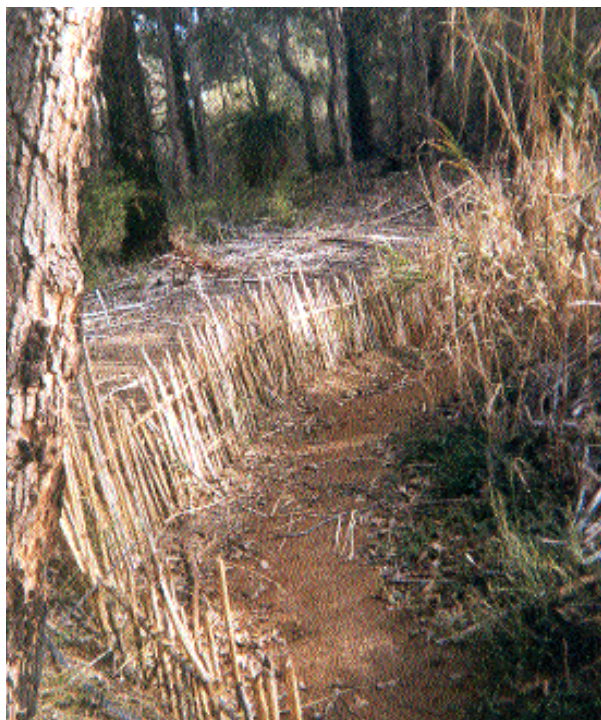
Giant reed, dried for a minimum of 2 years, used as brush fencing to prevent erosion.

The innovative use of an on site weed to control erosion has been an outstanding success in this project. Natural regeneration has been rapid, as there is a large native seed source within the vicinity. There was also a source of sedges for transplanting, and this method is proving to be low cost and effective. The project has been running for two years, and Herbert estimates that within two more years the area will have returned to excellent condition, requiring little maintenance.

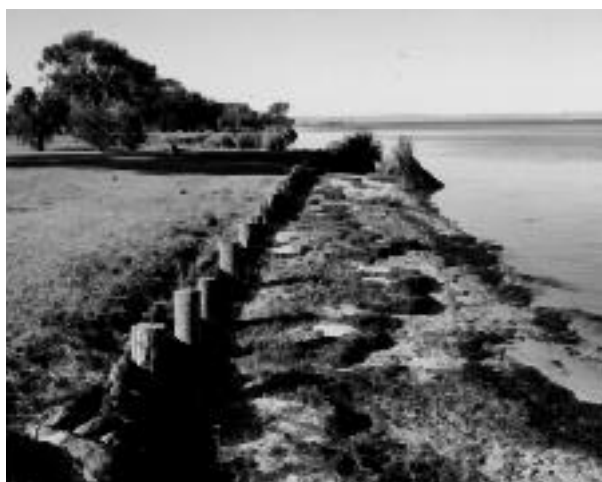
The foreshore reserve has been virtually denuded of vegetation, with only isolated clumps of shore rush (*Juncus kraussii*) and knotted club rush (*Isolepis nodosa*) left along the tidal zone. The area affected by development was almost totally cleared, however it is adjacent to some remnants of estuarine vegetation in good condition.

A section of foreshore prior to revegetation.

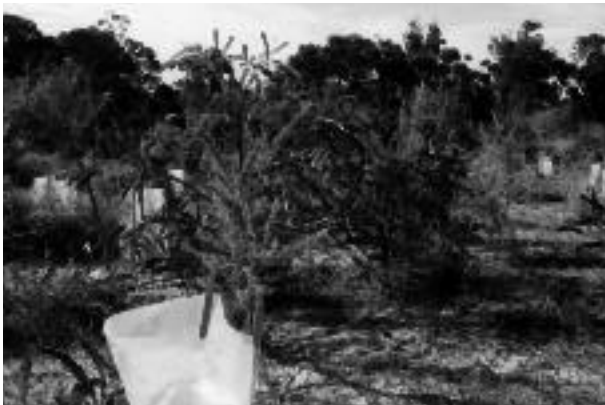
There is a large rabbit population in the area, and the tree and shrub plantings were protected with tree guards to prevent predation. Part of the area had been filled with beach sand, and had very little organic matter to provide sustenance for the seedlings. The dead algal matter, which had accumulated along the foreshore, was buried within this sandy area, providing moisture retention and additional organic matter. The plants in this area have thrived.

Tree and shrub plantings in cleared area. Tree guards were used to help prevent loss to rabbits.

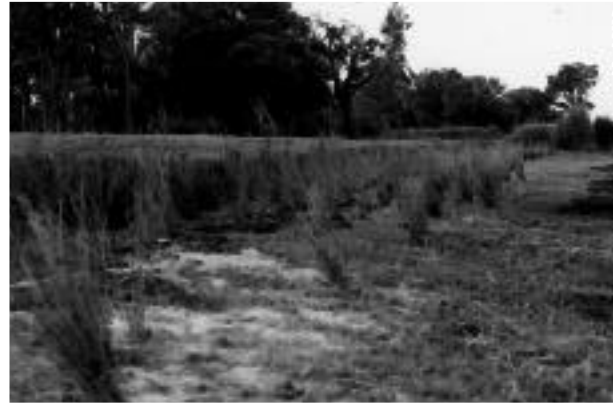
Rush planting on the foreshore — couch grass is being left untreated until rushes are established.
