General Technical Report FPL–GTR–211

# Evaluating a Small Structural Insulated Panel (SIP) Designed Solar Kiln in Southwestern New Mexico—Part 1. Design and Operation

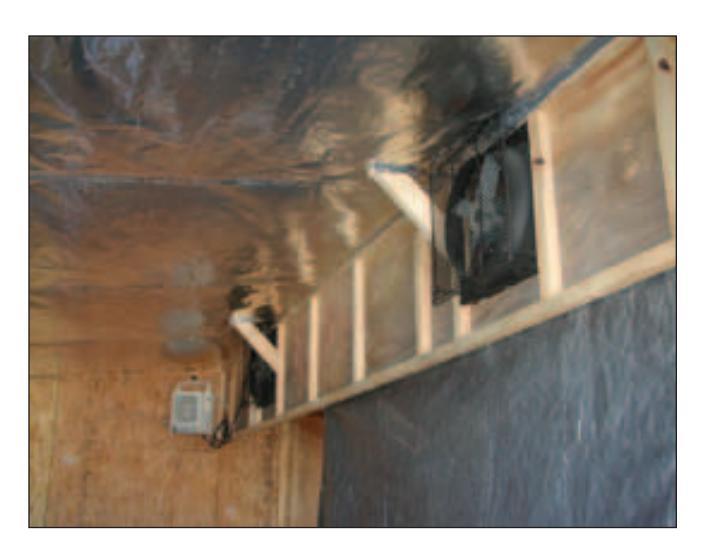
Figure 2—An electric heater in rear of solar dry kiln. Note lack of aluminum foil insulation on the sidewall showing the uncovered structural insulated panels (SIPs).

Another problem noted was the lack of aluminum foil completely covering the solar kiln's interior. Insufficient cover will eventually result in decay of the OSB skin especially when solar drying green lumber and reducing the potential of preventing thermal degradation of the EPS insulation in the SIP. A complete cover of the kiln interior would prevent premature deterioration of the SIPs, which are expensive to replace.

Additional foil is needed to completely cover the kiln's interior as shown in Figure 2. This would help both in reducing radiant heat loss through the dryer walls and to prevent damage of the kiln's OSB shell from the moisture released by drying lumber, thereby possibly extending the kiln's operating life. The foil may also protect the OSB shell when temperatures of 160 °F are required for driving out volatiles to set the pitch. In addition, heat-resistant coatings applied to the inner shell would also aid in preventing any possible degrade of the wood structure. An alternative to coatings would be to add additional sheathing to protect the higher value SIPs and monitor the additional sheathing for degrade. Further research in this area may be worthwhile.

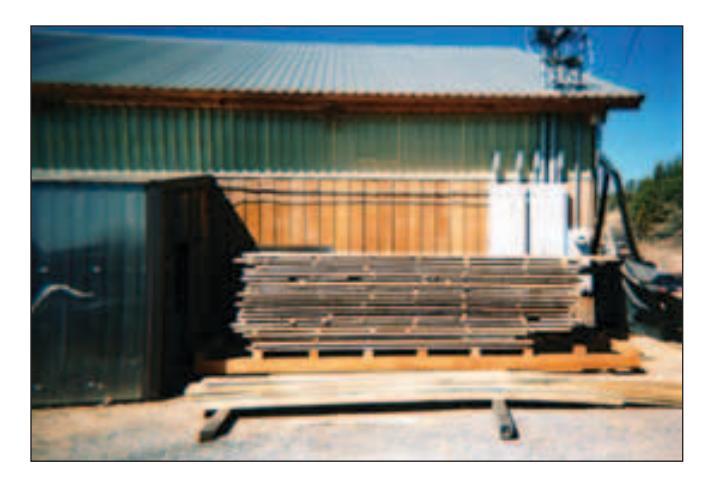
Figure 6—Stickered ponderosa pine lumber stacked on rail cart. Note poor lumber piling, spacing of stickers, and alignment.

random lengths of lumber and the too narrow plenum space prevented a uniform airflow. Air uniformity allows all boards to dry evenly during the run. As shown in Figure 6, stickers were unevenly spaced and vertically misaligned (Fig. 6) from 16 to 24 in., thus tending to cause higher warpage than if the lumber was properly stacked (Simpson 1991; FPL 1999).

Two operational problems were revealed through measurements of the ponderosa pine charge. First, stickers were not properly aligned (Fig. 6). Uneven weighting can contribute to drying degrade through warping and kinks in the dried lumber (Simpson 1991, chapter 5). Some of this uneven spacing could be due to handling random lengths of lumber but was most likely due to inattentiveness of the stacker. Misaligned stickers can exacerbate uneven airflow problems. Additional training for the stacker is recommended.
