Assessment of the status of river pools in the Avon catchment

Water resource management series

Report No. WRM 47
December 2007

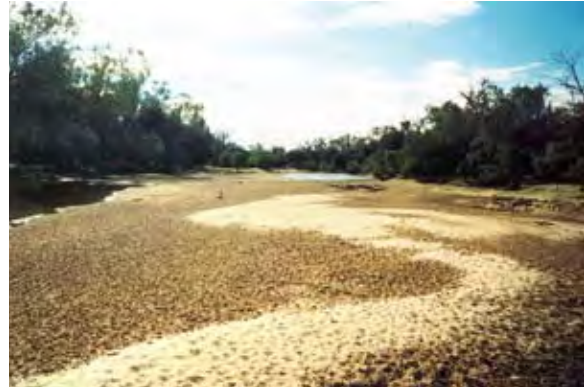
Deepdale pool is approximately 2 km upstream of the Folewood Road and River Road intersection. This pool marks the downstream extent of the river training scheme. Prior to the RTS, Deepdale Pool was used for swimming, fishing (for cobbler and mullet) and was suitable for stock water. The pool filled with sediment soon after the RTS was completed in this section and the survey of 1977 noted the pool was full (WRC and AWC, 2002a).

*Deepdale Pool filled with sediment
(Photo courtesy Viv Read)*

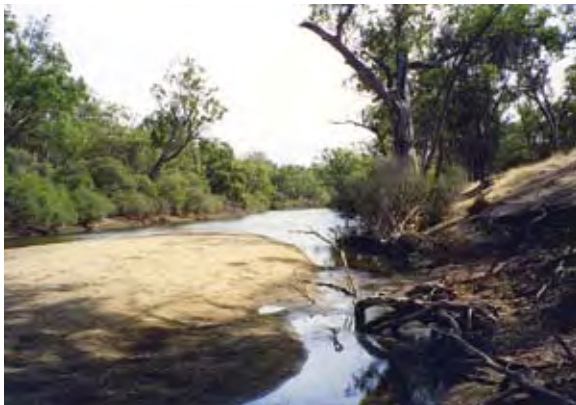
*Sediment filling Long Pool
(Photo courtesy Viv Read)*

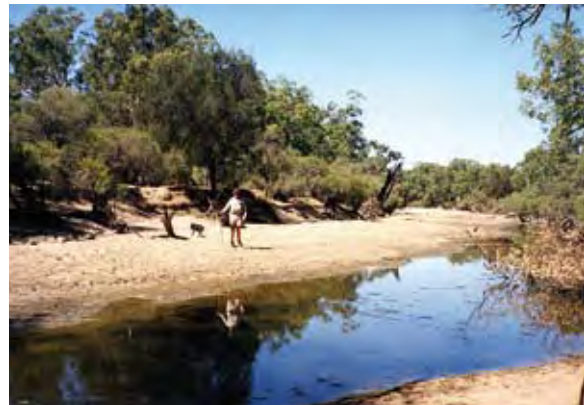
*Sediment in the downstream end of Jimperding Pool
(Photo courtesy Viv Read)*

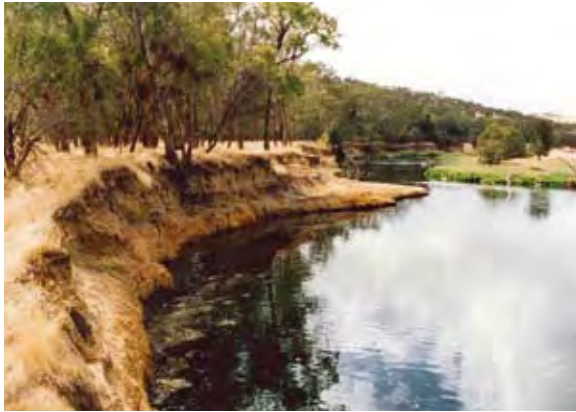
Red Banks Pool is downstream of the Bindi-Bindi Toodyay Road bridge. This is the only major pool on the Avon River that is circular due to active erosional processes caused by a conspicuous rock bar. There is only limited information available about this pool, however it is known that the pool was formed by the substantial raising in the late 1950s of the old Whitefield's Crossing (now known as Extracts Weir) to provide water for a tanning factory. The pool was popular for swimming. It remains deep (approximately 5 m) and has very steep (cliff-face) banks (5–8 m above the water level) (Davies et al. 1996). It is likely that this pool is self-scouring and may increase in size with time.

*Red Banks Pool - self scouring
(Photo courtesy Viv Read)*

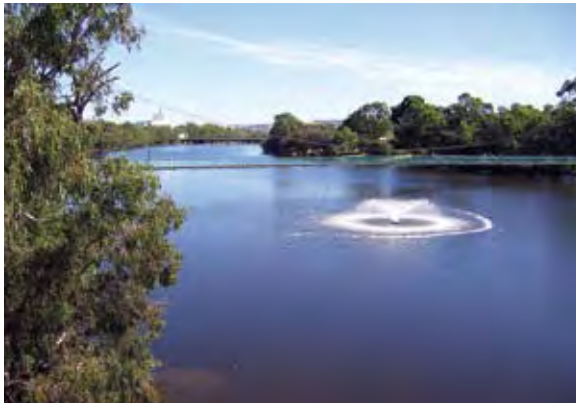
*Aerator on Northam Town Pool looking upstream, 2006
(Photo courtesy Rebekah Esszig)*

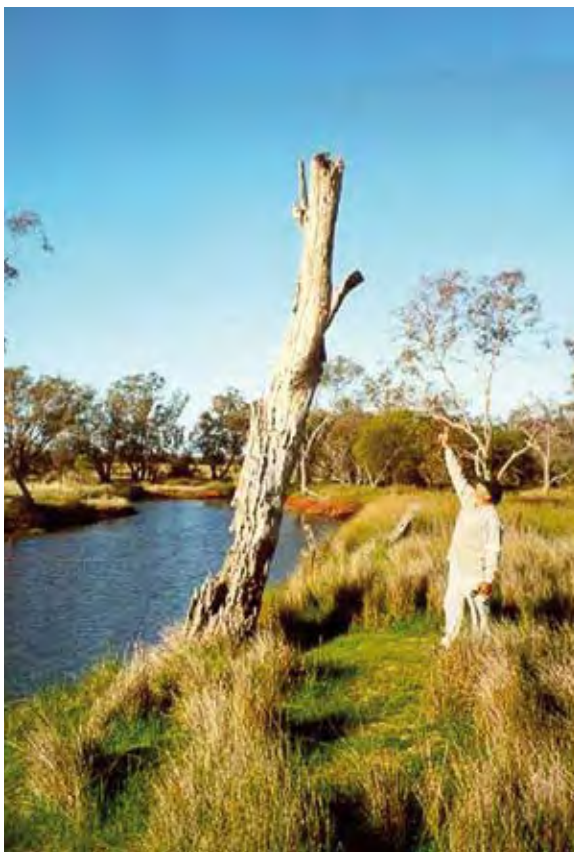
Remnants of a diving board structure at One Mile Pool (Photo courtesy Viv Read)

Some people remember swimming in One Mile Pool, which is within walking distance of the town. This pool was once deep enough for diving into from a four-metre-high tower (see photo to the left) but is now filled with sediment (WRC and ARMA, 2001b).

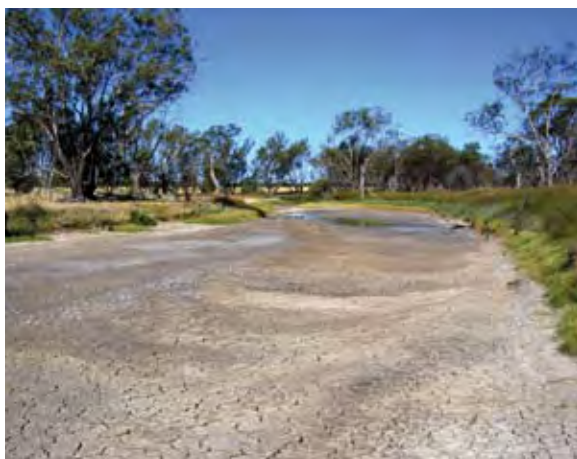
One Mile Pool is downstream of the Brookton townsite. Although now filled with sediment, the site remains attractive due to extensive rock outcropping and a river meander.

One Mile Pool looking upstream prior to sediment removal. (Photo courtesy Prue Dufty)
