River Recovery Plan, Foreshore and Channel Assessment Section 19 – Aldersyde-Kweda

REPORT NO. RRP 11
DECEMBER 2006

Section 19 - Aldersyde-Kweda

Prepared by
Viv Read & Associates
for Department of Water and
the Avon Waterways Committee

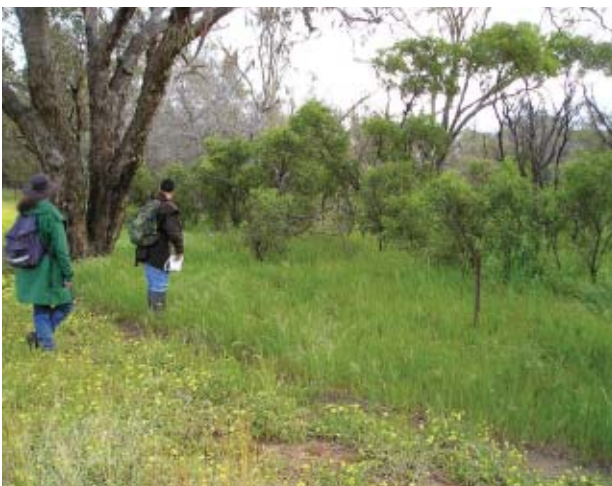
Photo 11: Senescent Banksia prionotes on LHS in Photo Section 6

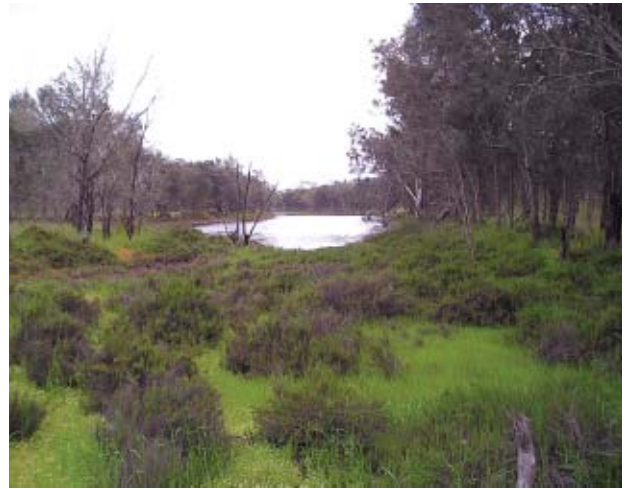
River pools are a significant characteristic of the Avon River. Until relatively recently, many of the larger pools in the Aldersyde-Kweda section were used for swimming and some were used for water supply or for the past practice of sheep-washing (eg at Stock Pool, PS22). Many pools were well known for the now illegal sport of duck-shooting. Dwarlacking Pool (PS22) was used through summer for family or community picnics. Remnants of a diving board and tennis courts indicate the previous social value of this pool (Photos 16 and 17).

Photo 16: Upstream end of Dwarlacking Pool at Pt 105 in Photo Section 22

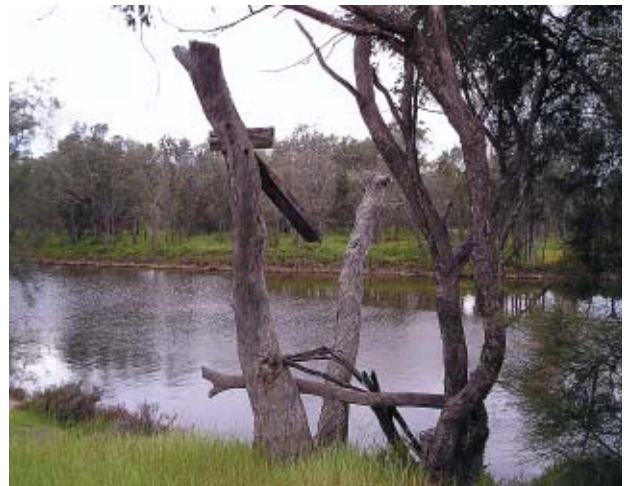
Photo 17: Diving board structure at Dwarlacking Pool in Photo Section 22

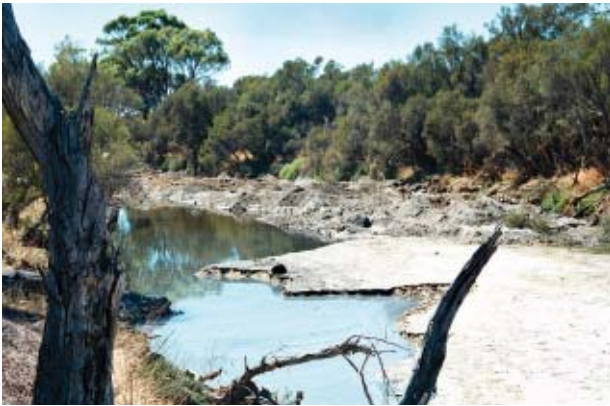
Photo 19: Boyagarra Pool prior to dredging, April 2002 (Department of Water)

The source of sediments in the pool is from the eroding river channel and from major tributaries. Nalyaring Gully is noted as having a high sediment load (UWA Centre for Water Research, 1999) however other tributaries also contribute to the river sediment load. It is also noted that the sediment load is depleted downstream of the Boyagarra Pool and this may limit the opportunity for channel rehabilitation.

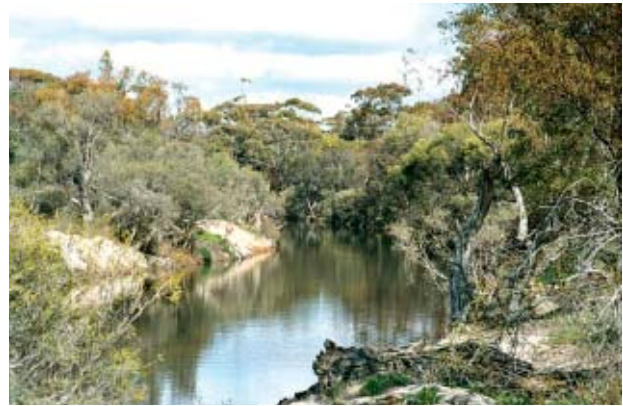
Photo 20: Boyagarra Pool following the removal of 6000 m³ of sediment, August 2002 (Department of Water)
