Lake Bryde Recovery Catchment

Annual Report 2003

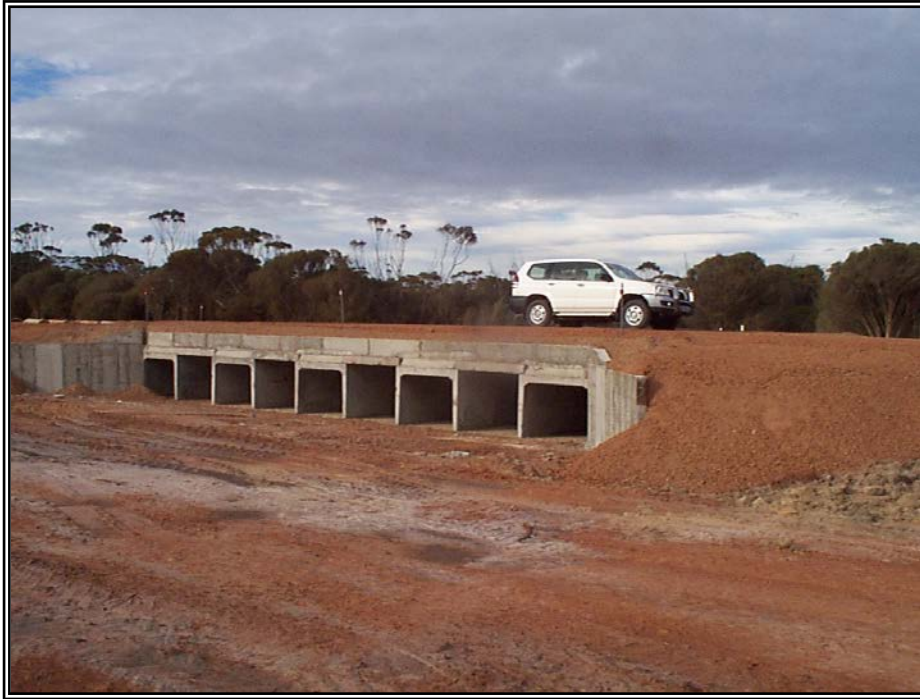
Culverts Under Pingrup – Newdegate Road

- 6.5.1 ***Culverts under Pingrup – Newdegate Road:*** Construction of culverts under the Pingrup – Newdegate Road was undertaken in June 2003. This sub project is now complete.
- 6.5.2 ***14 Mile Road:*** Design of floodway and culverts for the crossing on 14 Mile Road have been agreed with the Shire of Lake Grace and an accurate costing provided. Works were to be undertaken in 2003, however the Shire have delayed the works until March 2004.
