Carbunup River Action Plan

2000

Prepared for Geographe Catchment Council - GeoCatch
and the Sussex Land Conservation District Committee

by
Community Environmental Management

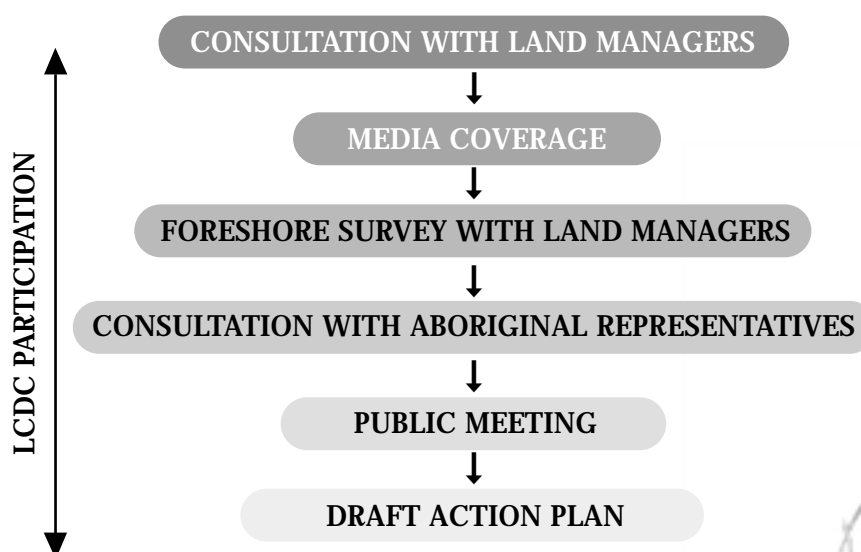
Figure 6: Community consultation flow diagram.

Consultation with members of the community formed an integral component of the project. Community members directly contributed a wide range of knowledge to the report such as land use, stock access and management advice. This input has helped make the report more responsive to local conditions. Figure 6 shows the milestones of community involvement in the Carburnup River Action Plan.

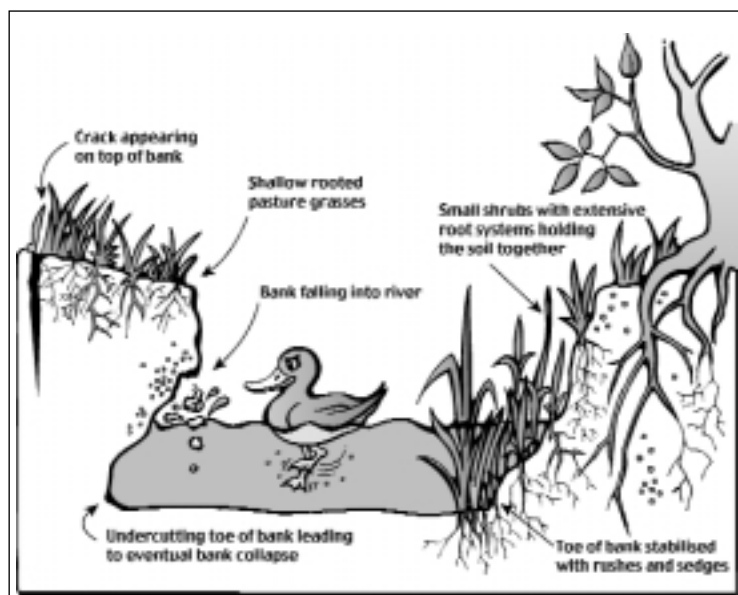
Figure 8: Undercutting of river bank. Picture courtesy of Stephen Elphick.

Erosion and siltation is a significant issue throughout the length of the Carburnup River due to modification of the land within or adjacent to the riparian zone. Undercutting and bank slumping are the two main types of erosion along the river.

A degree of erosion and sediment deposition is a natural process as the stream creates a meandering path to absorb the power of water flow. It is the level of erosion and its result that creates a management issue.

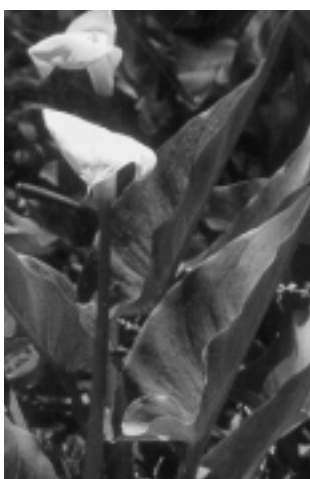
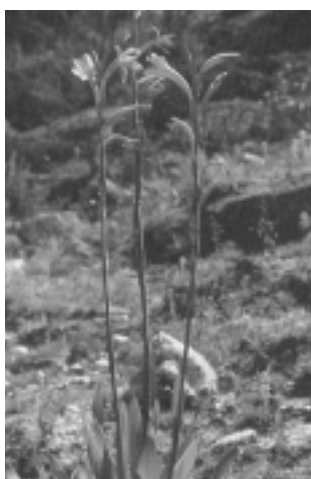
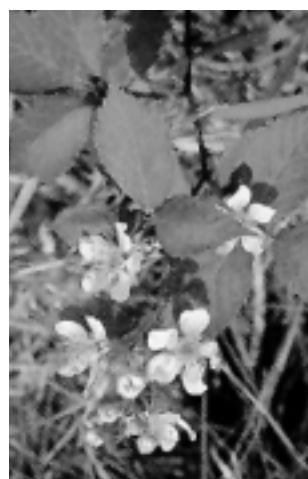
Figure 9: Weed species identified by the LCDC as requiring priority treatment.

Some weed species have been identified by the LCDC as a priority for control, suggesting that eradication and control measures should focus on

these species in the first instance. These weeds include those listed as declared plants and those know to be vigorous colonisers and invaders.

Zantedeschia aethiopica - arum lily

Watsonia bulbifera - watsonia

Rubus fruticosus - blackberry
