River Action Plan for the Sabina, Abba and Ludlow Rivers

Volume 1. Maps and Recommendations for Sabina River and Woddidup Creek

**Prepared for the Geographe Catchment Council - GeoCatch
and the Vasse-Wonnerup Land Conservation District Committee**

**by
Genevieve Hanran-Smith**

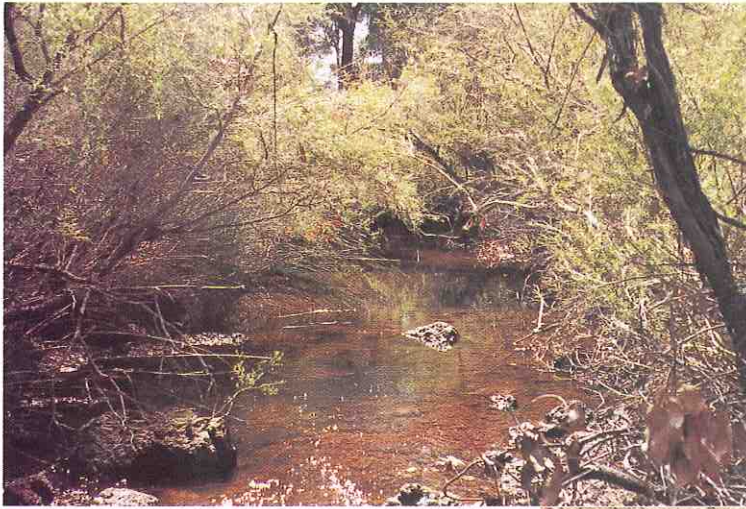
A2 grade foreshore on the upper Sabina River. Native fringing vegetation protects the banks from erosion and traps sediment and organic material before it reaches the river

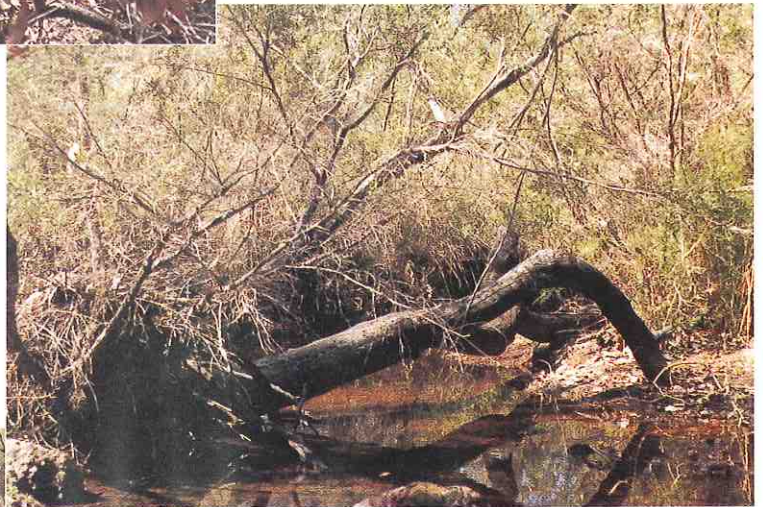
A2 grade foreshore on the upper Sabina River. Fringing vegetation shades the water, providing a cooler environment for aquatic fauna and limiting algal growth.

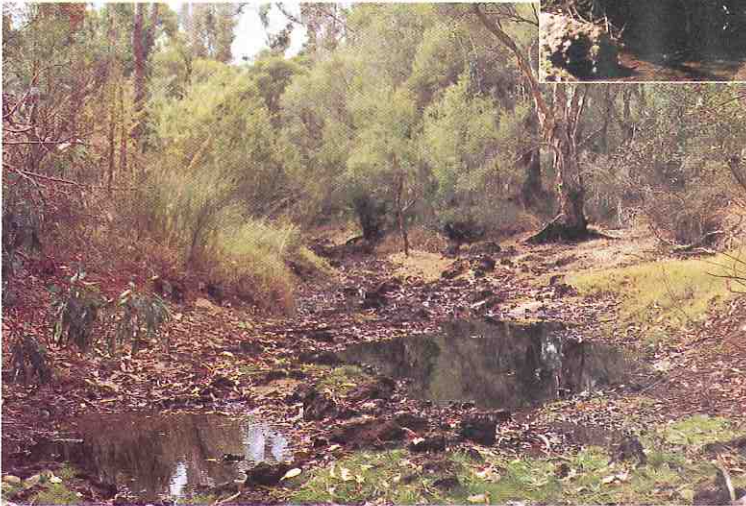
B1 grade foreshore on the Ludlow River. Weeds, mainly grasses, have become a significant component of the understorey vegetation.

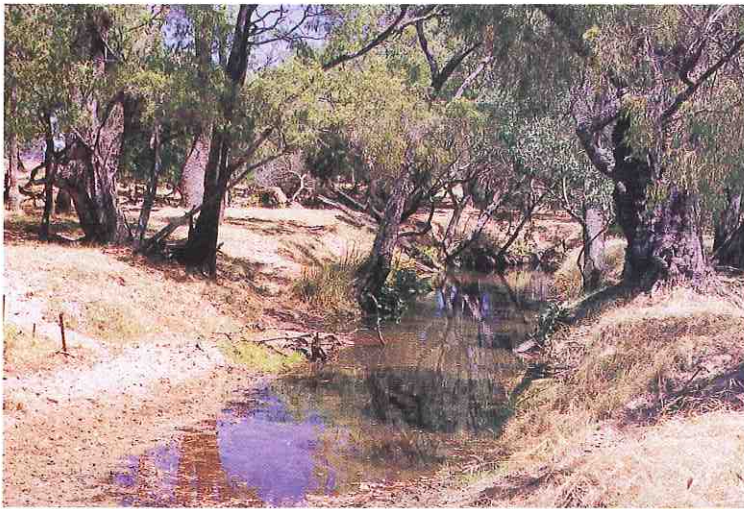
C1-C2 grade foreshore on the Sabina River. Trees remain though there is little evidence of regeneration. The shallow-rooted weedy understorey provides no support to the soil, making the banks vulnerable to erosion.

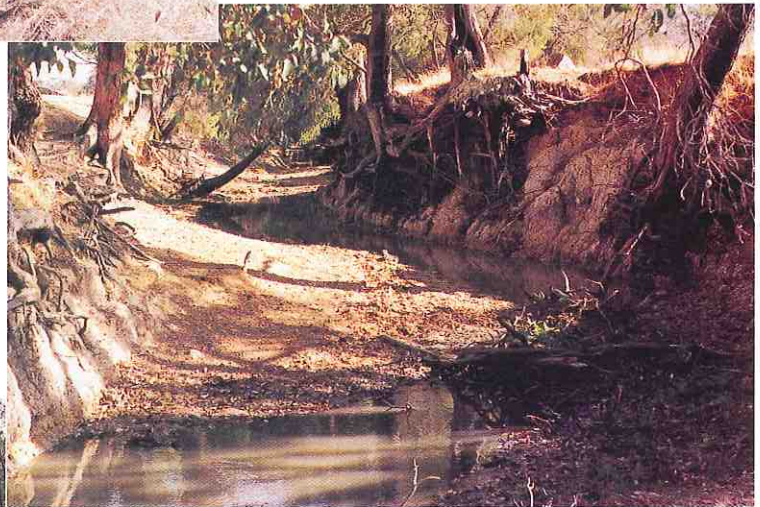
C3 foreshore on the Sabina River. Soil is being washed away from between tree roots and the undermined trees are at risk of falling into the river. This will cause ongoing erosion problems.

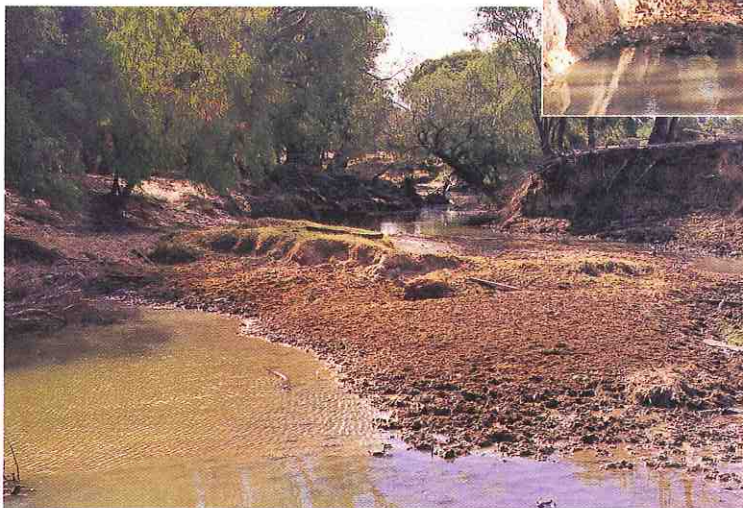
D1-D2 grade foreshore on the Abba River. Large deposits of sediment are accumulating along the river and the channel is widening and eroding back into farmland. The remaining trees retard erosion in places but are doomed to be undermined eventually.

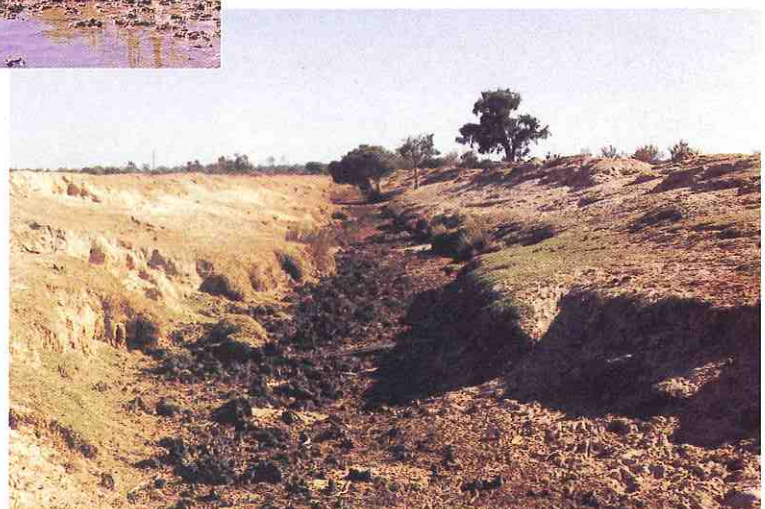
D2 grade foreshore on the Abba River. No vegetation remains to control erosion. The sandy banks are actively eroding and contributing to the accumulation of sediment downstream.
