# **Margaret River Action Plan**

2003

Prepared for the Cape to Cape Catchments Group

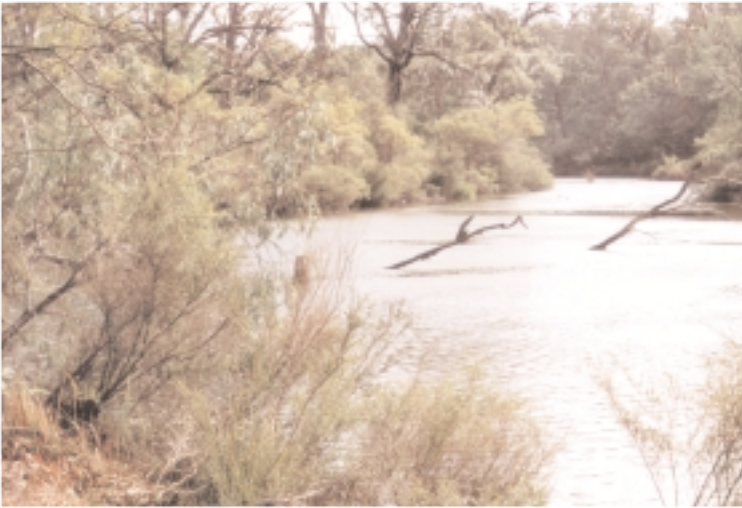
*A grade foreshore. Native fringing vegetation protects the banks from erosion and traps sediment and organic material before it reaches the river.*

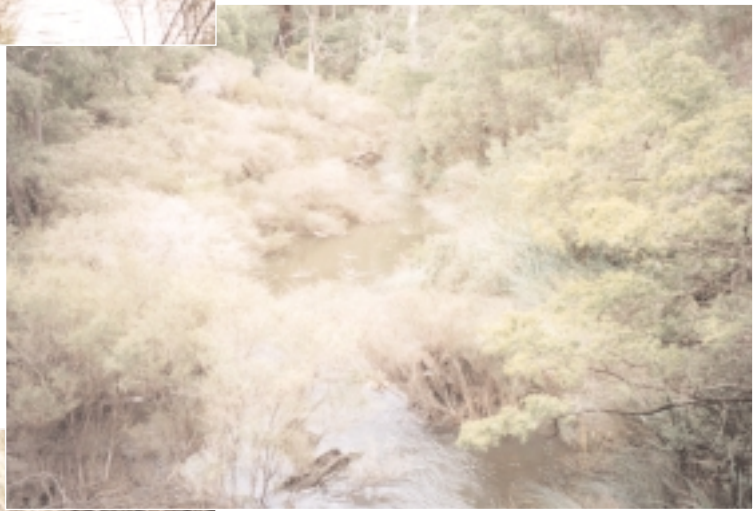
*A grade foreshore. Fringing vegetation provides habitat, shade and leaf litter, important elements of a healthy river ecosystem.*

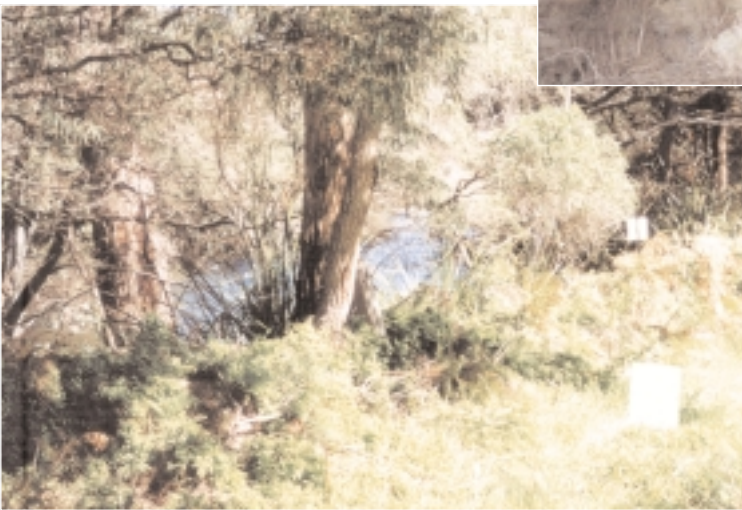
*B2 - B3 grade foreshore. Weeds have become a significant component of the understorey vegetation.*

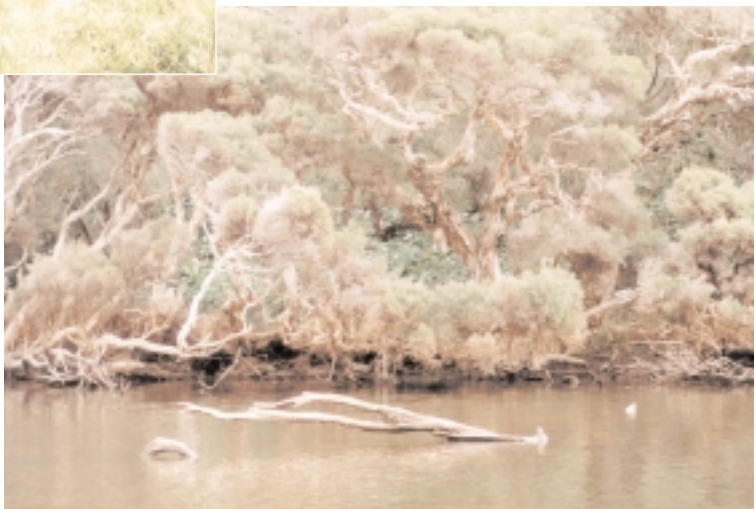
*B3 grade foreshore. Weeds dominate the understorey, restricting the regeneration of native species.*

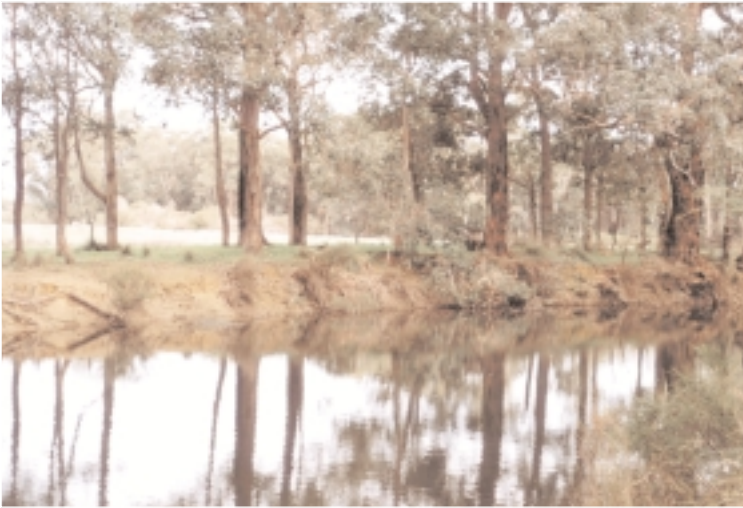
*C2 foreshore. Trees remain though there is little evidence of regeneration. The shallow-rooted weedy understorey provides no support to the soil, making the banks vulnerable to erosion.*

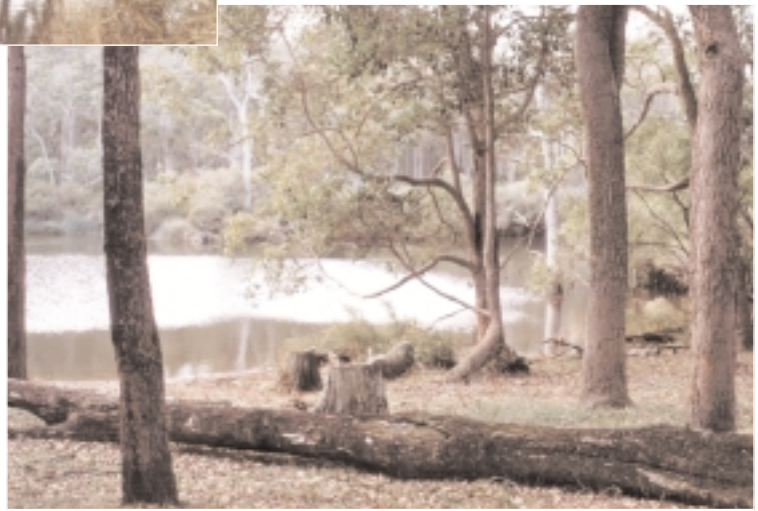
*C1-C2 foreshore. Native understorey has been degraded through stock grazing and trampling. A vital component of a healthy river ecosystem has been lost from this C grade foreshore.*

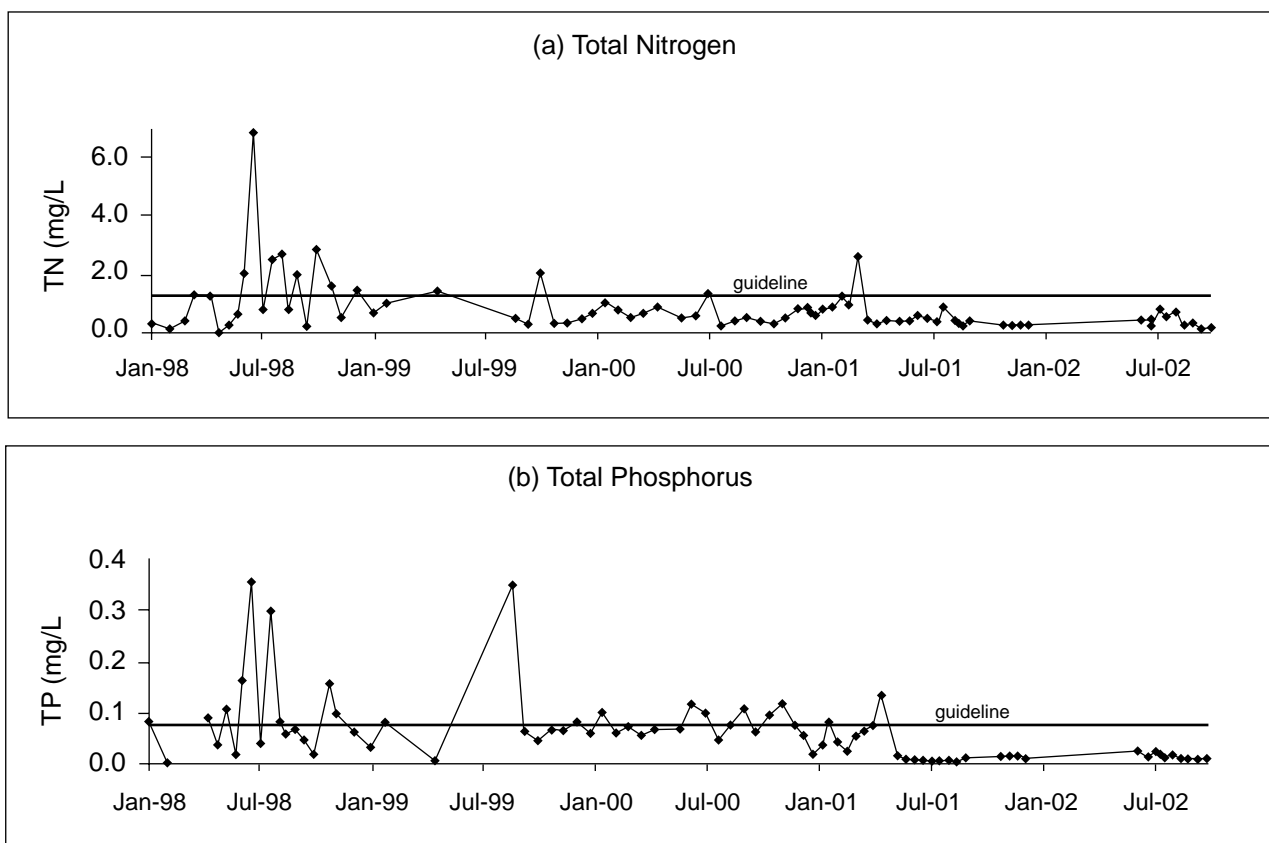
Figure 4: Total nutrient data for the Margaret River: (a) total nitrogen; (b) total phosphorus

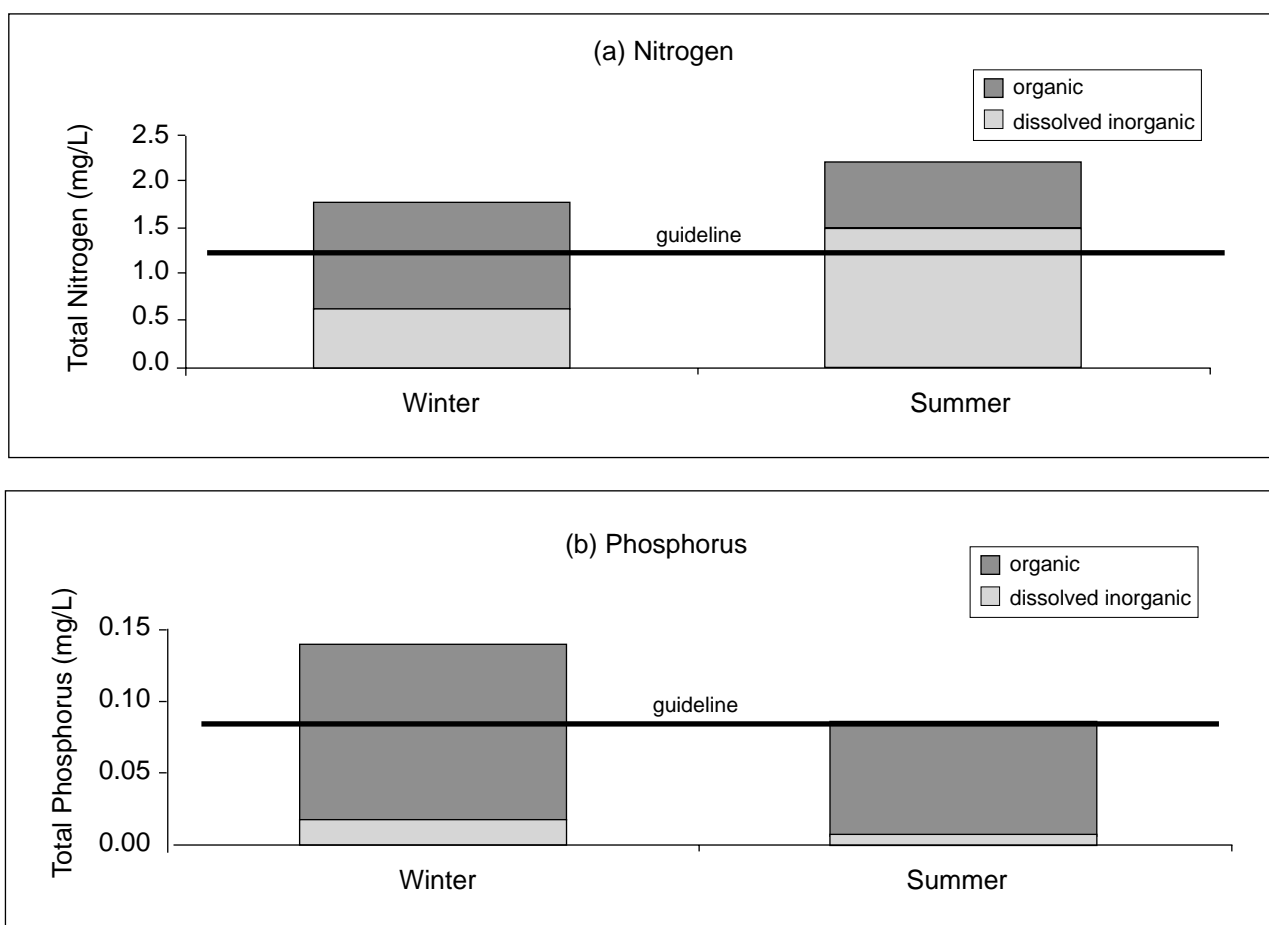
Figure 5: Forms of nutrients in the Margaret River: (a) nitrogen; (b) phosphorus
