MT HAMPTON

VEGETATION MONITORING

Summary Report to Water Corporation

December 2003

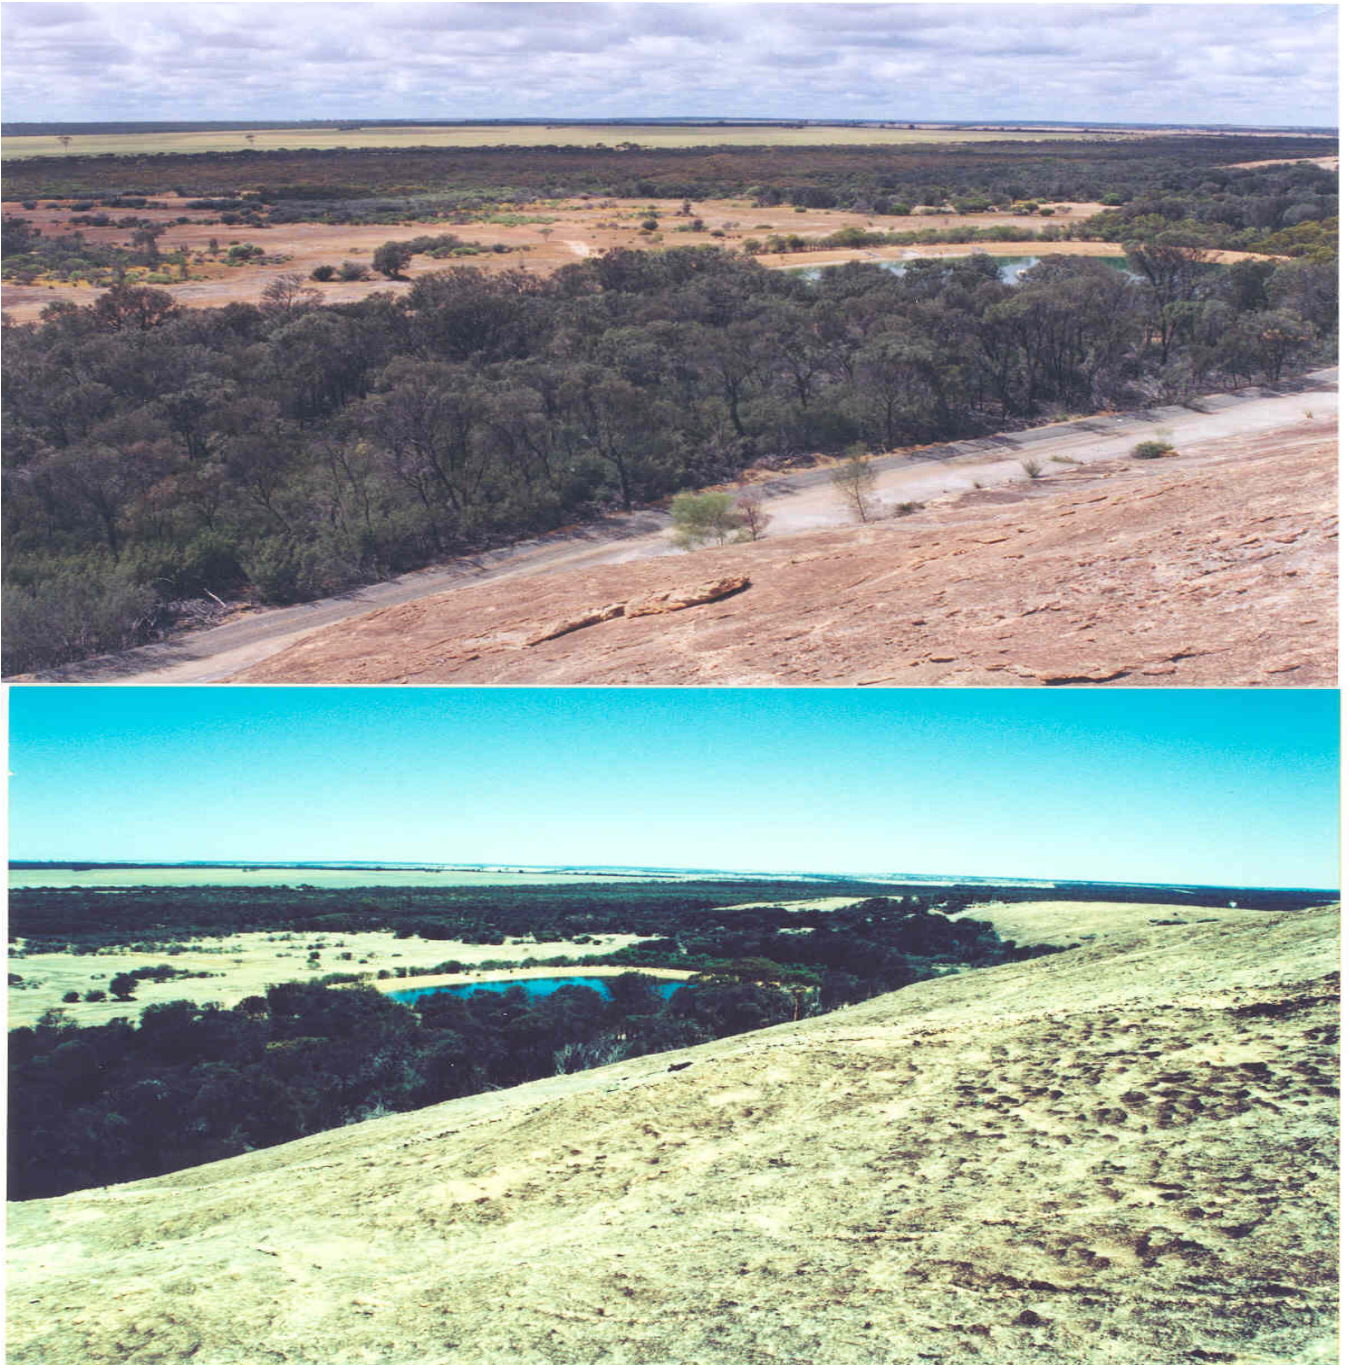
Figure 1: Photographs of the location of the bitumen-lined channel at base of Mt Hampton showing the general area before (a) and after (b) construction.

Pre and post catchment construction photographs were taken of the bitumen channel at the base of the eastern side of the rock and the dam (Figure 1a & 1b), as well as the rock wall.

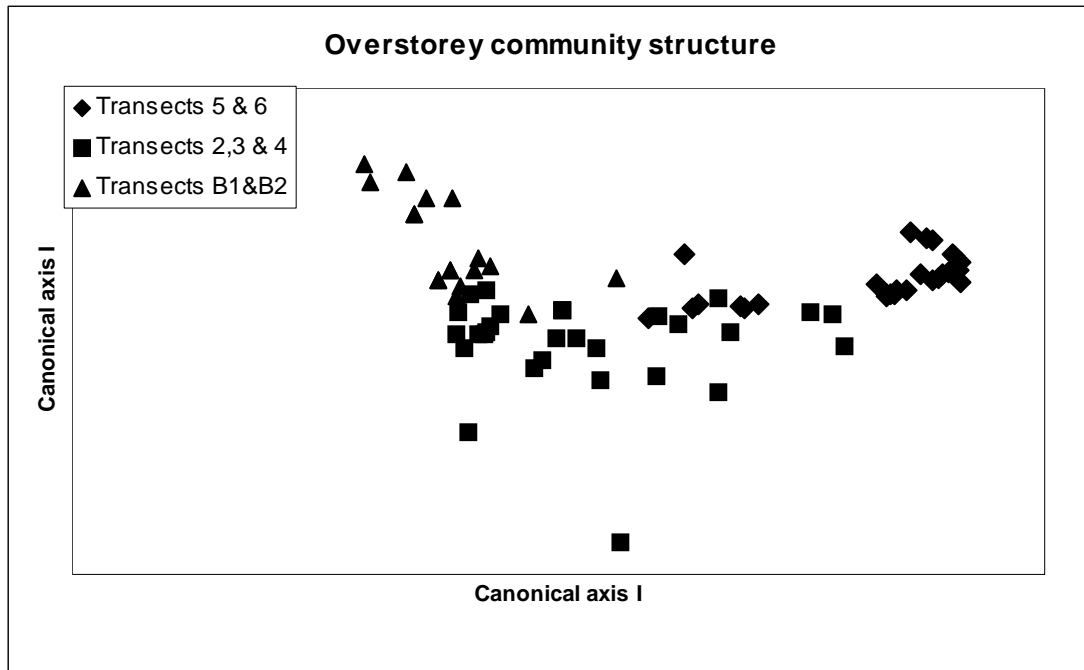
Table 3: Ordination of the multivariate overstorey live and dead stems data from two locations at Mt Hampton and at Mt Bailey using generalized canonical analysis. The two Mt Hampton localities are transects 5 & 6, and transects 2, 3 & 4; the control site transects are B1 and B2. The data were averaged across plots within each transect and the Bray-Curtis dissimilarity calculated between all pairs of observations.

For the canonical procedure, $m=10$ principal coordinates were calculated, which explained 98.9% of the total variability of the species cover data. The cross-validation produced a 21% mis-classification, but the randomization analysis indicated a highly significant difference ($p<0.0001$) between the three groups. This indicates that the the overstorey assemblages at each of the three localities are, with some overlap, very different. At the Mt Hampton north locality, plots closest to the rock (1-6) were distinctly different to all other plots; however, plots 7, 8 and 9 were similar to the plots on transects 2, 3 and 4. There was also some similarity between the two control site transects and transects 2, 3 and 4, but the overstorey at the control site and Mt Hampton north were very distinct. To assess temporal changes in the Mt Hampton north overstorey, the samples from plots 1-6 were analysed separately to test for differences between

the three sampling years. No significant difference between the three years were found ($p=0.389$).

The lack of similarity between the overstorey assemblages at the two Mt Hampton localities, and between Mt Hampton and the control site, indicate that temporal changes in overstorey assemblages are unlikely to provide information on any changes due to hydrology. Being different, these overstorey communities are unlikely to respond in the same manner to external disturbances. Within the locality (Transect 5 & 6) most likely to be affected by the construction of the dam wall, there was no evidence of any temporal change in the overstorey assemblage.

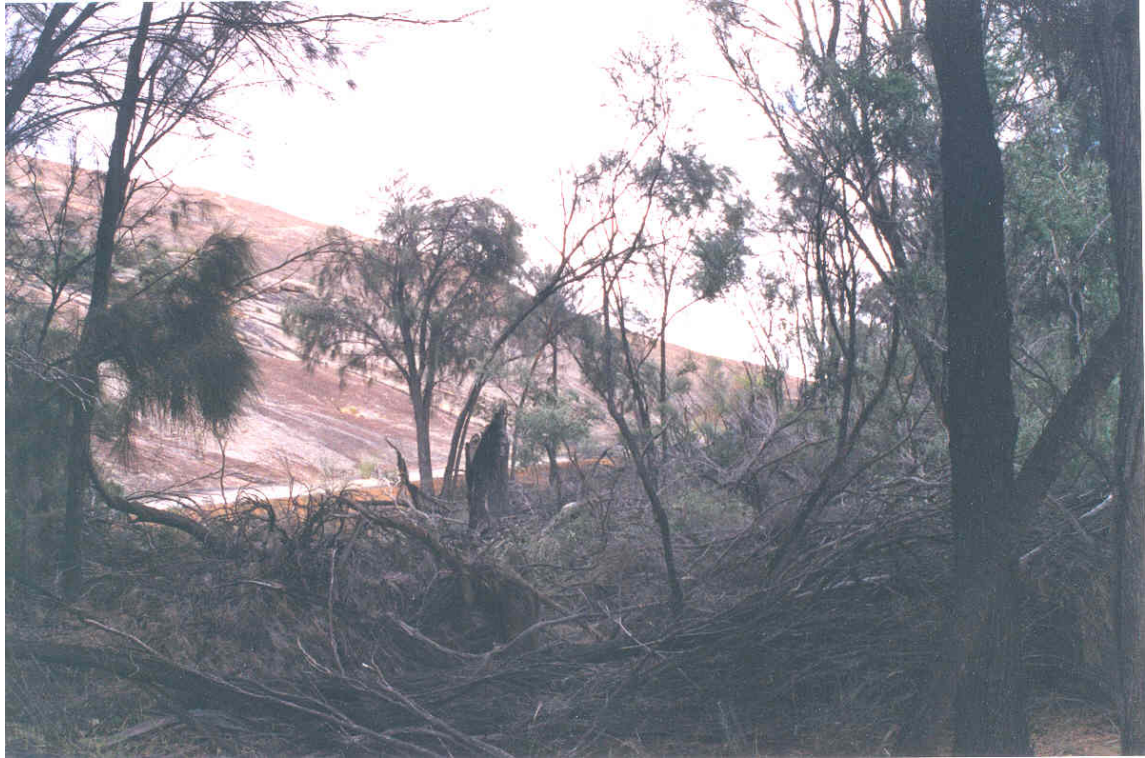
Monitoring Point 1

Monitoring point	Lat	Long	Direction of photo	Subject description
1	31 45' 38.8"	119 04' 21.4"	East	Near main gate
2	31 45' 39.7"	119 04' 21.6"	North	Same spot as P/P1
3	31 45' 38.4"	119 04' 20.7"	North	Bitumen catchment
4	31 45' 34.0"	119 04' 20.9"	SE	Looking over dam and bitumen catchment
5	31 45' 33.6"	119 04' 21.0"	NNE	Fringing vegetation & paddocks
6	31 45' 31.4"	119 04' 17.7"	NE	Bitumen, fringing vegetation and paddocks
7	31 45' 30.8"	119 04' 17.8"	East	Fringing vegetation & paddocks
8	31 45' 26.6"	119 04' 19.6"	East	Fringing vegetation w/out catchment and vegetation beyond catchment
9	31 45' 33.1"	119 04' 16.9"	South	Looking across rock
10	31 45' 36.3"	119 04' 12.1"	SE	Across rock to fringing vegetation and dam
11	31 45' 42.3"	119 04' 11.2"	NE	Looking down at dam and main channel
12	31 45' 47.1"	119 04' 13.8"	NE	Rock wall and dam
13	31 45' 47.8"	119 04' 13.9"	SE	Rock and paddocks
14	31 45' 49.0"	119 04' 18.4"	East	Start of transect 3

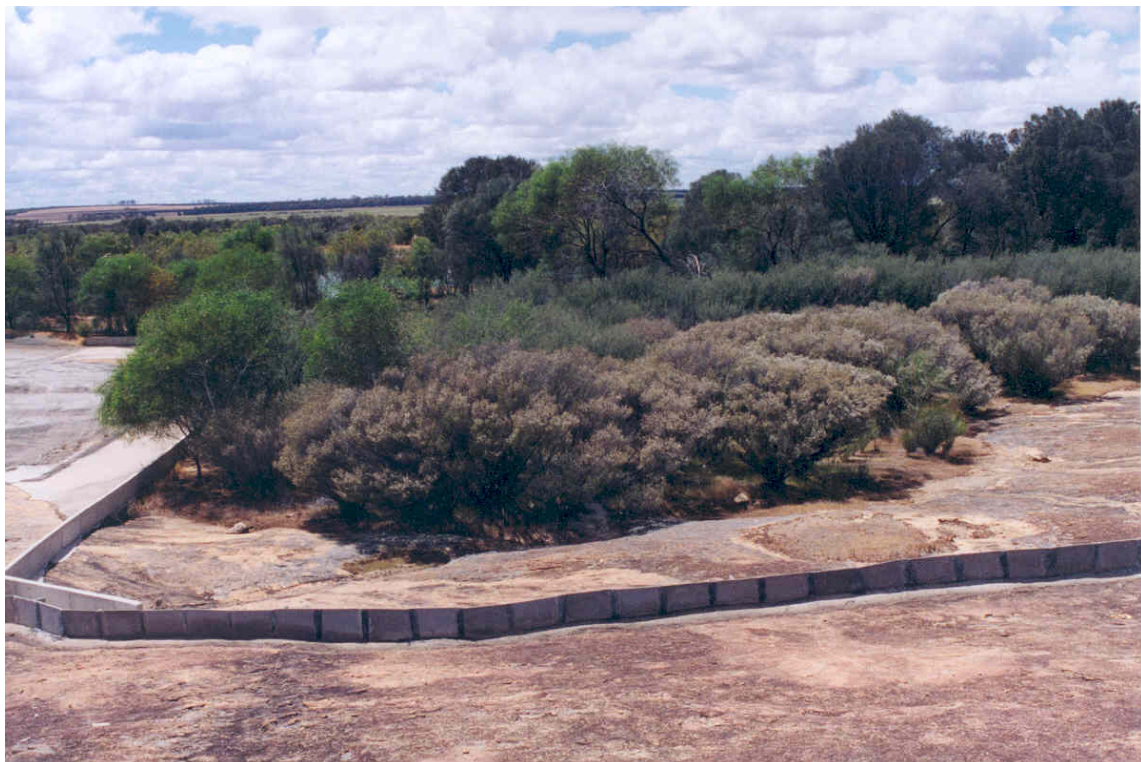
Monitoring Point 15

15	31 45' 42.4"	119 04' 17.6"	ENE	Rock wall
16	31 45' 47.3"	119 04' 17.1"	East	Start of transect 4
17	31 45' 49.8"	119 04' 18.2"		Fringing vegetation
