Department of Conservation
and Land Management, W.A.

**Peel-Harvey Catchment
Demonstration Farm Hydrological
Study Under National Afforestation
Program Project 15**

**PRELIMINARY REPORT
NOVEMBER 1990**

RICHARD SILBERSTEIN AND DON BENNETT

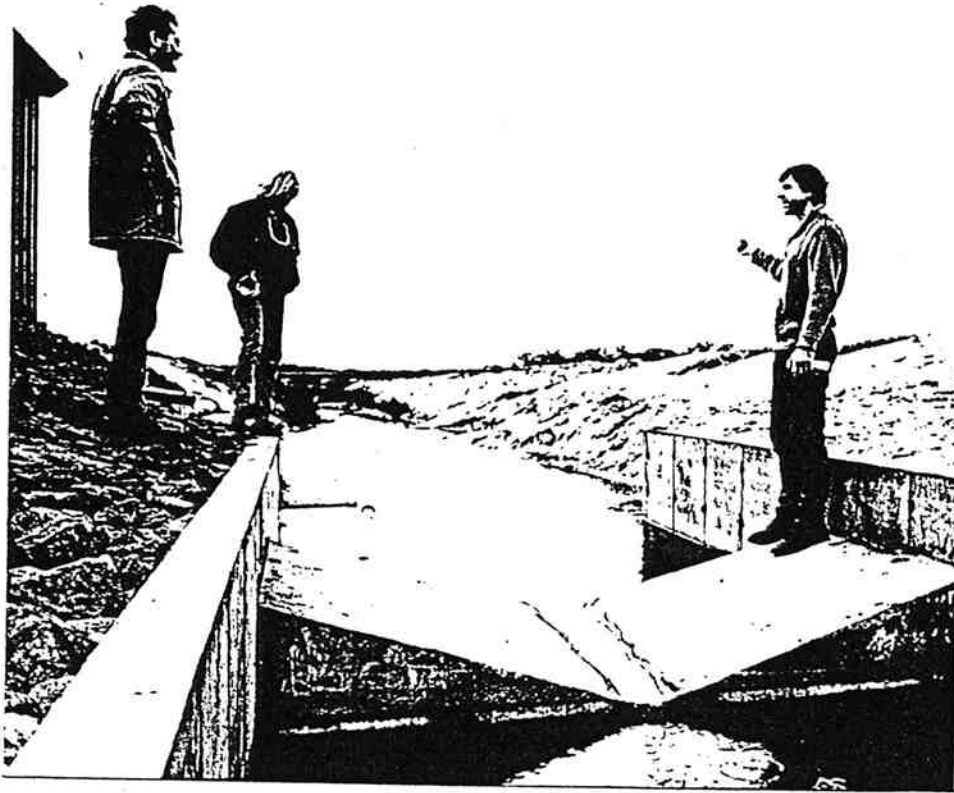
FIGURE 3a. Gauging weir of the eastern catchment.

The Water Authority of Western Australia (W.A.W.A.) have installed (~~under contract to C.A.L.M.~~) a stream gauging station on each catchment drain. They are both broad crested V-notch weirs (See FIGURES 3a and 3b), although due to the different topographies of the catchments, they have quite different shapes. The eastern catchment drain is excavated to the hardpan and the drain deeply incised. The weir cease to flow level (CTF) is set at the hardpan level. The western catchment is flatter and the drain is wider, and not as steeply incised as the eastern. It also is not excavated to the hardpan, although the pad of the weir is set on the hardpan, at a depth of about 80cm below the CTF of the weir. This is in fact a possible source of error in the intercalibration of the two catchments. However, the data collected to date show that the catchments and gauging stations are well matched. (See Section 4)

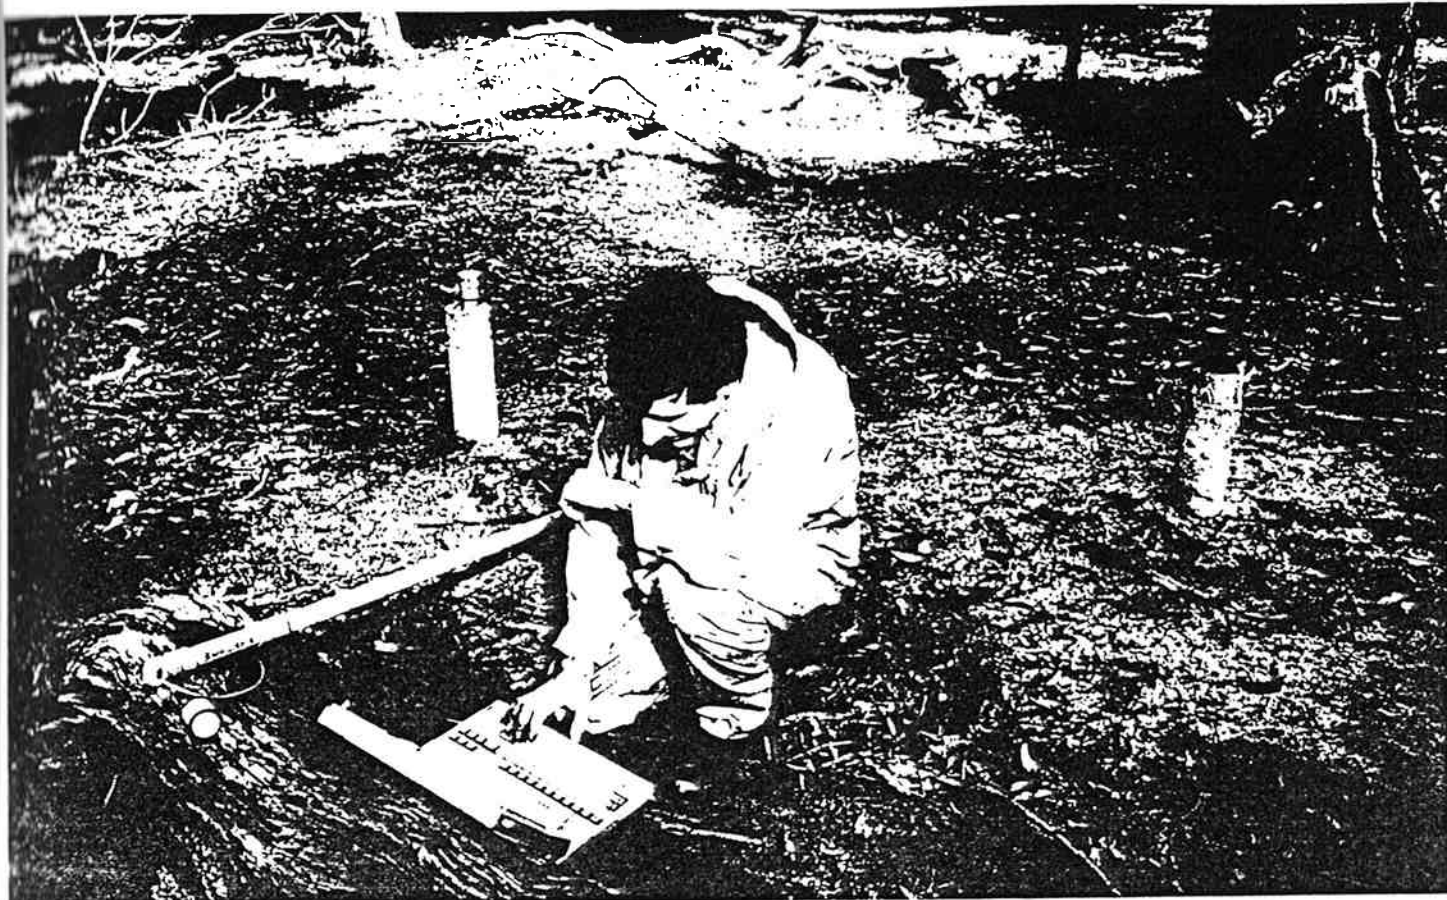
FIGURE 5. Down loading bore level loggers in the field.

continuously logged with Wesdata capacitive probes and loggers. These fit entirely within the bore and are suspended from the cap by a cable. These are downloaded on site using a lap-top computer (See FIGURE 5). They functioned reliably apart from early battery problems. Occasionally a bore top was broken by cattle and had to be repaired.

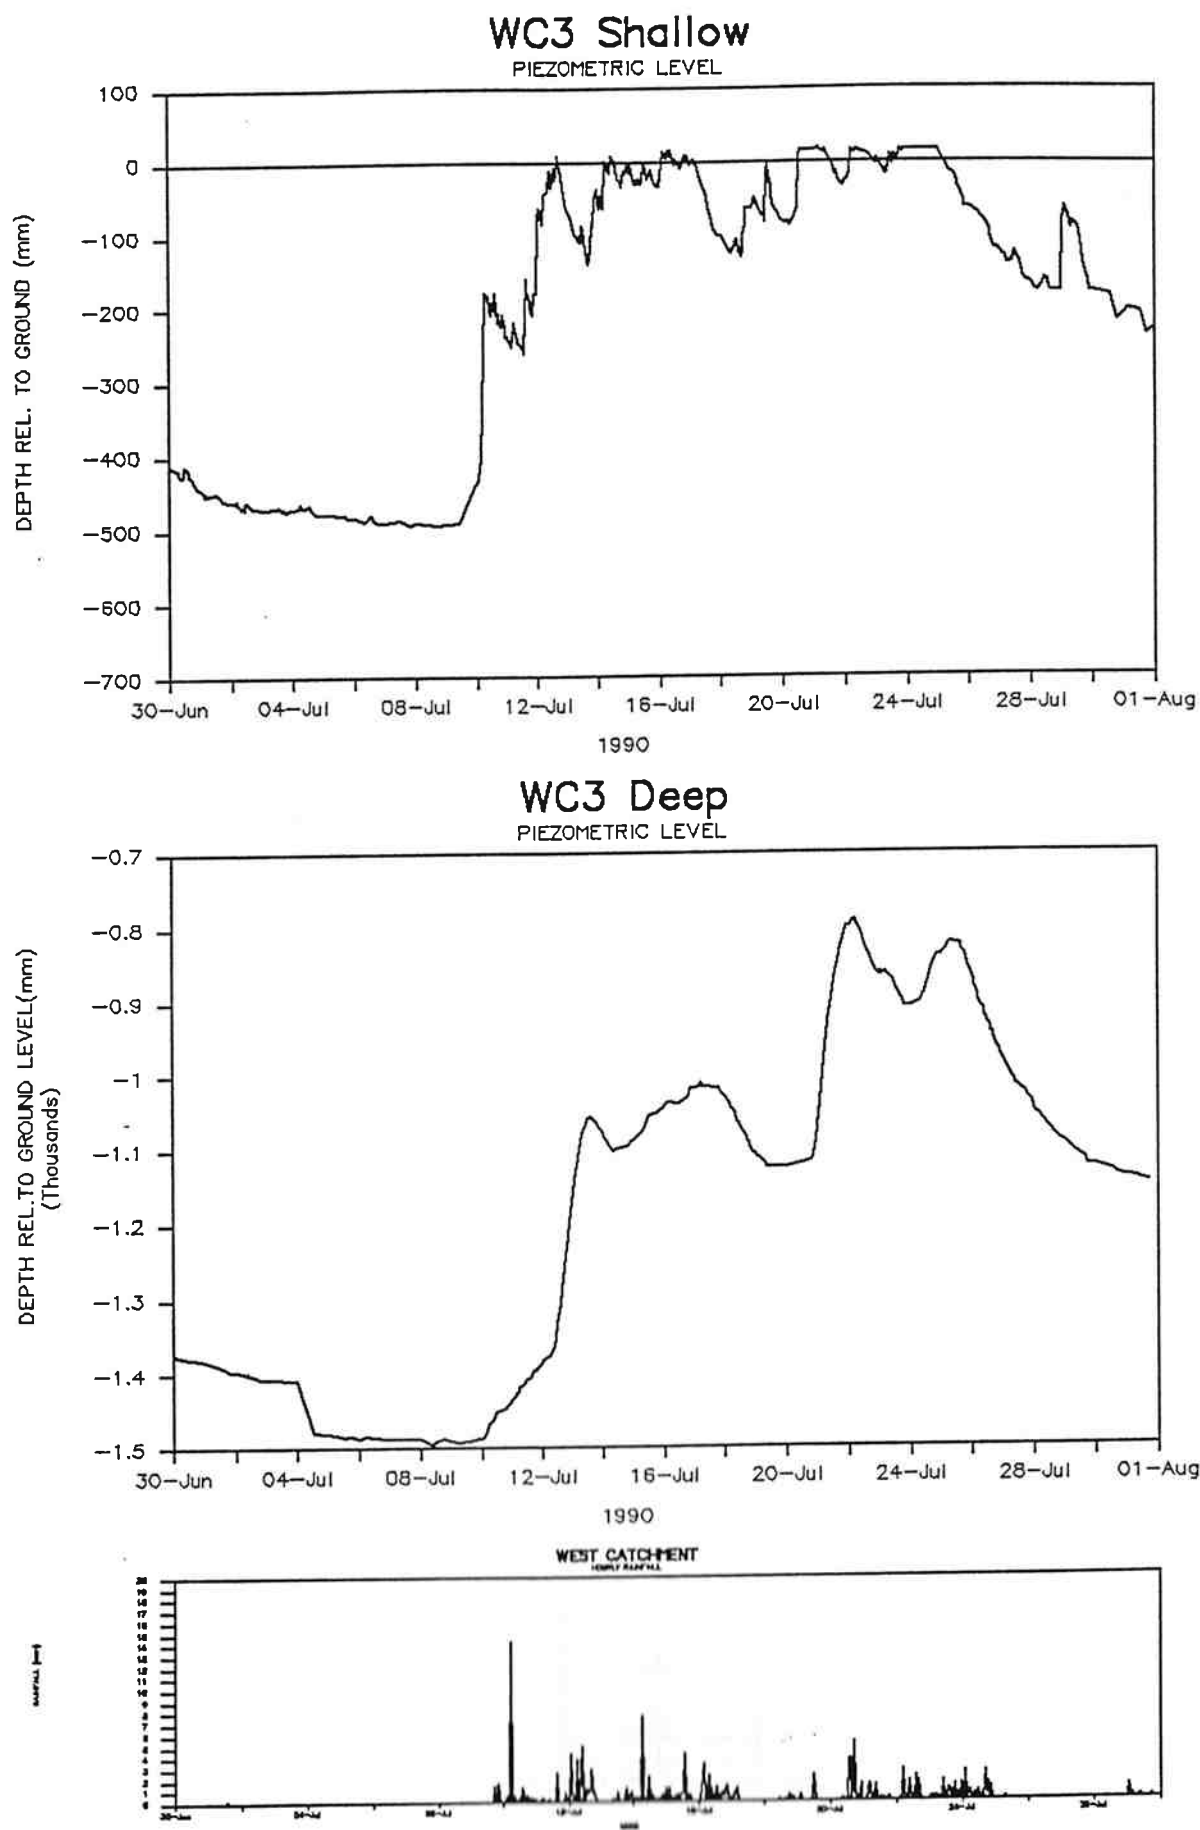
FIGURE 20. Response of deep and shallow piezometer to rainfall over two storm events.

FIGURE 20 shows hydrographs for one bore pair during a series of storm events in July 1990. The rapid response of the deeper aquifer is clearly visible. This gives cause for optimism in regard to tree growth in this area, as there is clearly some hydraulic connection in the area between the shallow and deep aquifer systems - enough to allow the rapid response exhibited here. FIGURE 21 shows

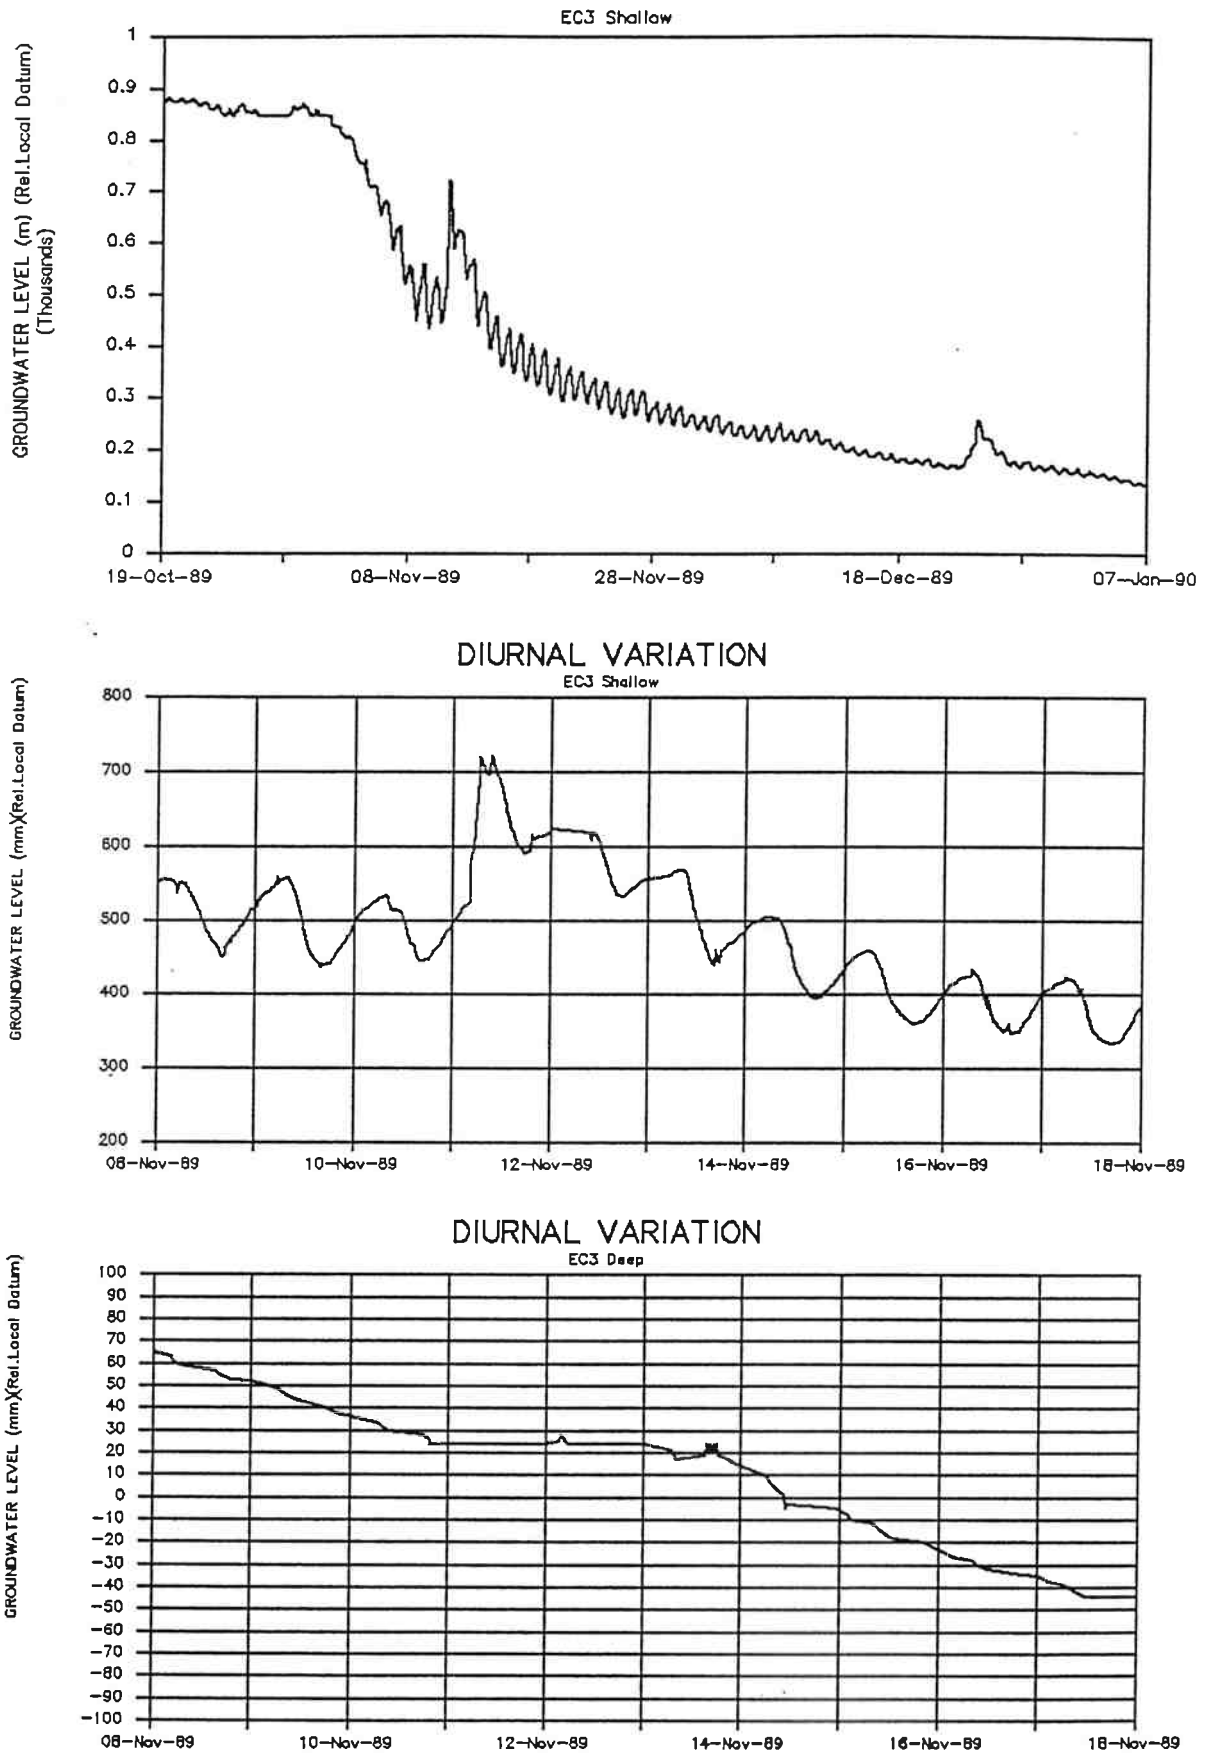
FIGURE 21. Diurnal variation of deep and shallow piezometers at site EC3.

the diurnal variation of one bore pair (EC3). This diurnal variation is evaporation driven, and also demonstrates that a connection exists.
