McNess Recreation Area Yanchep National Park Non-Indigenous Cultural Heritage Conservation Plan

Final Report
July 2003

Hocking Planning & Architecture

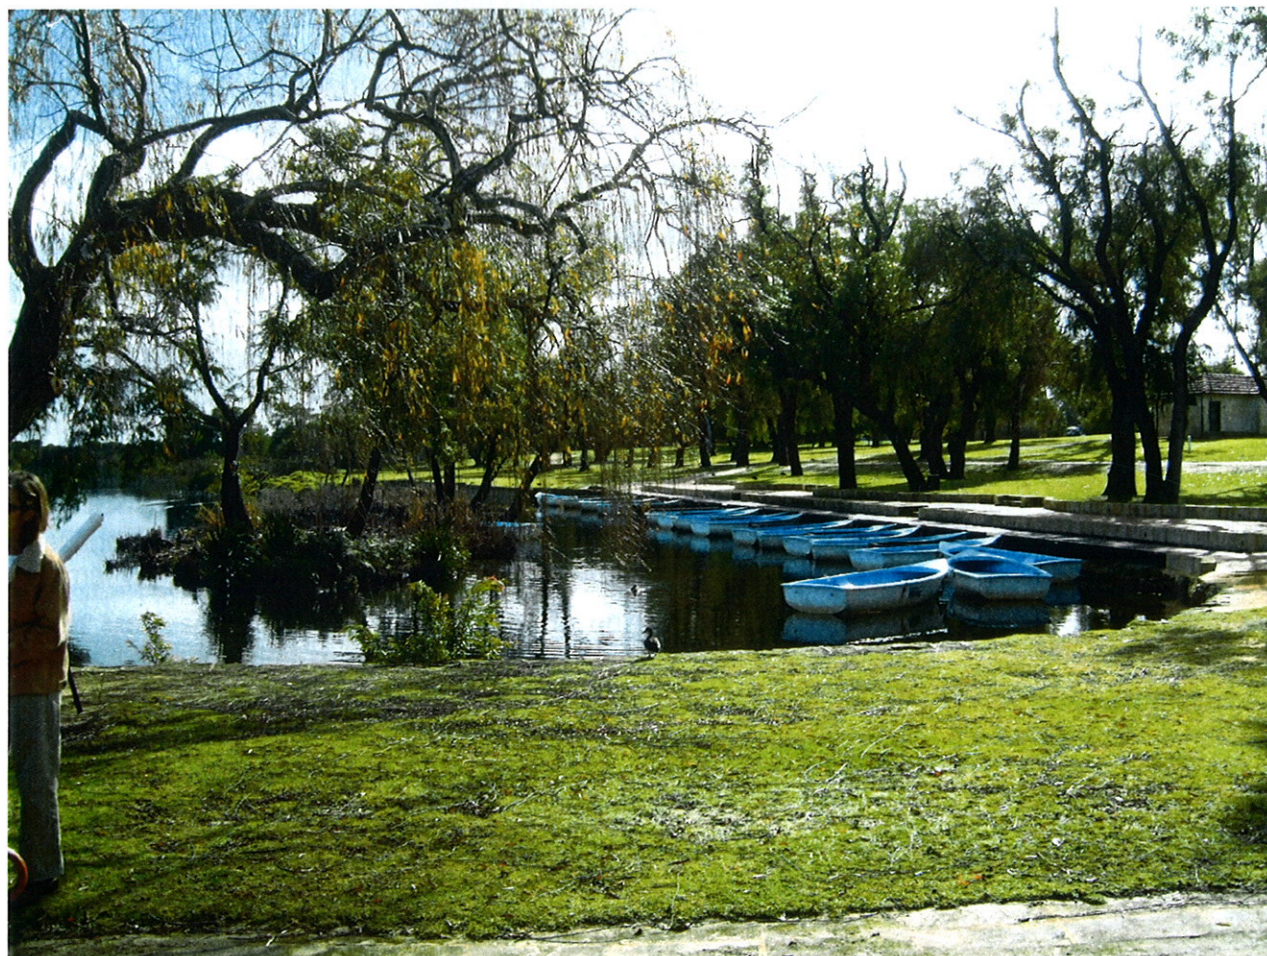
Figure 9 Loch McNess- Developed Foreshore-T.Blackwell photo. 2002.

Loch McNess is a permanent water-body. Although it is disturbed, it is less so than most of the lakes of the Swan Coastal Plain, particularly with regard to nutrients. South Loch McNess is open water, 27 hectares in extent. North Loch McNess is an overgrown wetland, supporting dense vegetation 150 hectares in extent. East Loch McNess is a wetland that has been substantially changed, from its original state; probably as a result of interference with water-flow during construction of the swimming pool. According to CALM staff on site, once one could row the whole length of the stream, from the bridge to where the ornamental lakes were built.

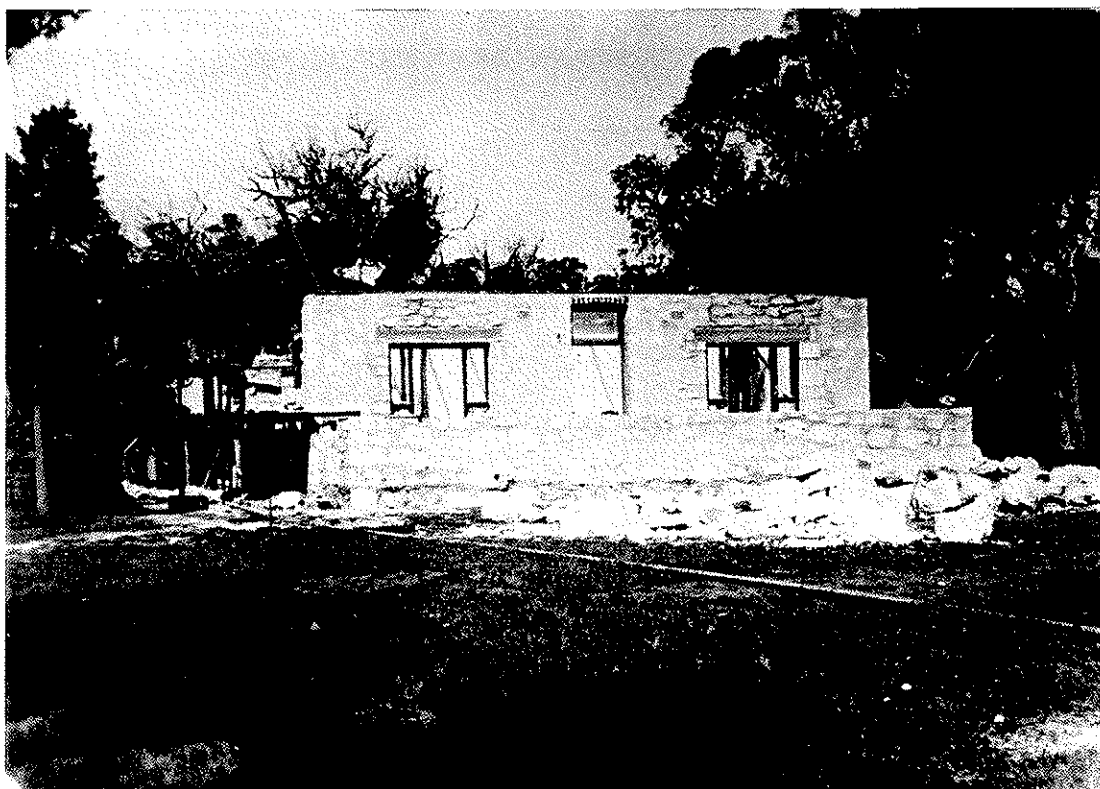
Figure 17 Works in progress for the adaptation of Caves House into McNess Hostel in 1931. Copy of photograph held in DCLM office, Yanchep National Park.

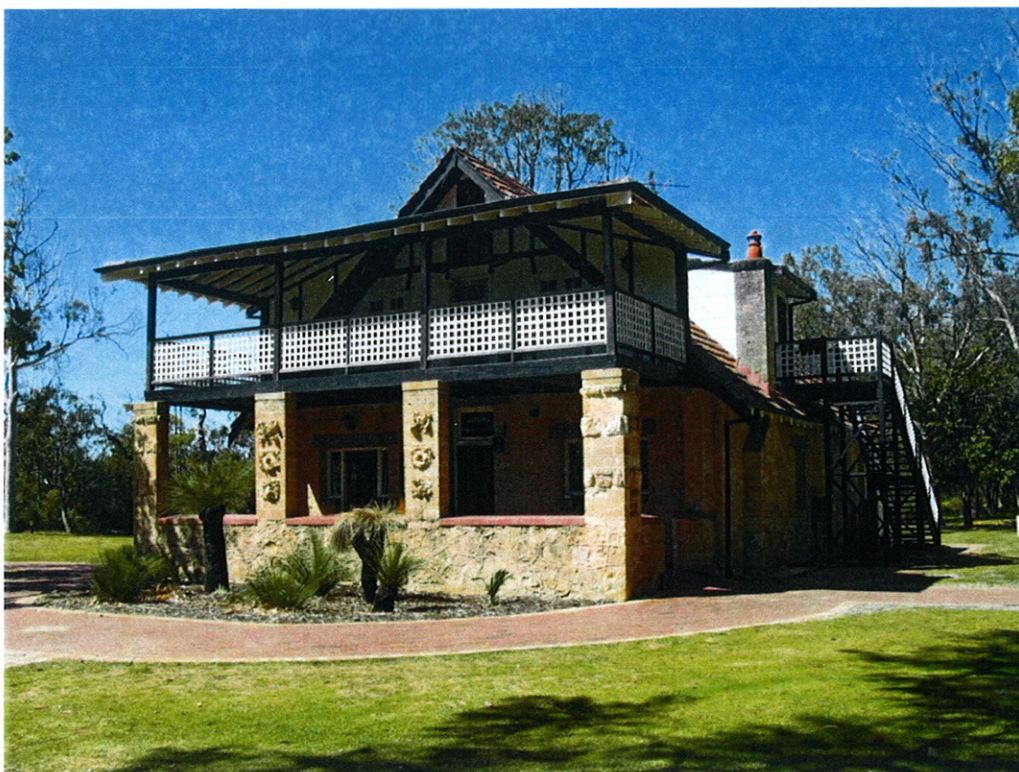
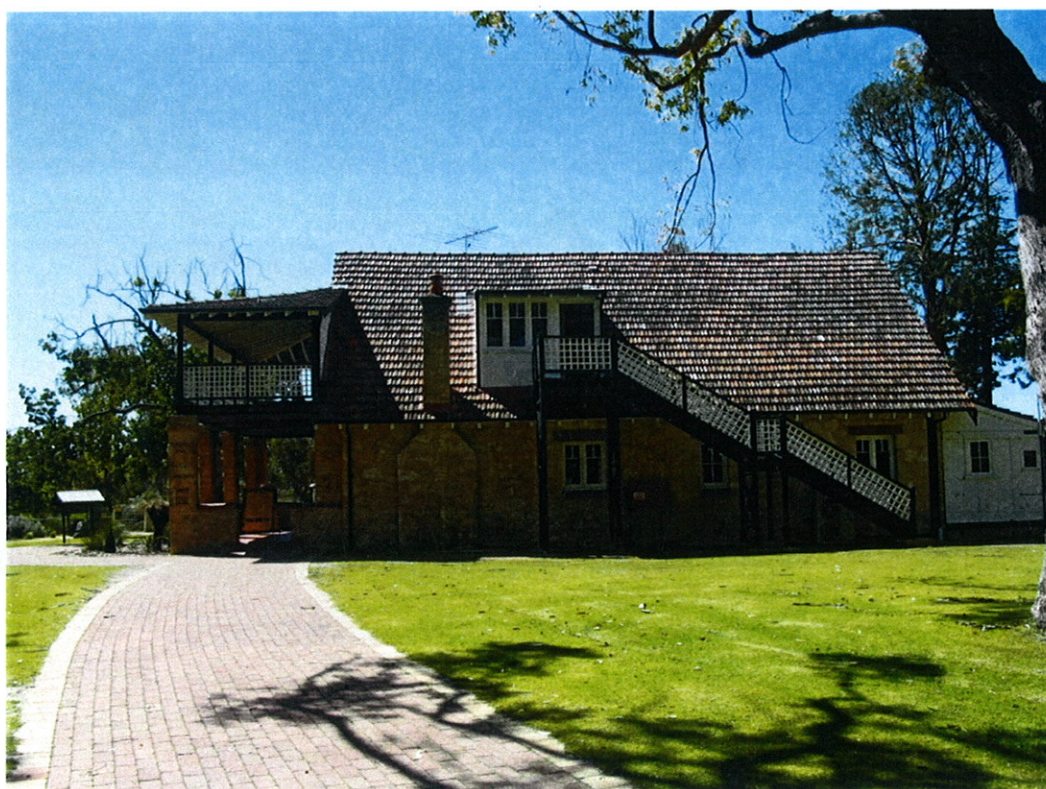
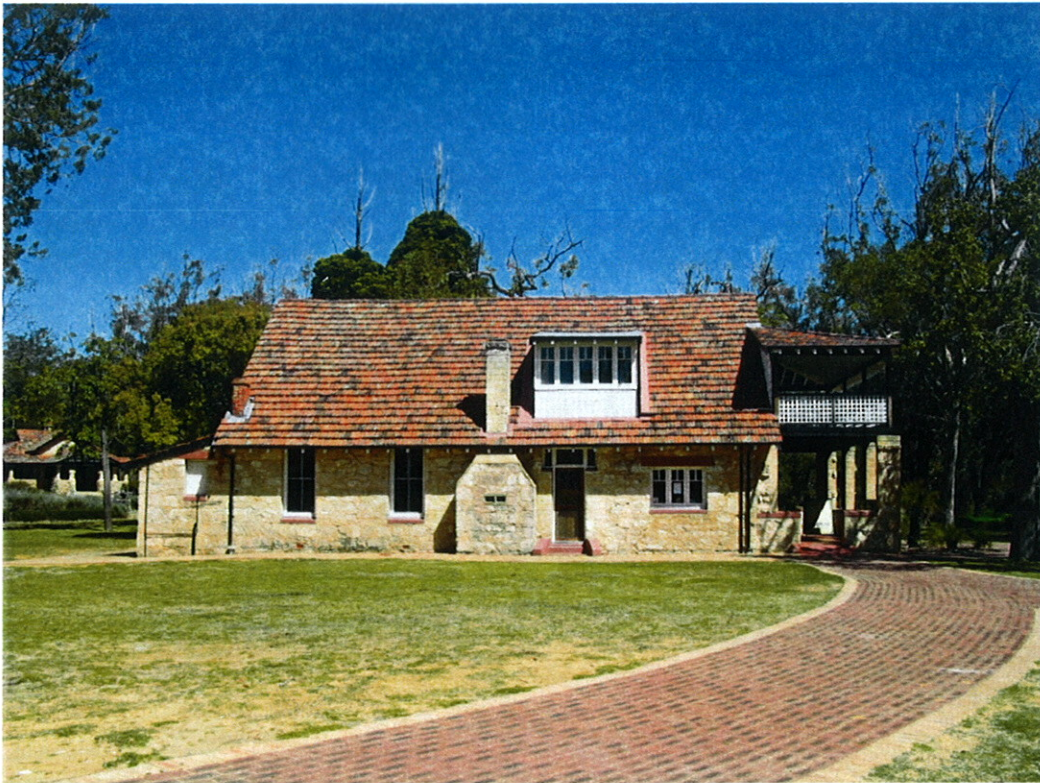
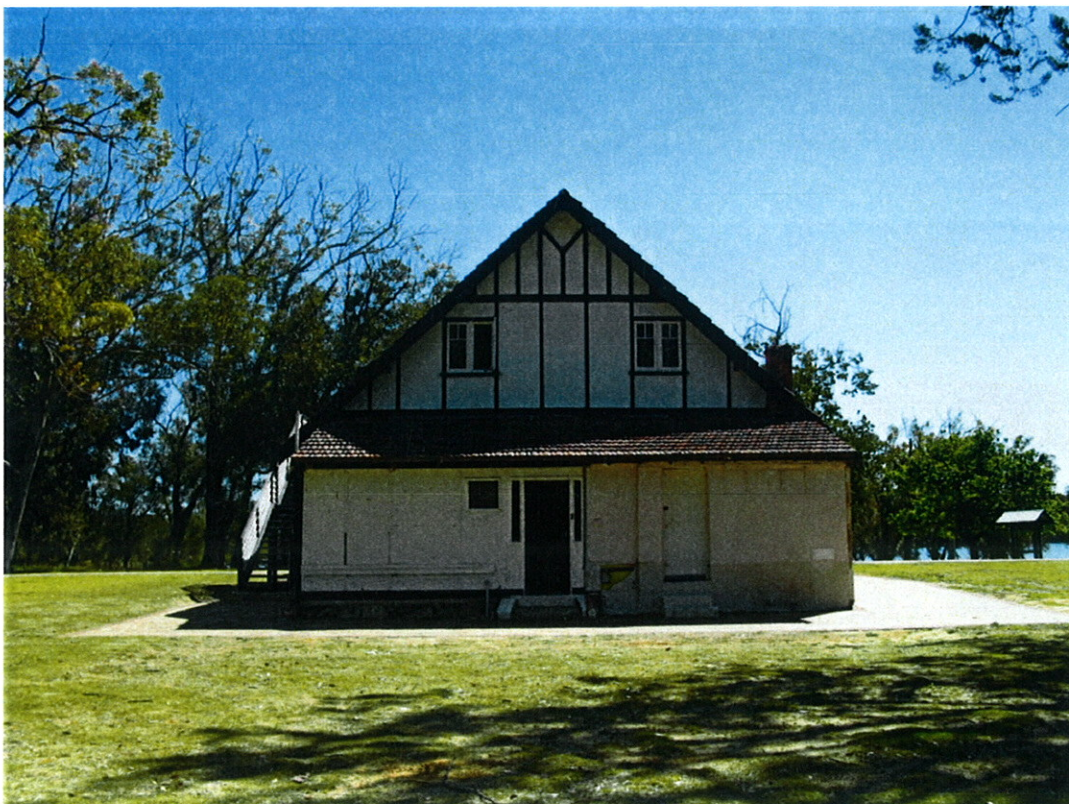
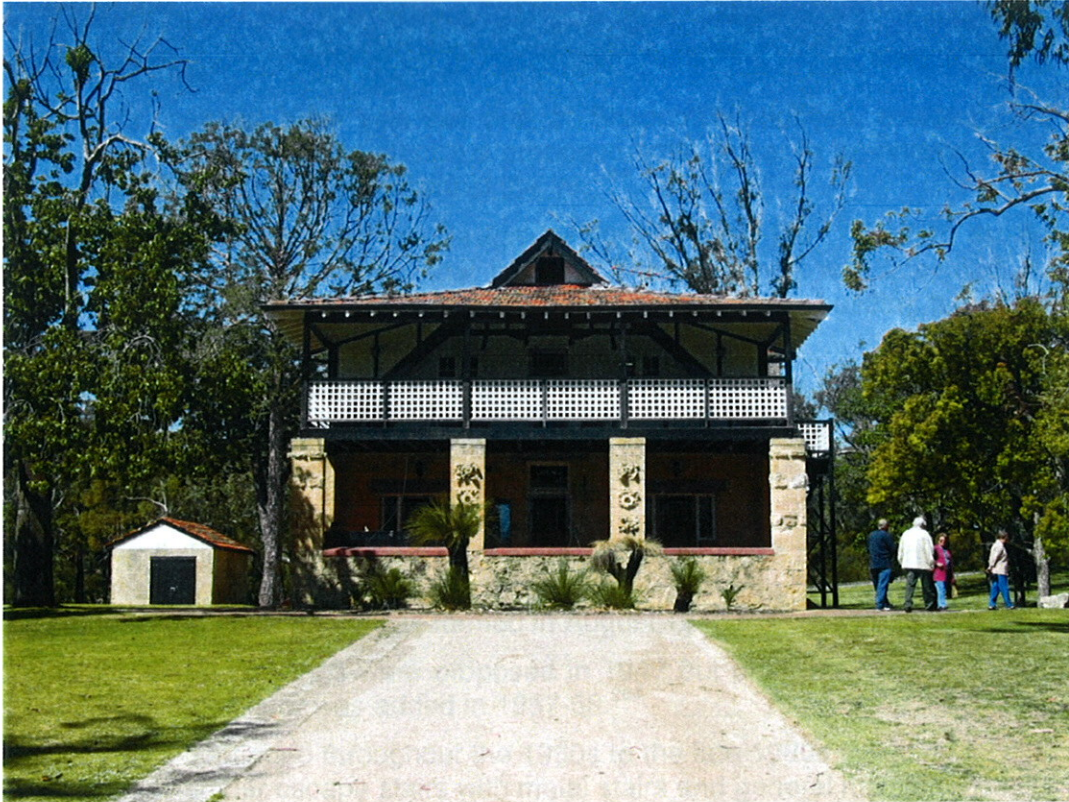
Figure 22 McNess Hostel viewed from the southwest. September 2002. Hocking Planning and Architecture.

Figure 23 McNess Hostel viewed from the south. September 2002. Hocking Planning and Architecture.

Figure 24 McNess Hostel viewed from the north. September 2002. Hocking Planning and Architecture.

Figure 25 McNess Hostel viewed from the east. September 2002. Hocking Planning and Architecture.

Figure 26 McNess Hostel viewed from the west. September 2002. Hocking Planning and Architecture.

There is no external physical evidence of staged construction indicating the extent of fabric from the original hunting lodge/Caves House. The physical evidence confirms the adaptation of the western verandah to accommodate the first floor balcony in 1935. From the documentary and physical evidence the sequence of development can be understood as follows:

- c.1890s Caves house
- 1931 Redeveloped as McNess Hostel
- 1935 Verandah added
- 1951 Kiosk added
- 1959/60 Kiosk extended

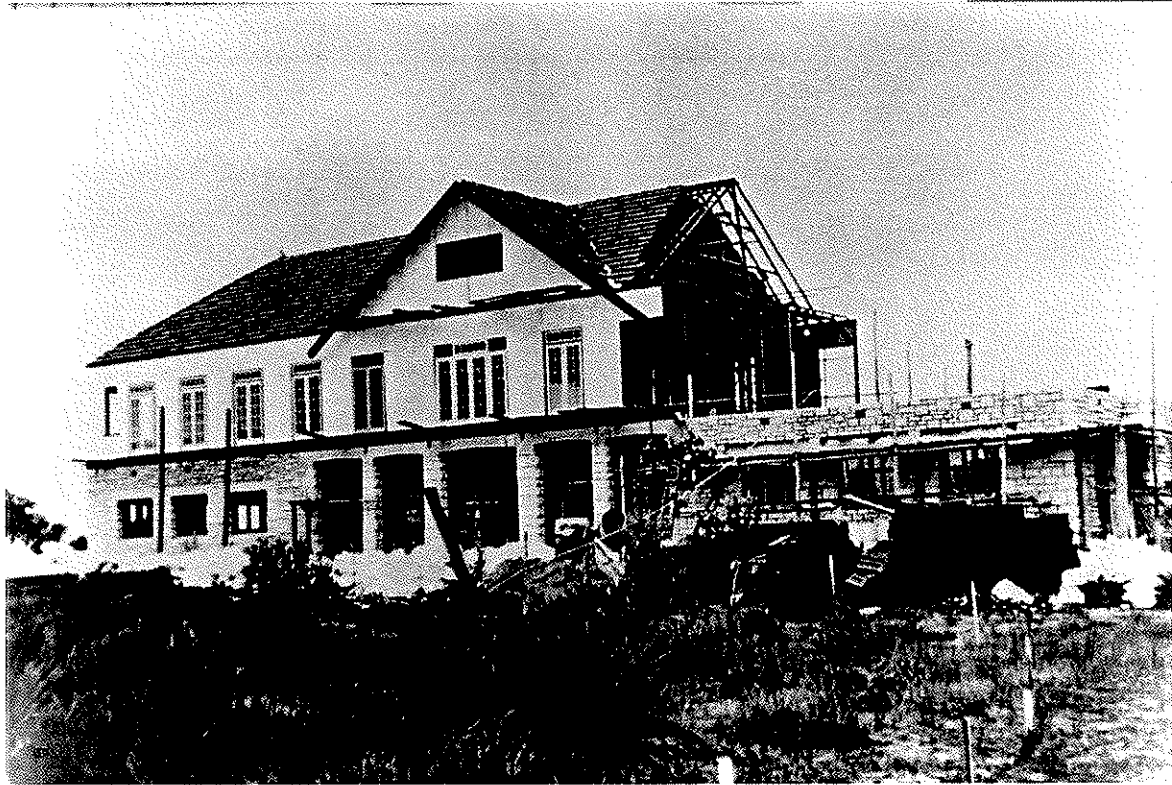
Figure 28 Yanchep Inn under construction, 1935. Copy of photograph held in DCLM office, Yanchep National Park.

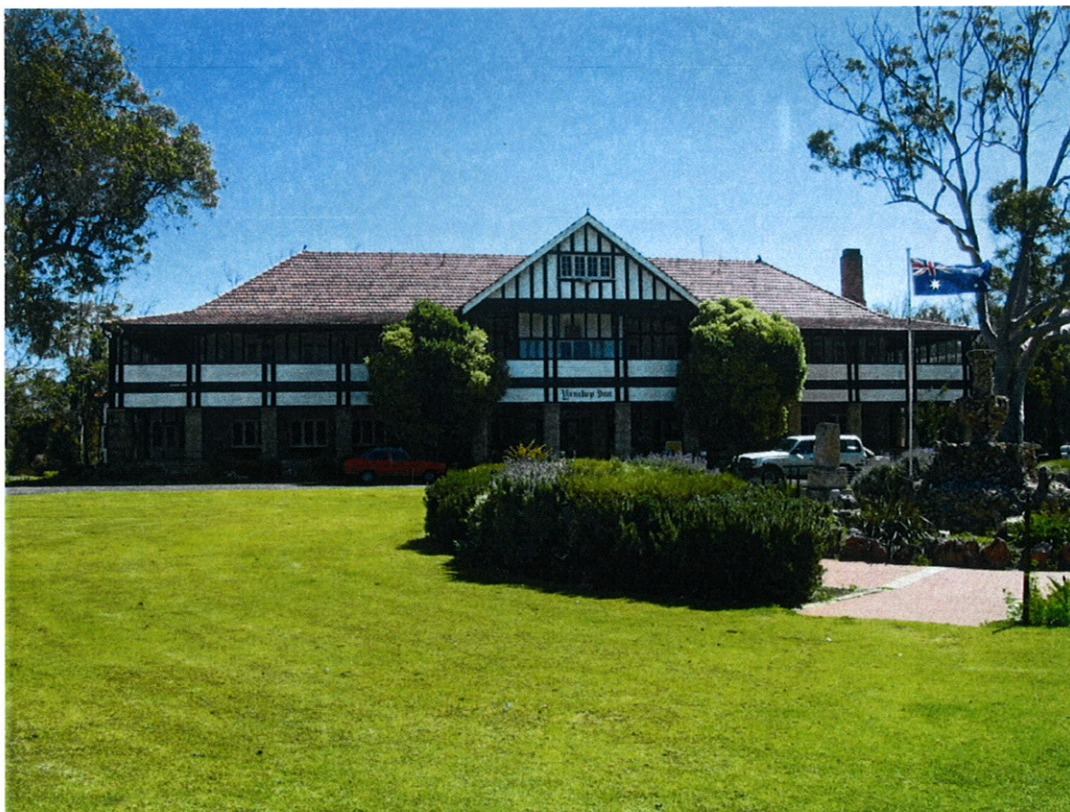
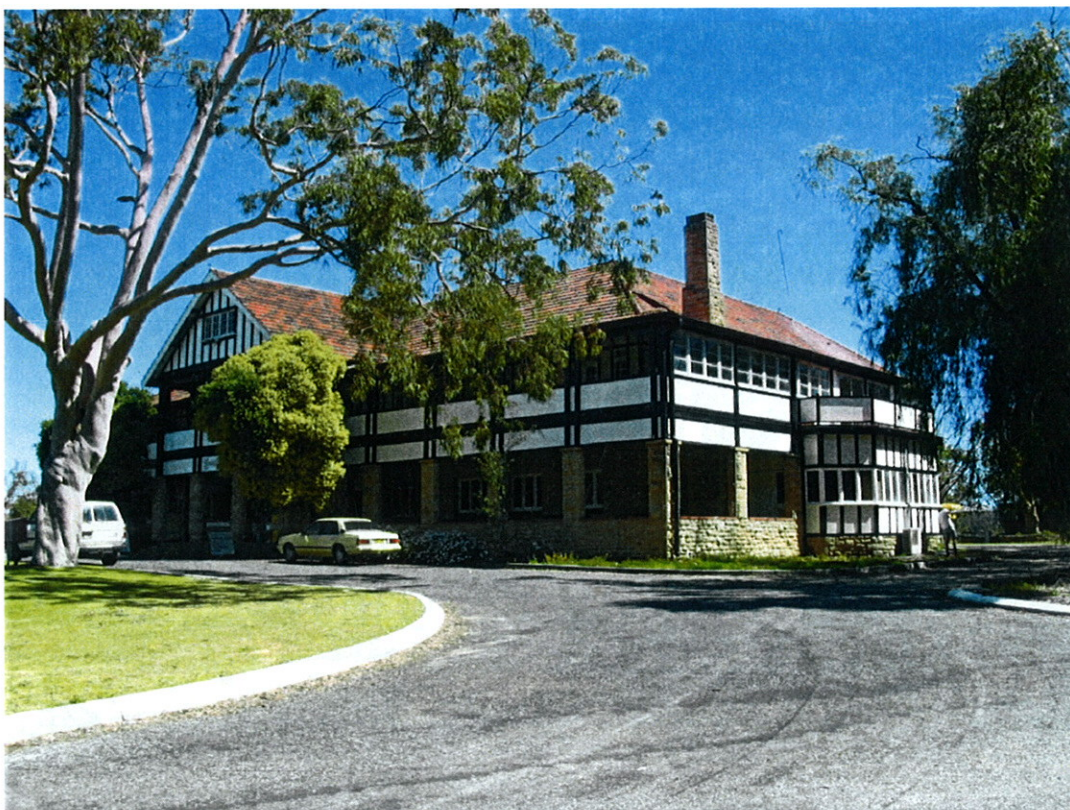
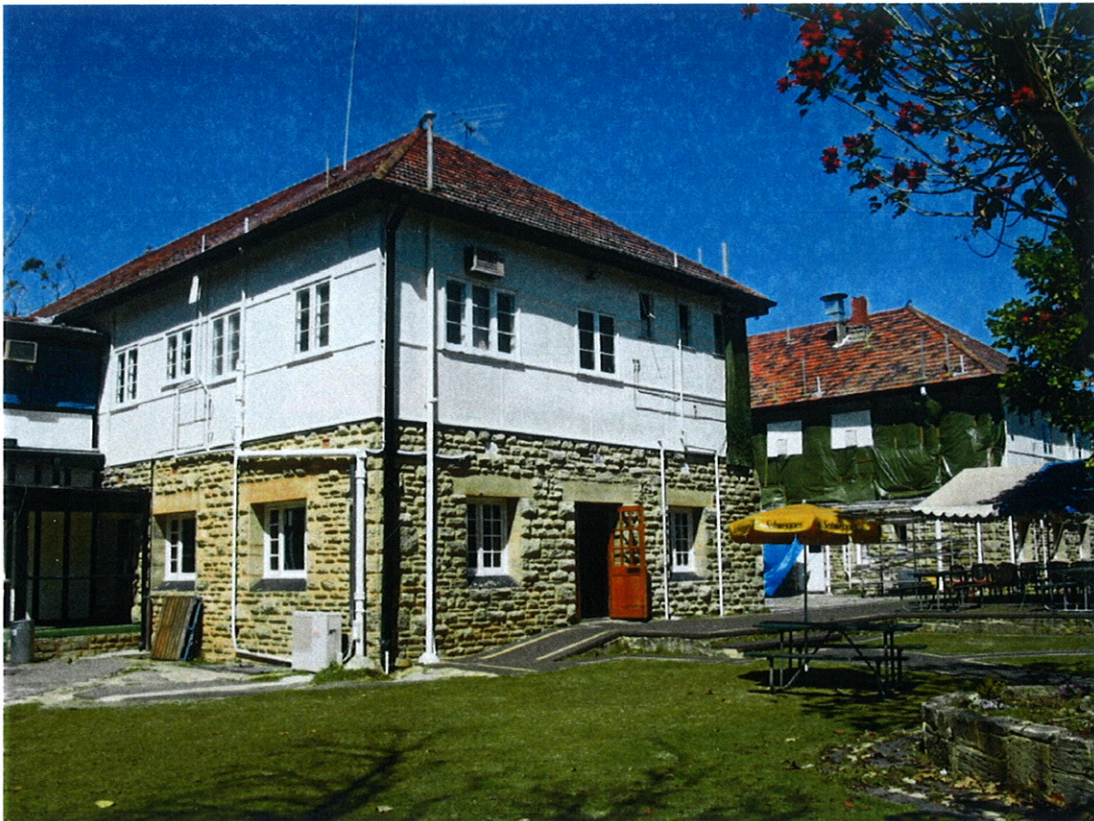
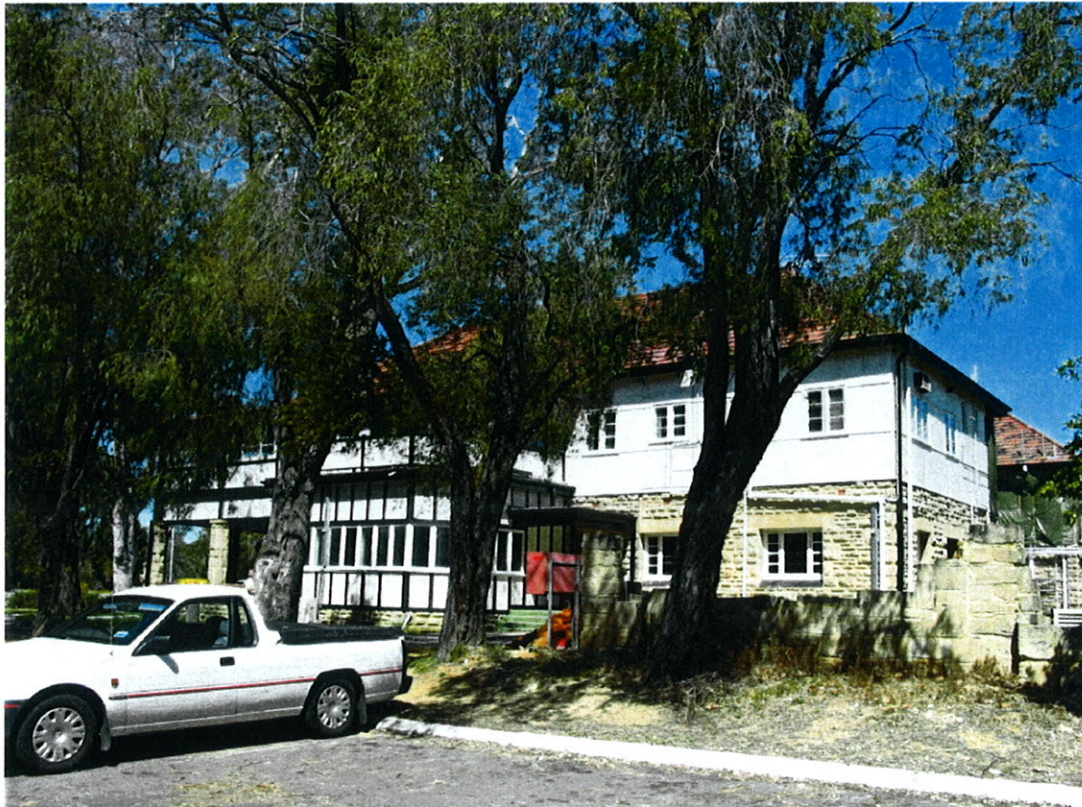
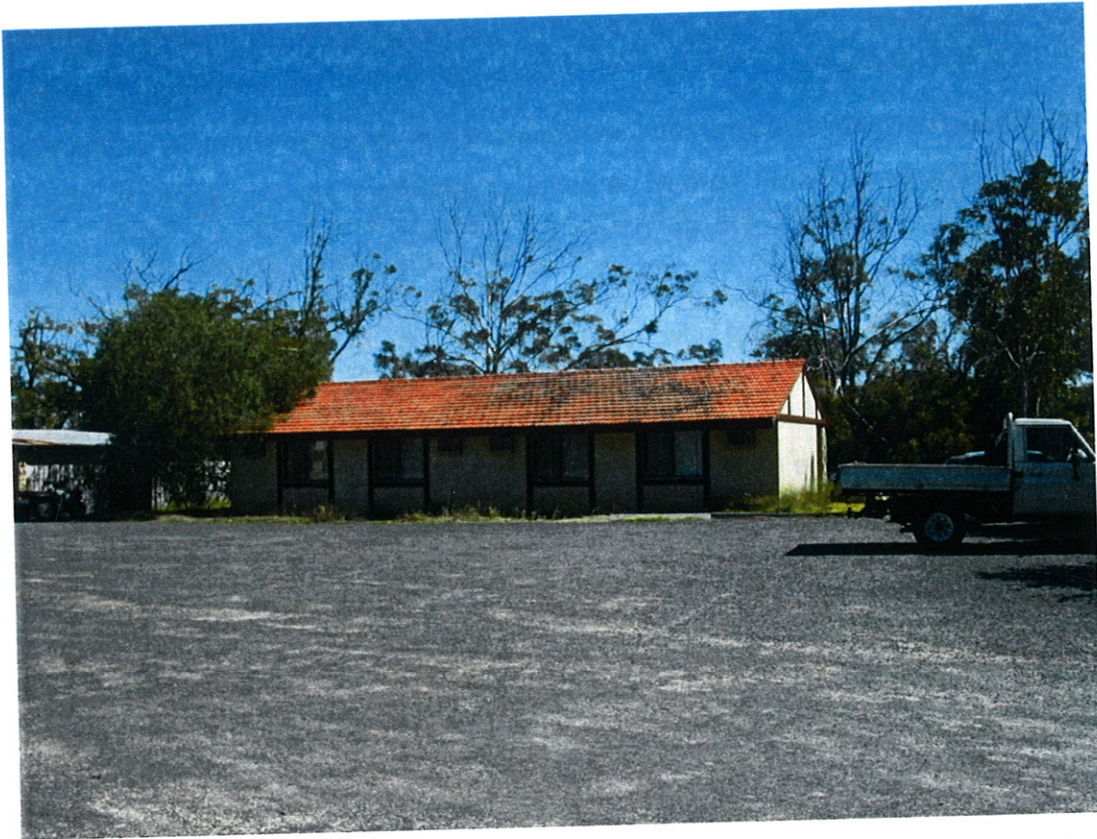
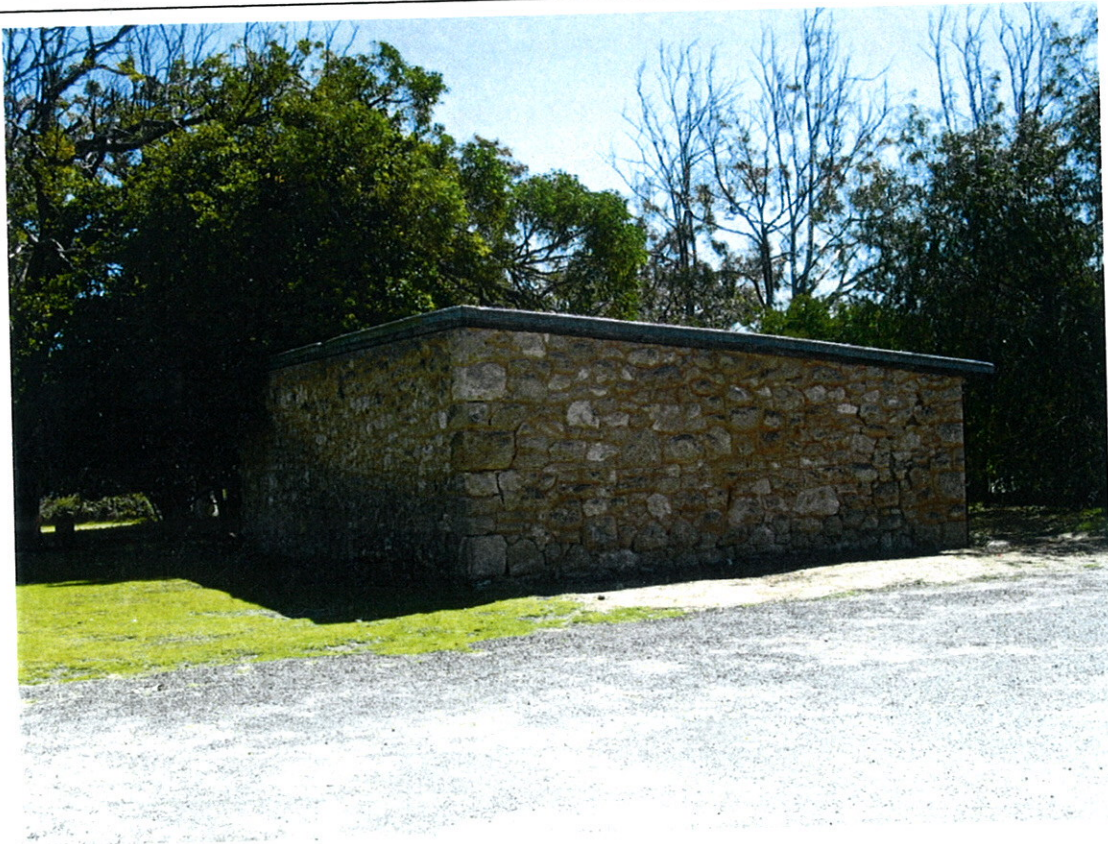
Figure 31 Yanchep Inn viewed from the east. September 2002. Hocking Planning and Architecture.

Figure 32 Yanchep Inn viewed from northeast. September 2002. Hocking Planning and Architecture.

Figure 33 Yanchep Inn viewed from the northwest. September 2002. Hocking Planning and Architecture.

Figure 34 Yanchep Inn viewed from the north. September 2002. Hocking Planning and Architecture.

Figure 35 Carpark and motel units south of Yanchep Inn. September 2002. Hocking Planning and Architecture.

Figure 36 Garage south of Yanchep Inn. September 2002. Hocking Planning and Architecture.

Physical evidence confirms the extension of the original tender to include sun porches. The garage appears to date from the original 1936 construction. The motel units appear to date from the late 1960s or 1970s.

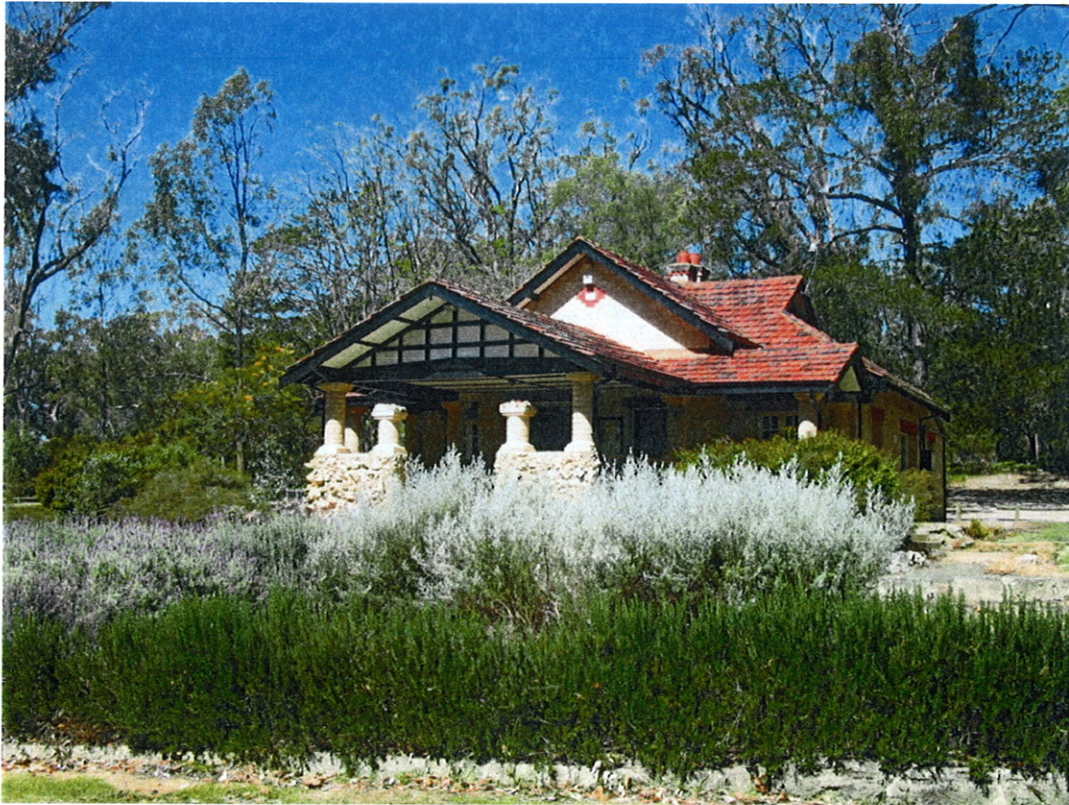
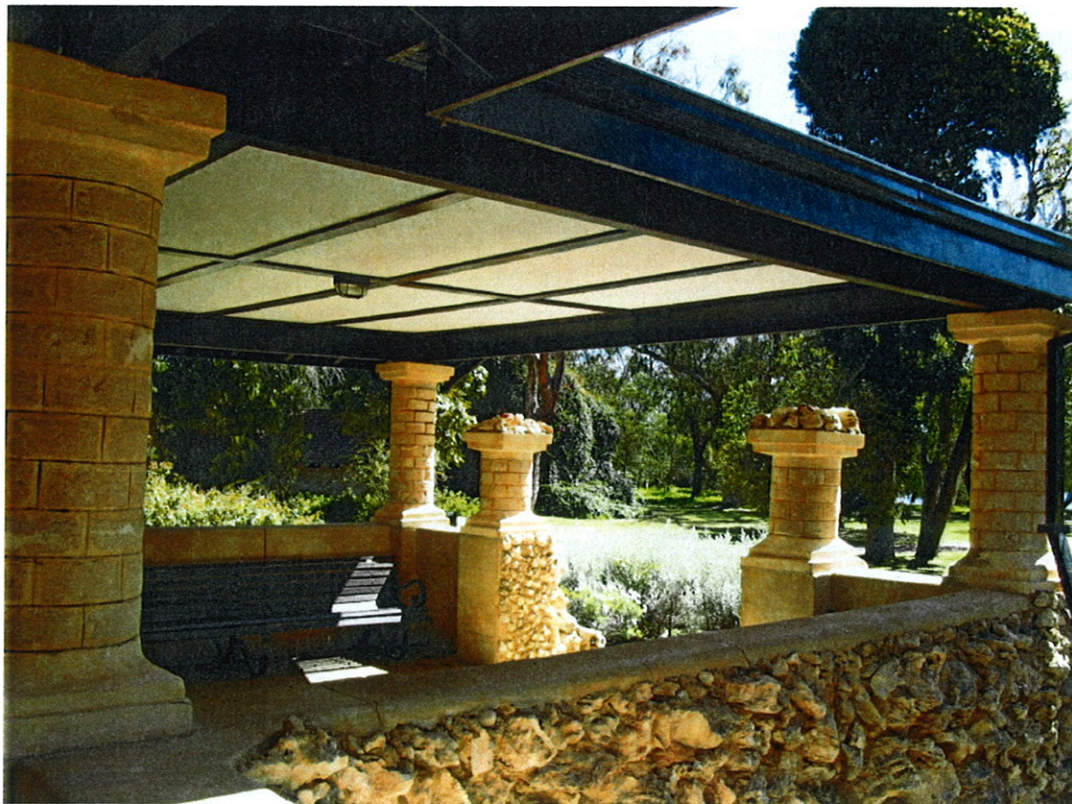
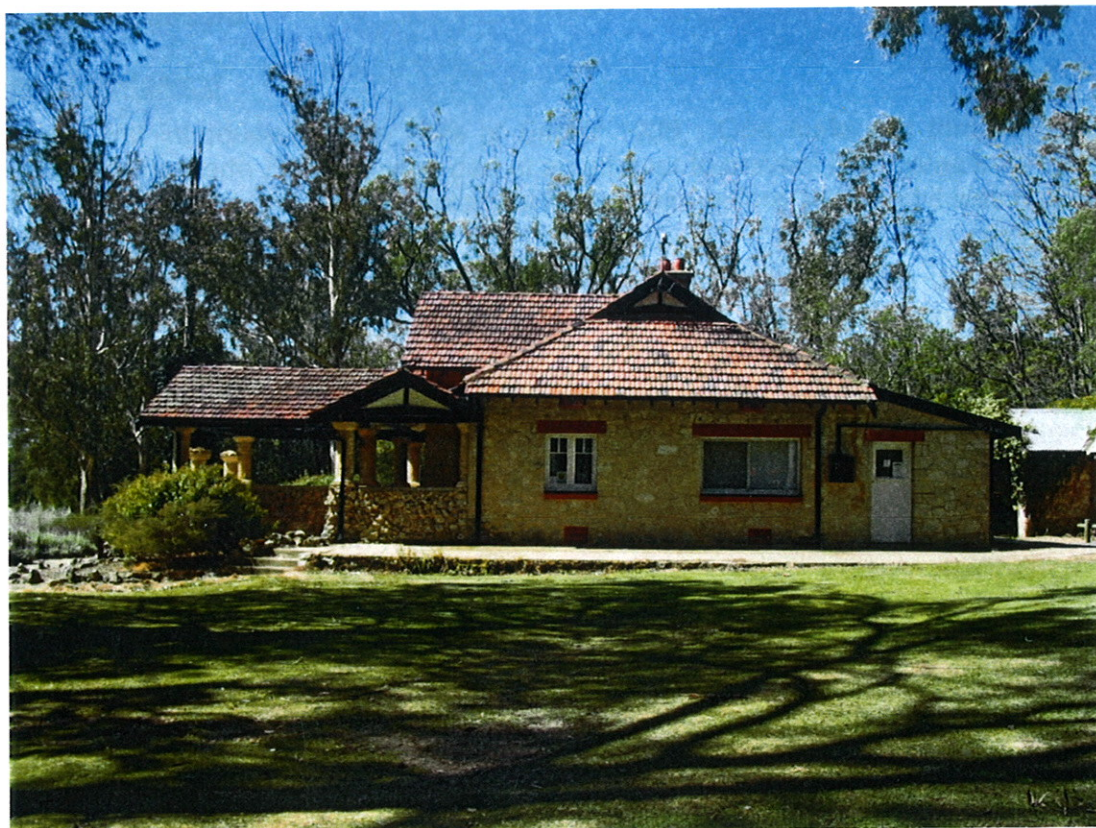
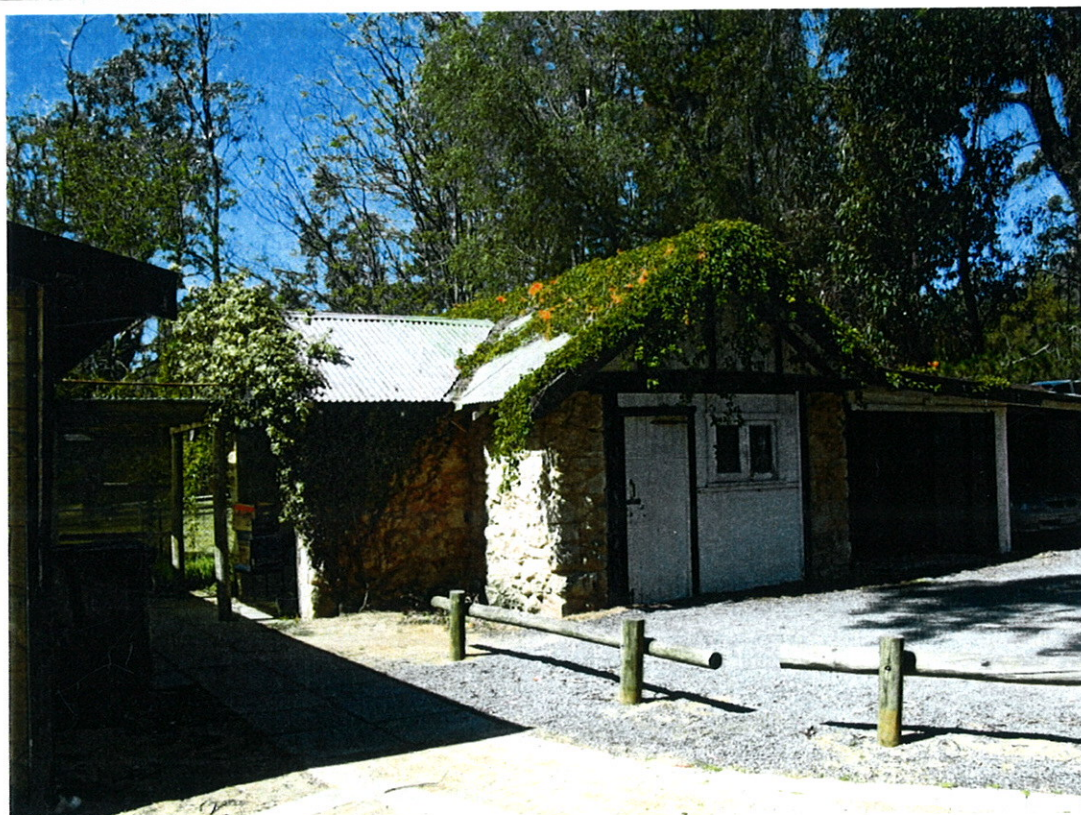
Figure 40 Administration building viewed from the northeast. September 2002. Hocking Planning and Architecture.

Figure 41 Front porch of the Administration Building. September 2002. Hocking Planning and Architecture.

Figure 42 Administration Building viewed from the west. September 2002. Hocking Planning and Architecture.

Figure 43 Flat to rear of Administration Building. September 2002. Hocking Planning and Architecture.

Physical evidence confirms a construction date for this building of the 1930s. The flat at the rear may have been built at the same time.

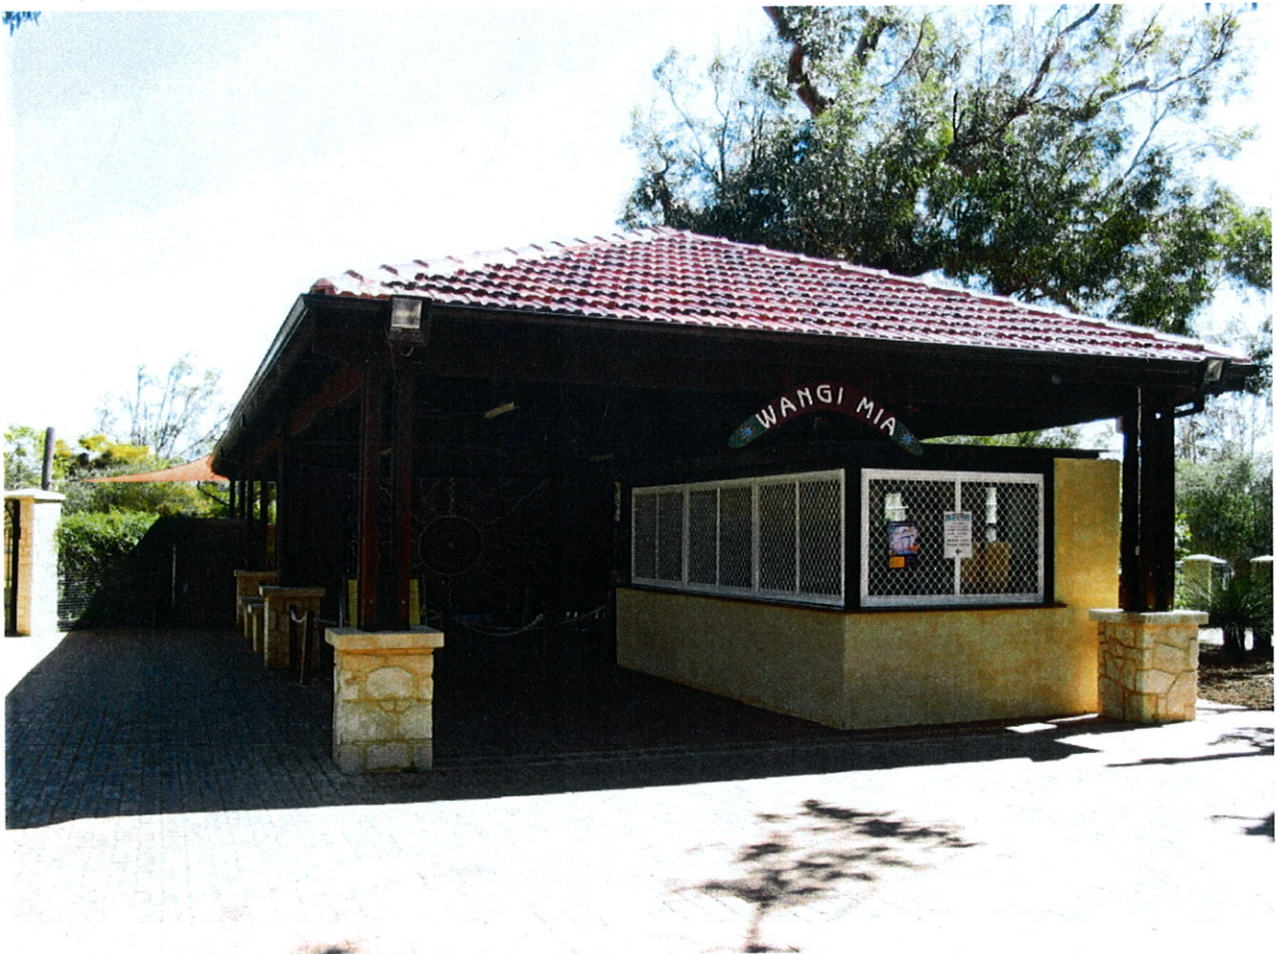
Wangi Mia is an open sided shelter with a hipped tiled roof. Steel and timber framing is set on limestone piers.

Figure 48 Wangi Mia. September 2002. Hocking Planning and Architecture.

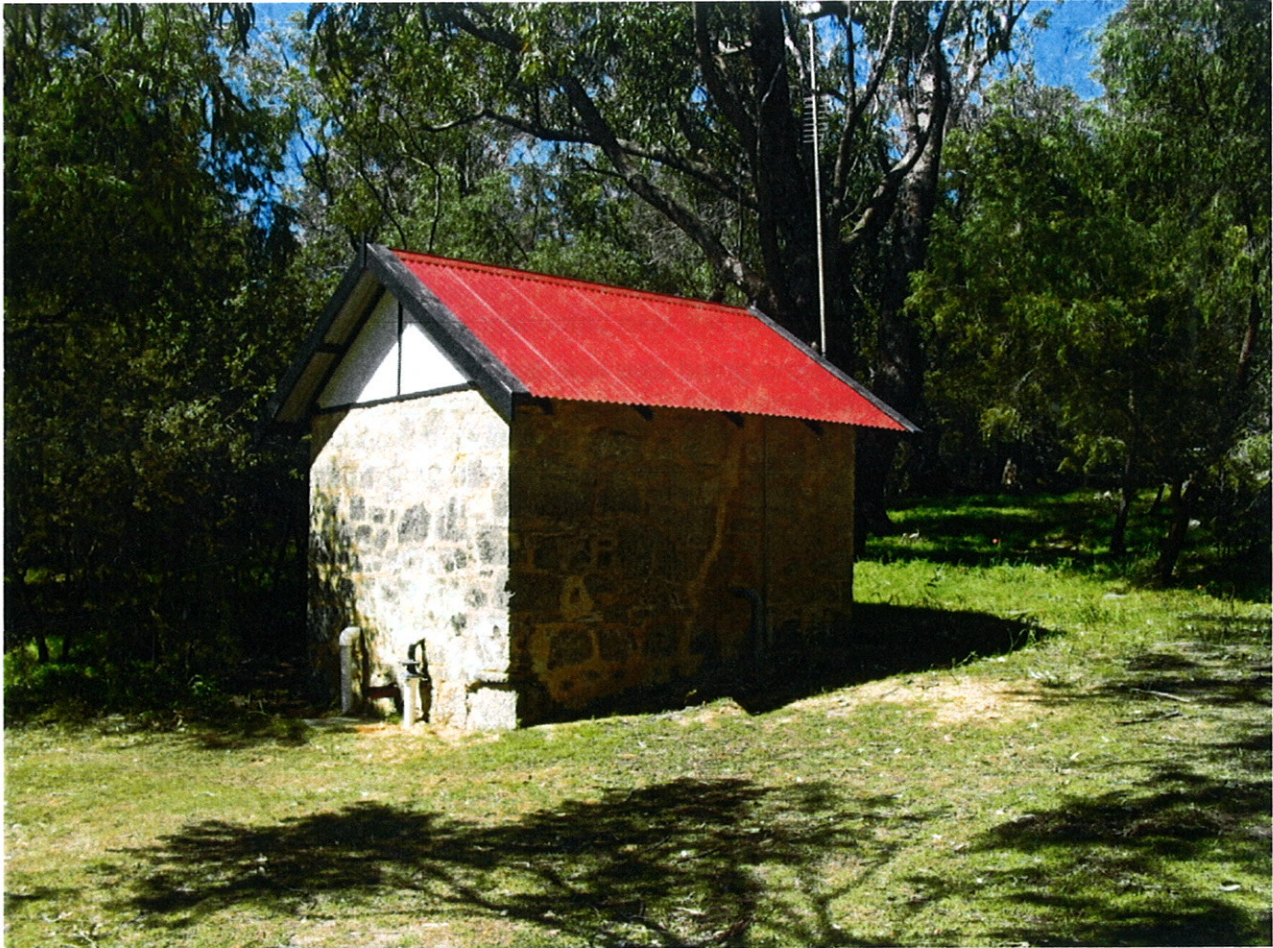
The building is a small limestone walled, Colorbond roof gabled shed-like structure located near the shore of Loch McNess.

Figure 49 The power house. September 2002. Hocking Planning and Architecture.

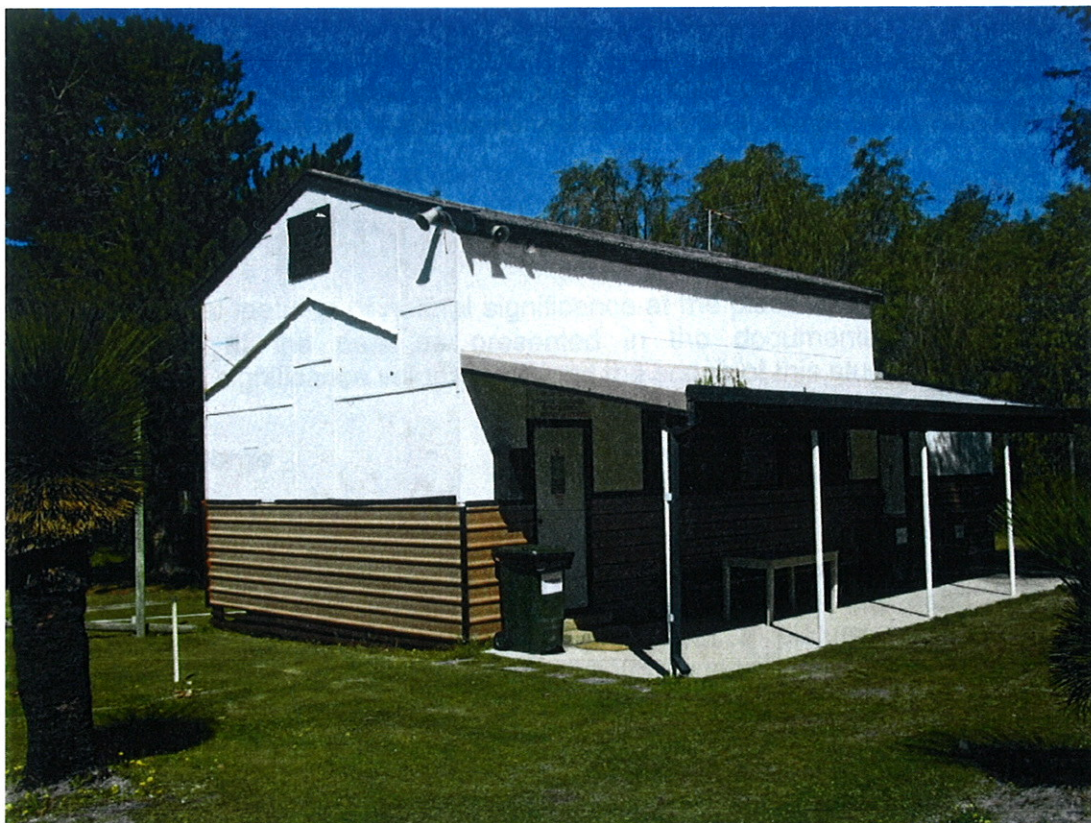
The physical evidence confirms a possible construction date of 1961 for the clubhouse. The limestone hut appears to date from the 1920s or 1930s.

Figure 50 Golf Clubhouse viewed from the northwest. September 2002.
Hocking Planning and Architecture.

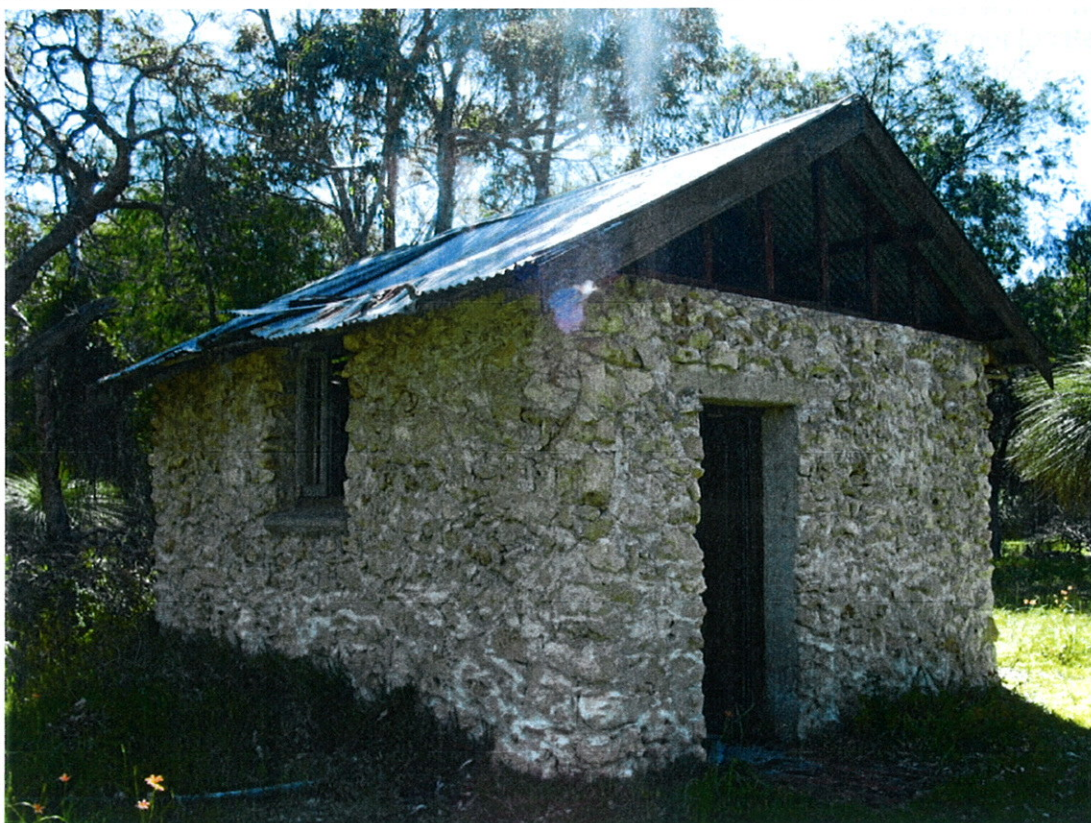
Figure 51 Limestone Hut viewed from the southeast. September 2002.
Hocking Planning and Architecture.

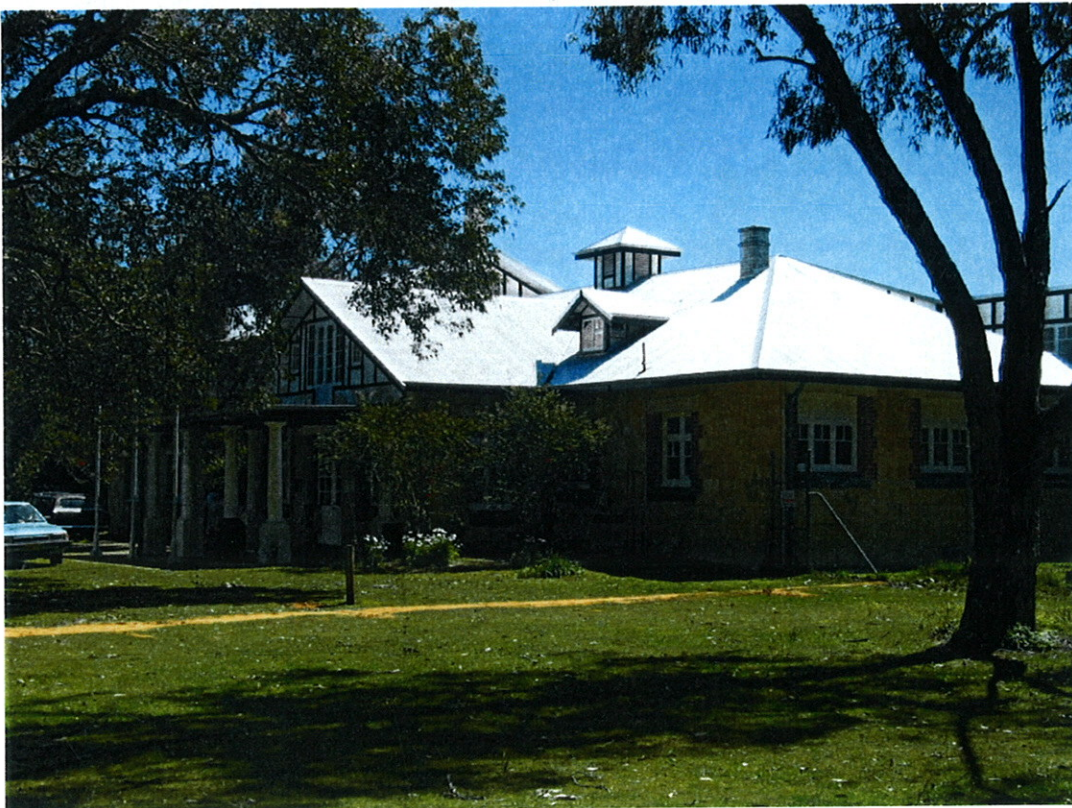
The physical evidence confirms the documentary evidence of the two stage construction of the place. The eastern section was the earlier part (1932) with the western section a later extension (1938).

*Figure 56 Gloucester Lodge viewed from the southeast. September 2002.
Hocking Planning and Architecture.*

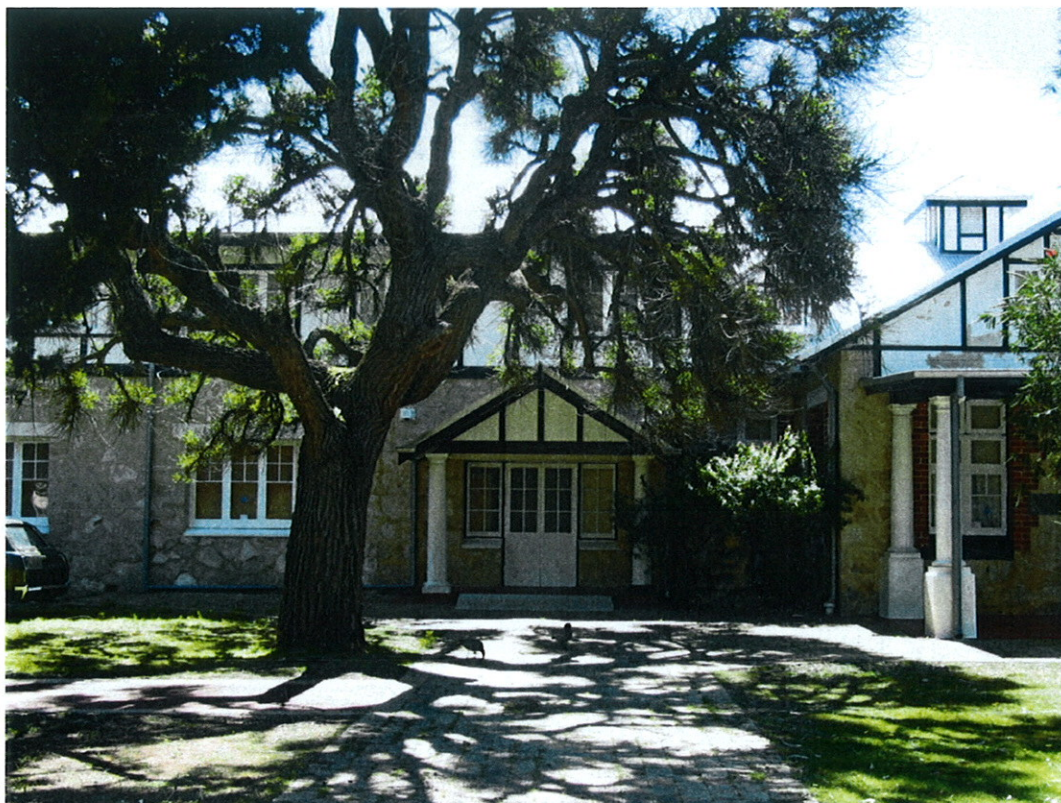
Figure 57 Entrance to the western section of Gloucester Lodge viewed from the south. September 2002. Hocking Planning and Architecture.
