McNess Recreation Area Yanchep National Park Non-Indigenous Cultural Heritage Conservation Plan

Final Report
July 2003

Hocking Planning & Architecture

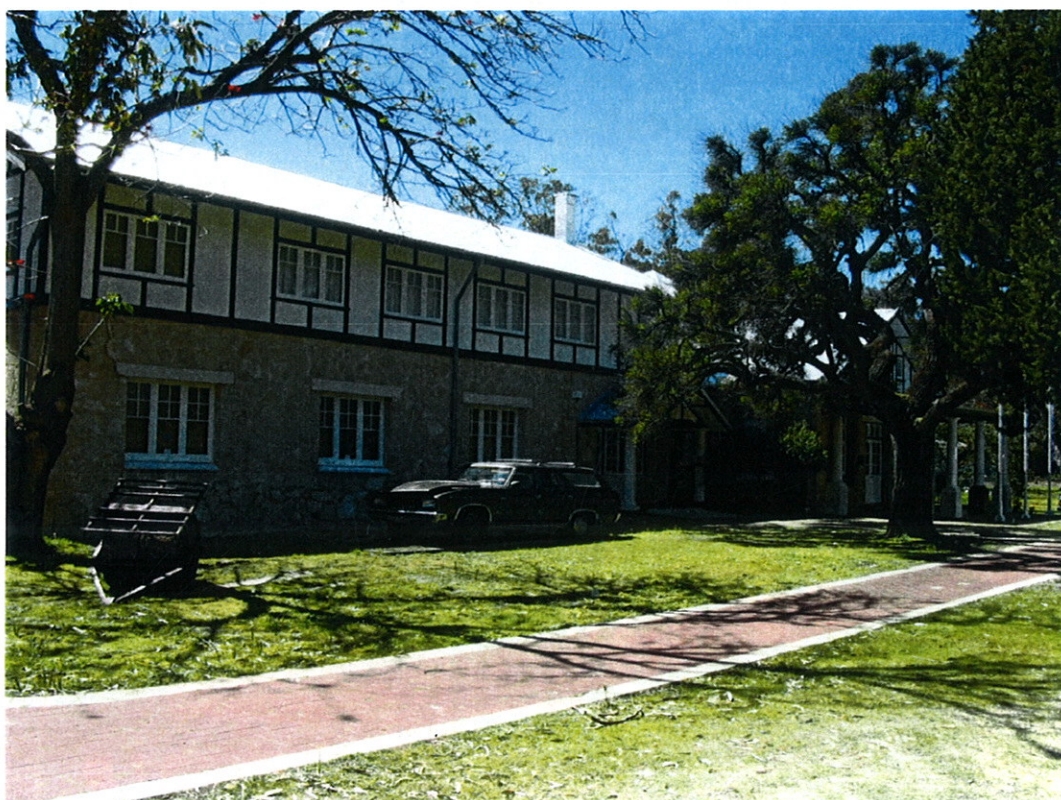
Figure 58 Gloucester Lodge viewed from the southwest. September 2002. Hocking Planning and Architecture.

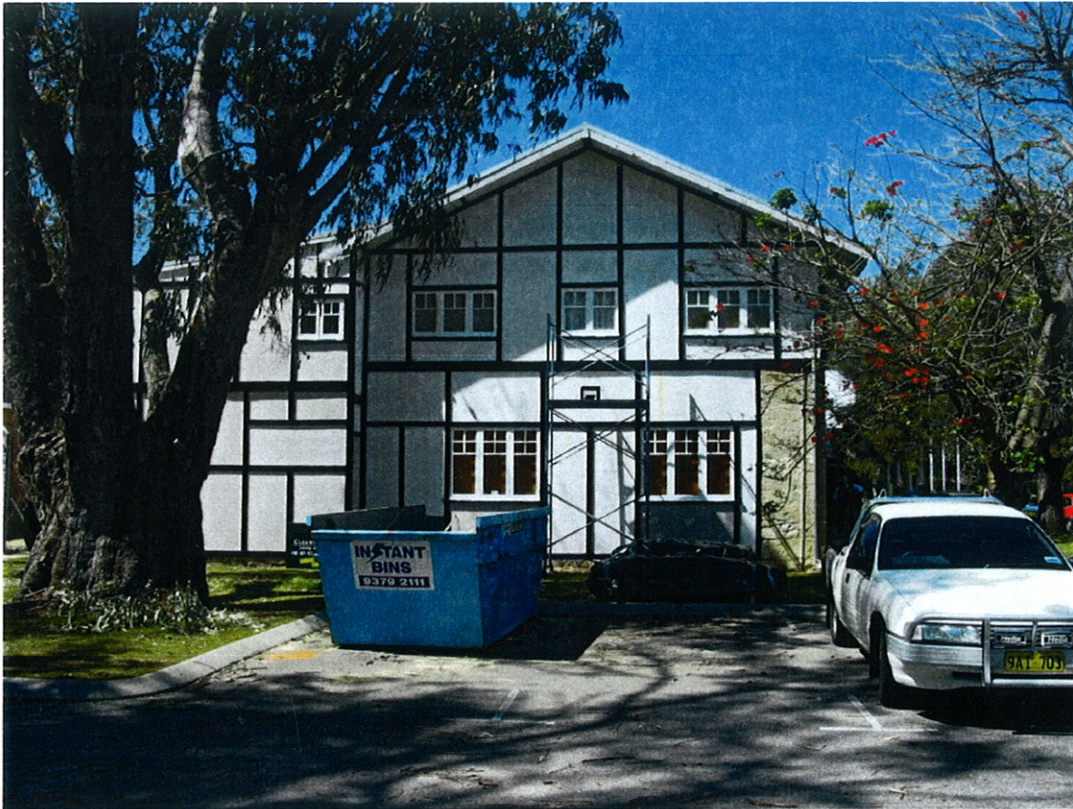
Figure 59 Gloucester Lodge viewed from the west. September 2002.
Hocking Planning and Architecture.

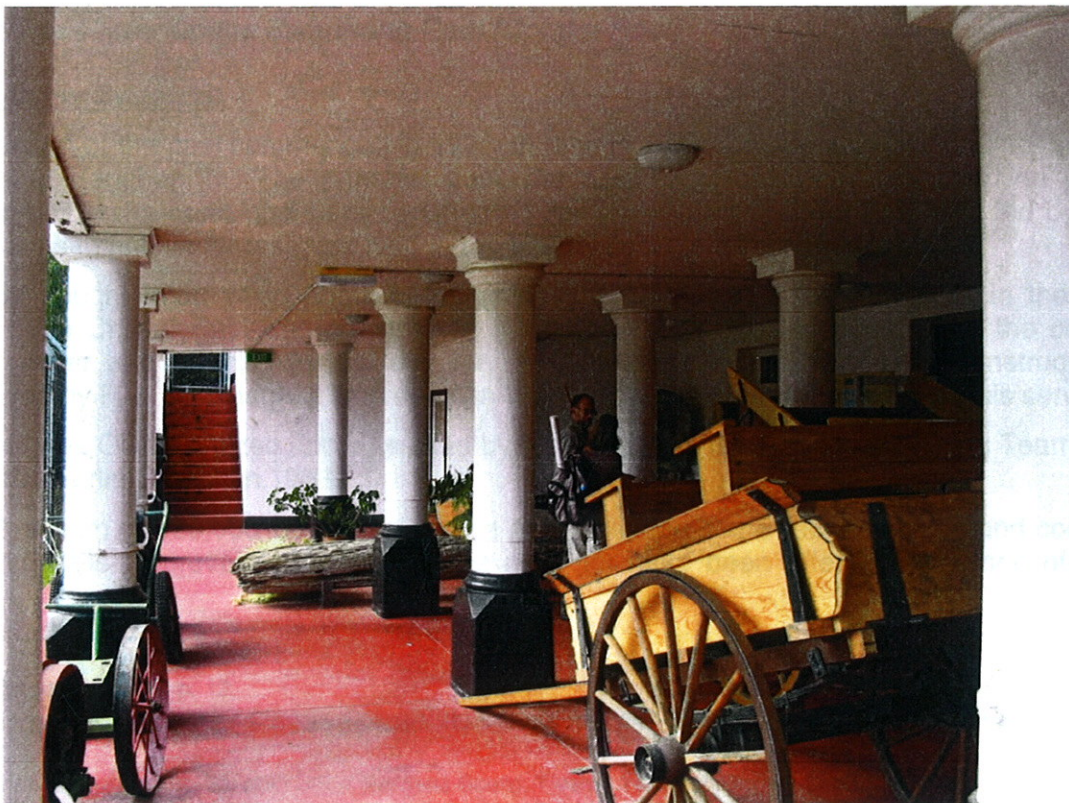
Figure 60 Ground floor loggia at north of Gloucester Lodge. July 2002.
Hocking Planning & Architecture.

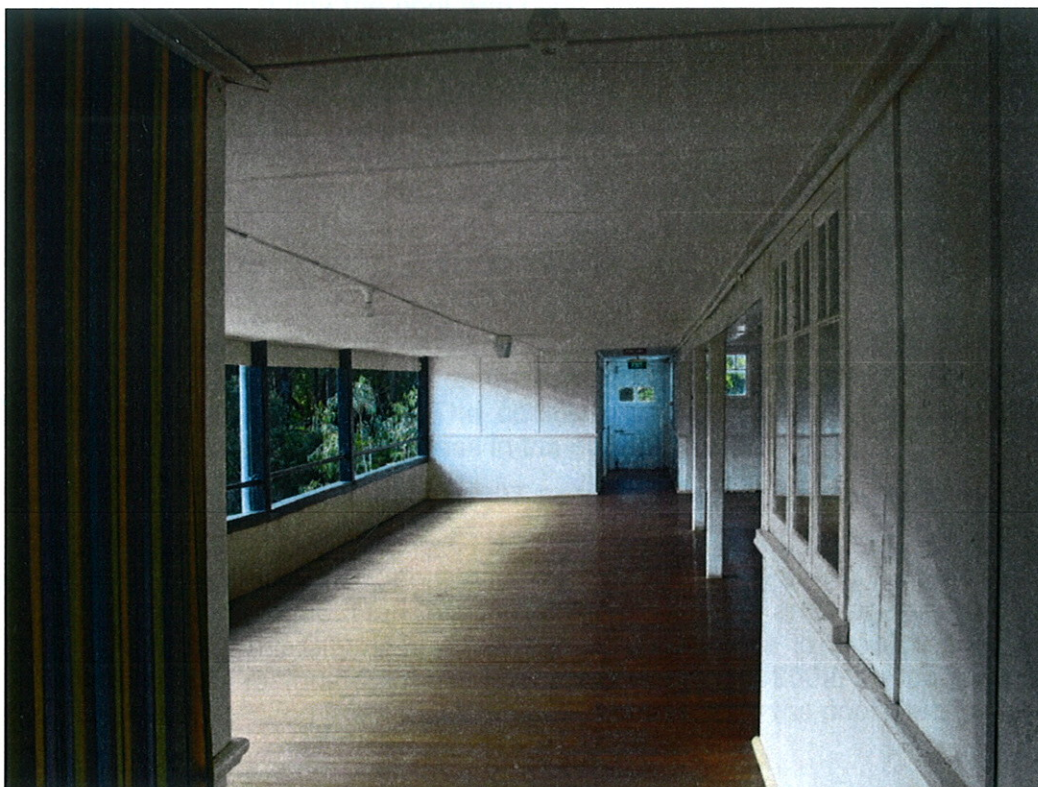
Figure 61 First floor loggia at north of Gloucester Lodge. July 2002. Hocking Planning and Architecture.

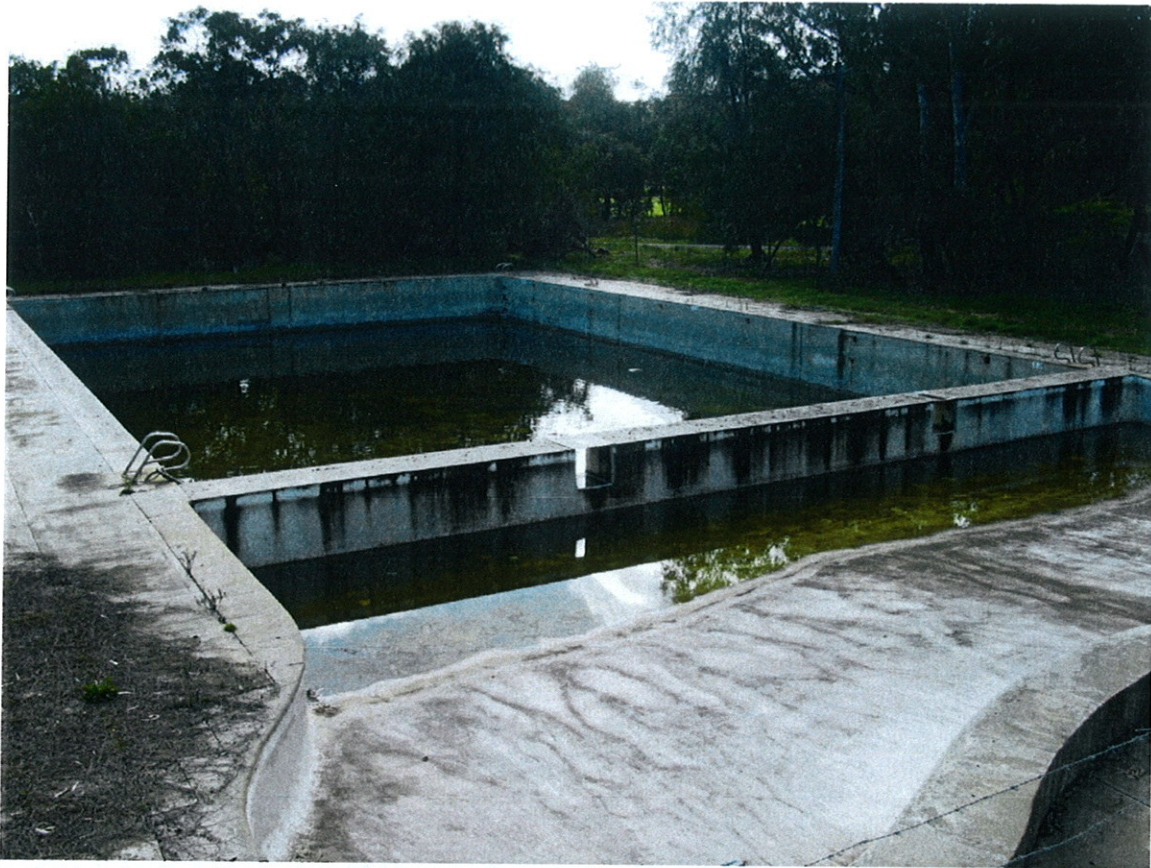
The physical evidence confirms the documentary evidence that the pool was constructed in 1932 and reconcreted in 1968. The diving tower has been lost. The date of construction of the plant room and change rooms has not been ascertained but may have accompanied the reconcreting in 1968.

Figure 63 Gloucester Lodge Swimming Pool viewed from Gloucester Lodge. July 2002. Hocking Planning and Architecture.

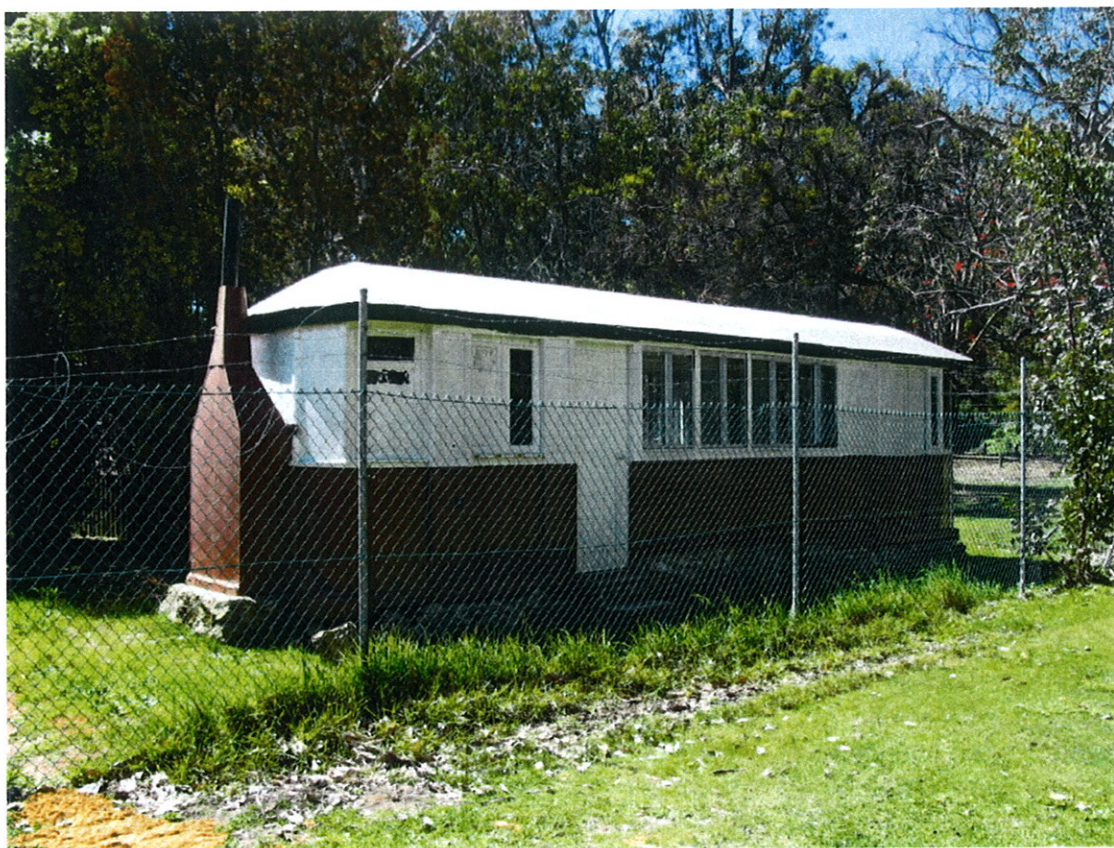
Trams were relocated to Yanchep in 1933 to provide accommodation. One remains adjacent to Gloucester Lodge having been relocated from the Gorge.

Figure 65 Tram Cottage adjacent Gloucester Lodge. Hocking Planning & Architecture, September 2002.

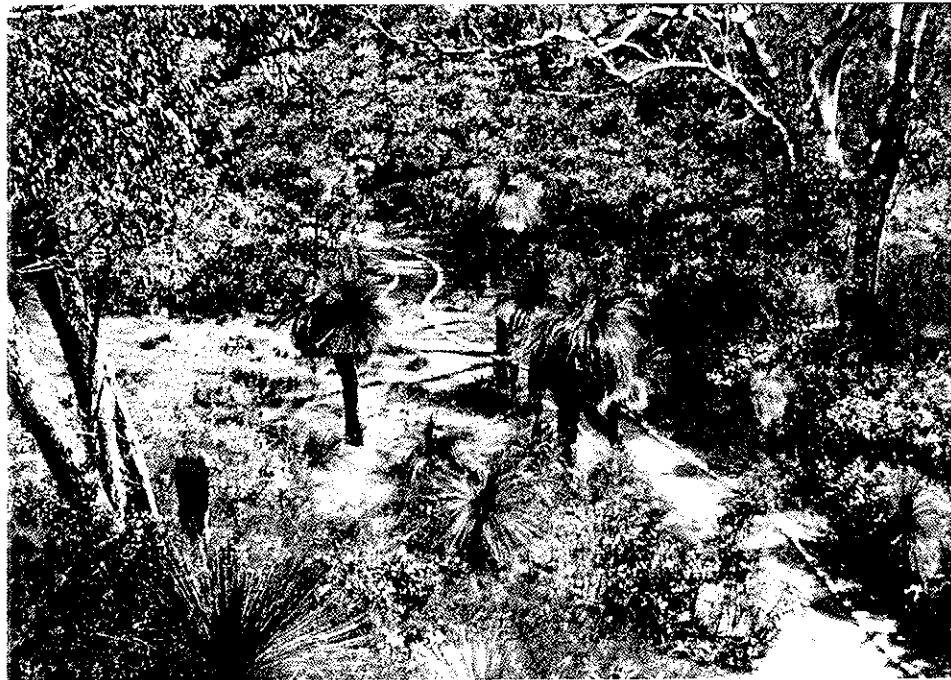
From an early stage of the development, the clearing of tracks was undertaken. To begin with, they were just bare earth with the vegetation 'chopped back'. Subsequently, the forming up of pathways was undertaken as part of garden development. Later again walking trails were developed as part of the "nature appreciation experience" of the Park. These Walking trails have been designed and implemented to give visitors 'a taste of the bush' in various different areas of the Park. The more recently implemented ones have been designed to a purpose and constructed to a standard. Although the extent of early paths has not been ascertained, Mr David Pike has stated that there are many early paths remaining with limestone edging but most are overgrown or lost now.²⁷⁴

Figure 66 Walking Trails. (Undated) Courtesy DCLM Park Office.

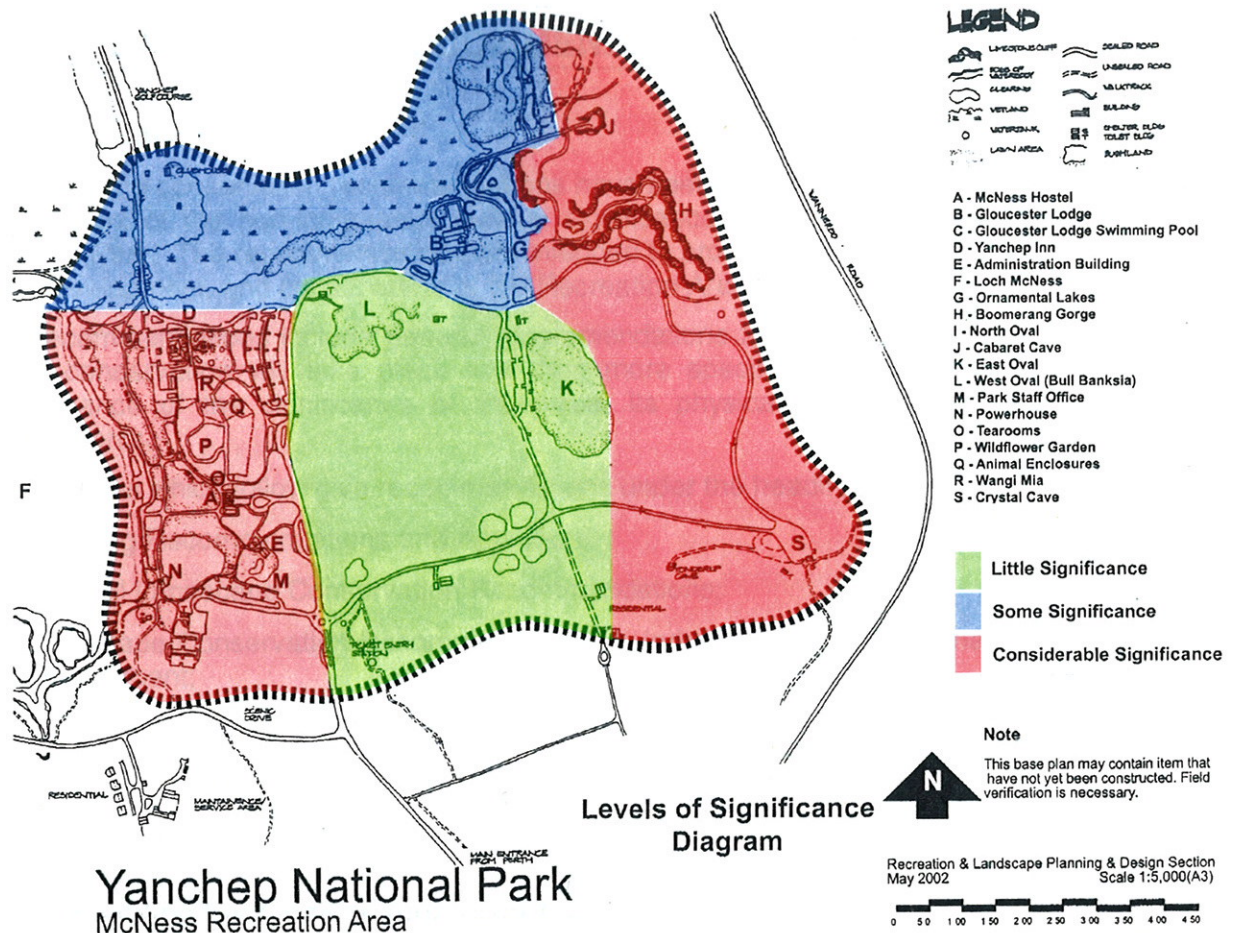
Figure 76 Levels of Significance of the Precincts within the McNess Recreation Area. Elements within precincts may differ in their level of significance.
